Aug 19, 2021 at 11:58:54 AM
39.986384,-104.527789
Manilla Rd
Teenesburg CO 80643
United States
COGCC

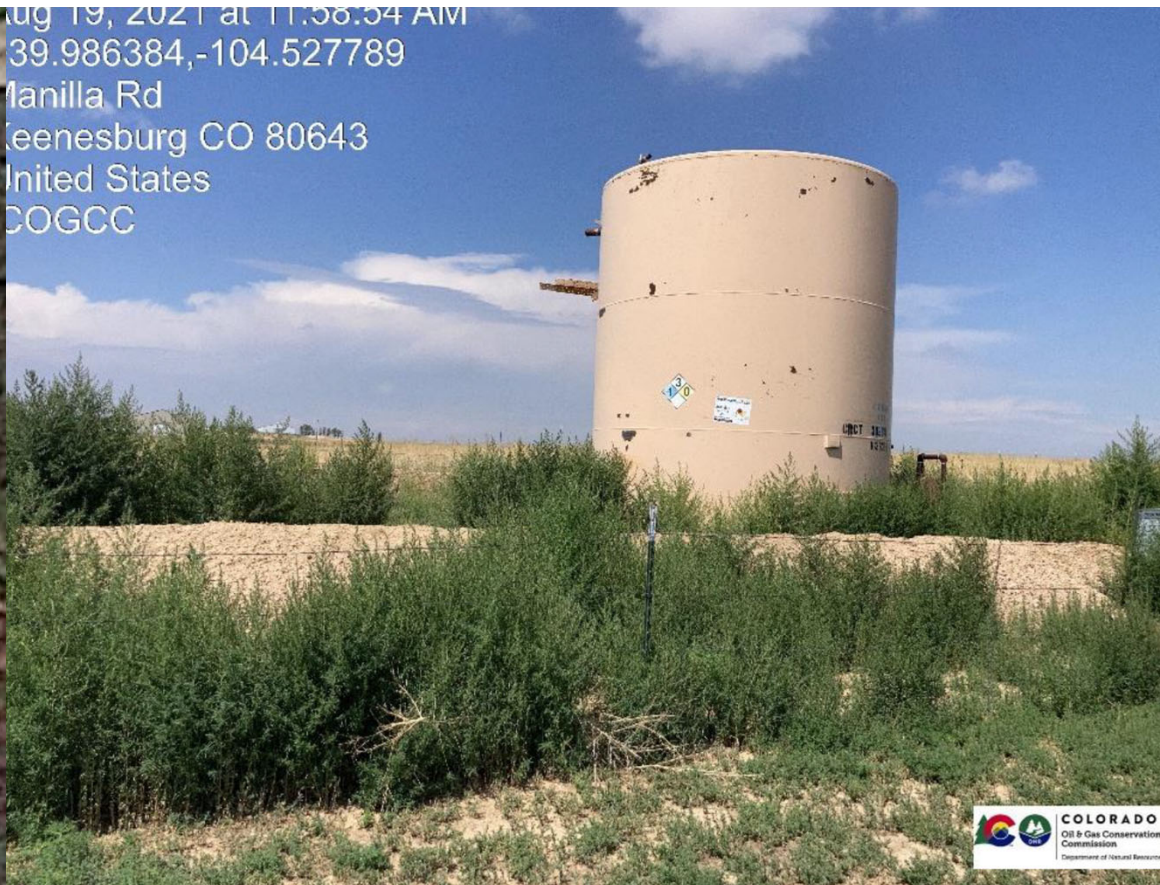
Here the Crude Oil Tank is situated higher than Produced Water Tank. They are both connected to the manifold in the Separator. A failed valve in the manifold could cause a gravity flow until the tanks equalize. The wells may also still be connected and could be the source of the overtopping. Easy access from Manilla Road and 160th Ave. suggests possible tampering.

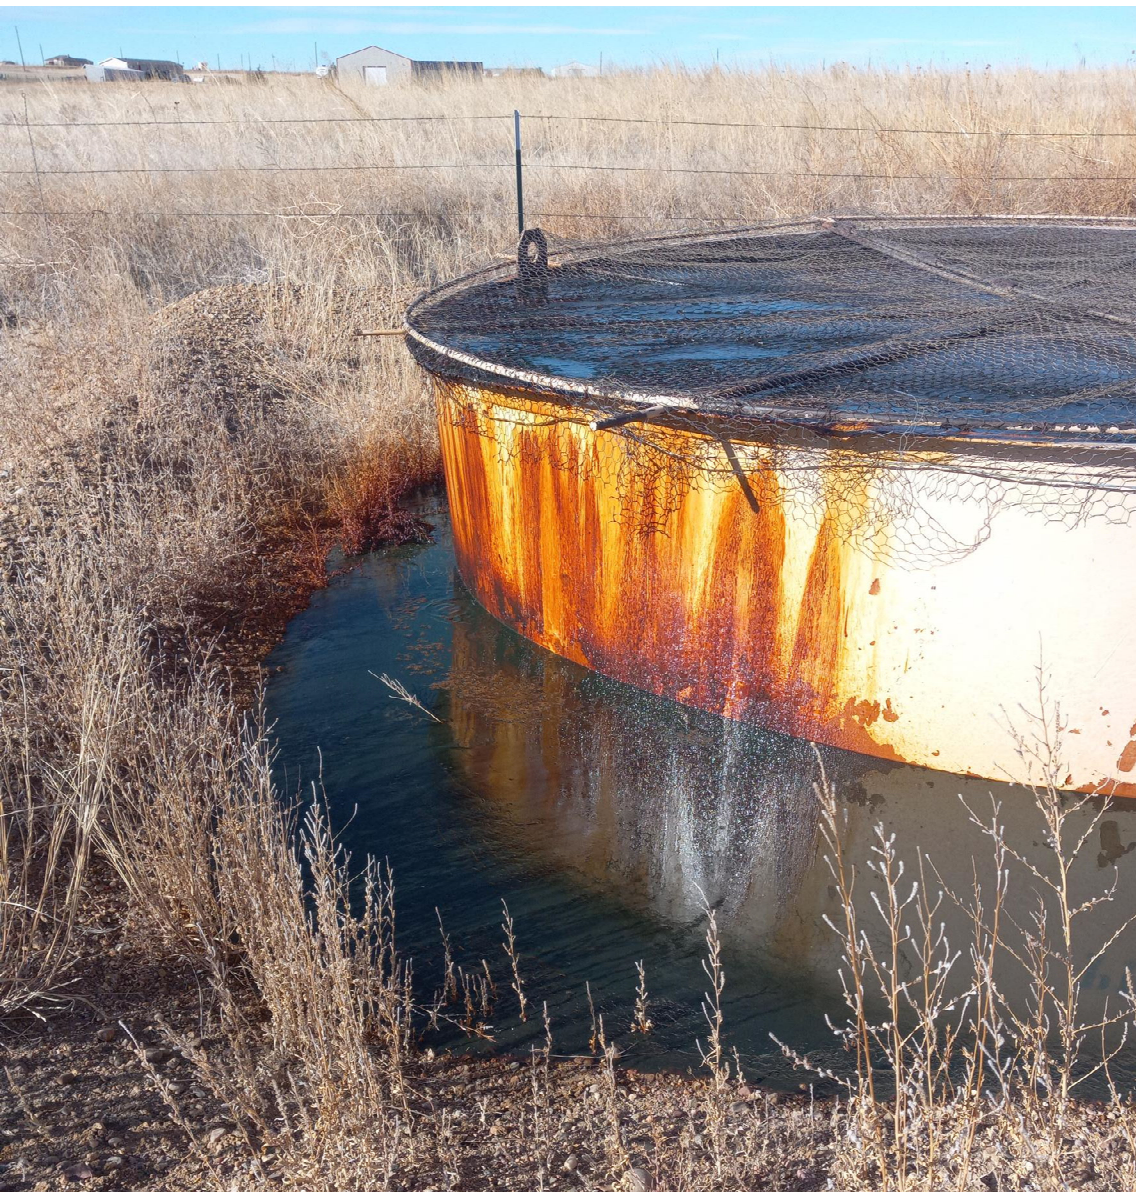
The overtopping on the produced water tank is encroaching on the secondary containment freeboard, but no longer appears to be flowing.

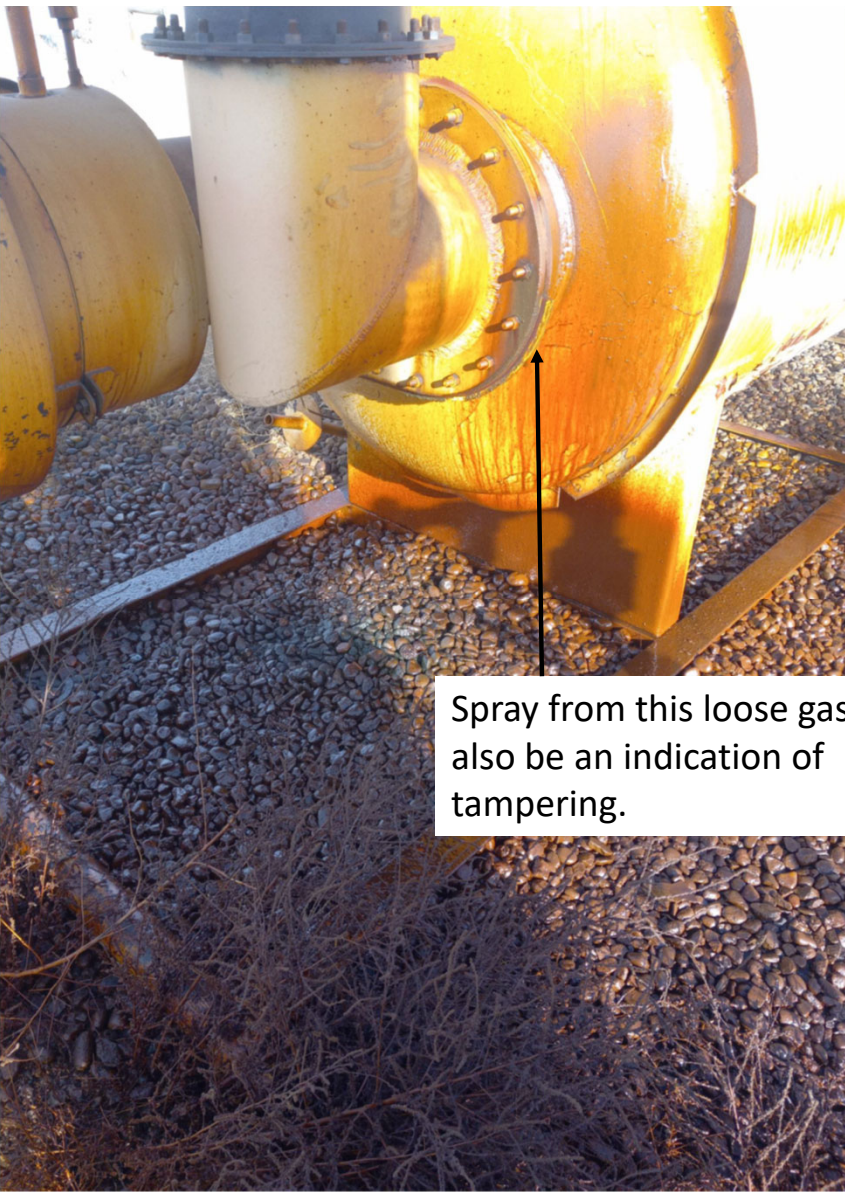
Spray from this loose gasket might also be an indication of tampering.
