Inspection Photos  
Location Name: Redwin 22-4  
API #069-06227

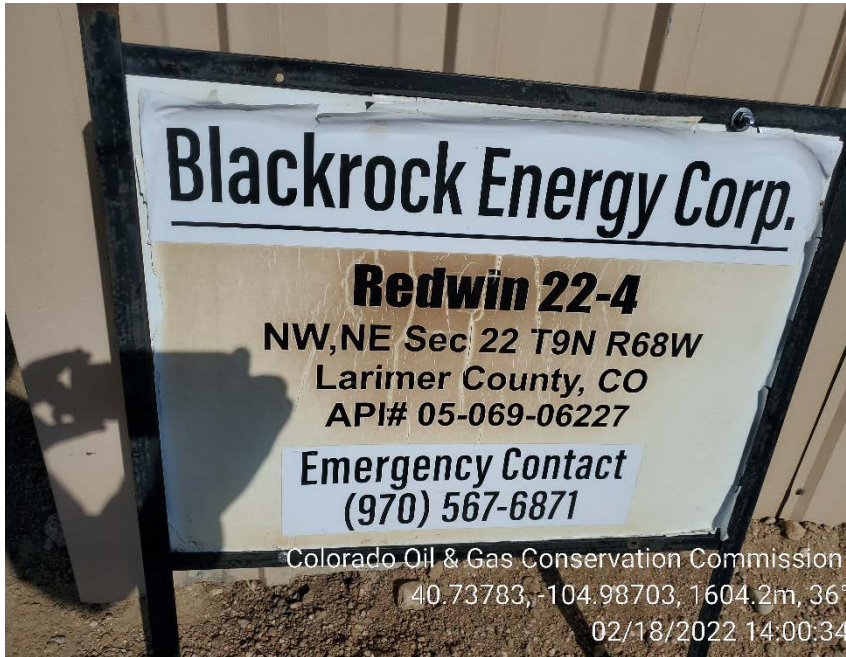
Wellhead sign

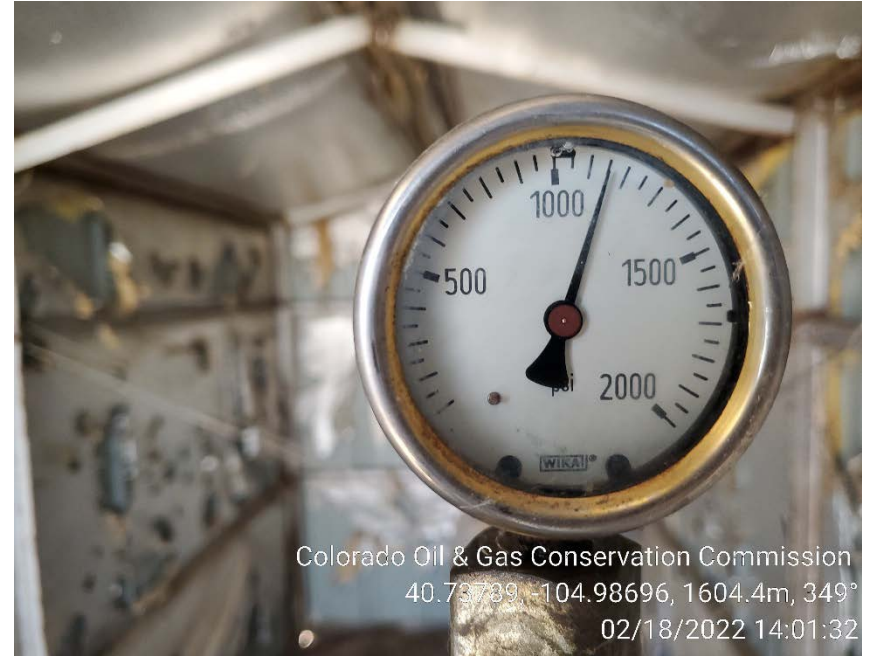
Tubing pressure

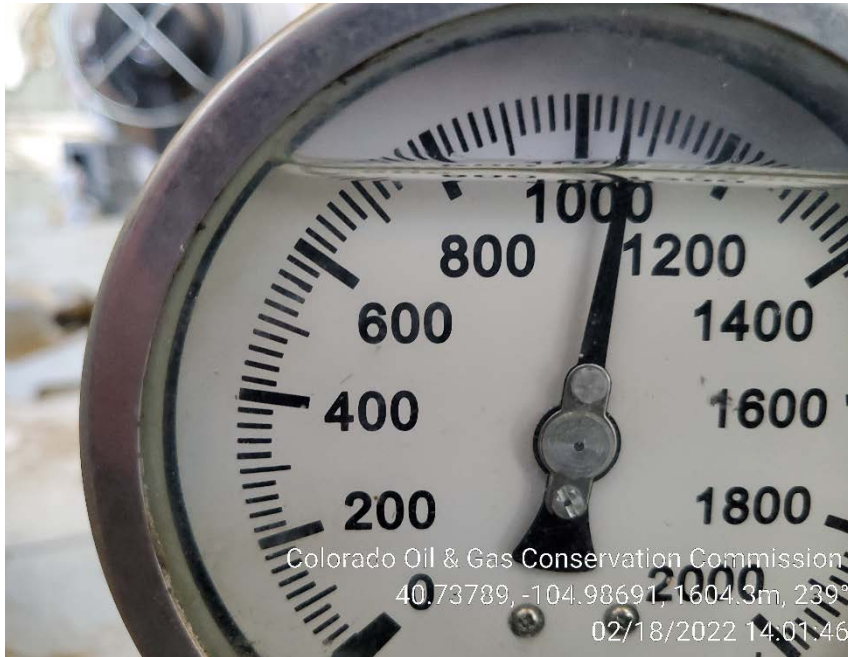
**Casing pressure**

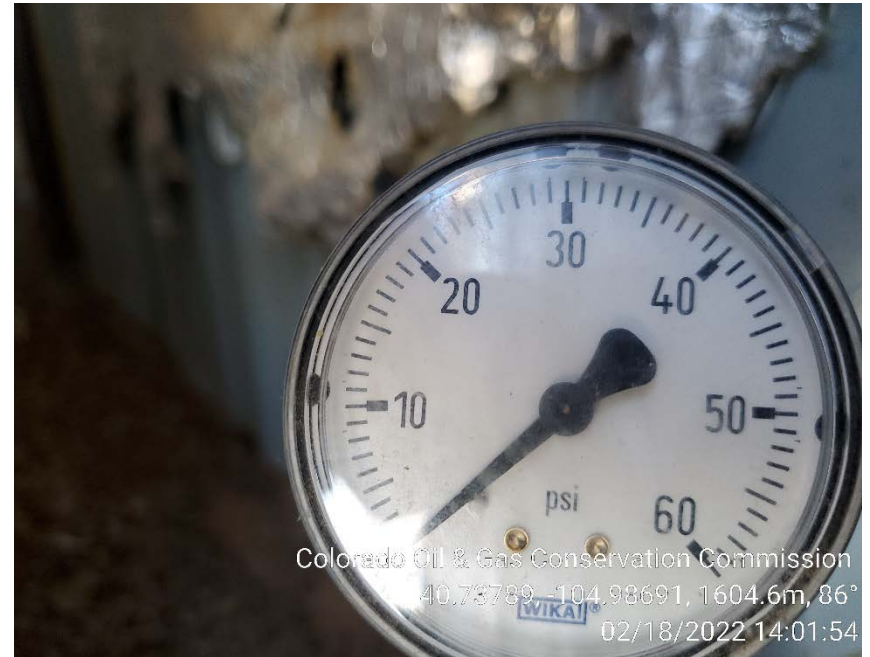
**Bradenhead pressure**
