Inspection Photos
Operator: Simcoe
API: 067-09054
Date: 2/18/2022

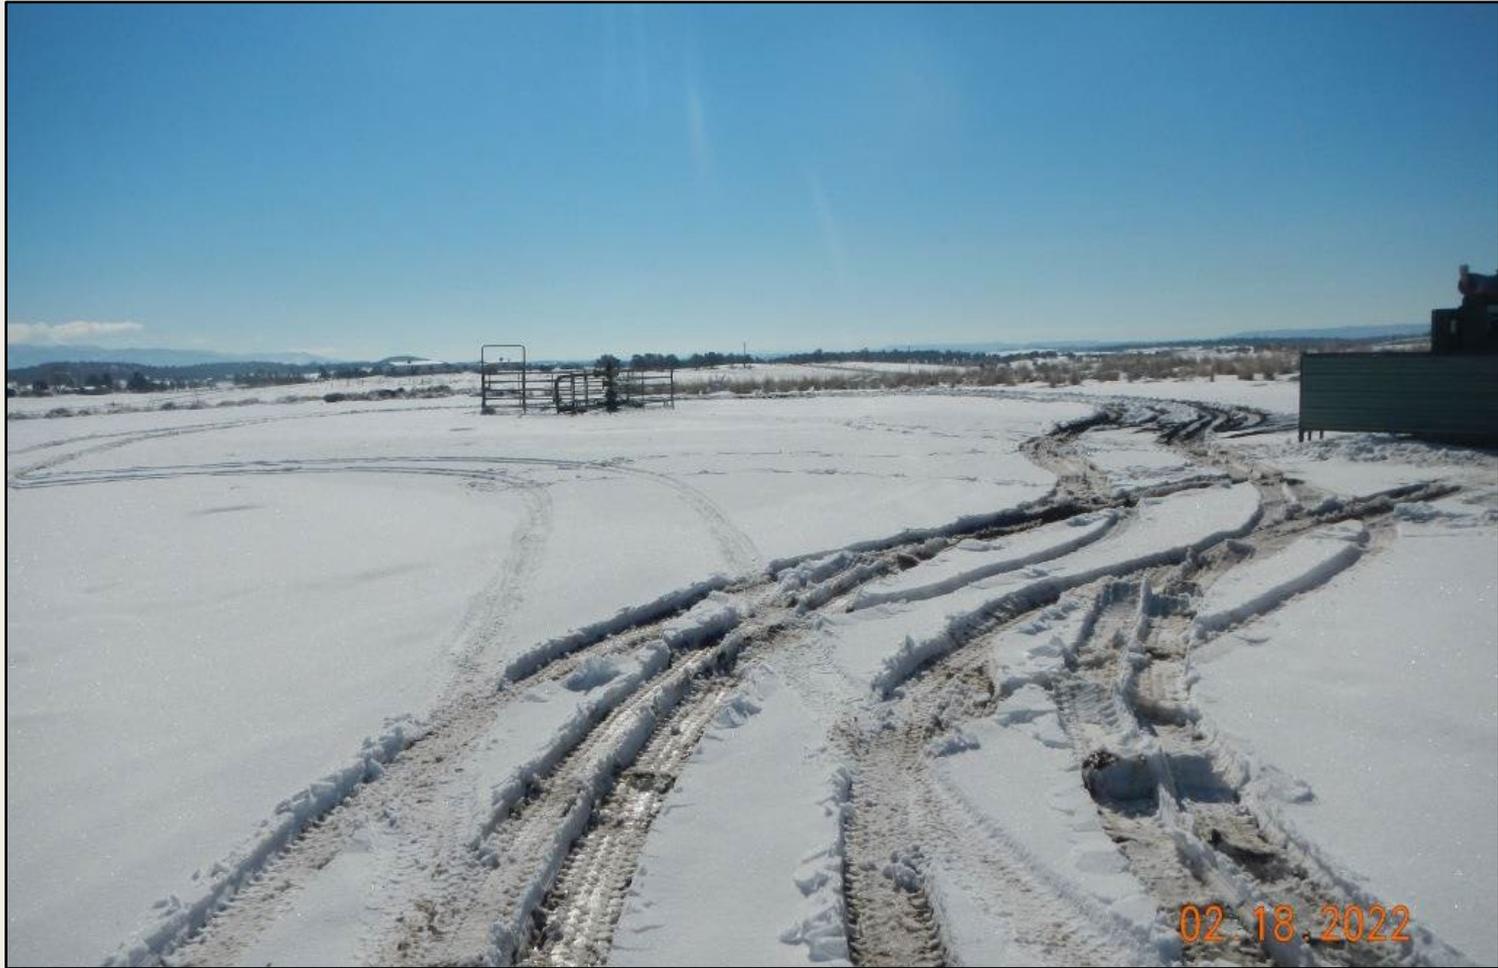
Photo 1. View of project area from the well pad entrance facing center.

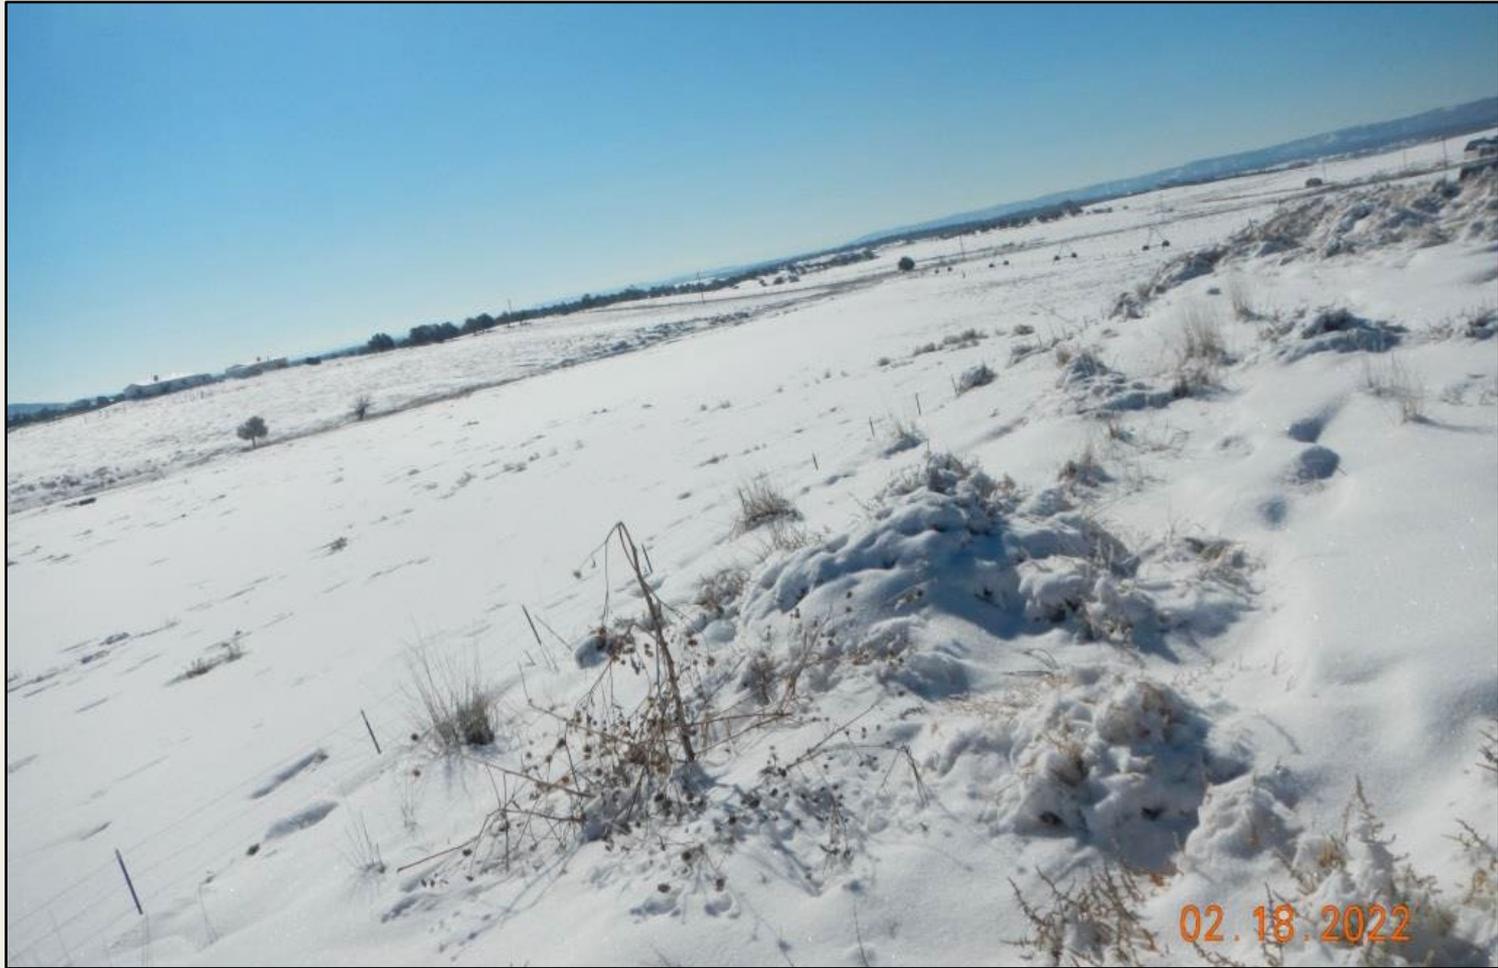
Photo 2. View of the eastern project area from the northeastern corner facing southward. Revegetation appears to be progressing with intermediate wheatgrass and crested wheatgrass. Vegetation cover and weeds should be monitored and managed during the active growing season.

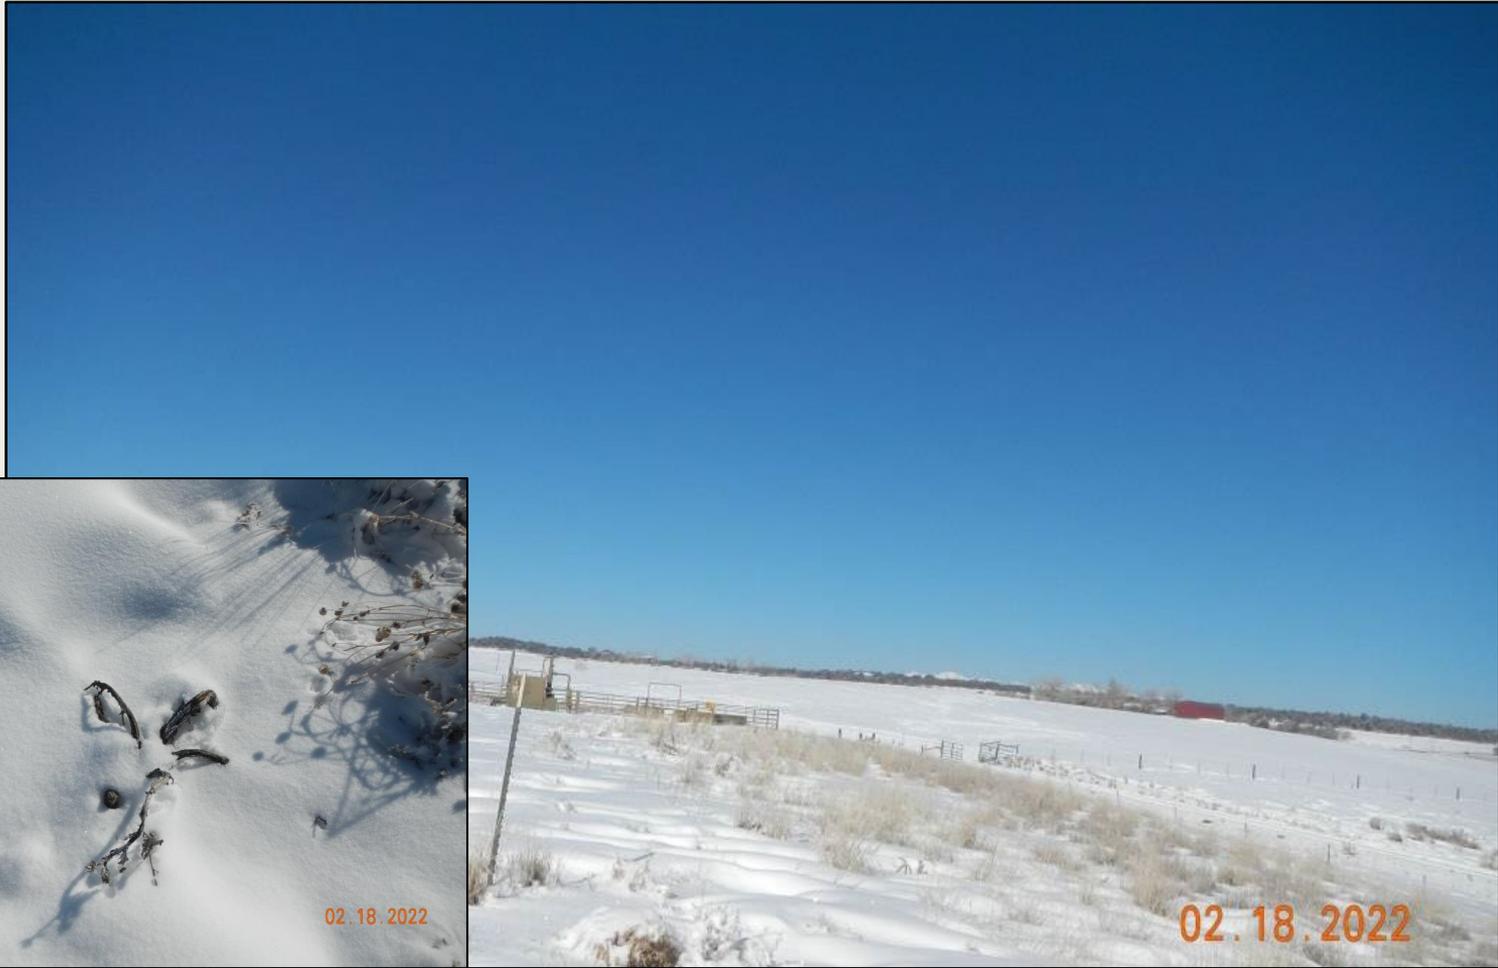
Photo 3. View of the northern portion of the project area from the northeastern corner facing westward. Scattered musk thistles observed through snow (inset).

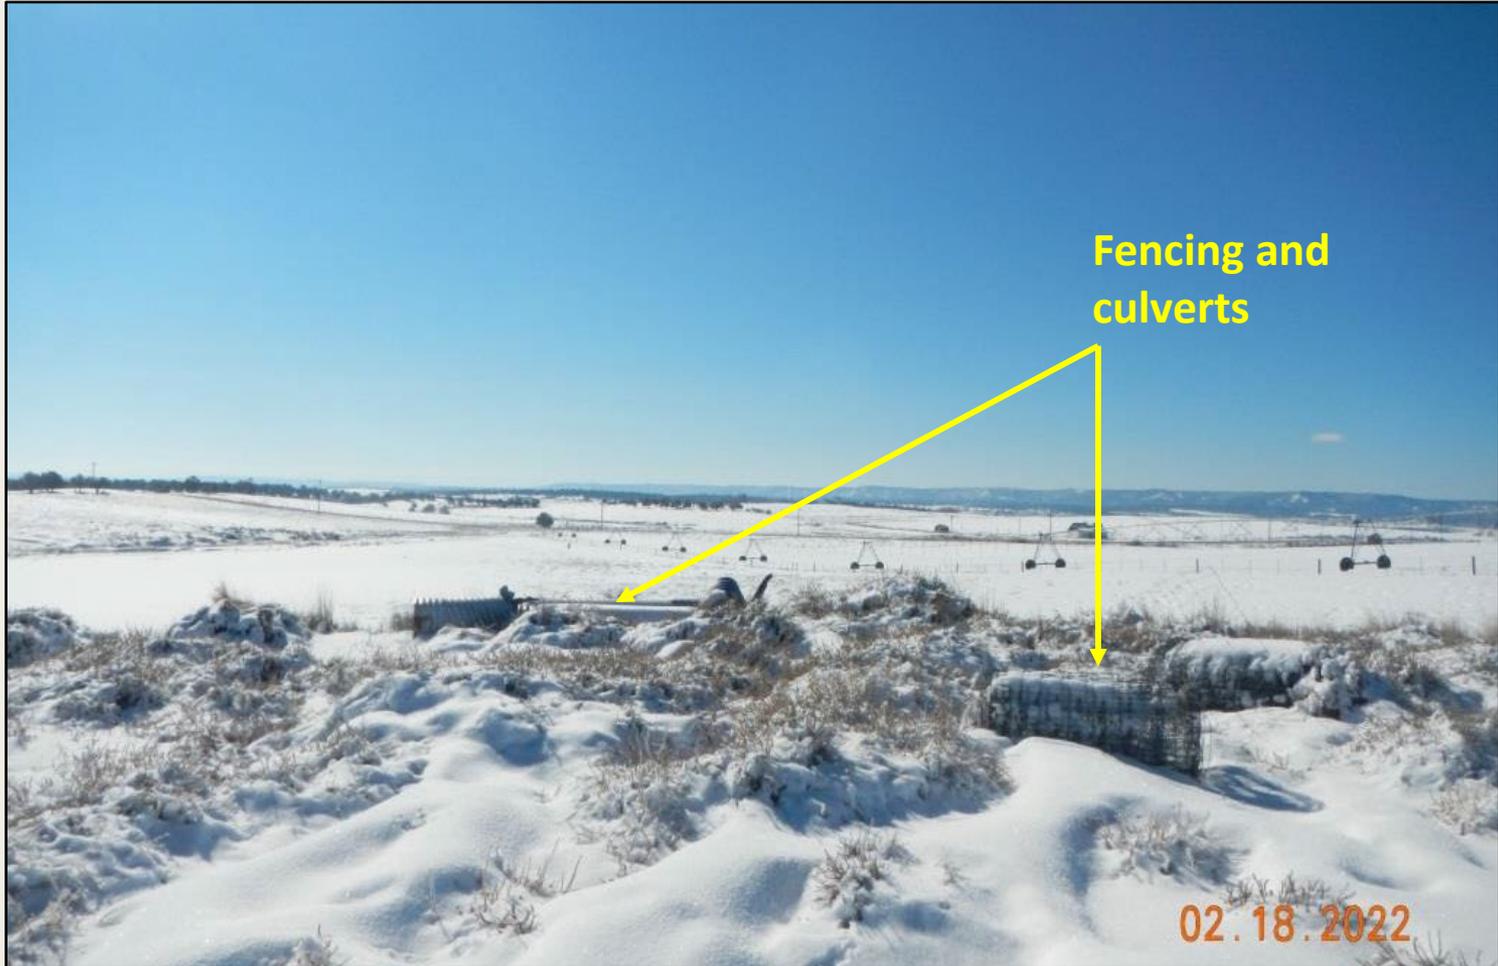
Photo 4. View of fencing and culvert debris observed within the southeastern corner of the project area.

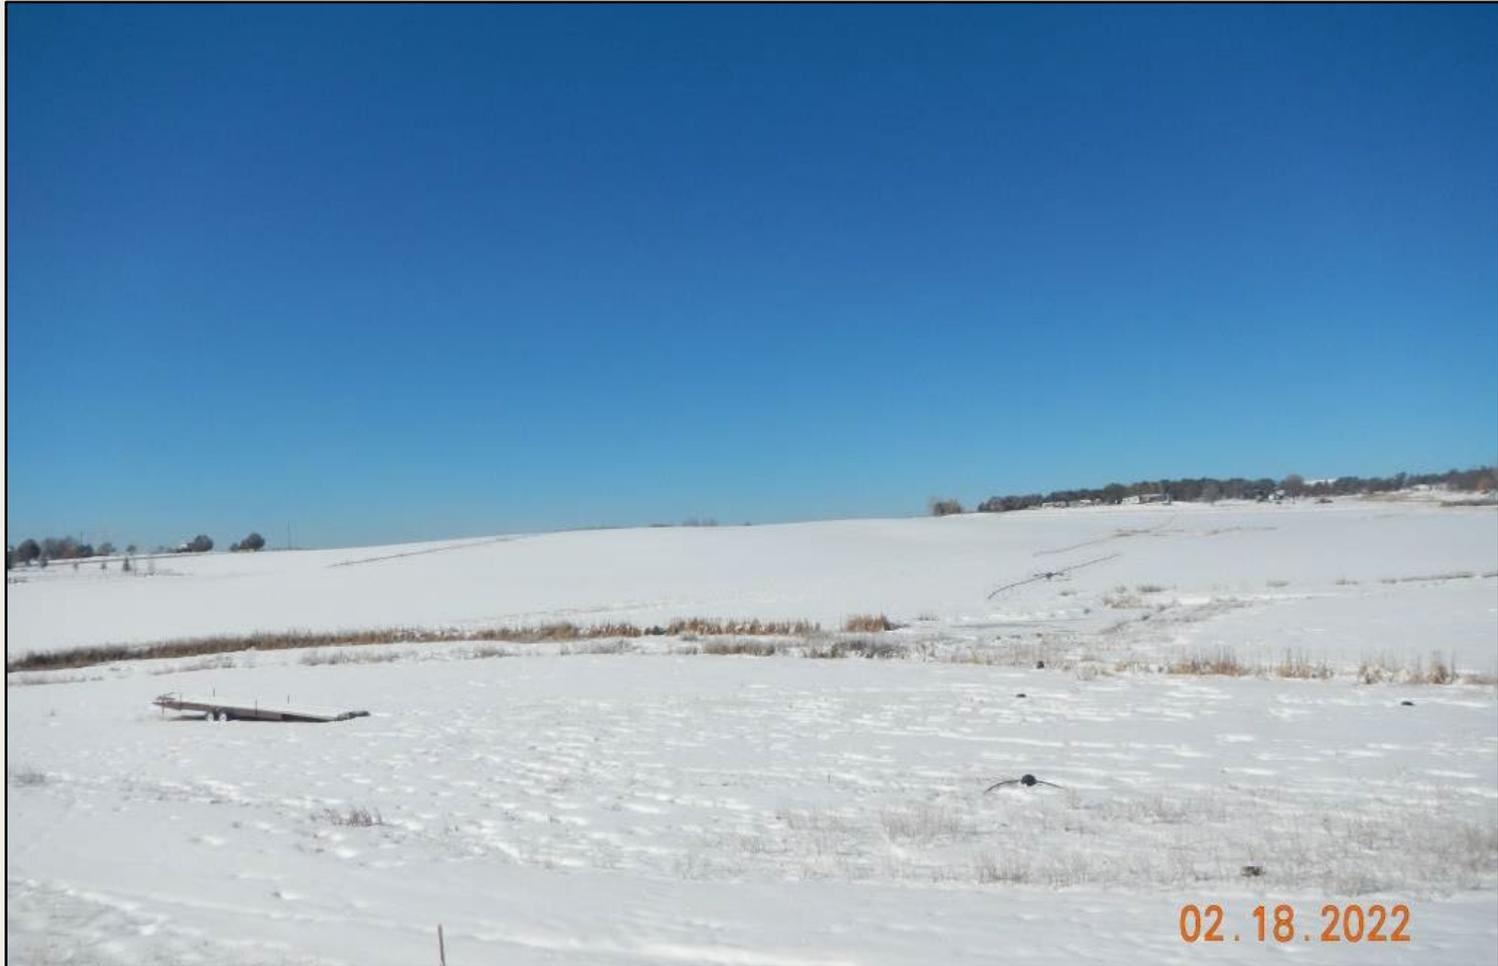
Photo 5. View of reference area vegetation comprised of open grass fields largely snow covered at this time.
