Inspection Photos
Operator: Simcoe
API: 067-07851
Date: 2/18/2022

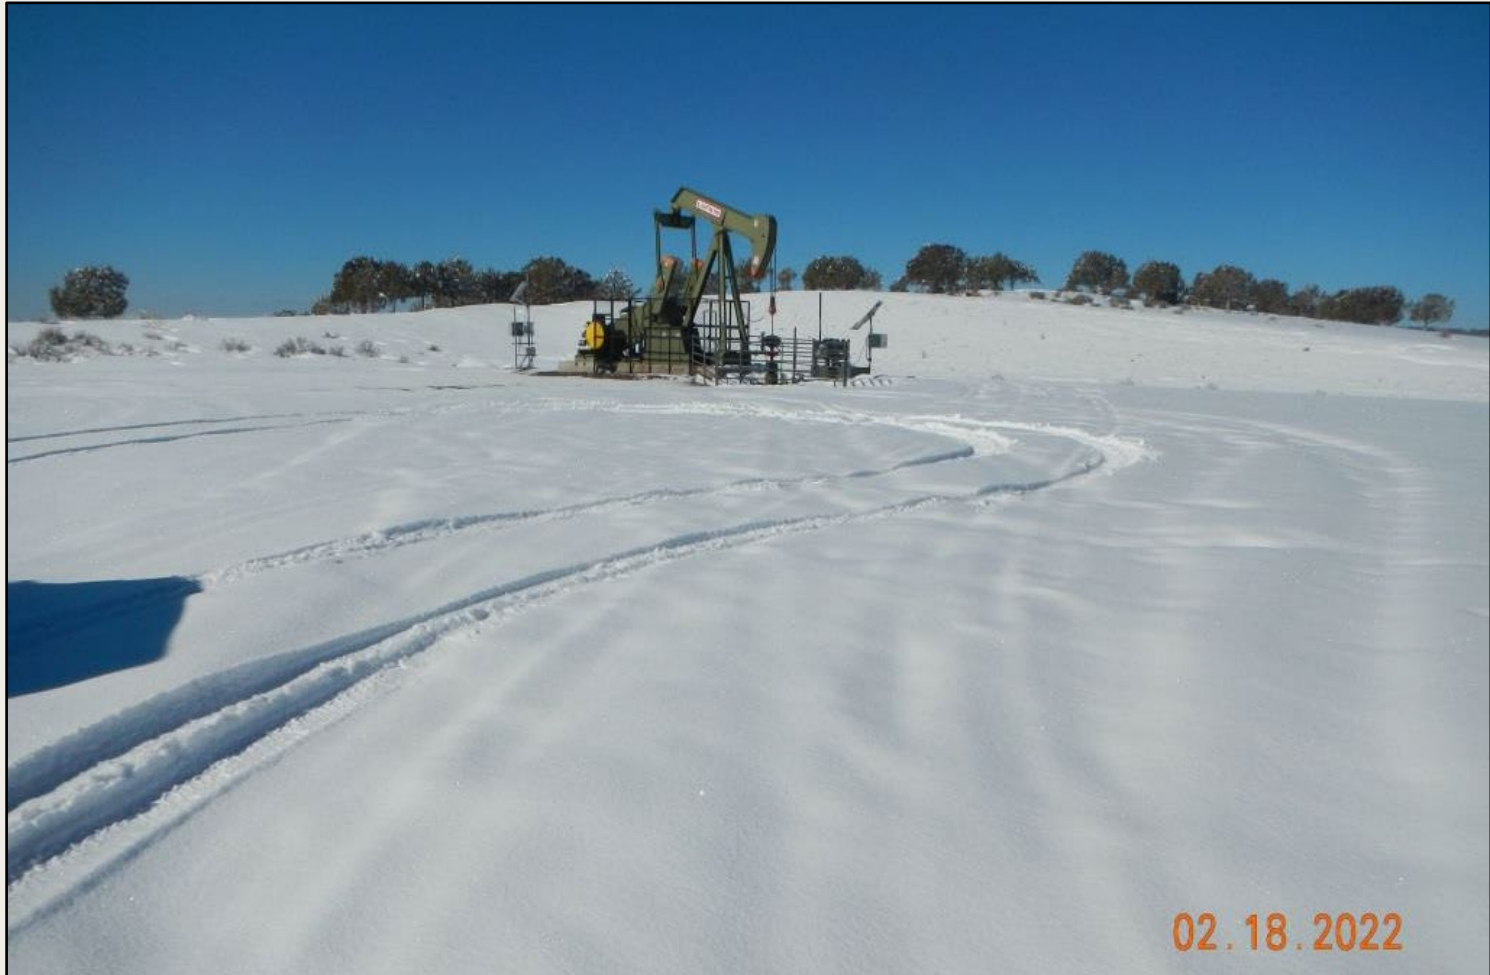
Photo 1. View of project area from the well pad entrance facing center.

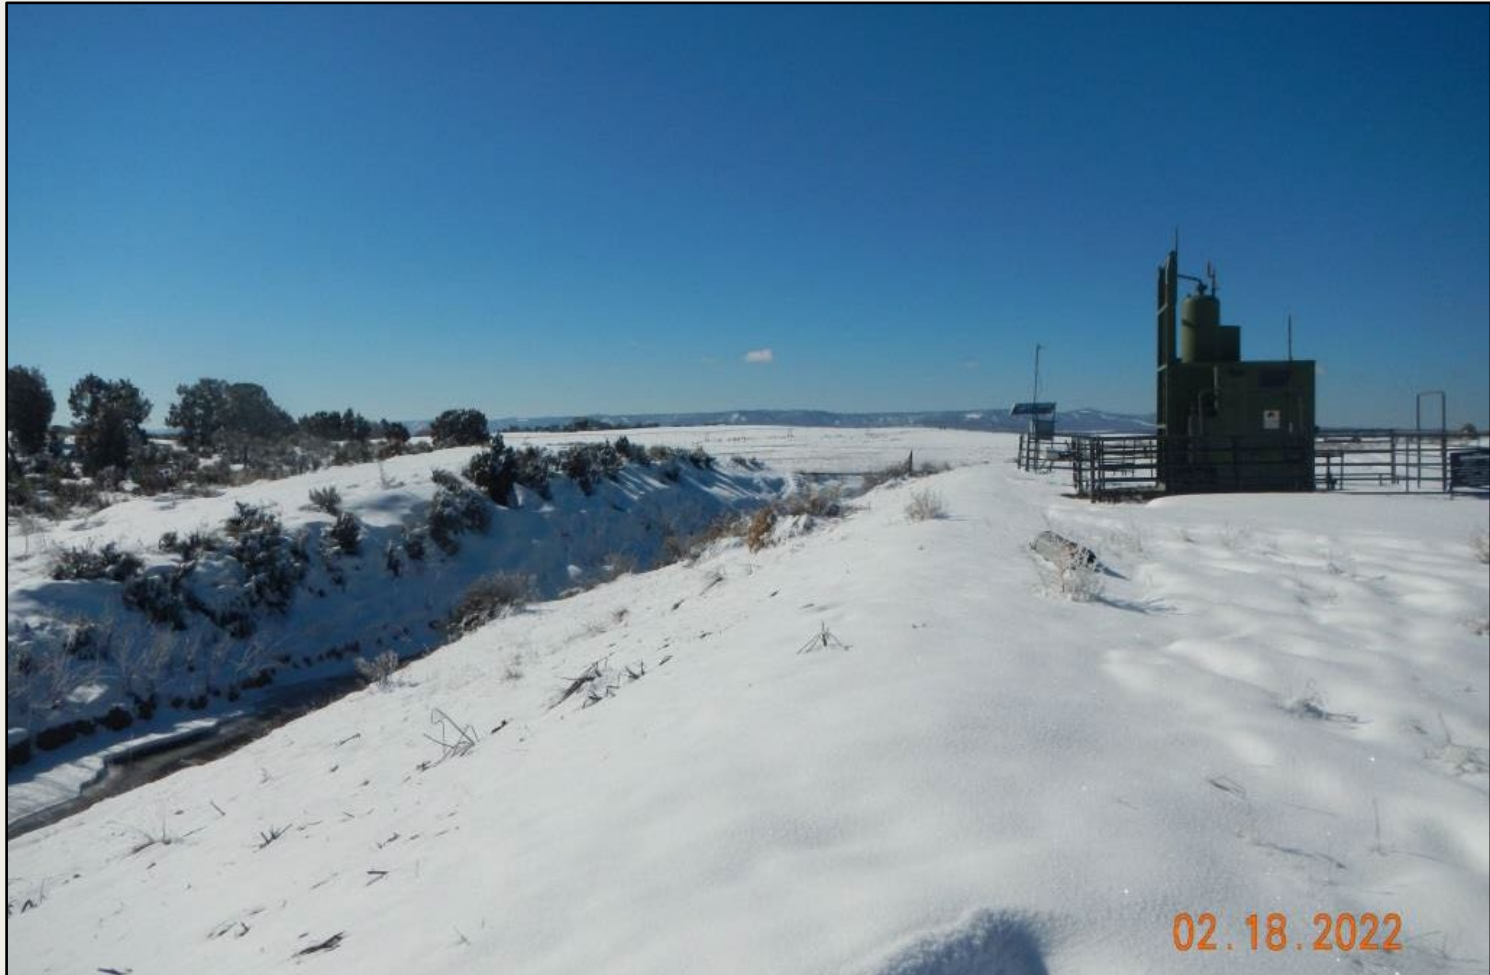
Photo 2. View of the eastern project area from the northeastern corner facing southward. Revegetation appears to be progressing with intermediate wheatgrass and crested wheatgrass, although largely snow covered. Vegetation cover and weeds should be monitored and managed during the active growing season.

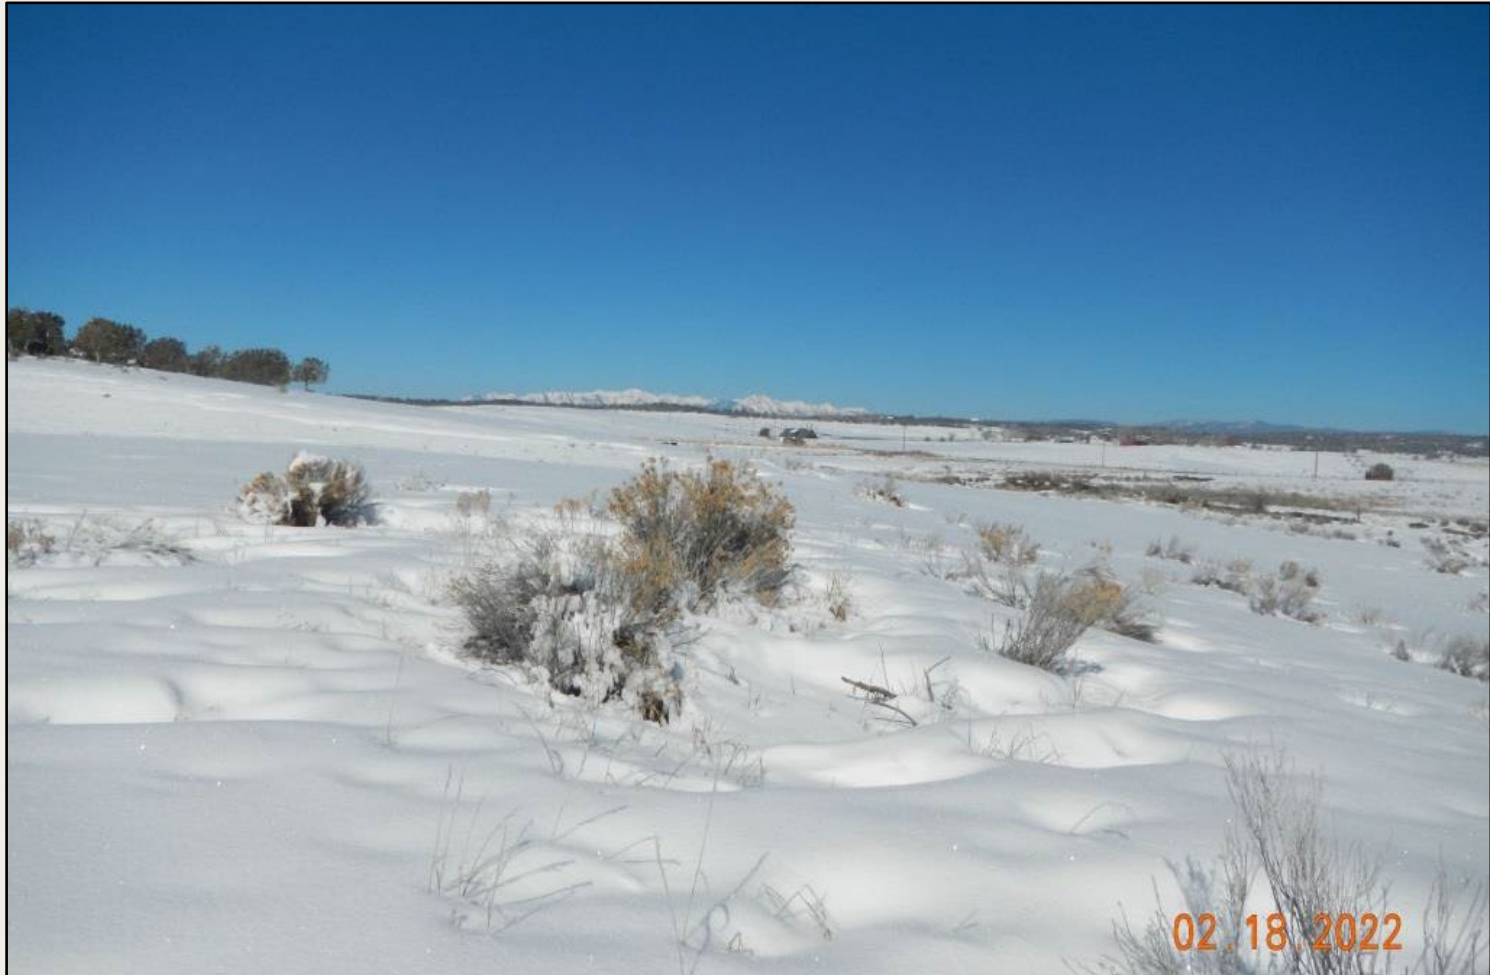
Photo 3. View of the northern portion of the project area from the northeastern corner facing westward.

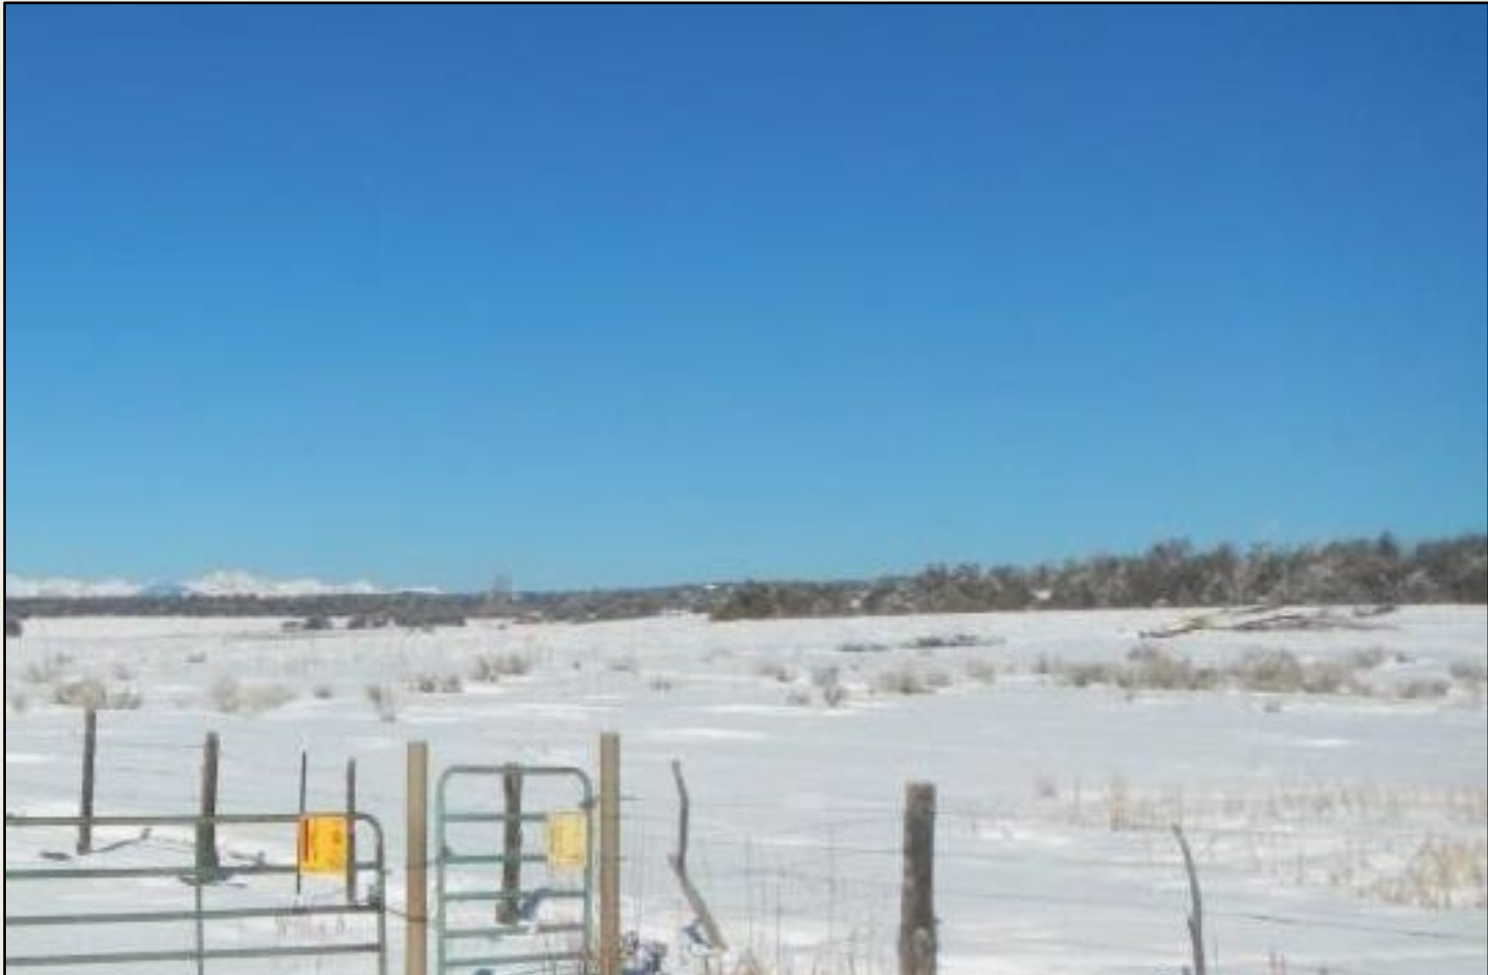
Photo 4. View of reference area vegetation comprised of open grass fields mixed with scattered sagebrush, rubber rabbitbrush, and pinyon and juniper trees.
