**Inspection Photos**  
**Location Name: Elaine 41-18**  
**Location ID: 320103**

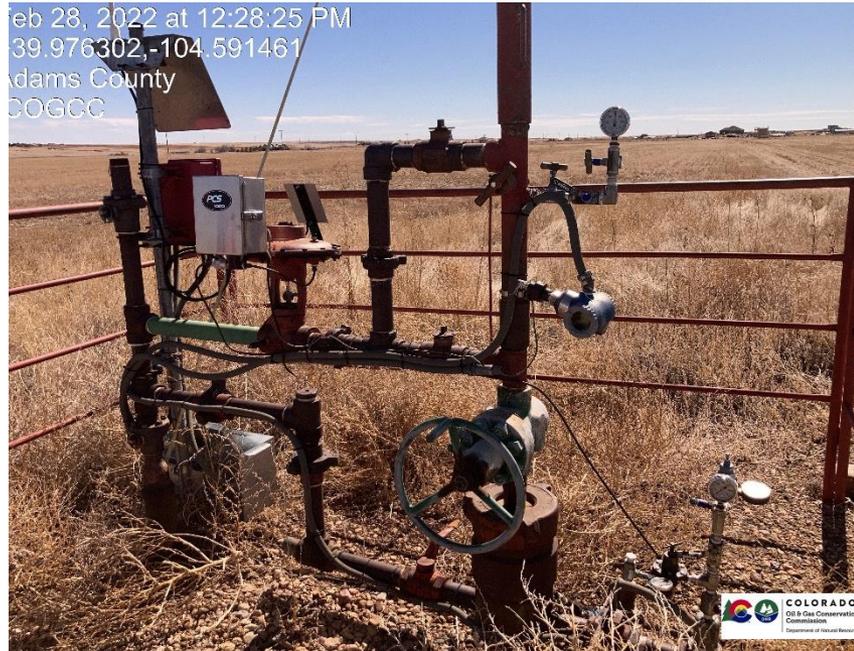
**Pic 1 Master valve is free moving, and in the shut position. All casing, flowlines, and bradenhead valves are in the close position prior to inspection. LOTO is installed on master valve**

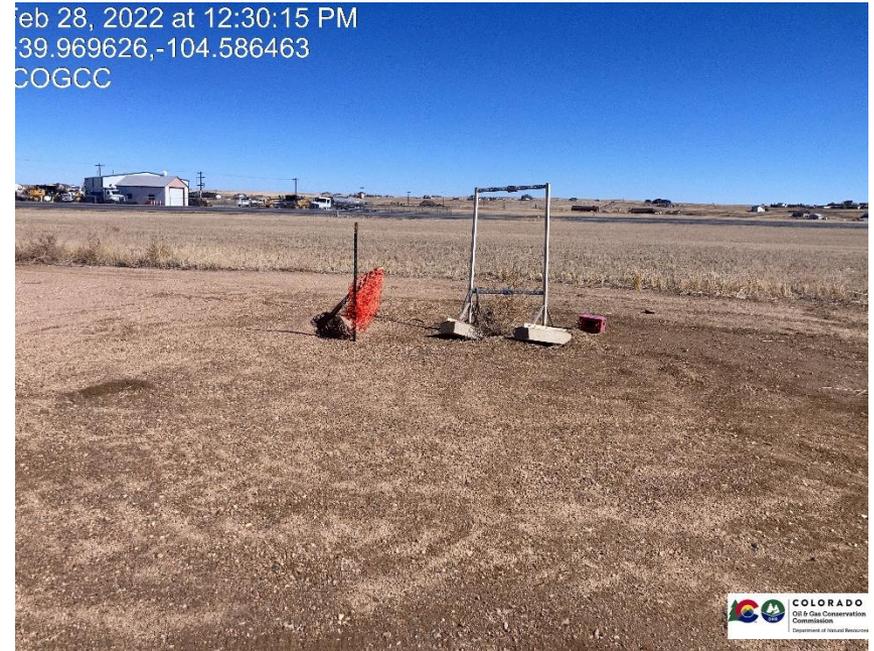
**Pic 2 Midstream equipment needs to be removed.**

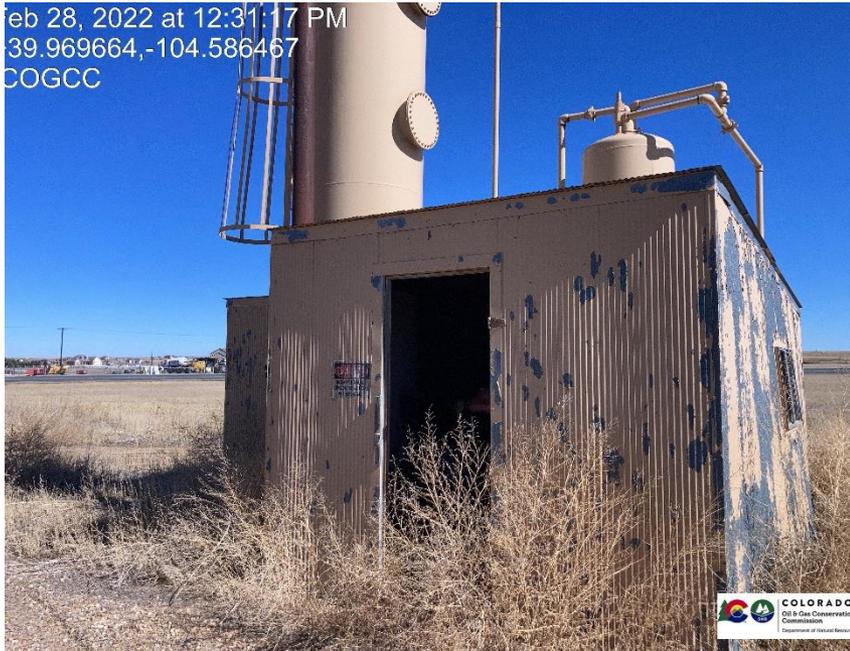
**Pic 3 verticle separators, 1 heated. Unable to access separator house due to condition of building**

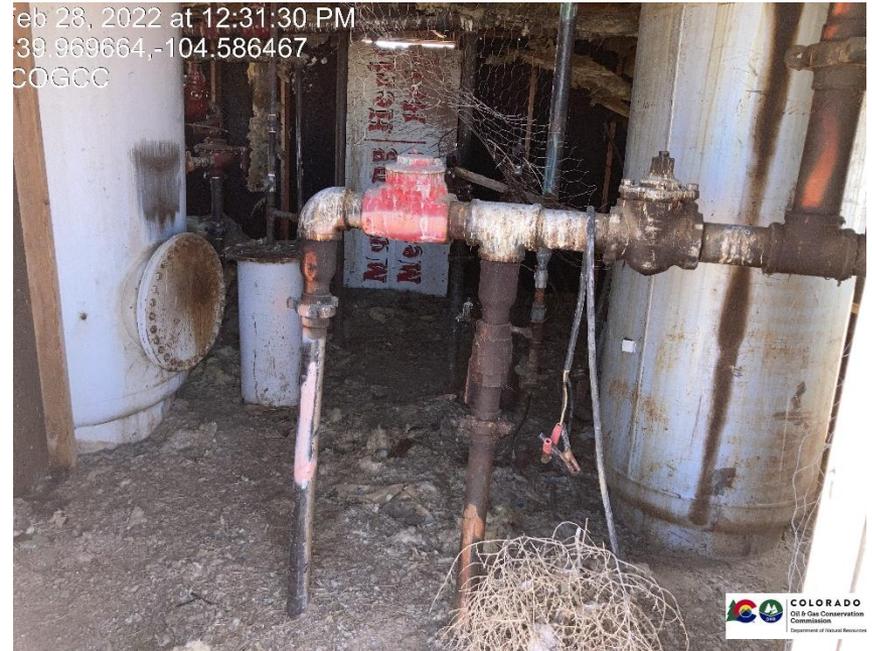
**Pic 4 inside of separator house**

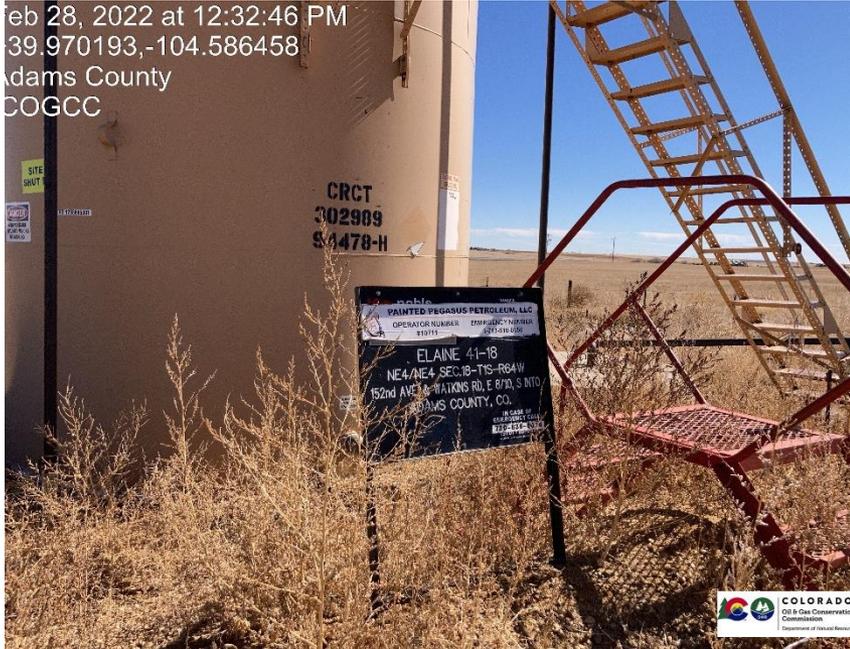
**Pic 5 tanks, oil tank appears to be empty, water tank is almost full**

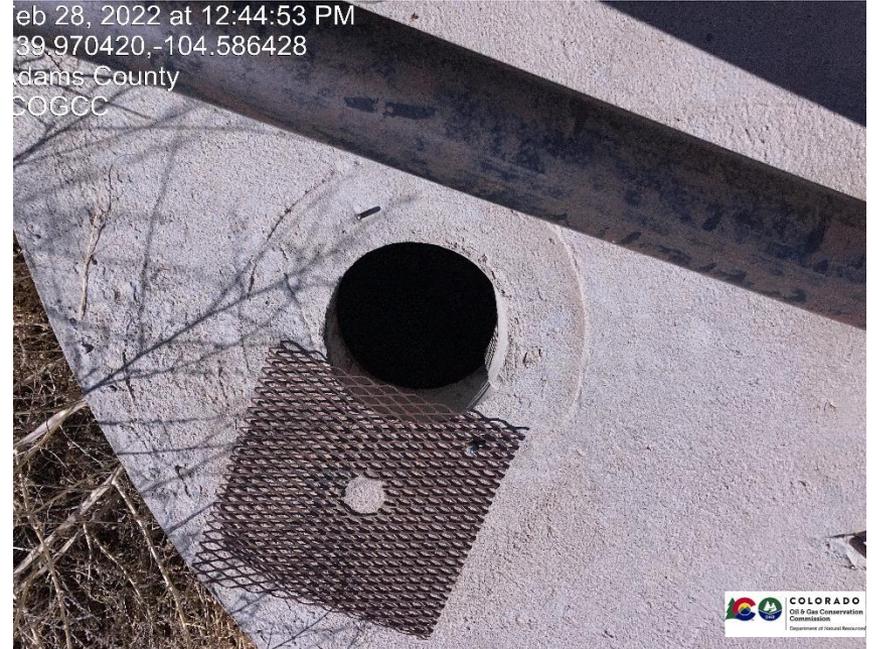
**Fluid level in concrete buried vault is almost full.**
