Inspection Photos

Location Name: UPRR Julie 1

Location ID: 320137

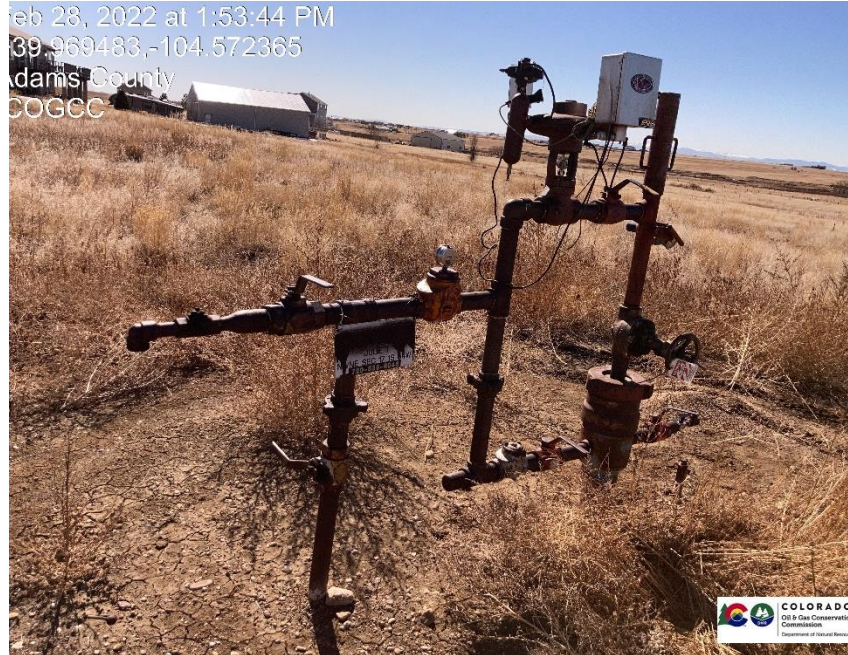
Pic 1 All ball valves were in close position at time of inspection. Master valve was seized in position, unable to determine if valve is open or shut. Bradenhead needle valve is shut.

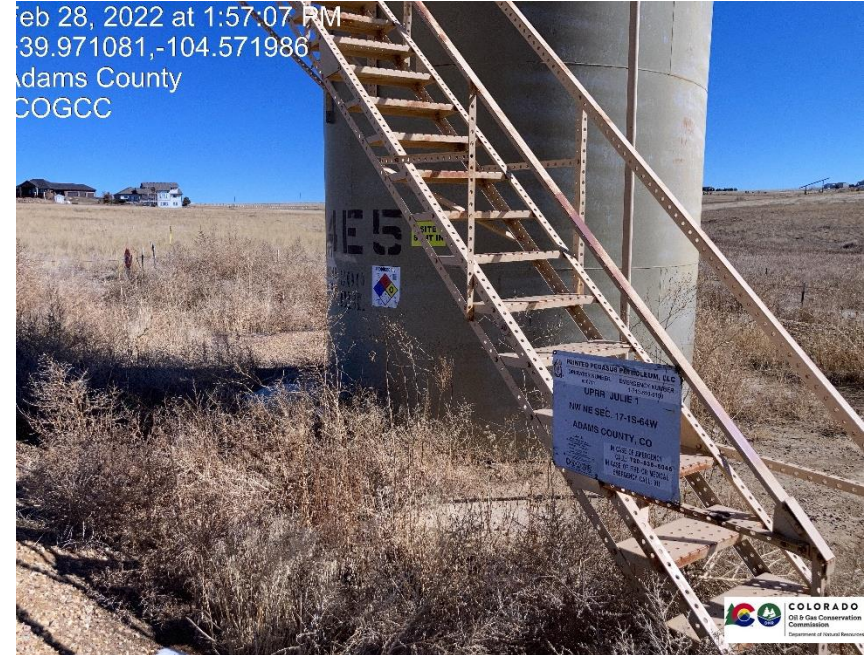
Pic 2 tank appears to be empty

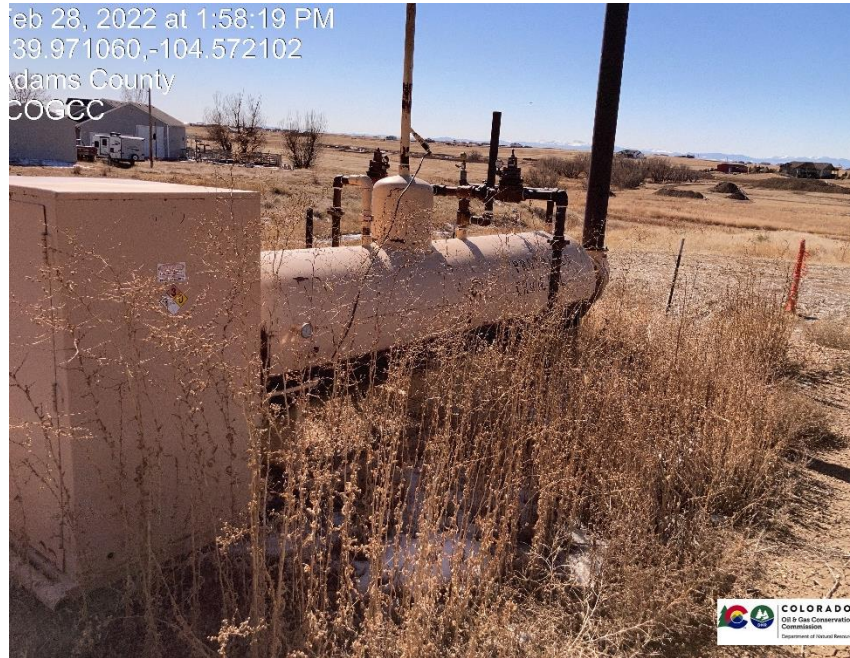
Pic 3 Separator, and abandoned midstream.
