# Inspection Photos

API: 071-06902

Operator: EVERGREEN NATURAL RESOURCES

Inspection Date: 2/28/2022

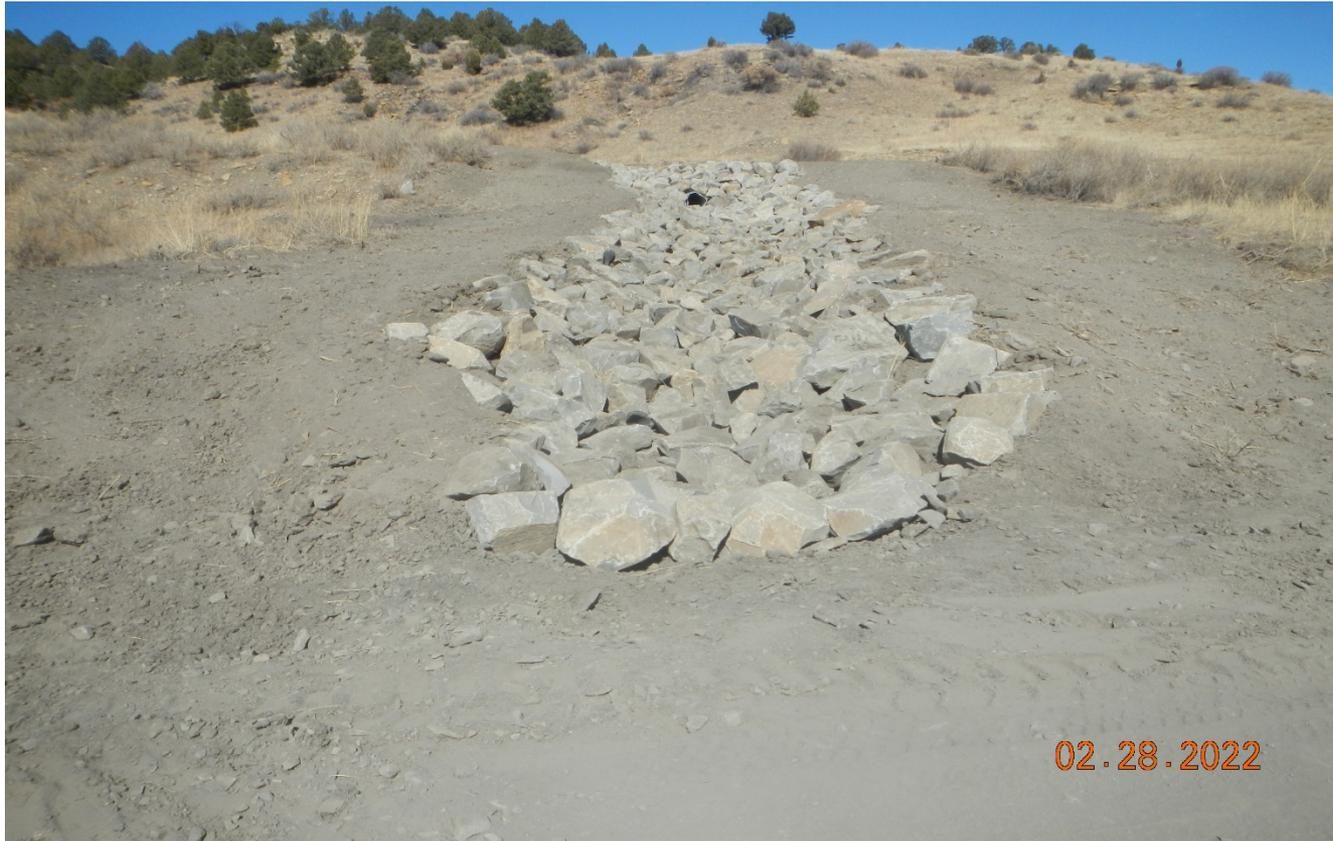
**Photo 1.** There has been rock rip/rap outlet protection installed at the culvert near the main road in Lorencito Canyon. Disturbed areas have been seeded.

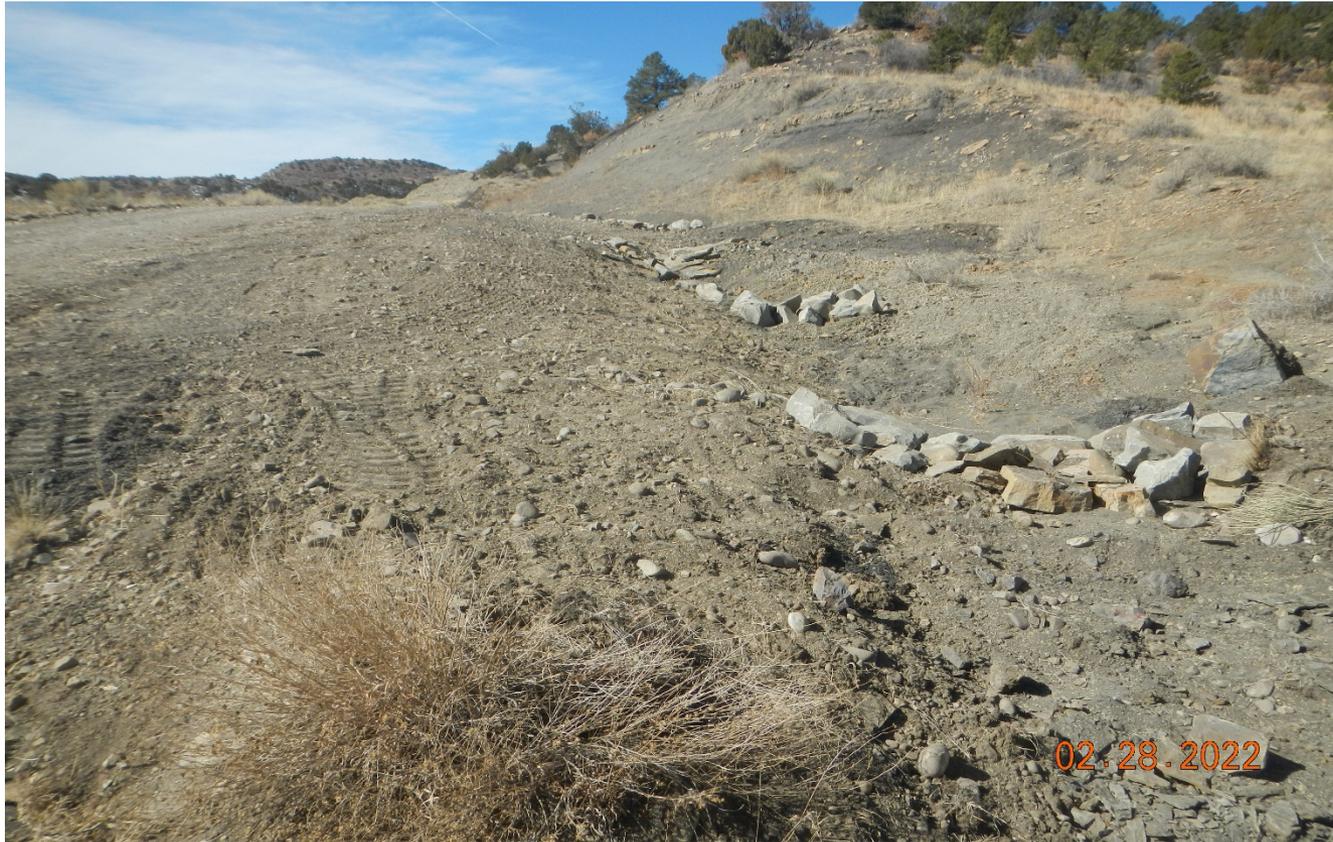
**Photo 2.** Facing southwest along the main road to the well site. There area rock check dams installed along the road side and areas of erosion have been repaired.

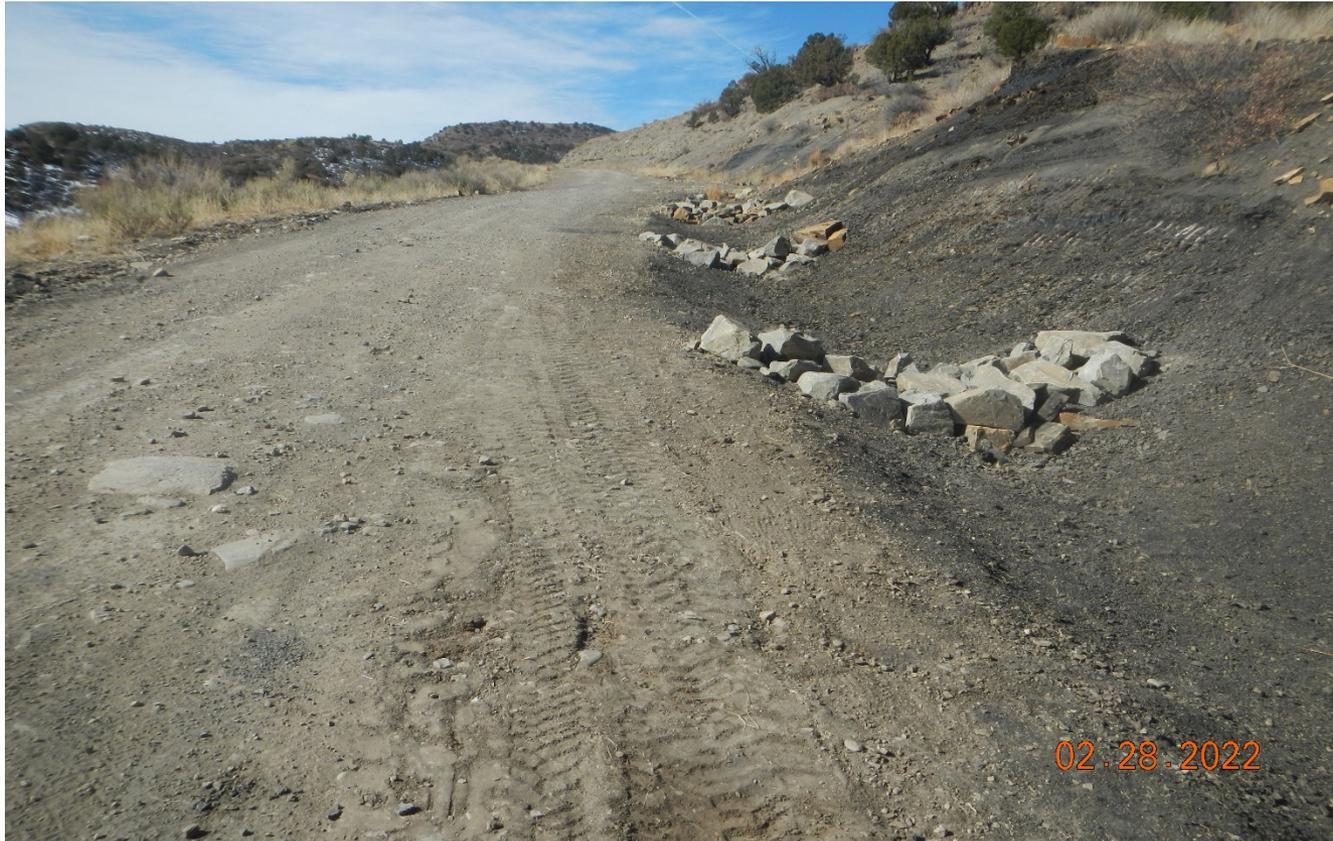
**Photo 3.** Facing southwest along the main road to the well site. There area rock check dams installed along the road side and areas of erosion have been repaired.

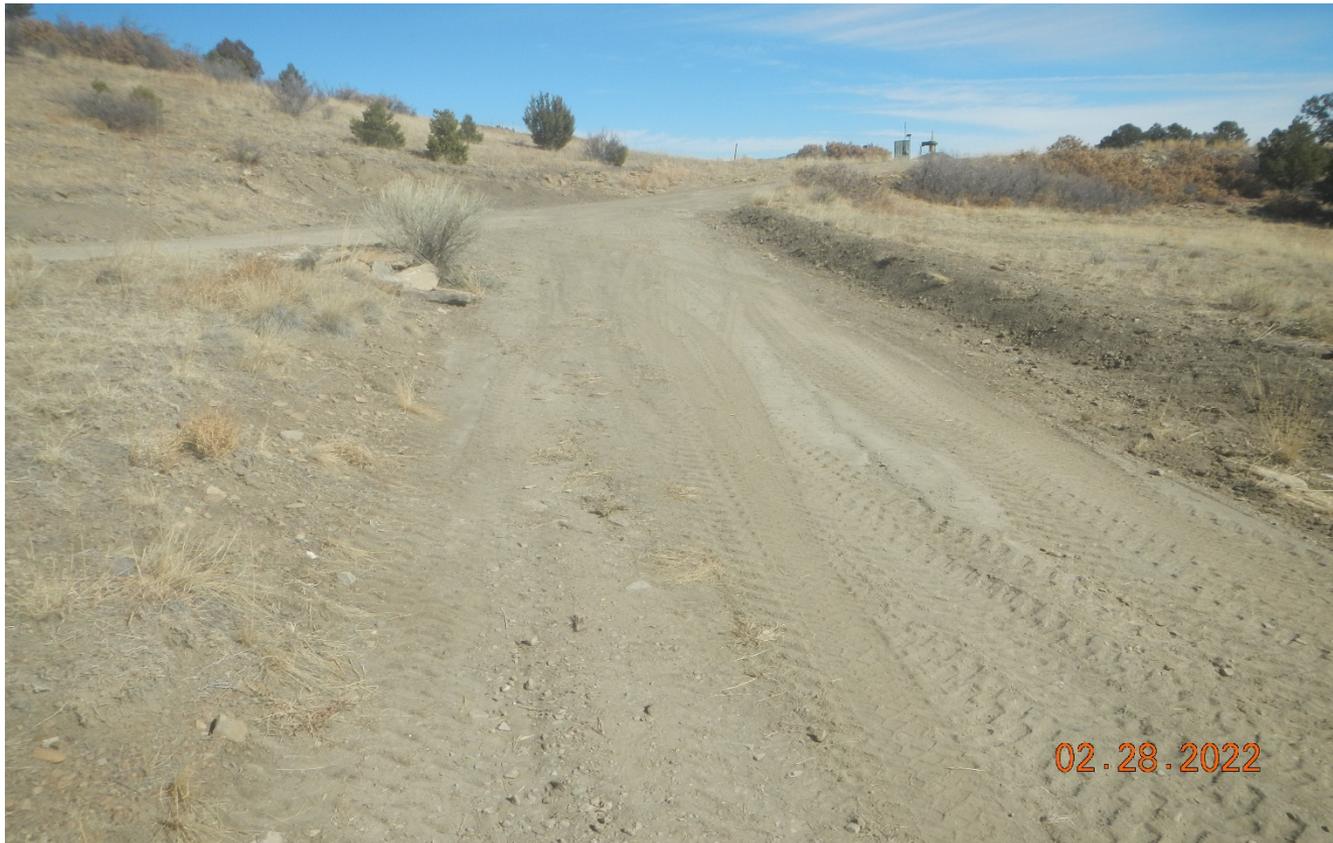
**Photo 4.** Facing northeast along the access road to the well site.

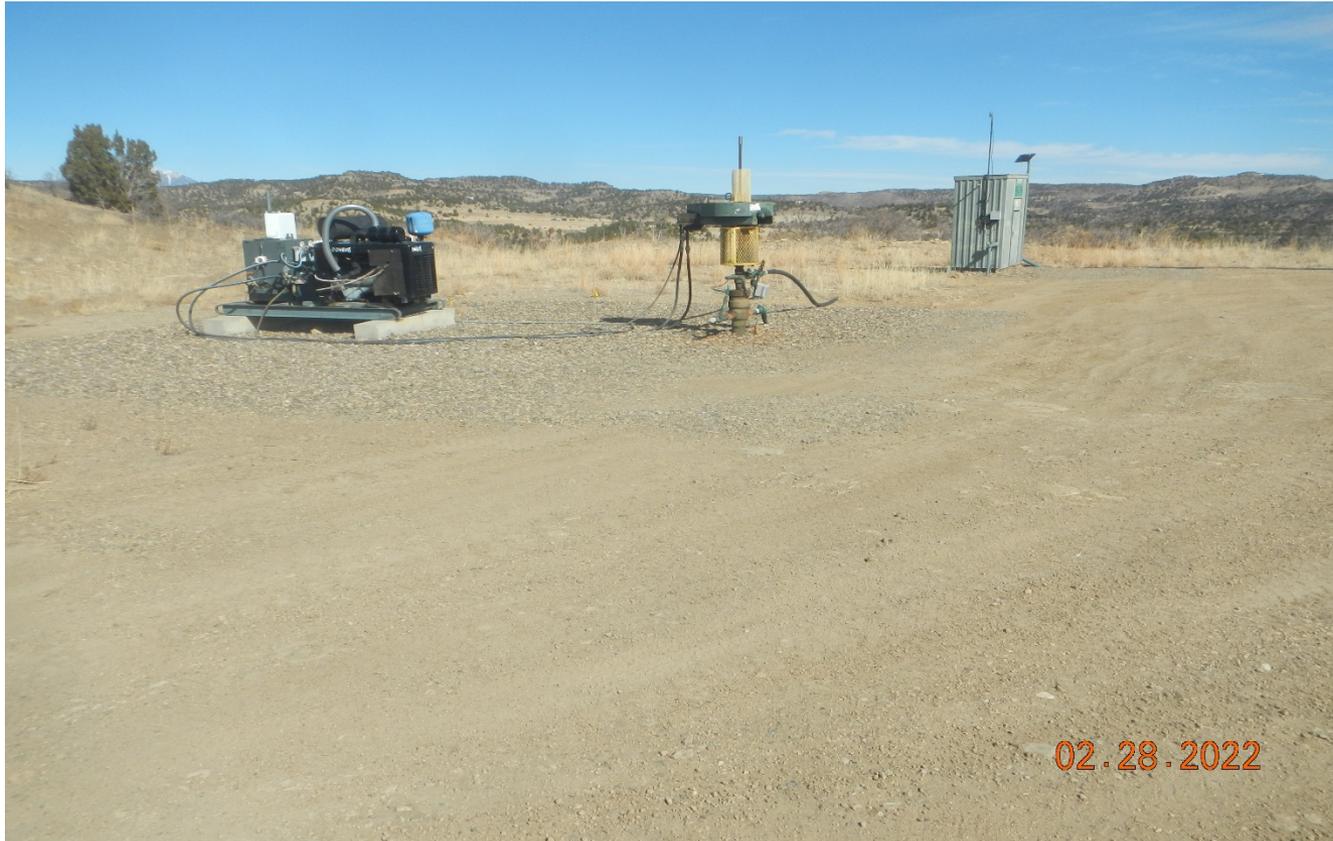
**Photo 5.** Facing northeast toward the well site.
