Inspection Photos

Location Name: TEP ROCKY MOUNTAIN LLC PA-66S95W /32SWSE

Location ID: 334700

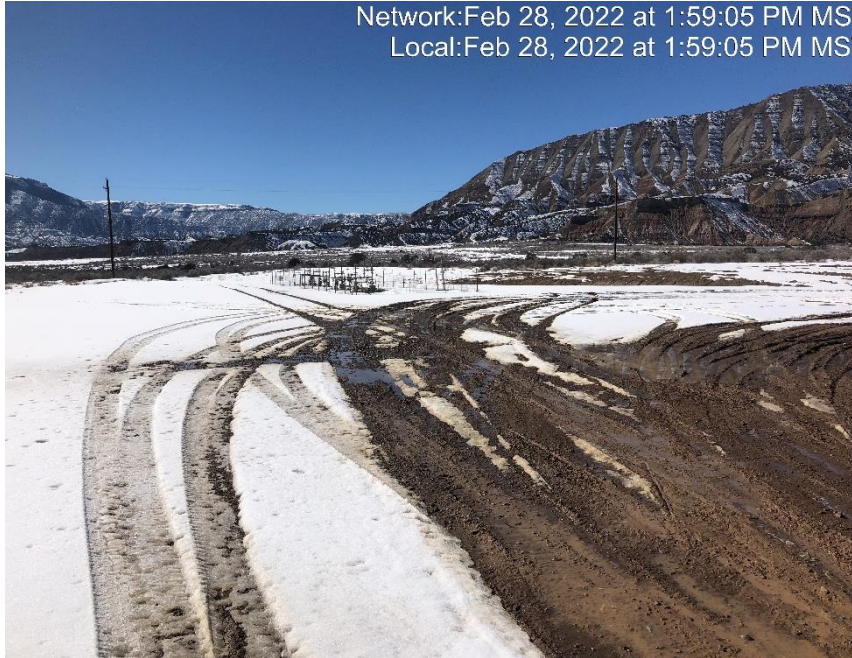
Photo #6042 from entrance to location.

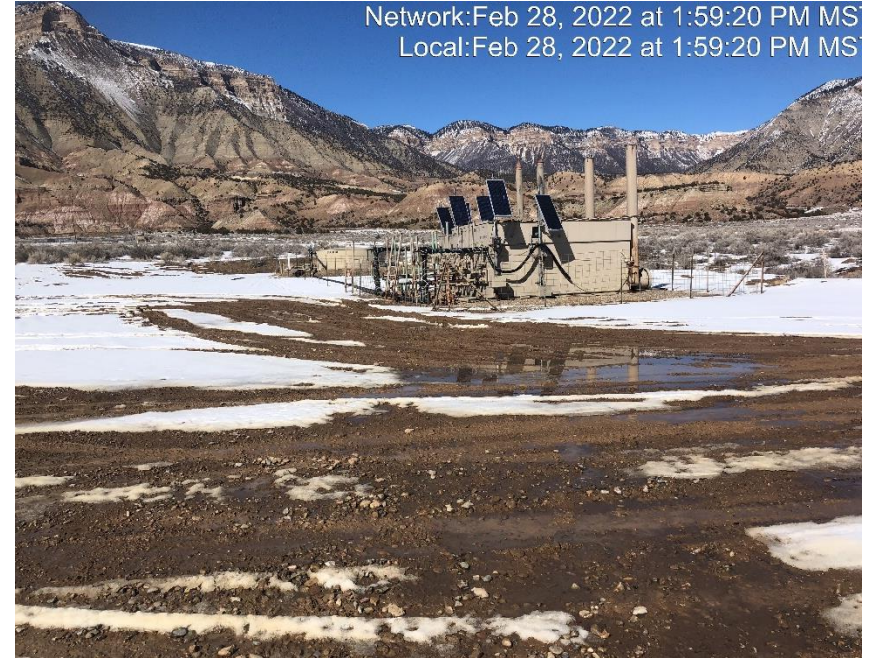
Photo #6043 from entrance to location.

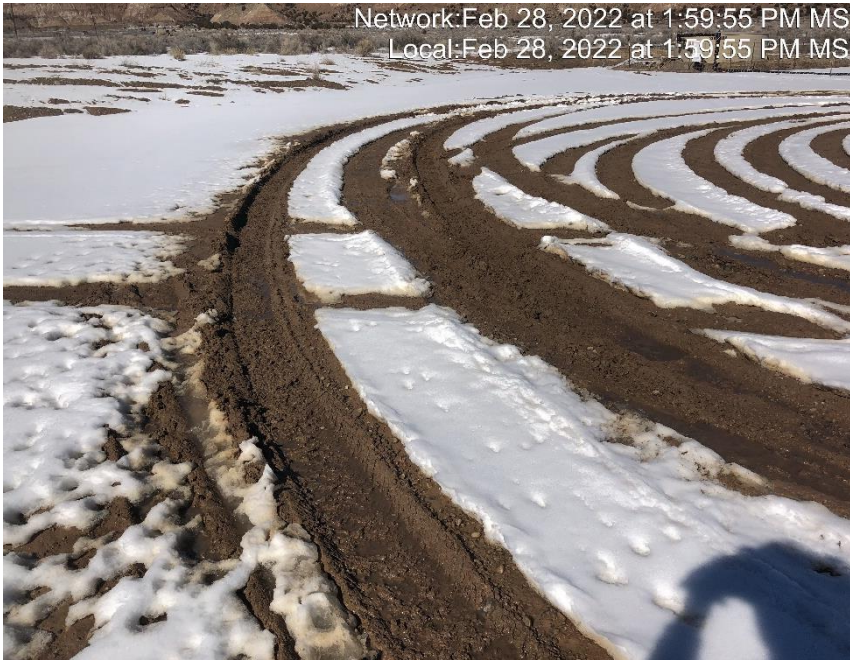
Photo #6044 Location lacks stabilization.

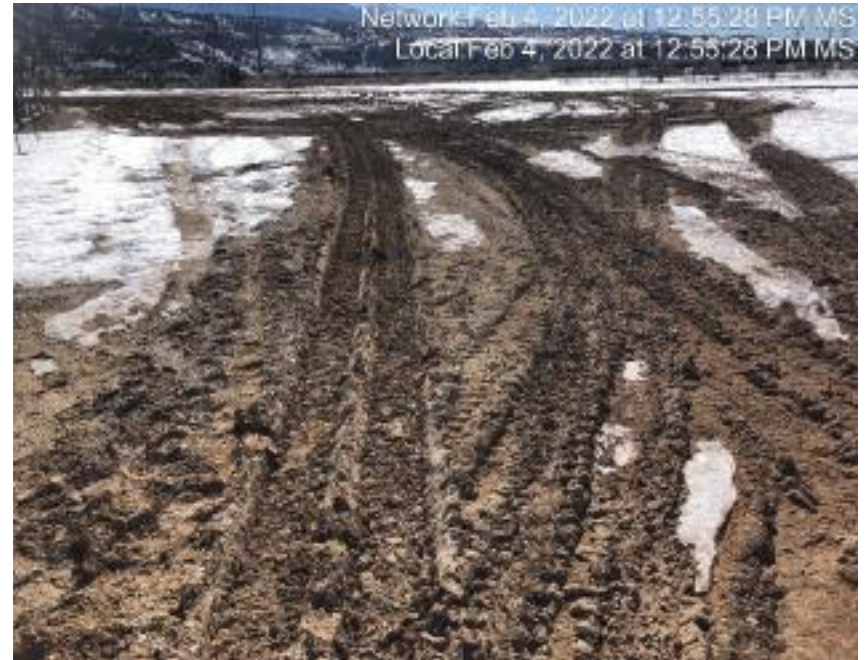
Photo #5872 from inspection #699804111 conducted on 2/4/22.

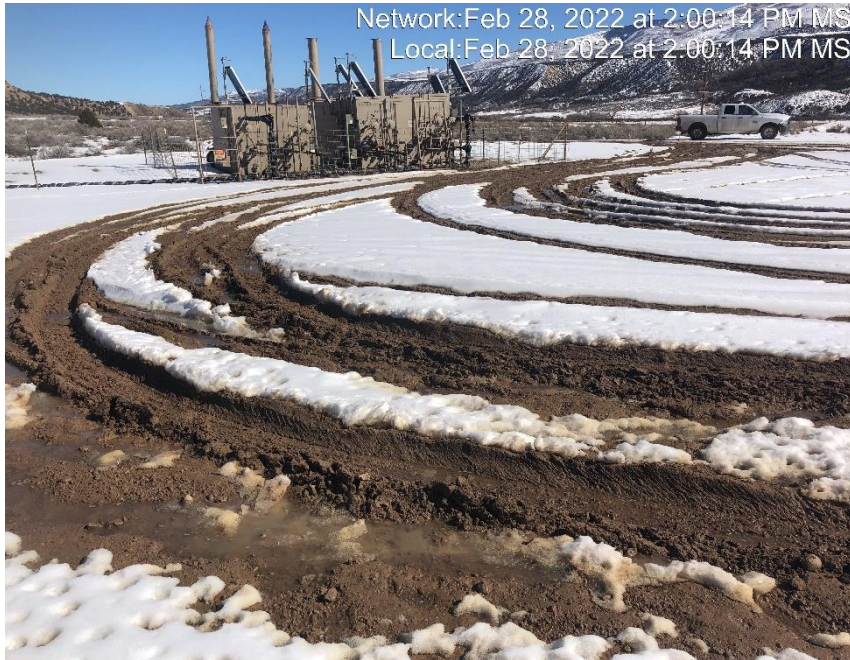
Photo #6045 Location lacks stabilization.

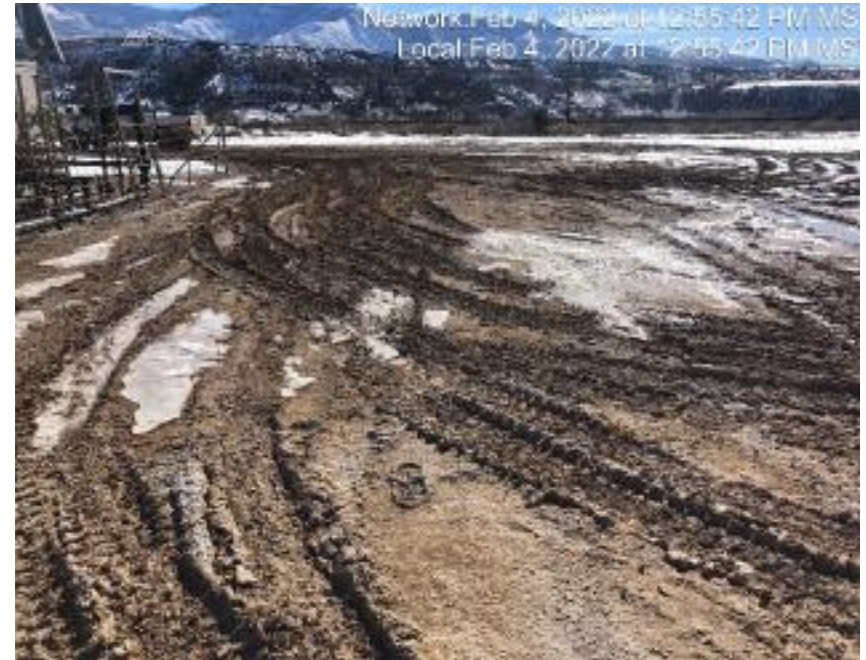
Photo #5873 from inspection #699804111 conducted on 2/4/22.

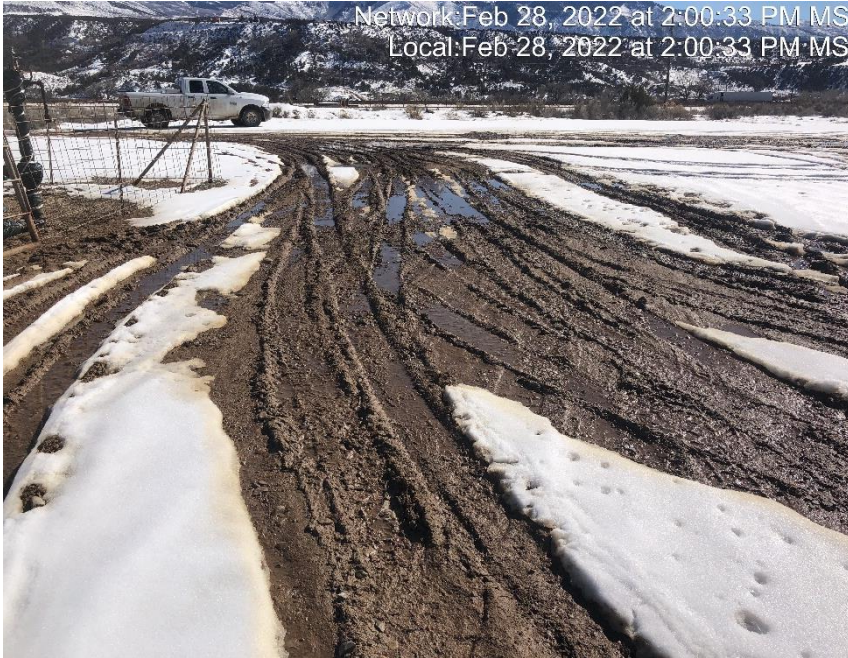
Photo #6046 Location lacks stabilization.

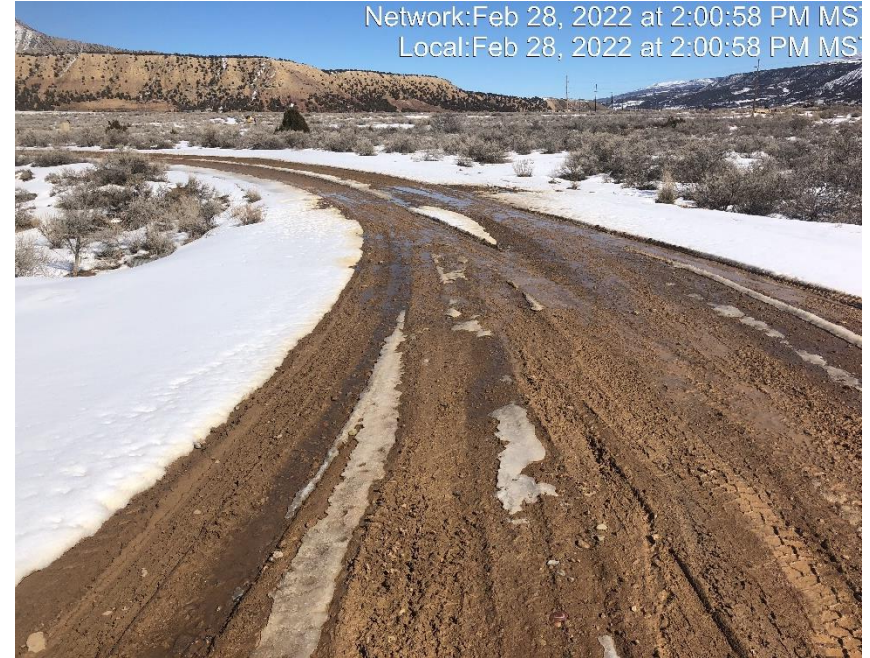
Photo #6047 Insufficient tacking control at entrance to location.
