Inspection Photos
Location Name: Joy 21-4
Location ID: 320088

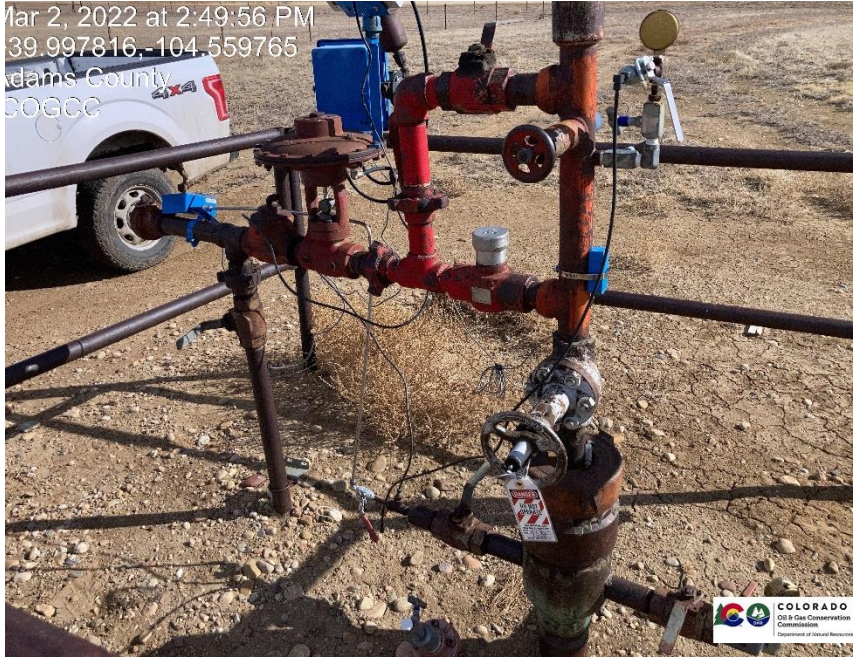
Pic 1 at time of inspection master valve, and both casing valves were open, Flowlines were closed. Master valve, and casing valves were put in the close position at time of inspection.

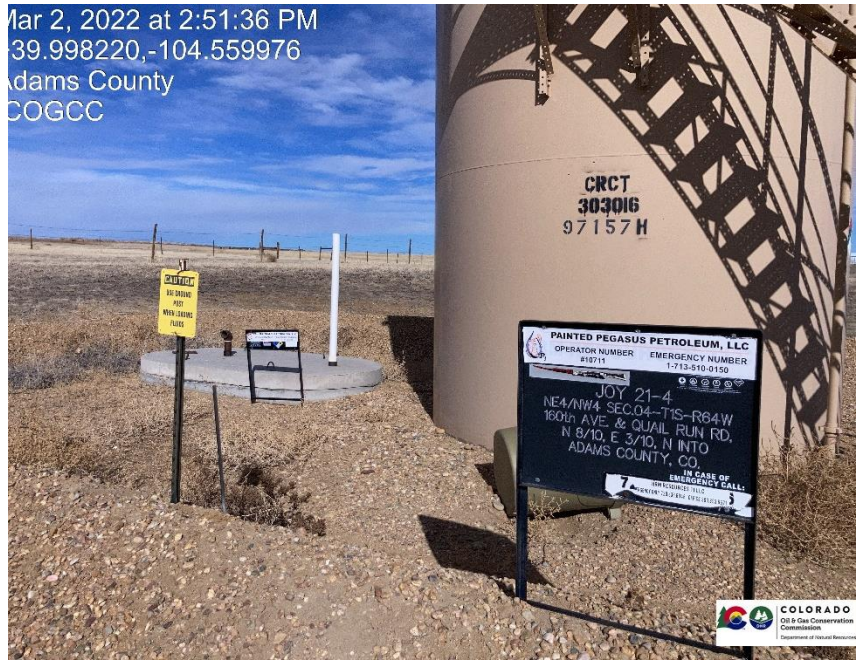
Pic 4 tanks, at time of inspection tanks appeared to have fluid inside.
