Inspection Photos

Location Name: Mckinney 1-9

Location ID: 320529

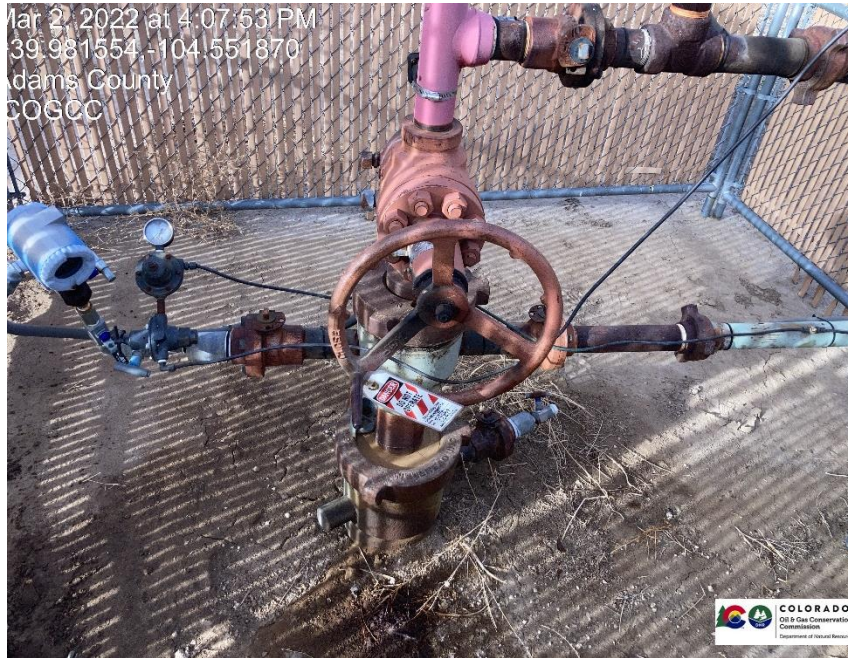
Pic 1 wellhead. At time of inspection master valve, and flowline valve were in the open position. During inspection master valve, and flowline valve were put in the close position.

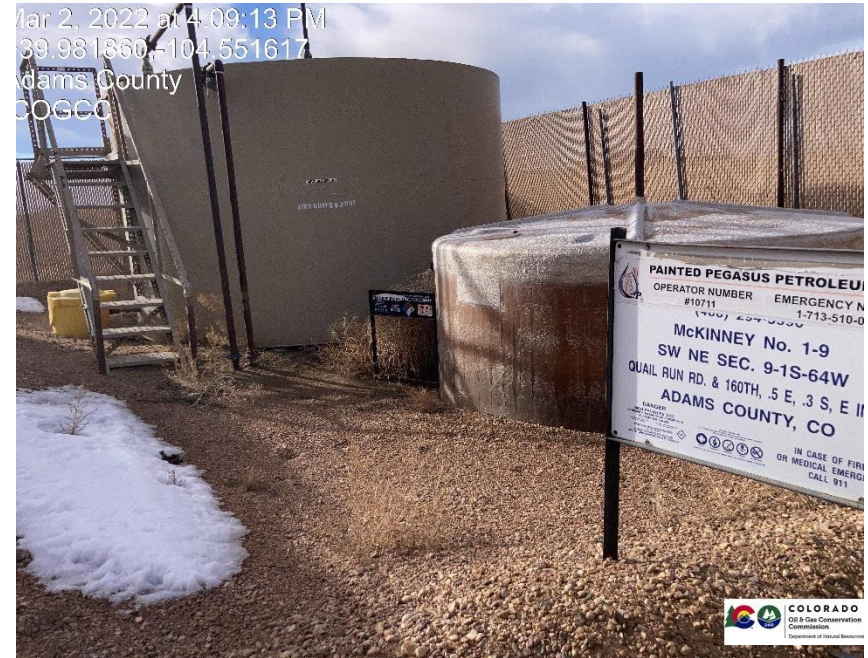
Pic 2 Tanks. At time of inspection production fluid appeared to be in metal tank, fiberglass tank appeared to be empty.

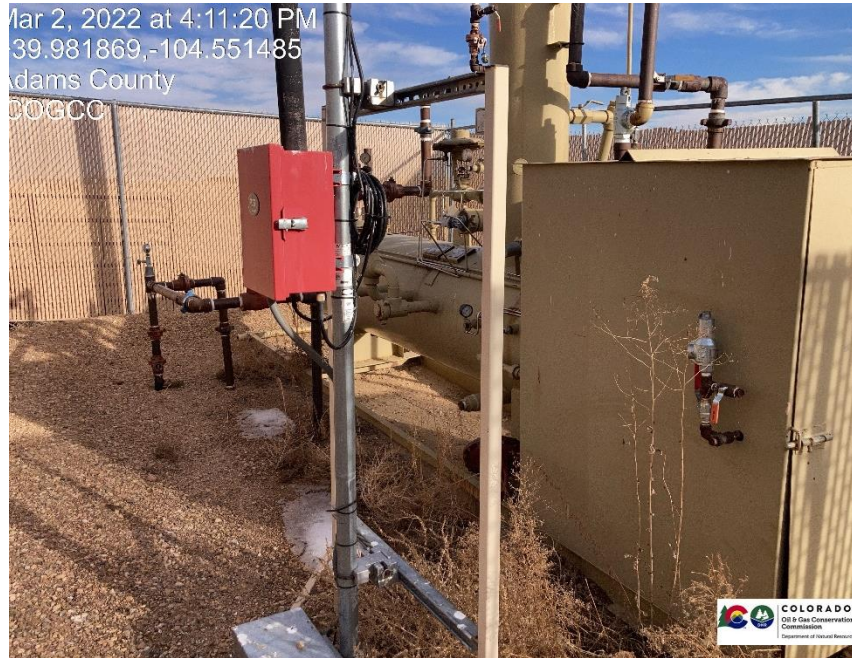
Pic 3 separator/ automation equipment
