Inspection Photos

Location Name: CAERUS PICEANCE LLC NOCKS-68S96W /2NENE

Location ID: 334078

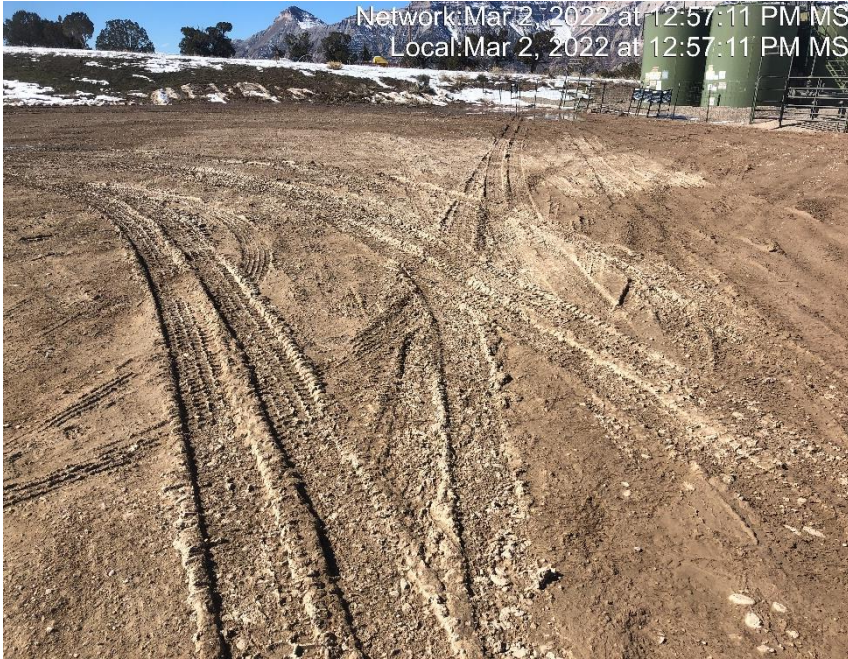
Photo #6065 Location lacks stabilization.

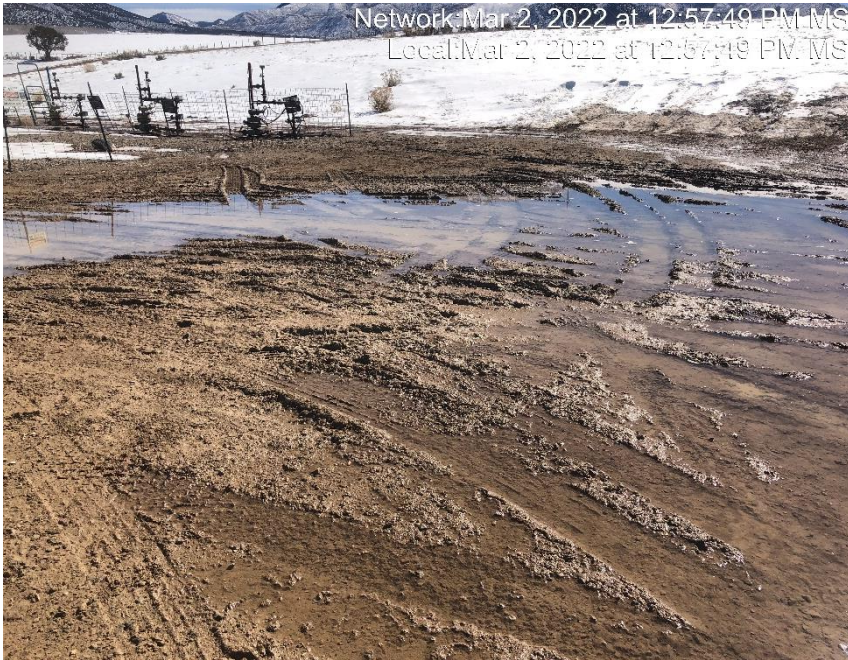
Photo #6066 Location lacks stabilization.

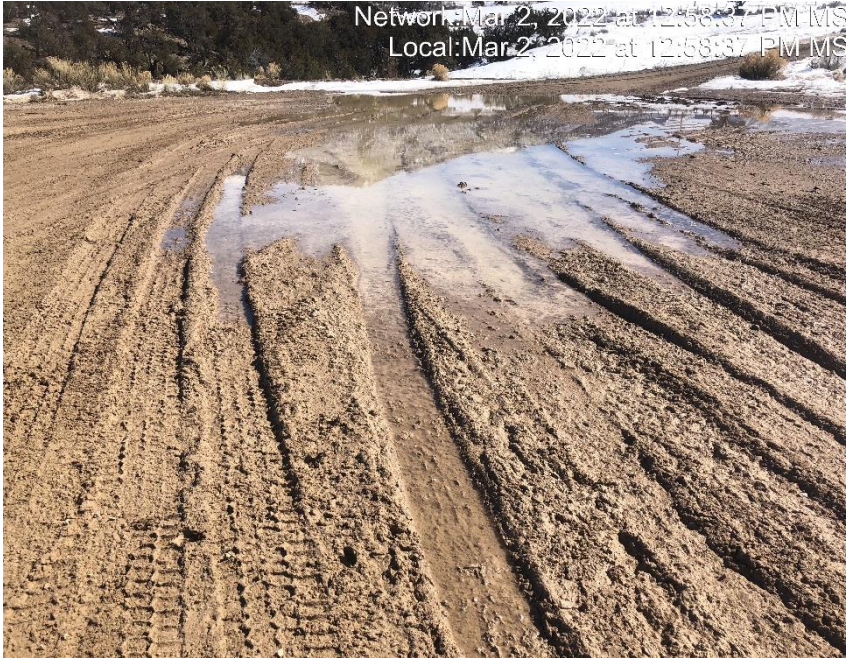
Photo #6067 Insufficient tracking BMP at entrance to location.
