Inspection Photos
Location Name: Randall 32-10
Location ID: 320024

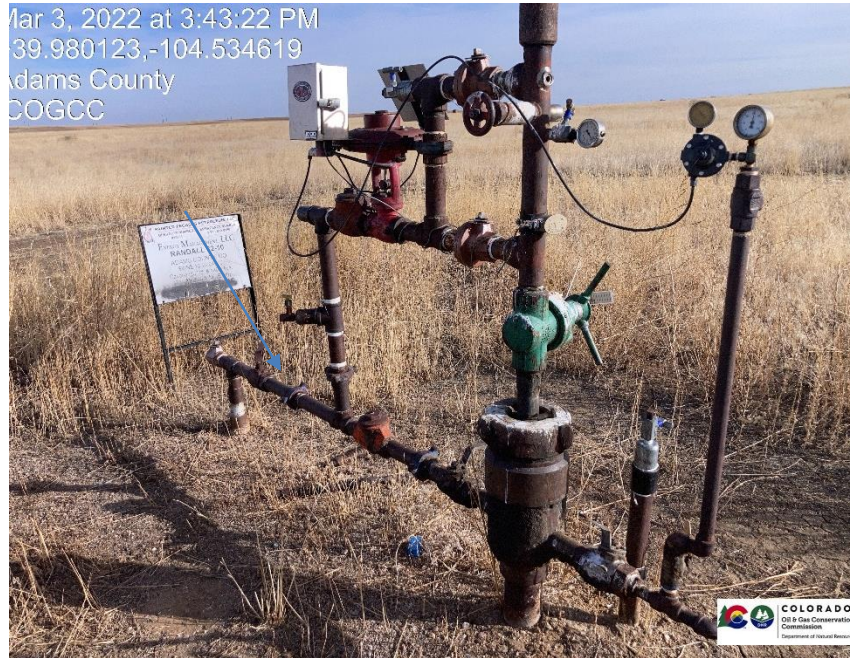
Pic 1 At time of inspection master valve, and casing valve were in open position. During inspection Master valve and casing valve were put in close position. Flowline valve is seized in the open position, casing valve, and tubing valve are both shut.
