Inspection Photos
Operator: Morningstar Operating
API: 007-06287
Date: 2/28/2022

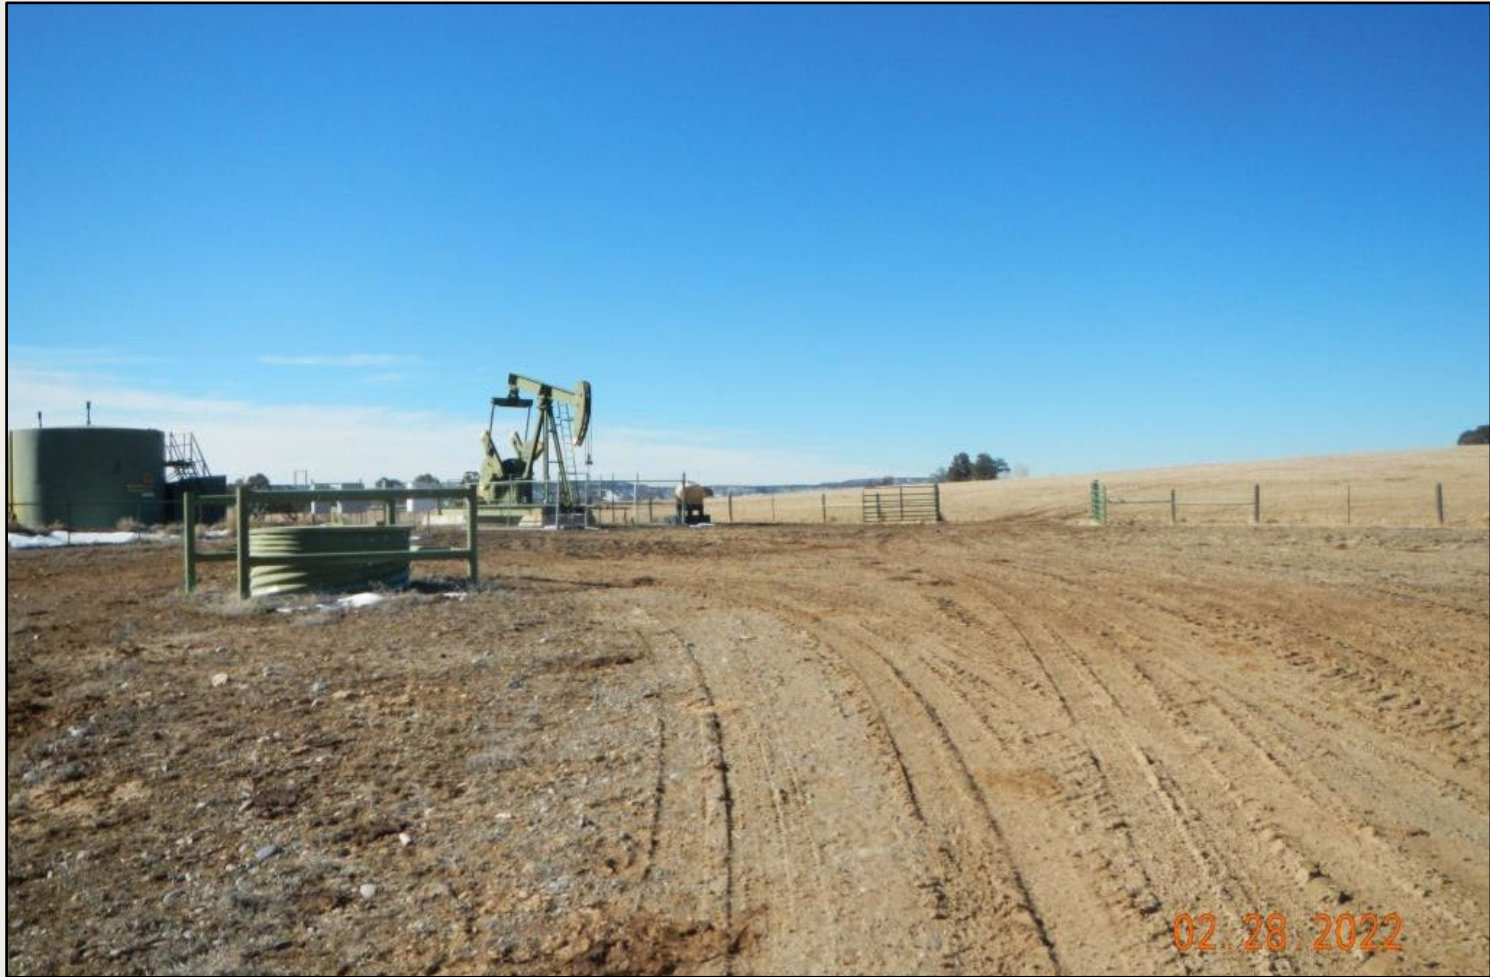
Photo 1. View of project area from the well pad entrance facing center.

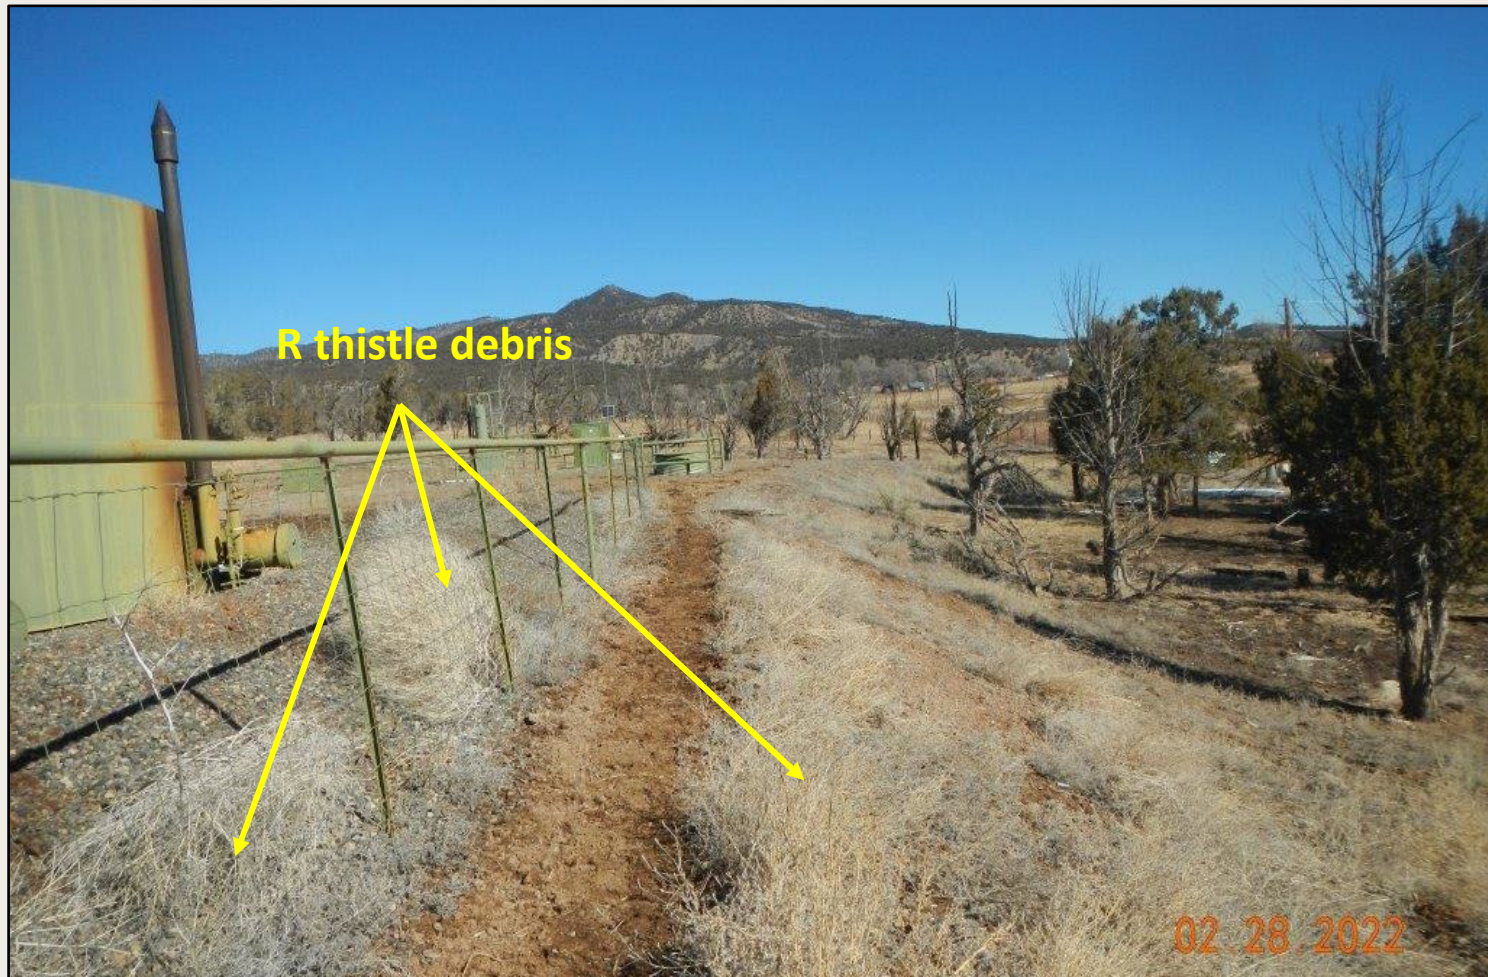
Photo 2. View of the eastern project area from the southeastern corner facing northward. Vegetation is largely dormant/grazed at this time. Russian thistle debris needs to be removed and managed to prevent debris.

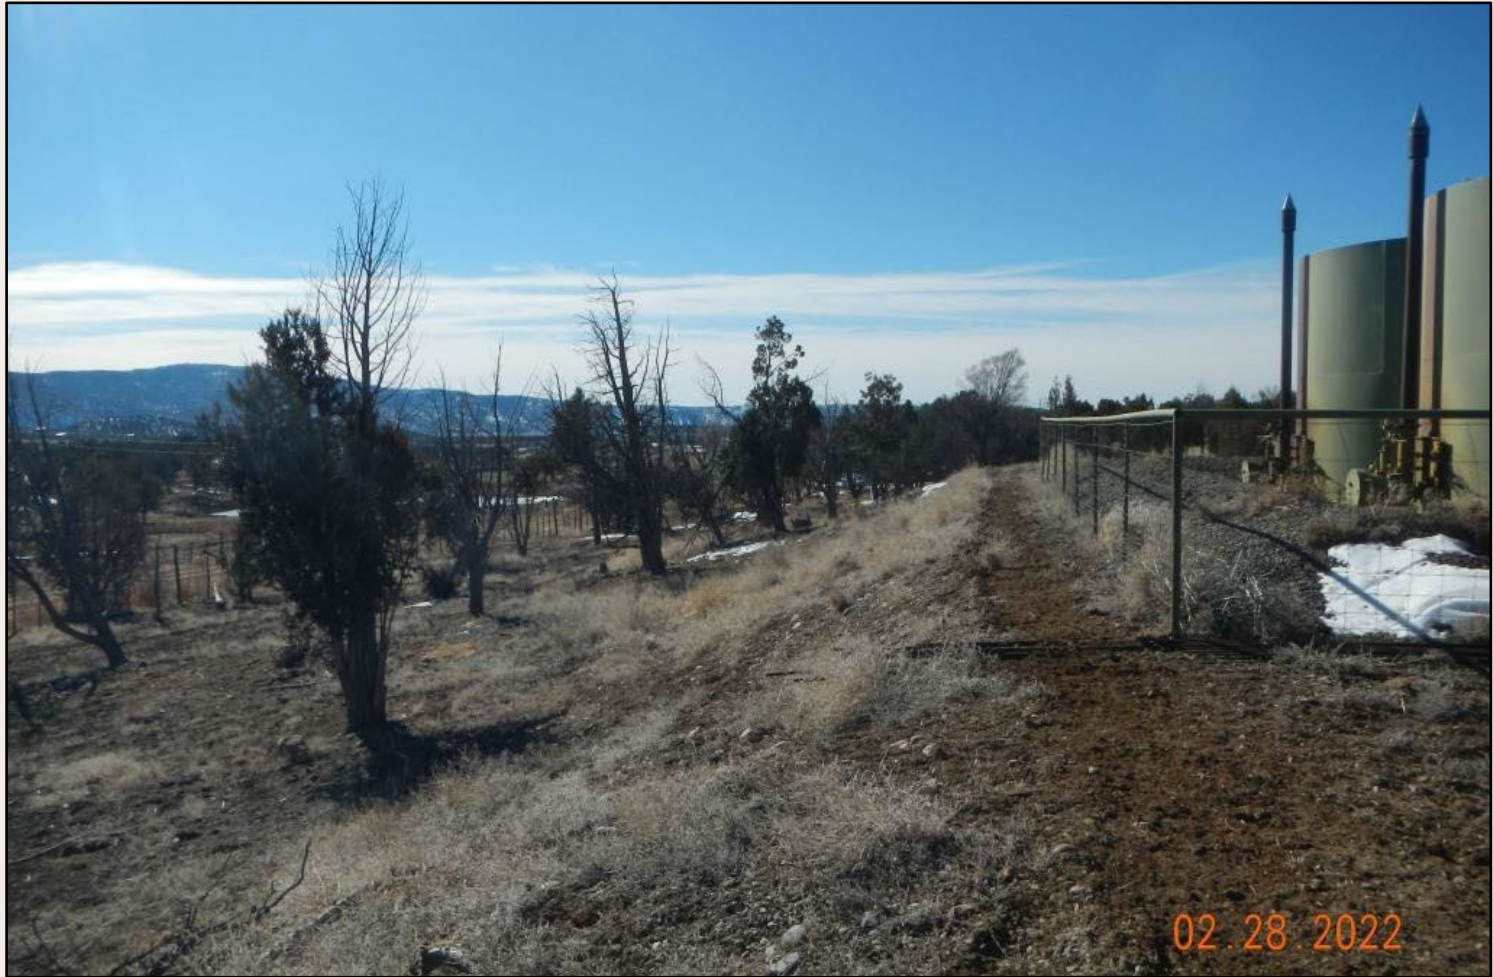
Photo 3. View of the southern project area from the southeastern corner facing westward.

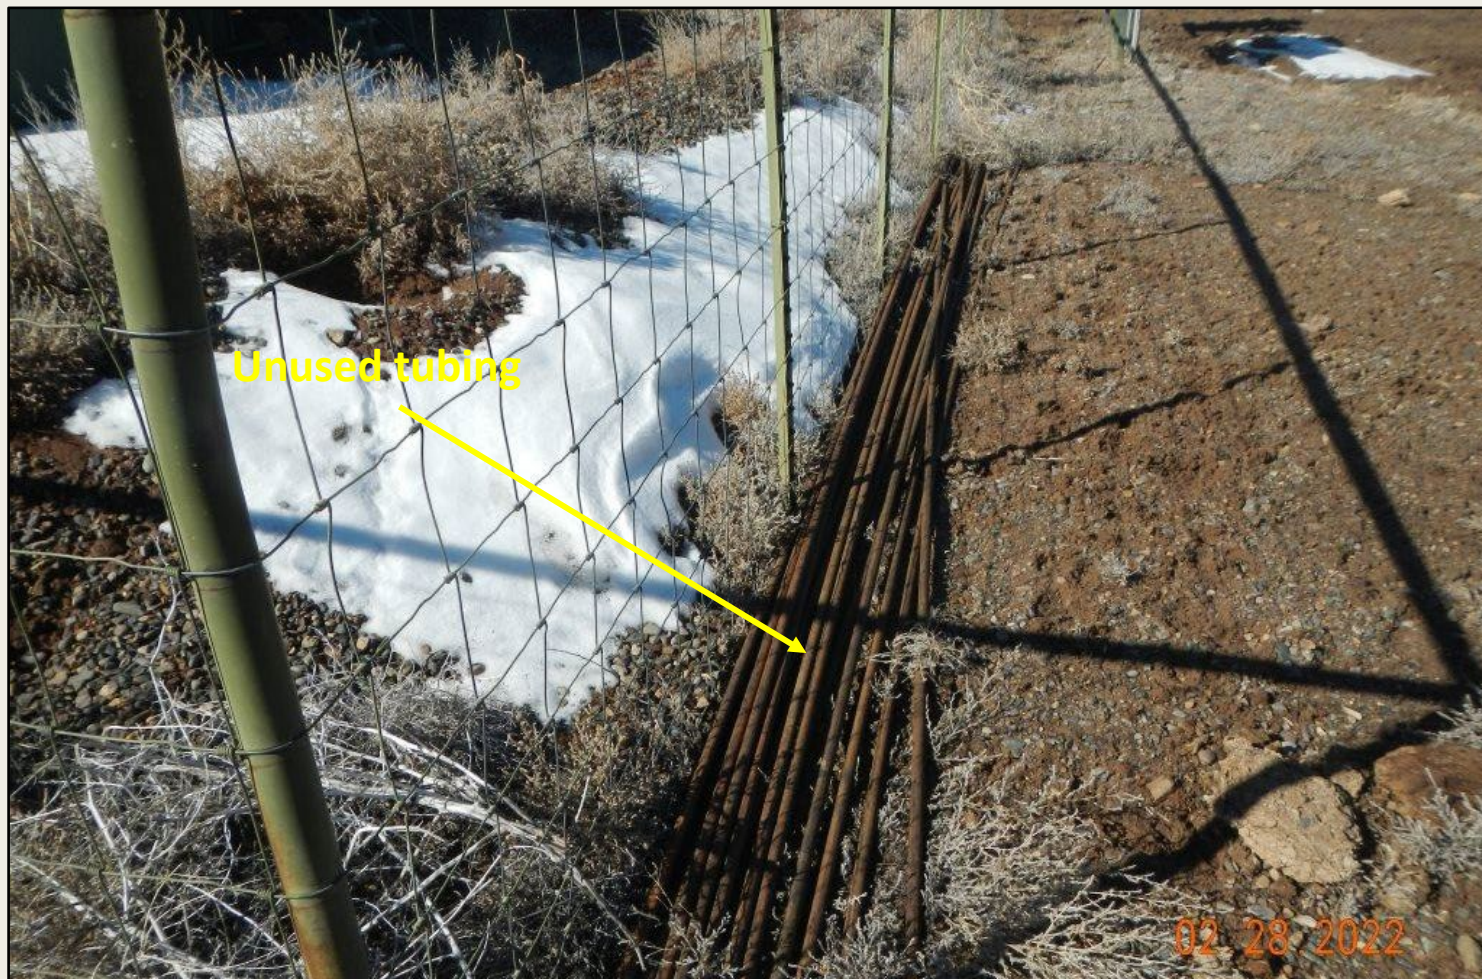
Photo 4. View of unused tubing stored along the edge of the tank storage area.

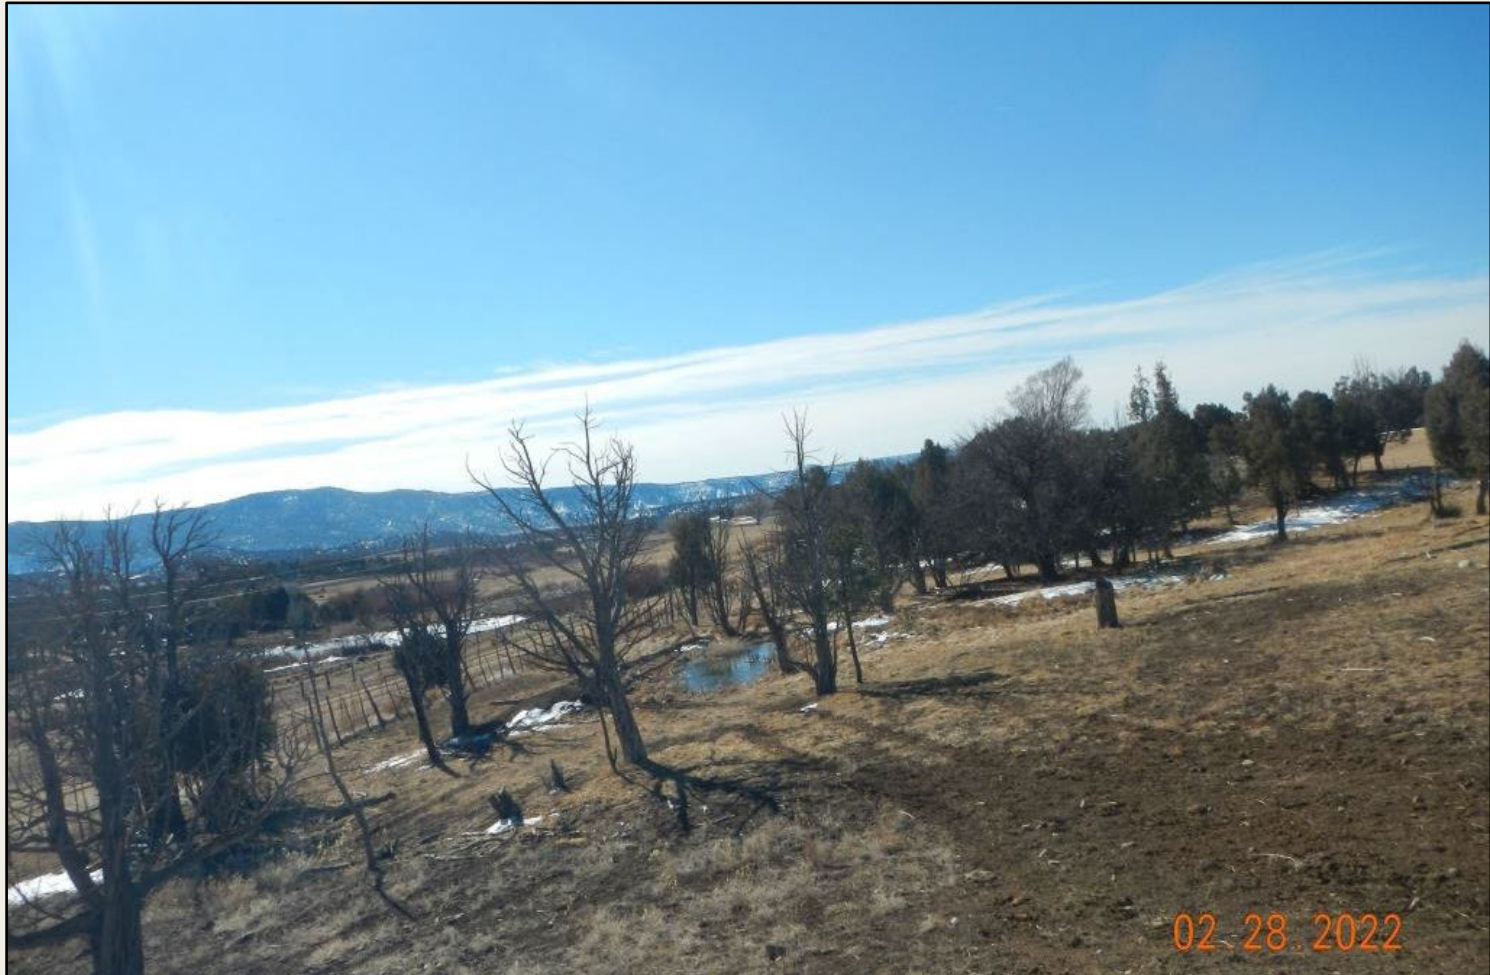
Photo 5. View of reference area vegetation comprised of open pinyon and juniper woodland with grasses in the understory, partially irrigated, with smooth brome, western wheatgrass, and blue grama observed.
