Inspection Photos
Operator: Simcoe
API: 007-06165
Date: 2/28/2022

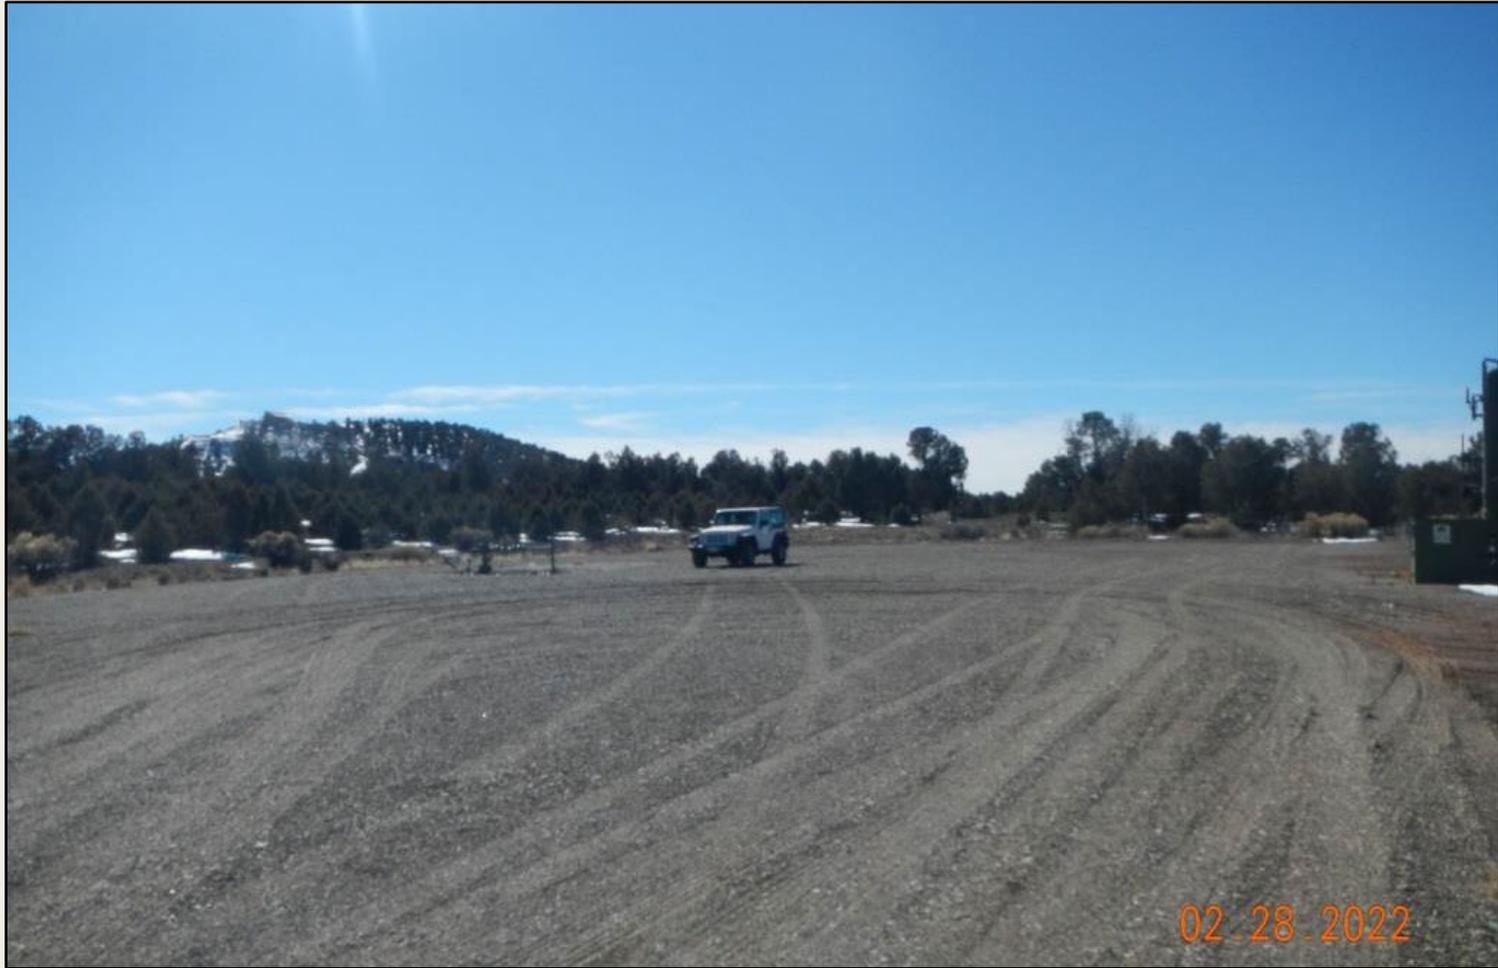
Photo 1. View of project area from the well pad entrance facing center.

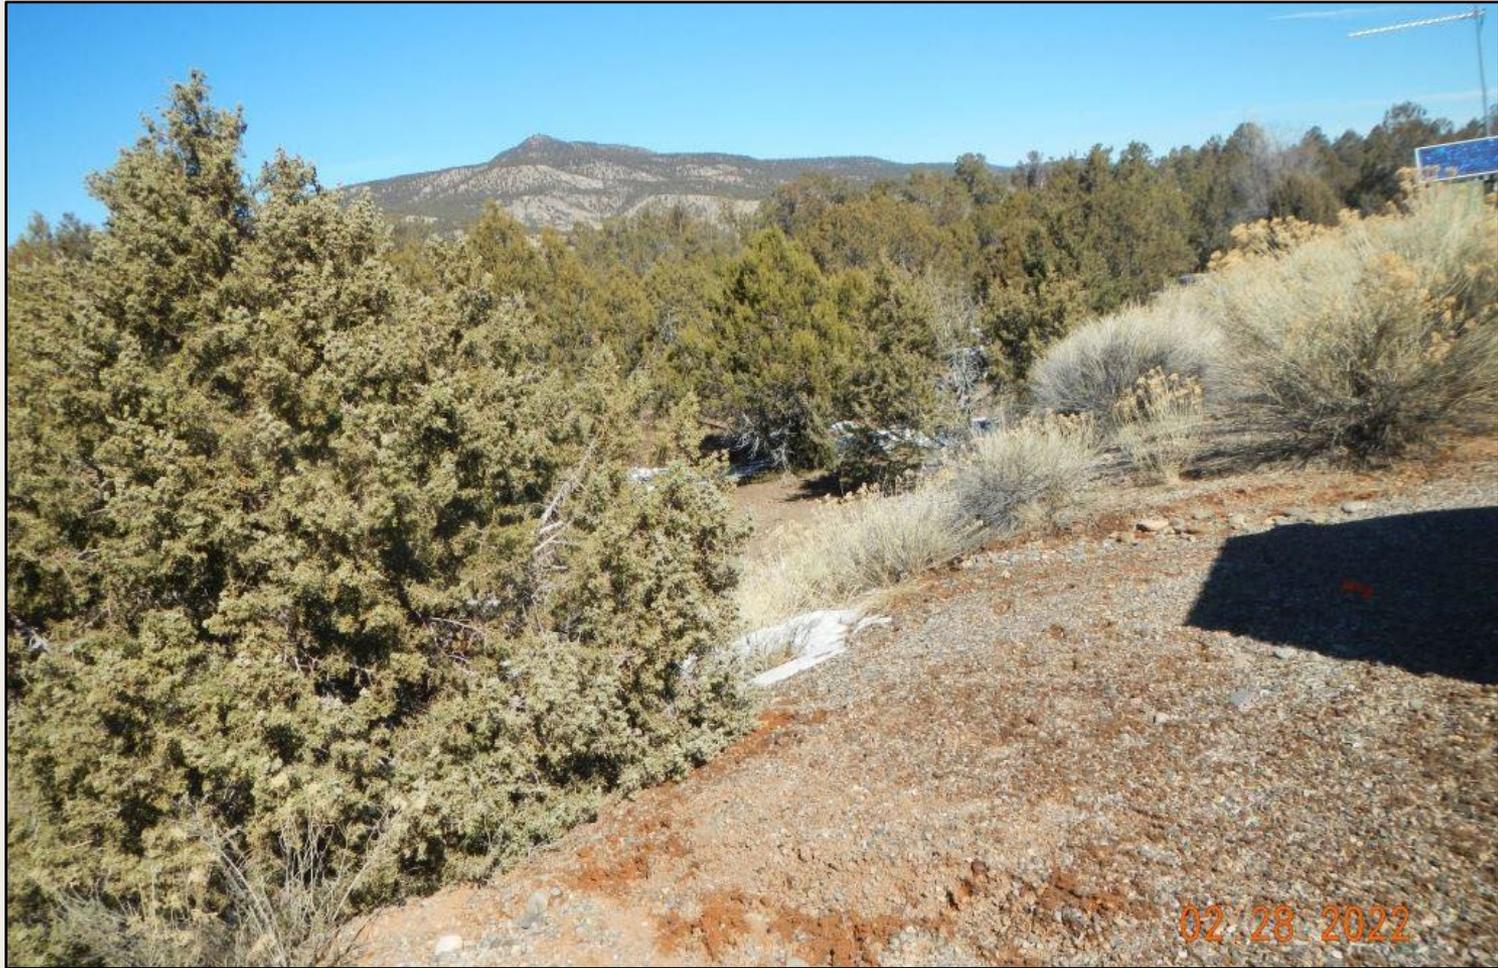
Photo 2. View of the western project area from the southwestern corner facing northward. Revegetation such as rubber rabbitbrush, sand dropseed, and western wheatgrass observed.

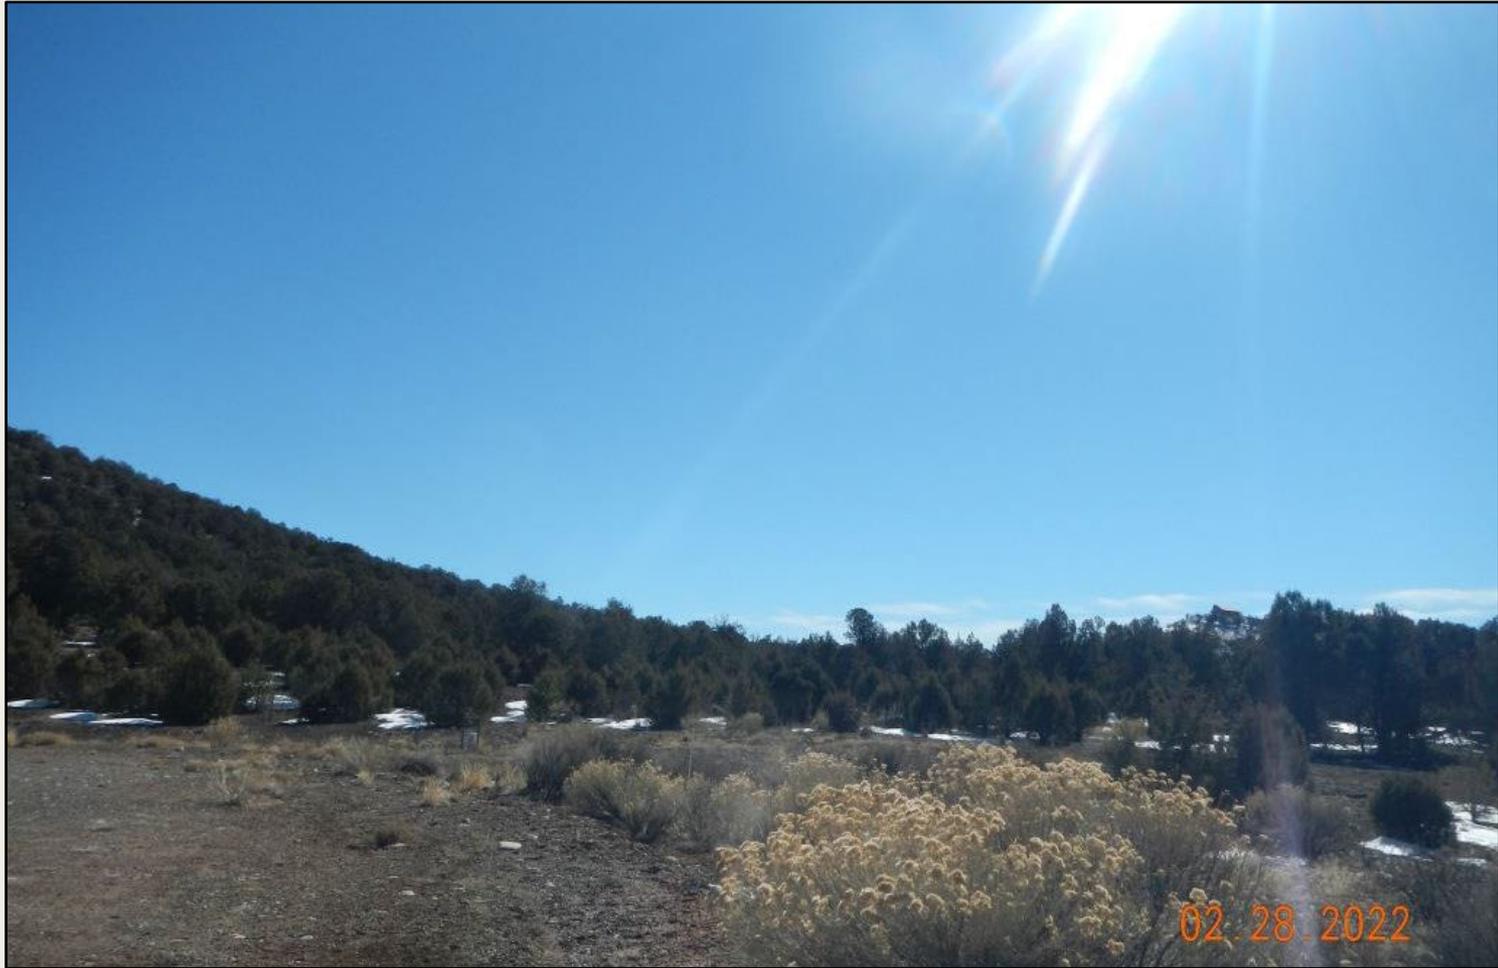
Photo 3. View of the southern project area from the southwestern corner facing eastward.

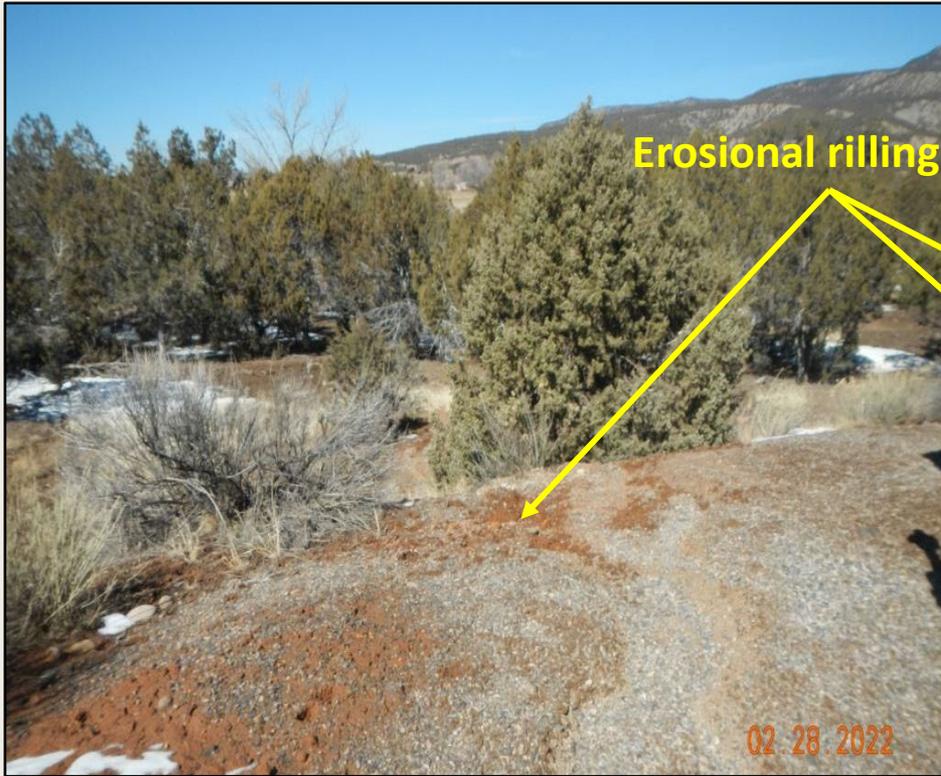
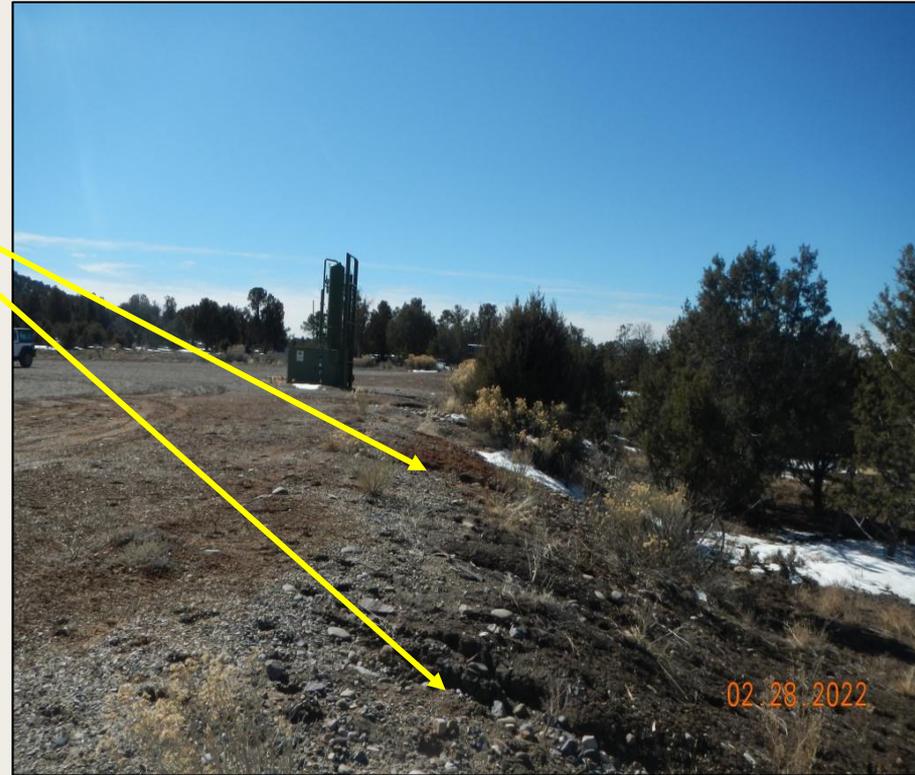
Photos 4/5. View of erosional rilling observed within the western fill slope (multiple areas). Stabilization is needed here.

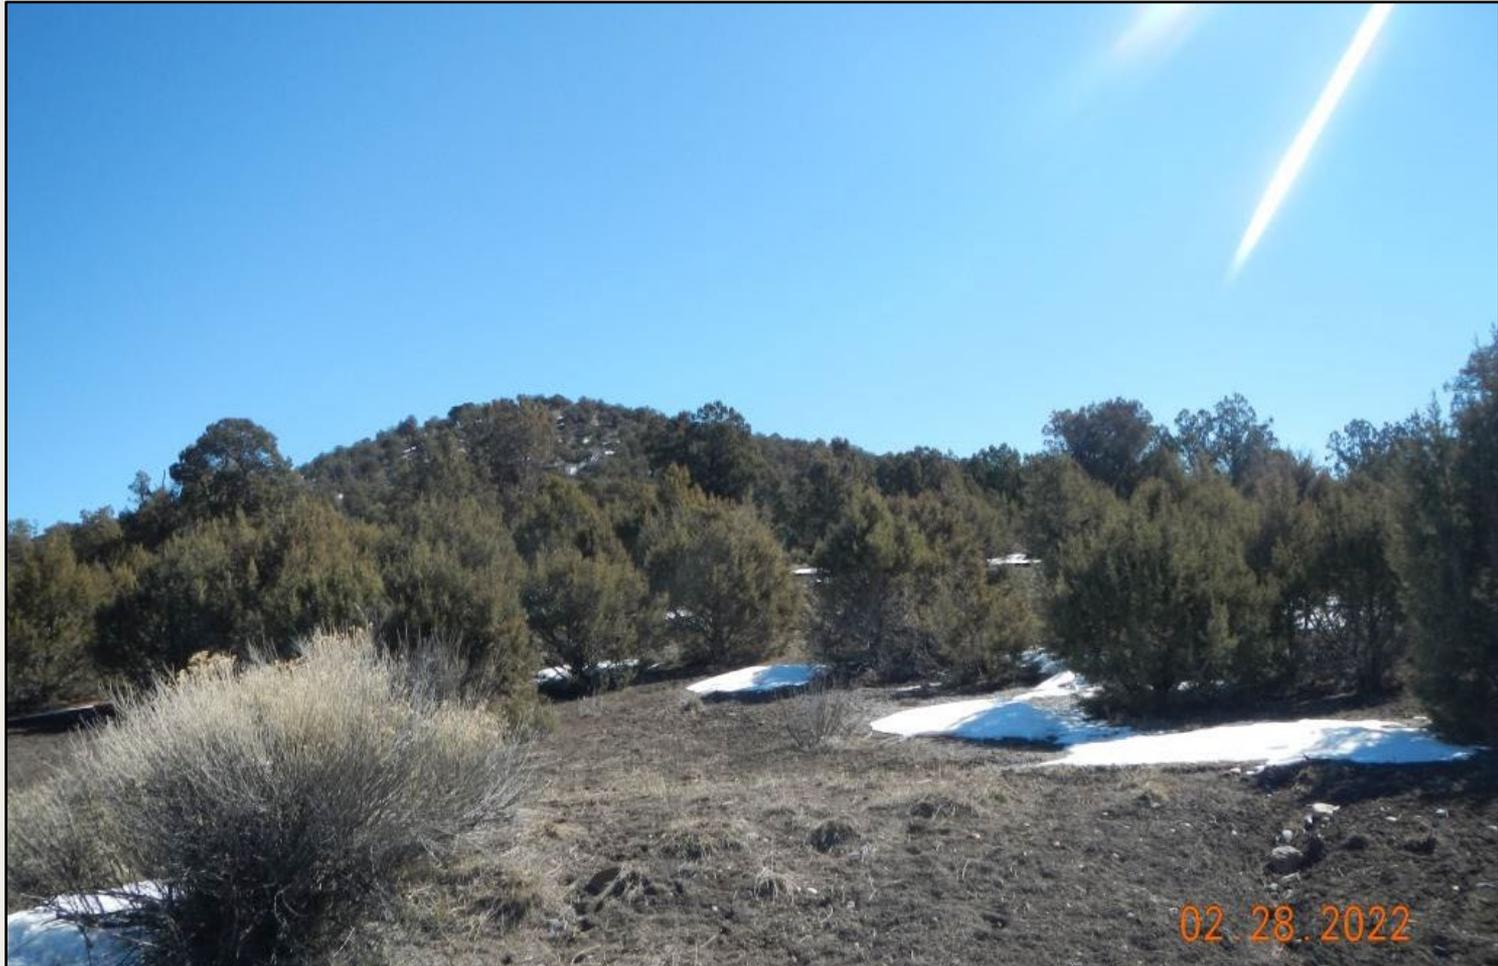
Photo 6. View of reference area comprised of pinyon and juniper woodland with sagebrush, blue grama, prickly pear, and snakeweed in the understory.
