Inspection Photos
Operator: Morningstar Operating
API: 007-06209
Date: 2/28/2022

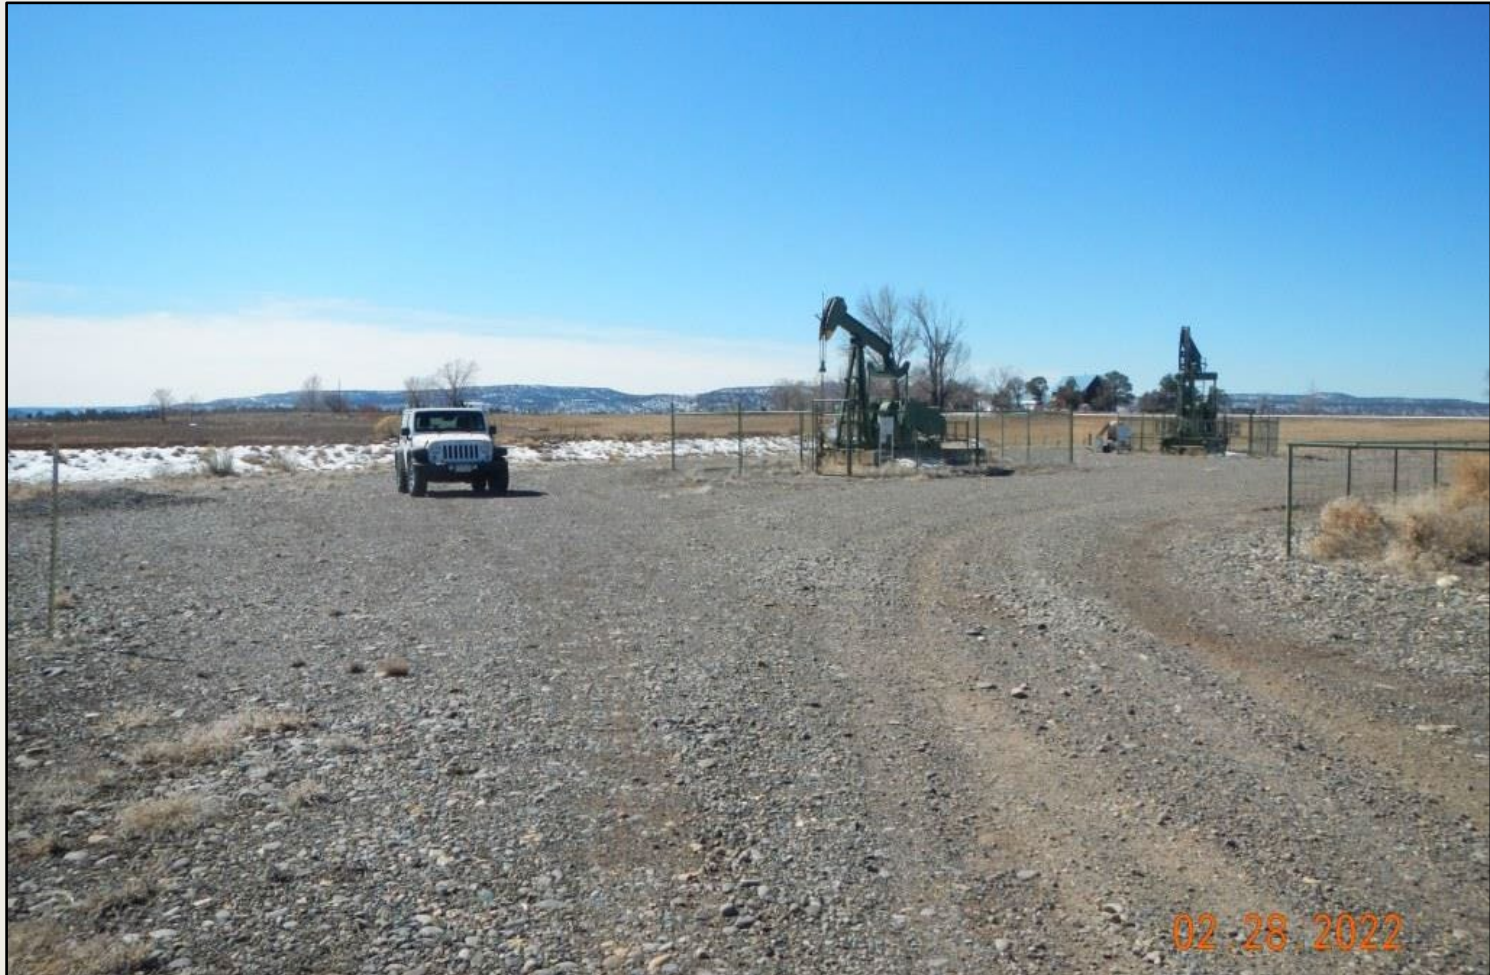
Photo 1. View of project area from the well pad entrance facing center.

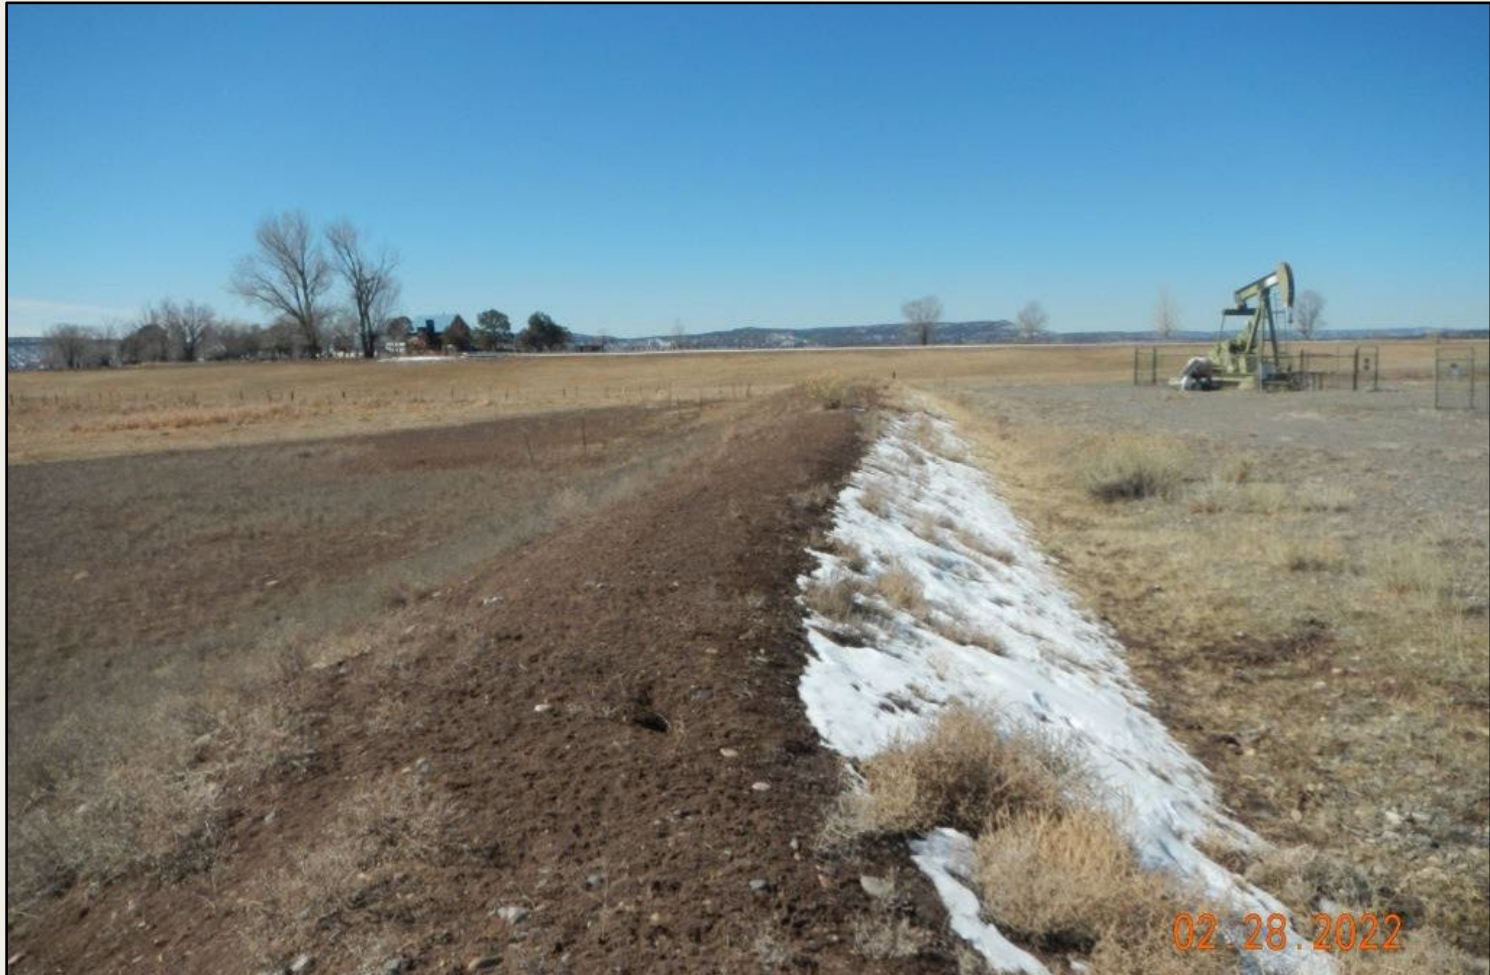
Photo 2. View of the southern project area from the southeastern corner facing westward. Revegetation is largely dormant and grazed at this time. Revegetation needs to be monitored during the active growing season and re-seeding conducted if needed.

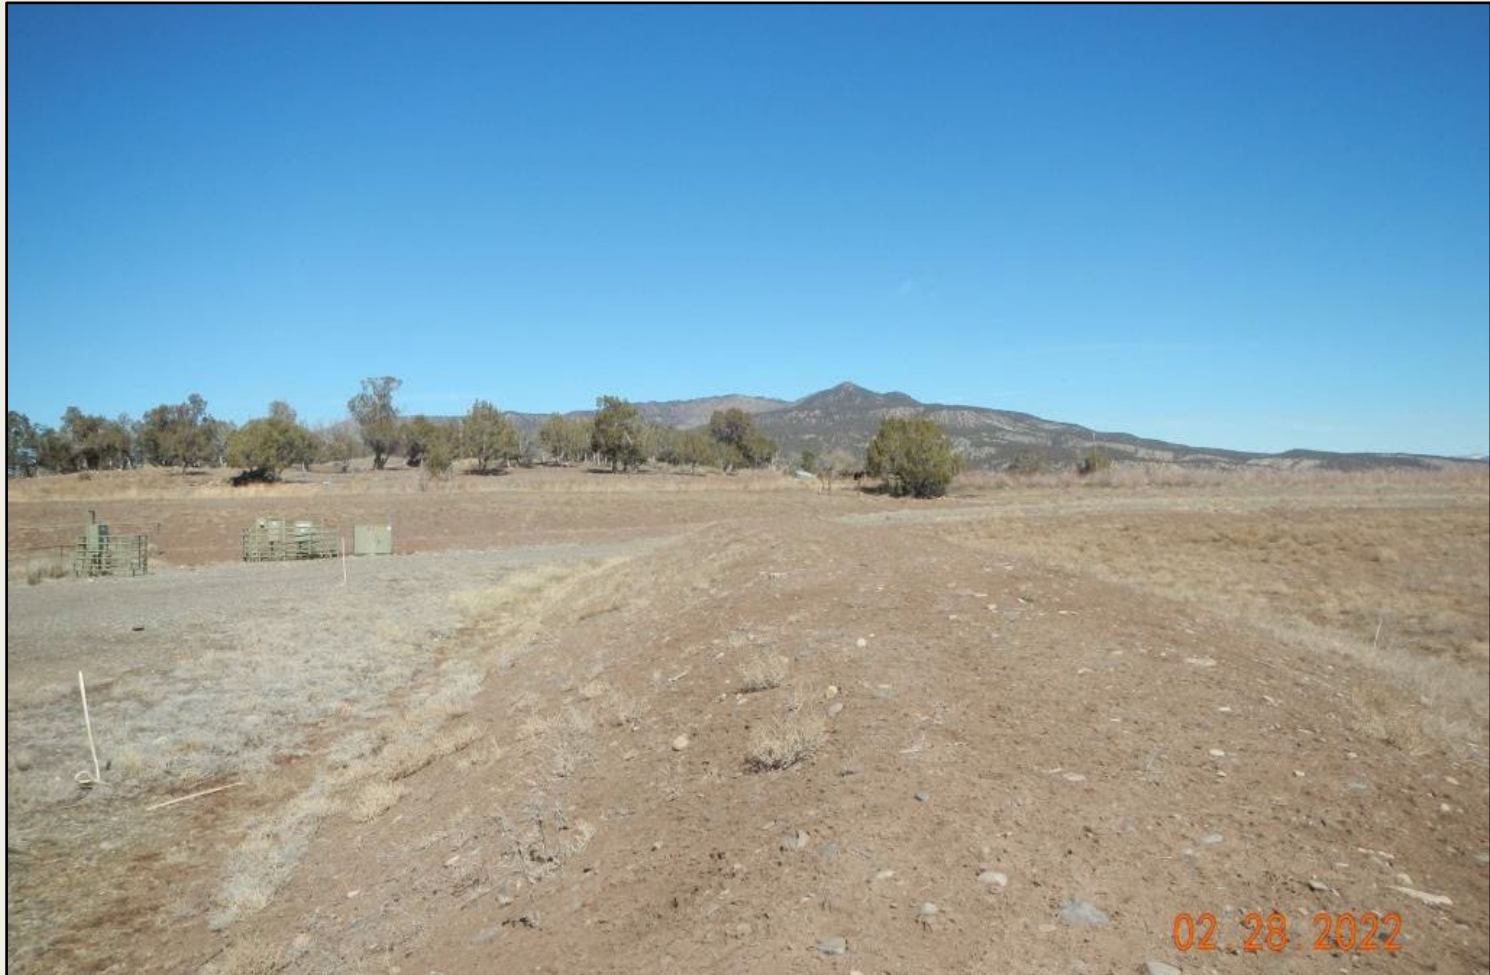
Photo 3. View of the eastern project area from the southeastern corner facing northward.

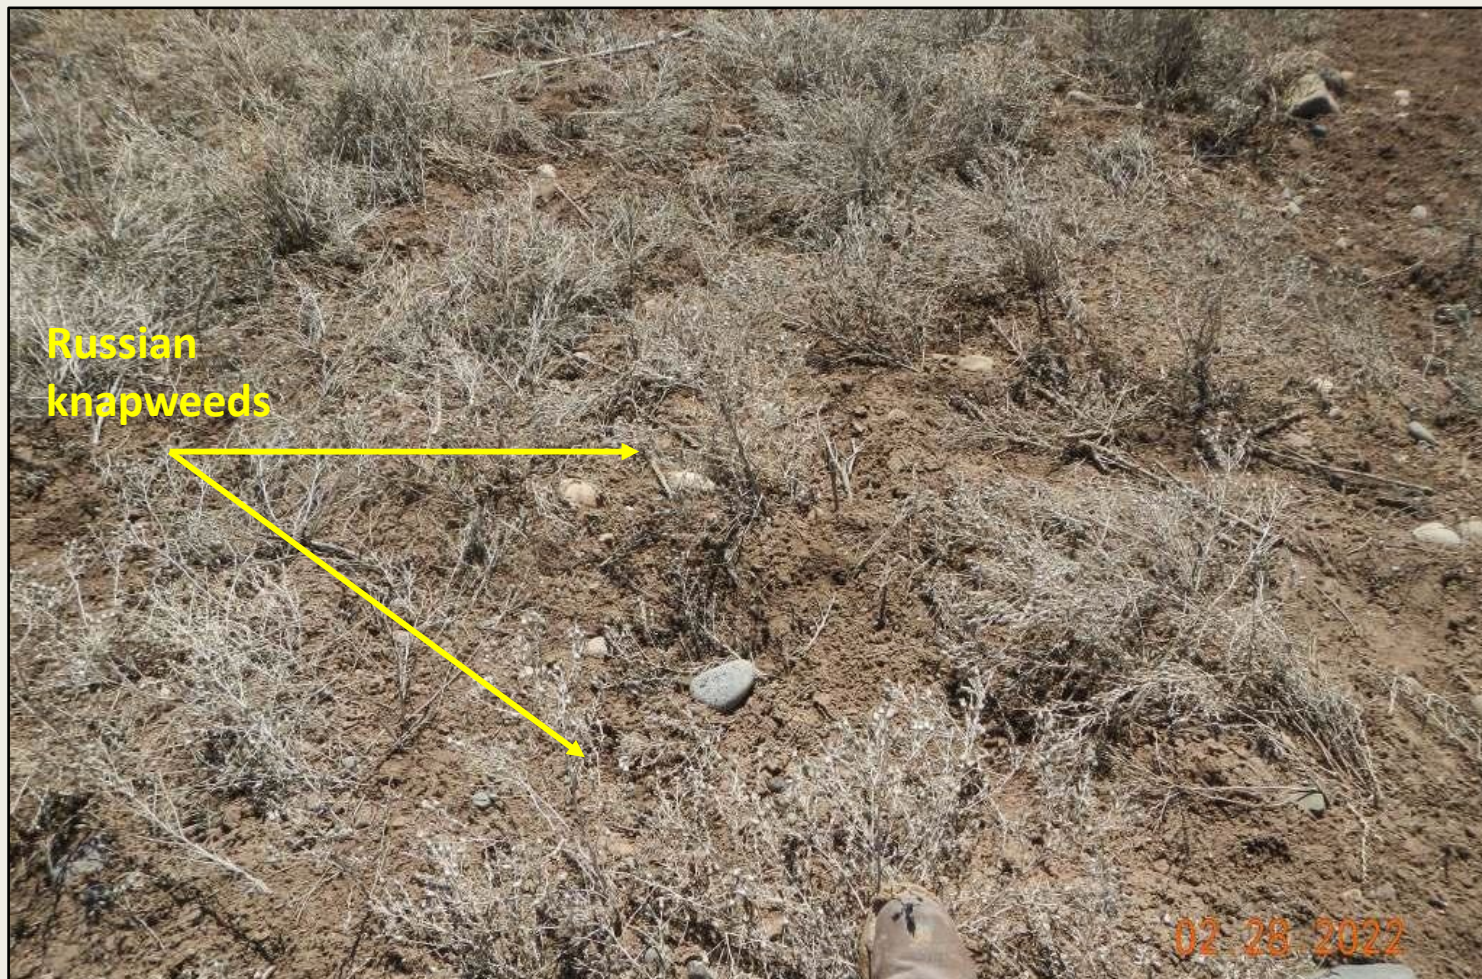
Photo 4. View of Russian knapweeds observed within the interim reclamation area. Approx. 1000 individuals observed.

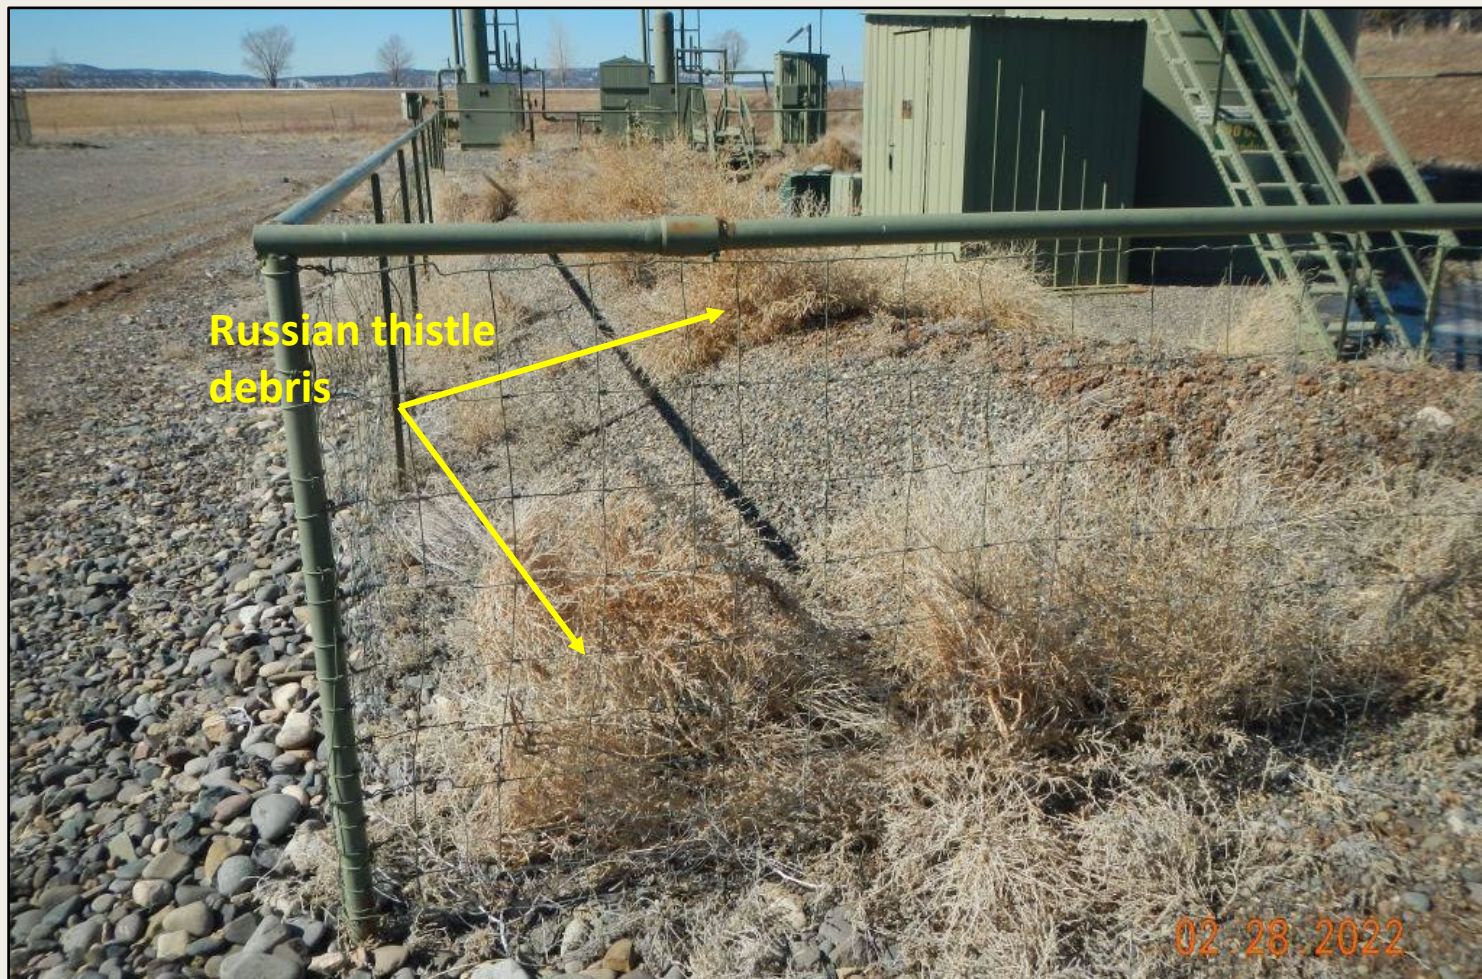
Photo 5. View of Russian thistle debris observed within the project area.

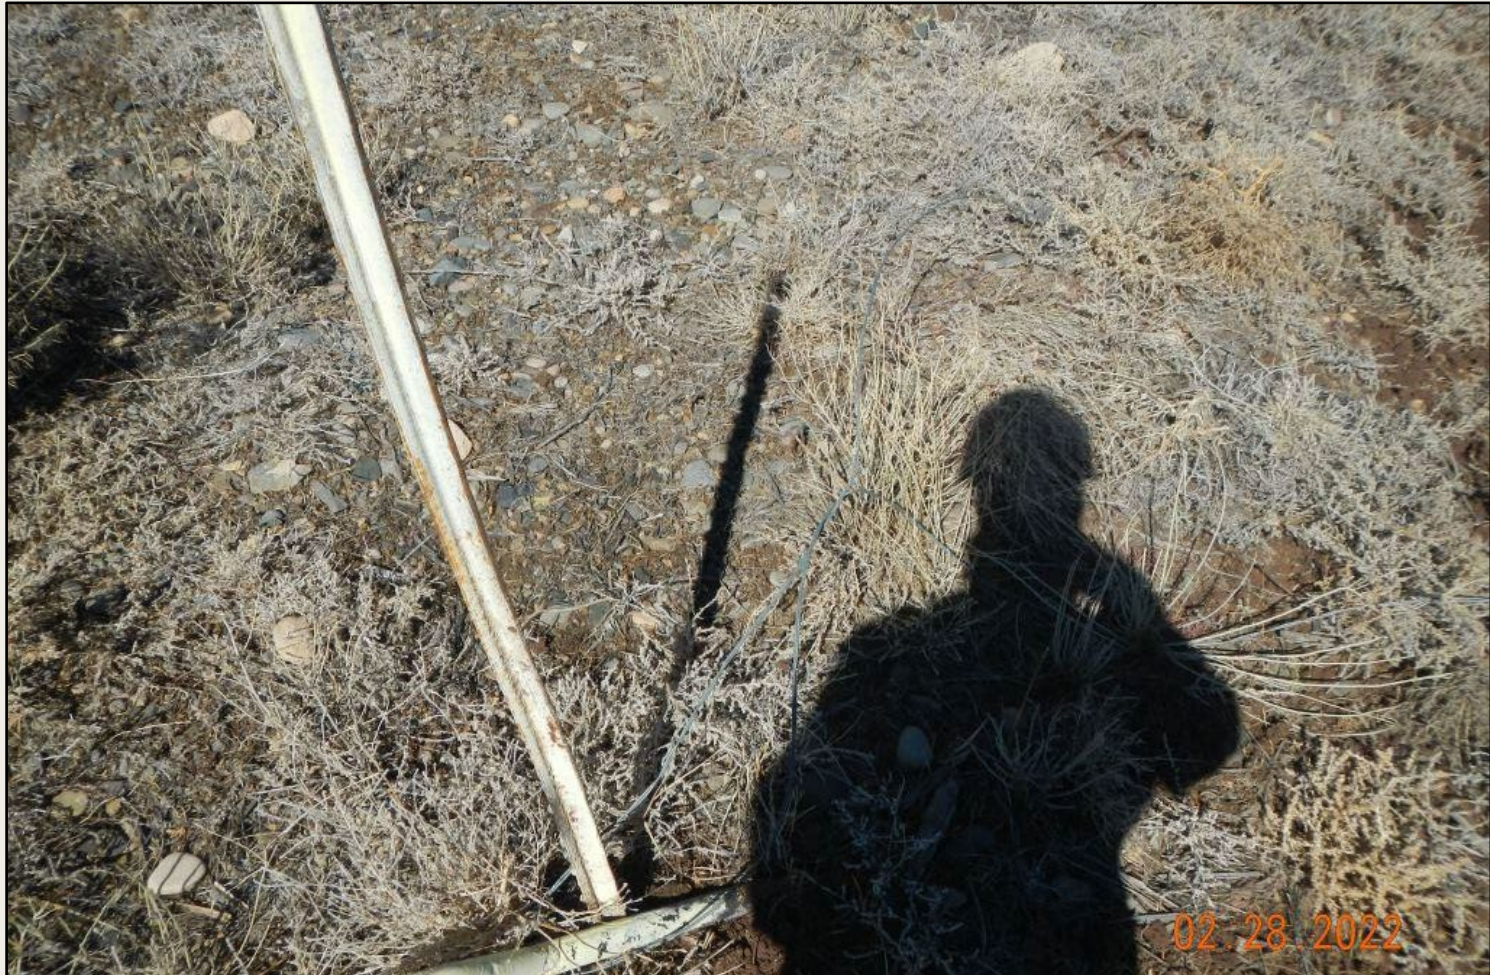
Photo 6. View wire/fencing debris (approx 75 ft long) within the eastern project area, needs to be removed.

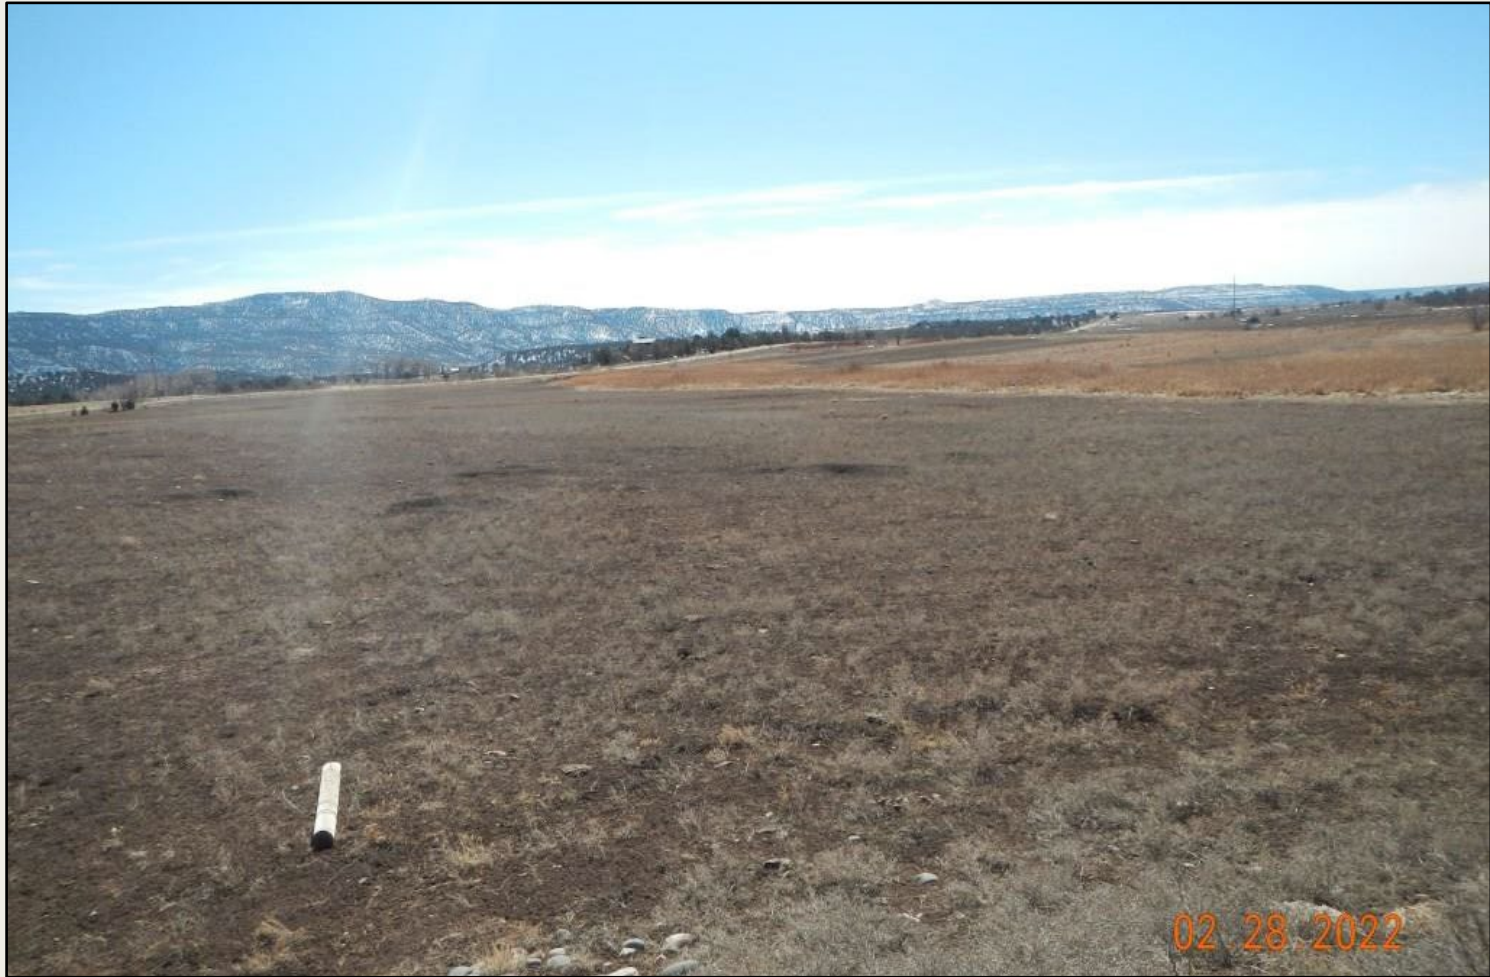
Photo 7. View of reference area comprised of open grass field, largely dormant at this time. Western wheatgrass is observable.
