Inspection Photos

03/02/2022

Operator: KOCH EXPLORATION COMPANY LLC

Location ID: 391071

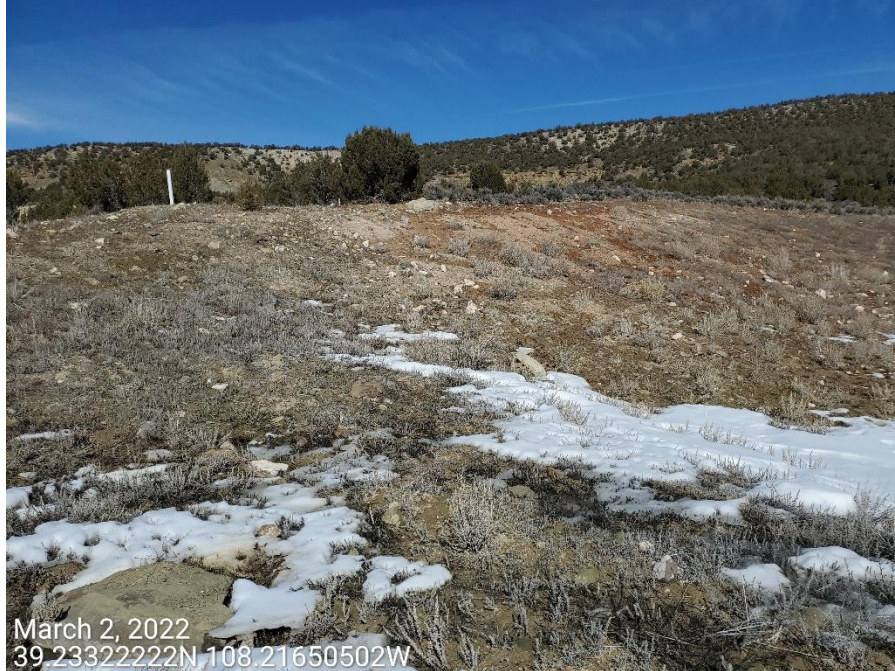
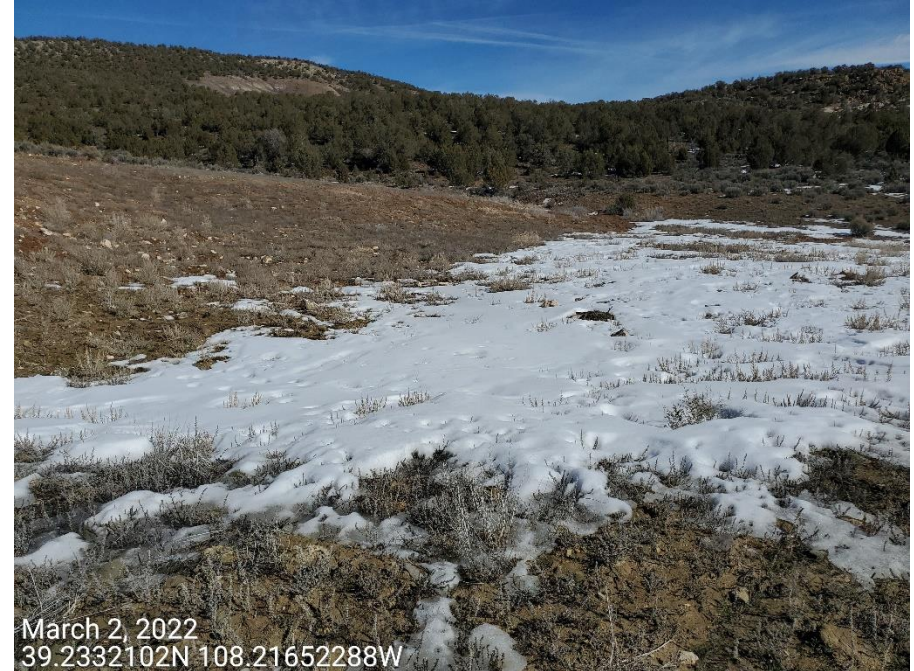
Photo 1: Photos taken from the south end of the Location. Photos 1-2 provide an overview of the Location from northwest, north, northeast to east.

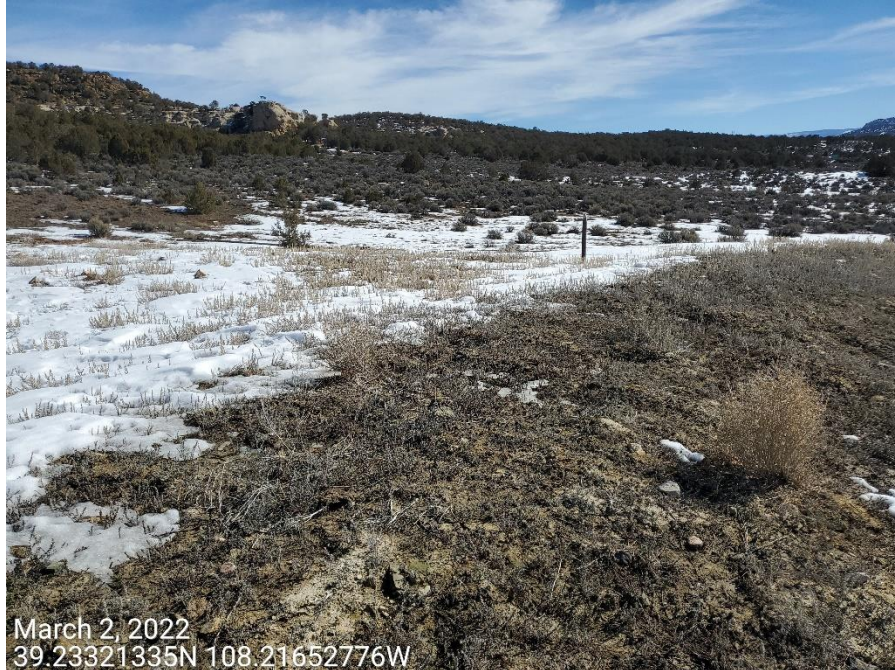
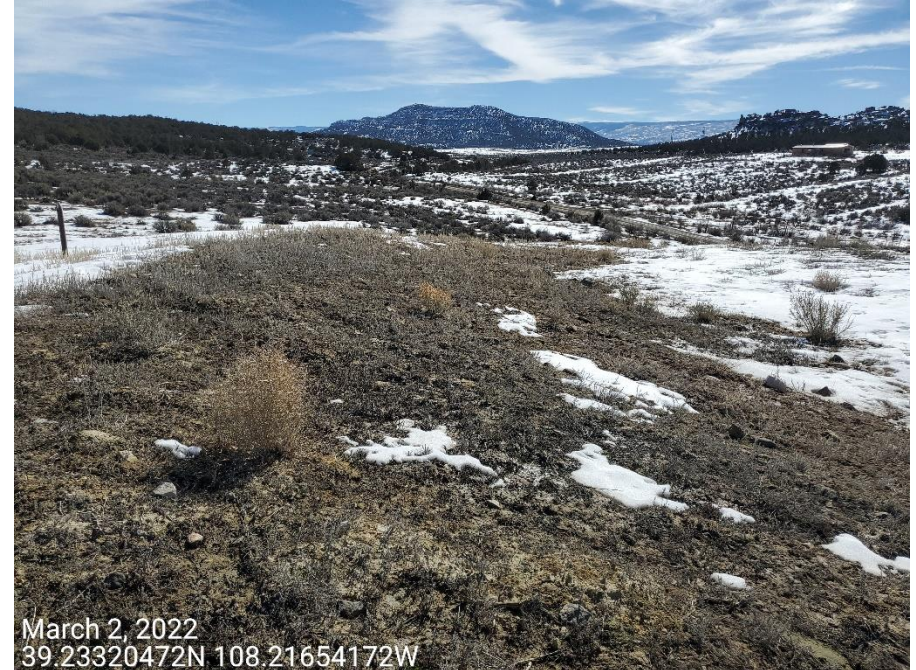
Photo 2: See comments under photo 1.

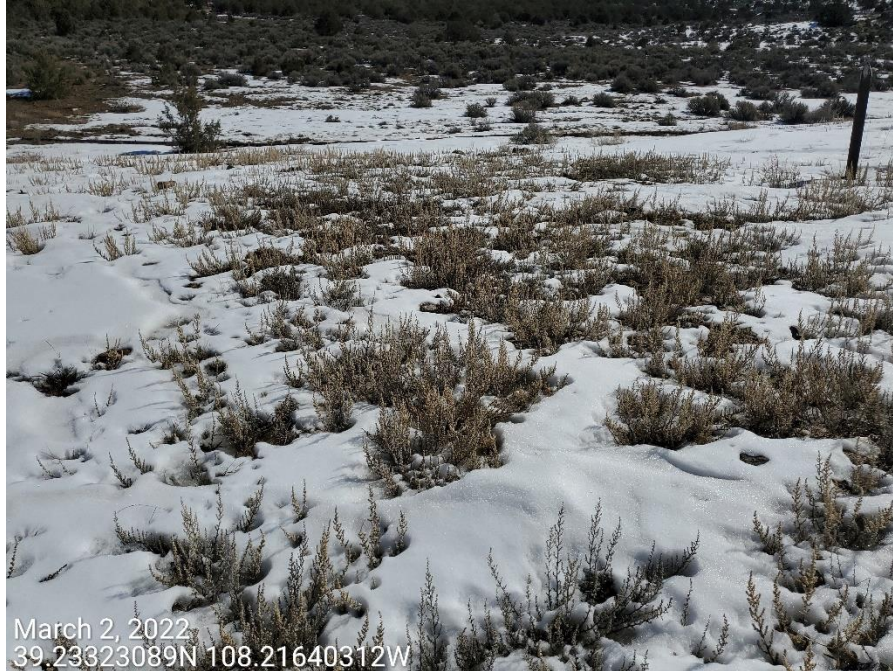
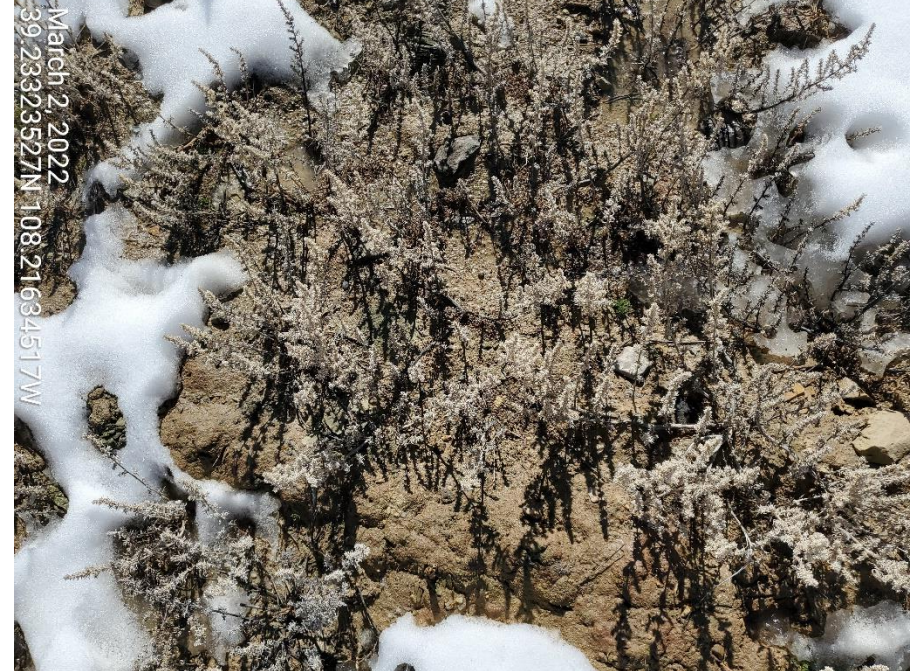
Photo 3: Photos taken from the Location. Photo provides example showing vegetation on the Location; vegetation observed is predominantly Undesirable Plant Species including *Salsola* sp., and *Halogeton* (a Colorado State listed noxious weed). Some desirable perennial vegetative establishment was observed, however desirable plant species is not uniform, and has not achieved and 80% vegetative cover to that of the adjacent reference areas.

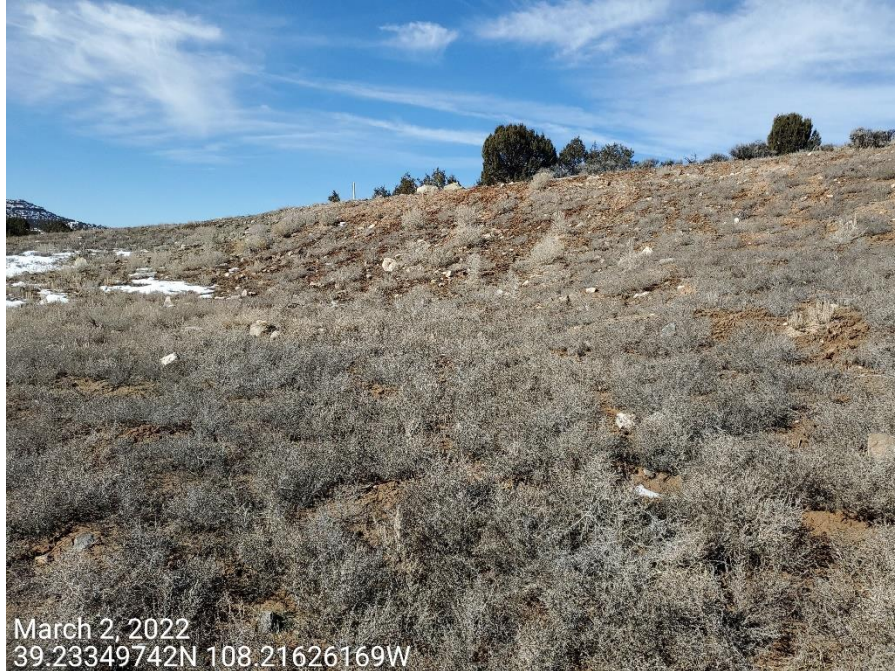
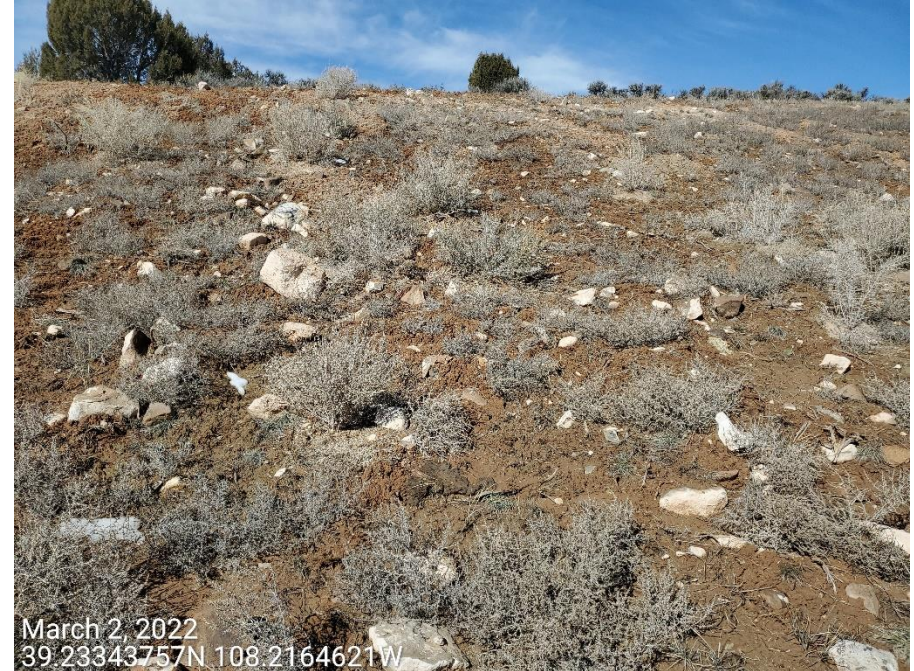
Photo 4: Photos taken from the west end of the Location. See comments under photo 3 regarding vegetation. Stormwater and erosion control measures to manage runoff and stabilize the soils were not observed.

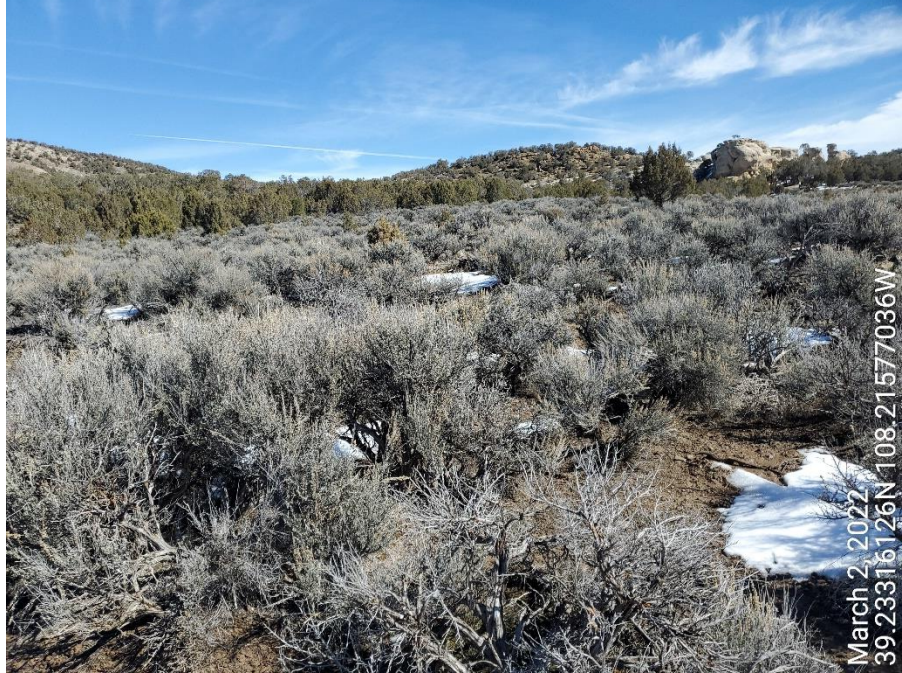
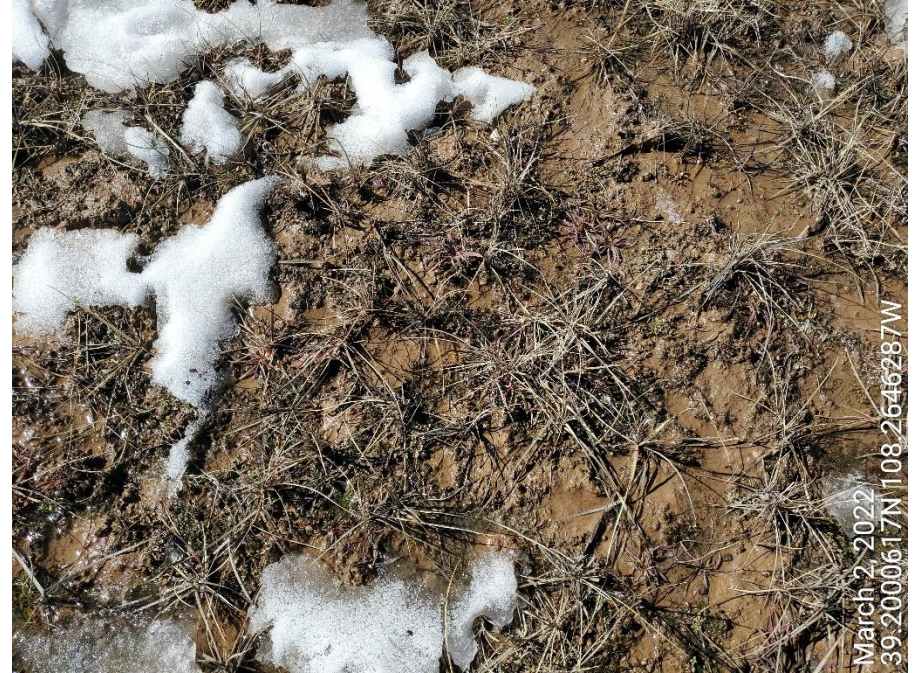
Photo 5: Photos taken from the adjacent reference areas. Photos show example of shrub and perennial grass establishment observed on the Reference. Vegetation on the disturbed oil and gas Location is not reflective of the reference.

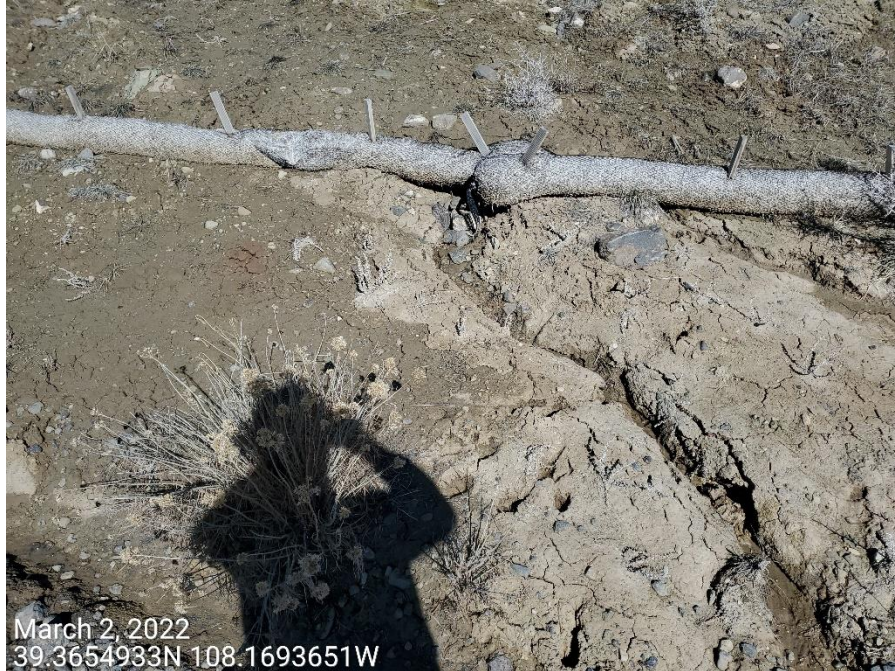
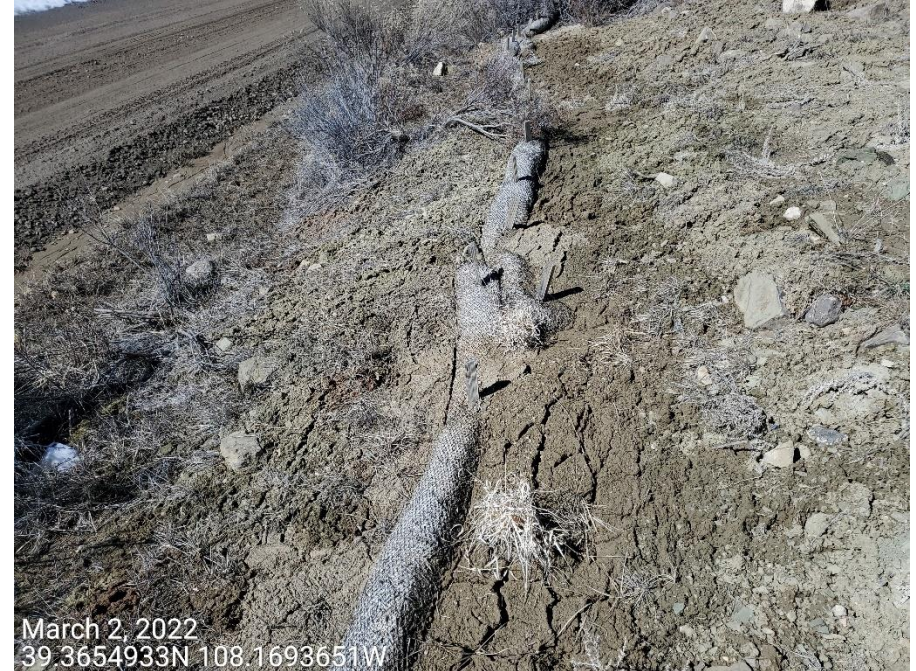
Photo 6: Photos examples showing Operator has installed a single straw erosion log (wattle) along the downslope-perimeter of the Location. Photos show stormwater and erosion control measures on the Location are missing, or have not been installed in accordance with good engineering practices and/or maintained in a proper functioning condition; runoff observed cutting under sections of wattle, and sediment was observed discharged over other sections and off-site. No other stormwater and erosion control measures were observed in conjunction with the erosion logs on the Location; BMPs to stabilize the slopes/soils of the location not observed.
