Inspection Photos
Operator: Simcoe
API: 007-06086
Date: 2/28/2022

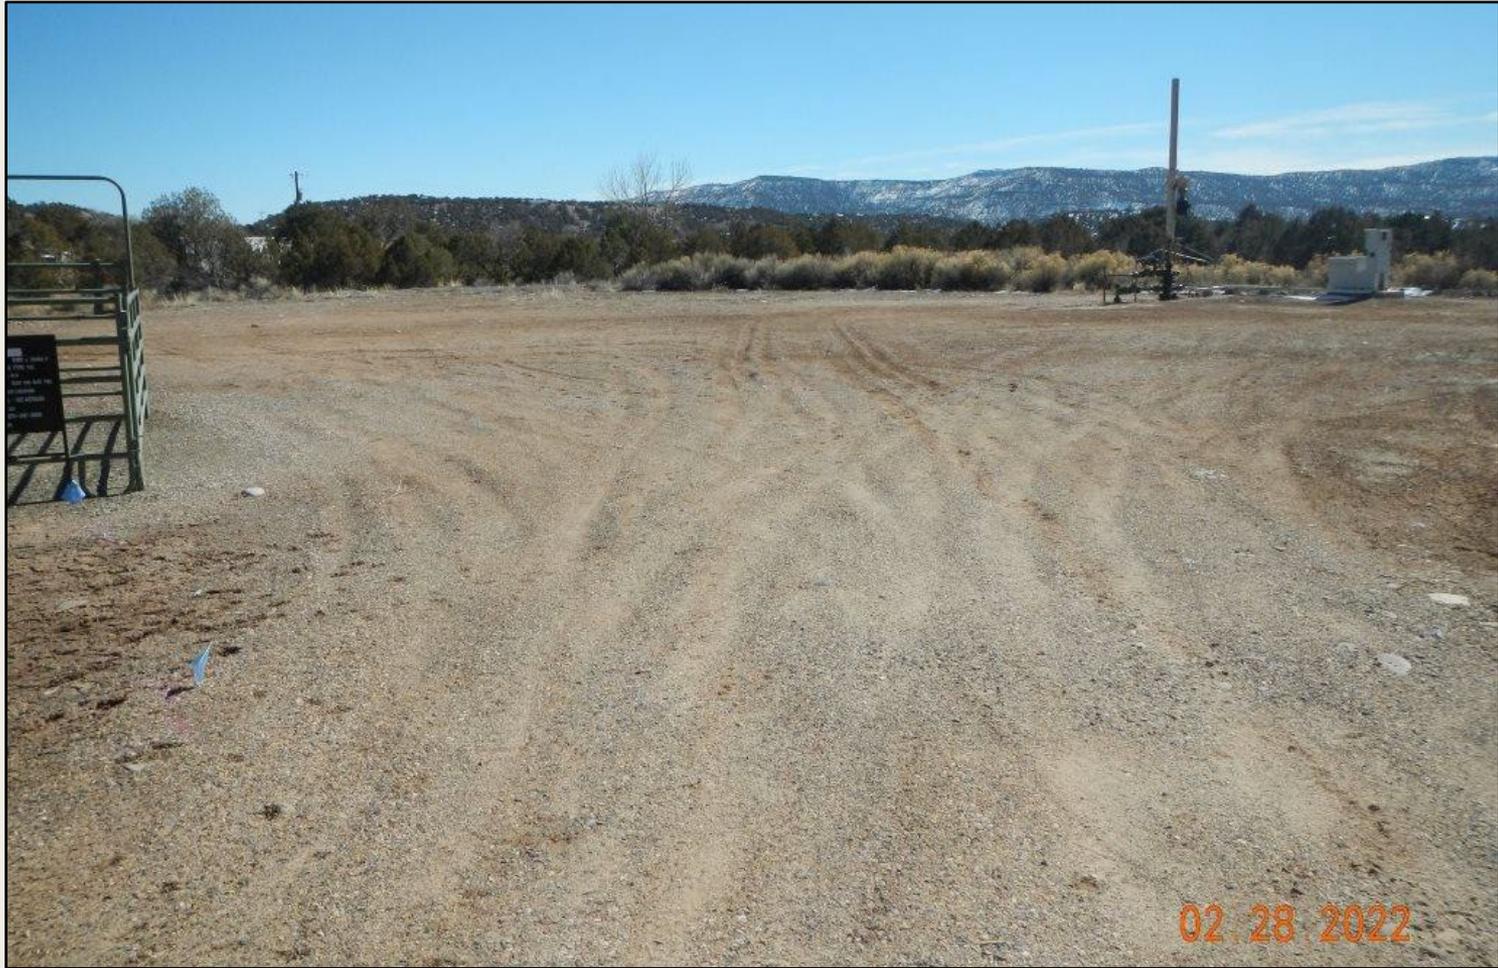
Photo 1. View of project area from the well pad entrance facing center.

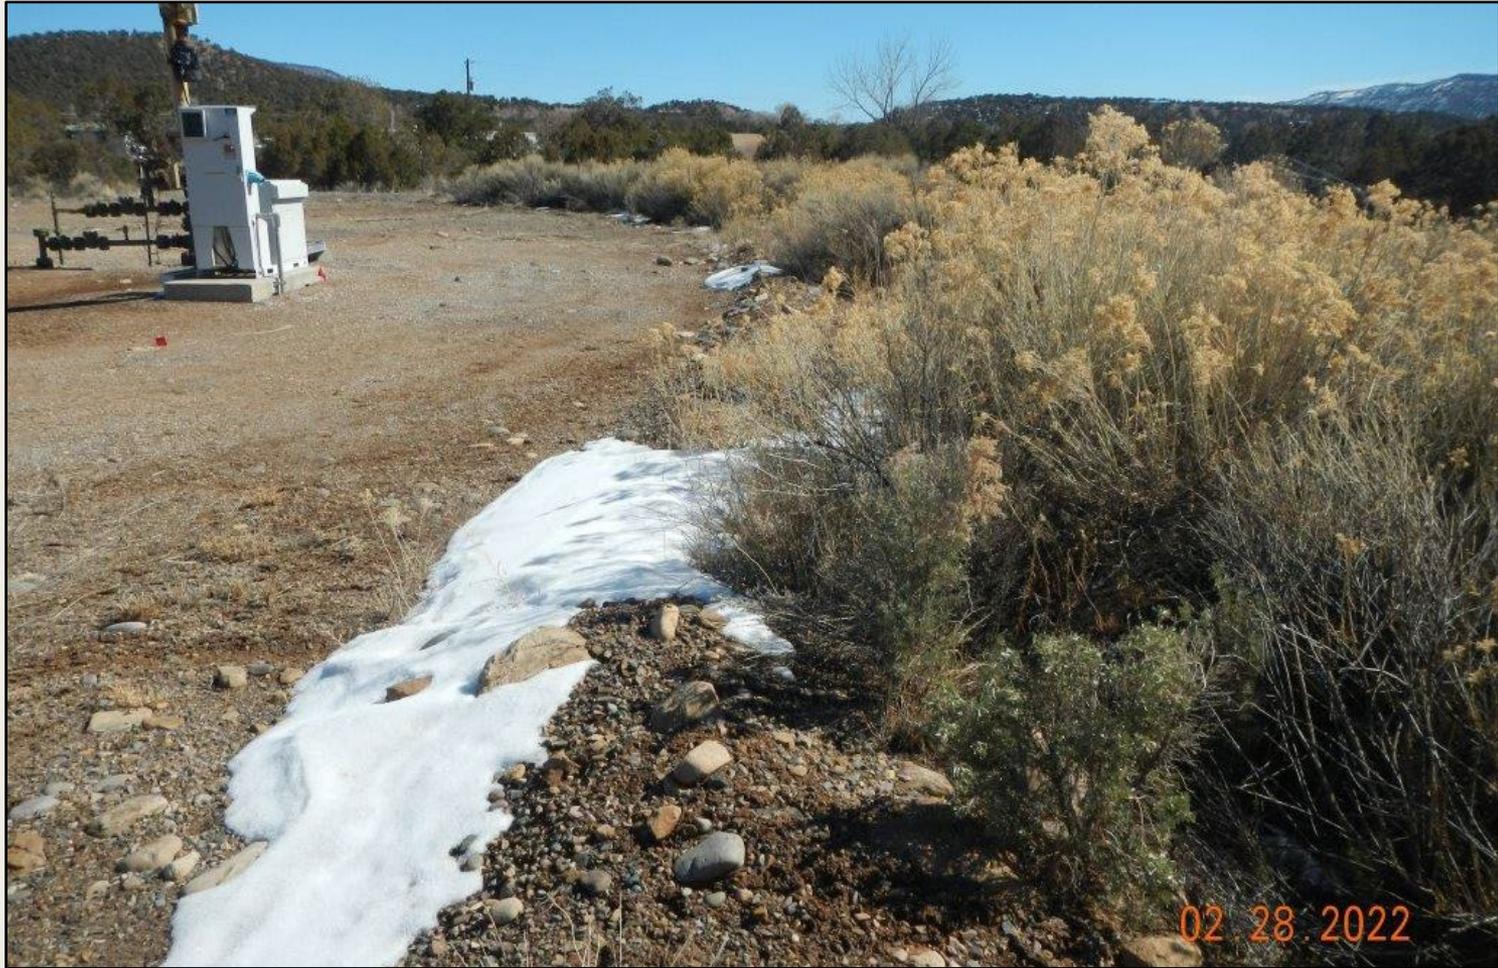
Photo 2. View of the southern project area from the southwestern corner facing eastward. Revegetation is progressing with dense rubber rabbitbrush, sand dropseed, and western wheatgrass.

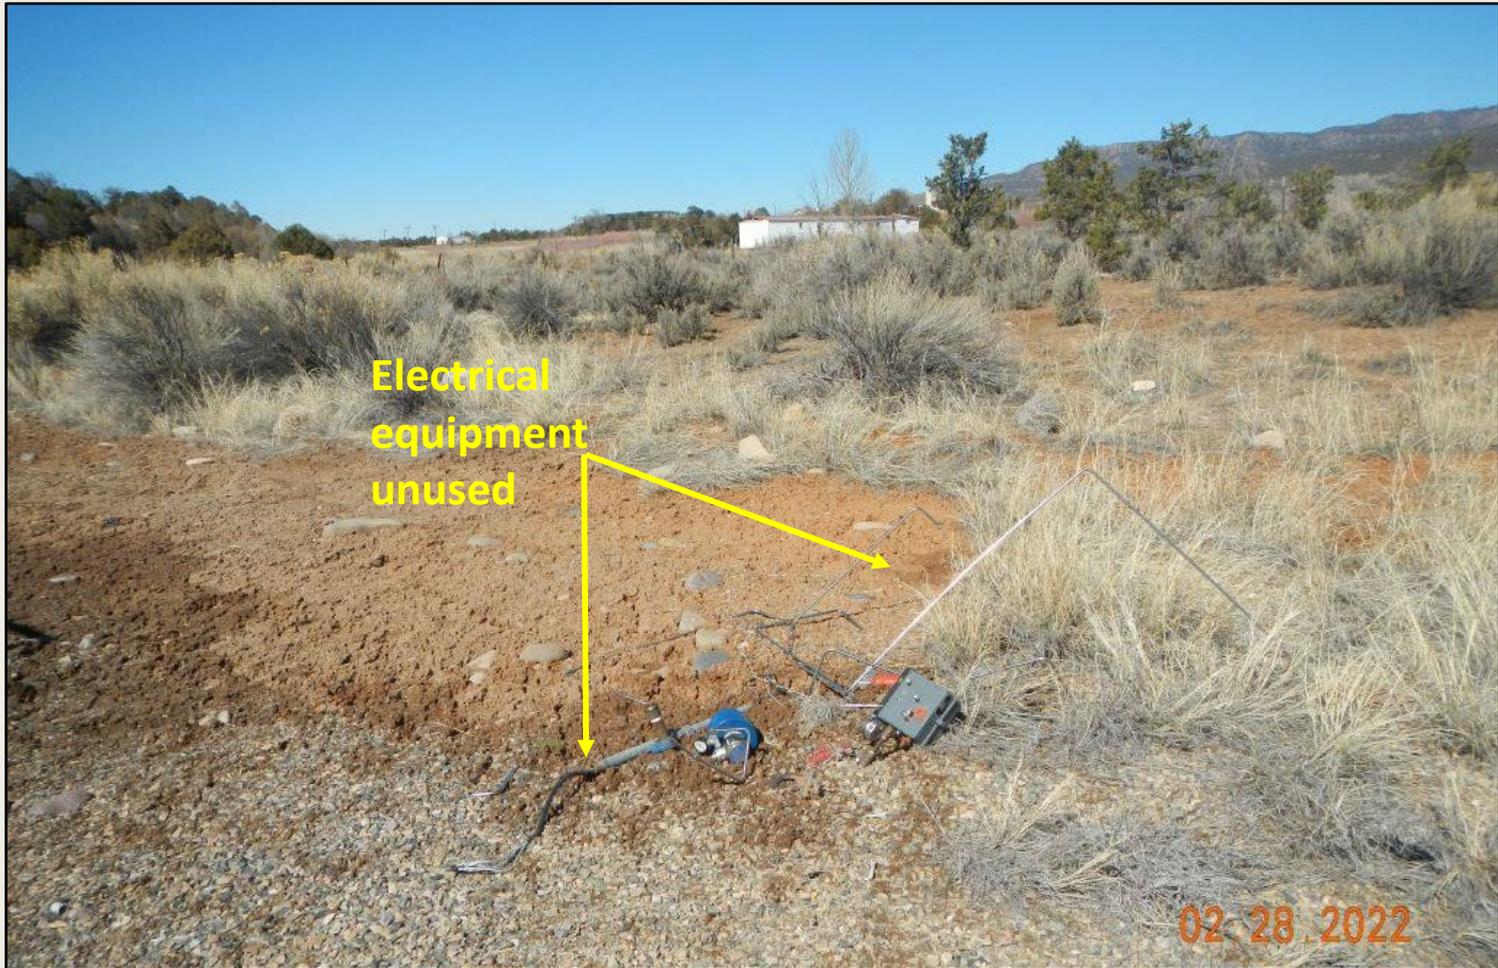
Photo 3. View of unused electrical equipment observed in the northern project area.

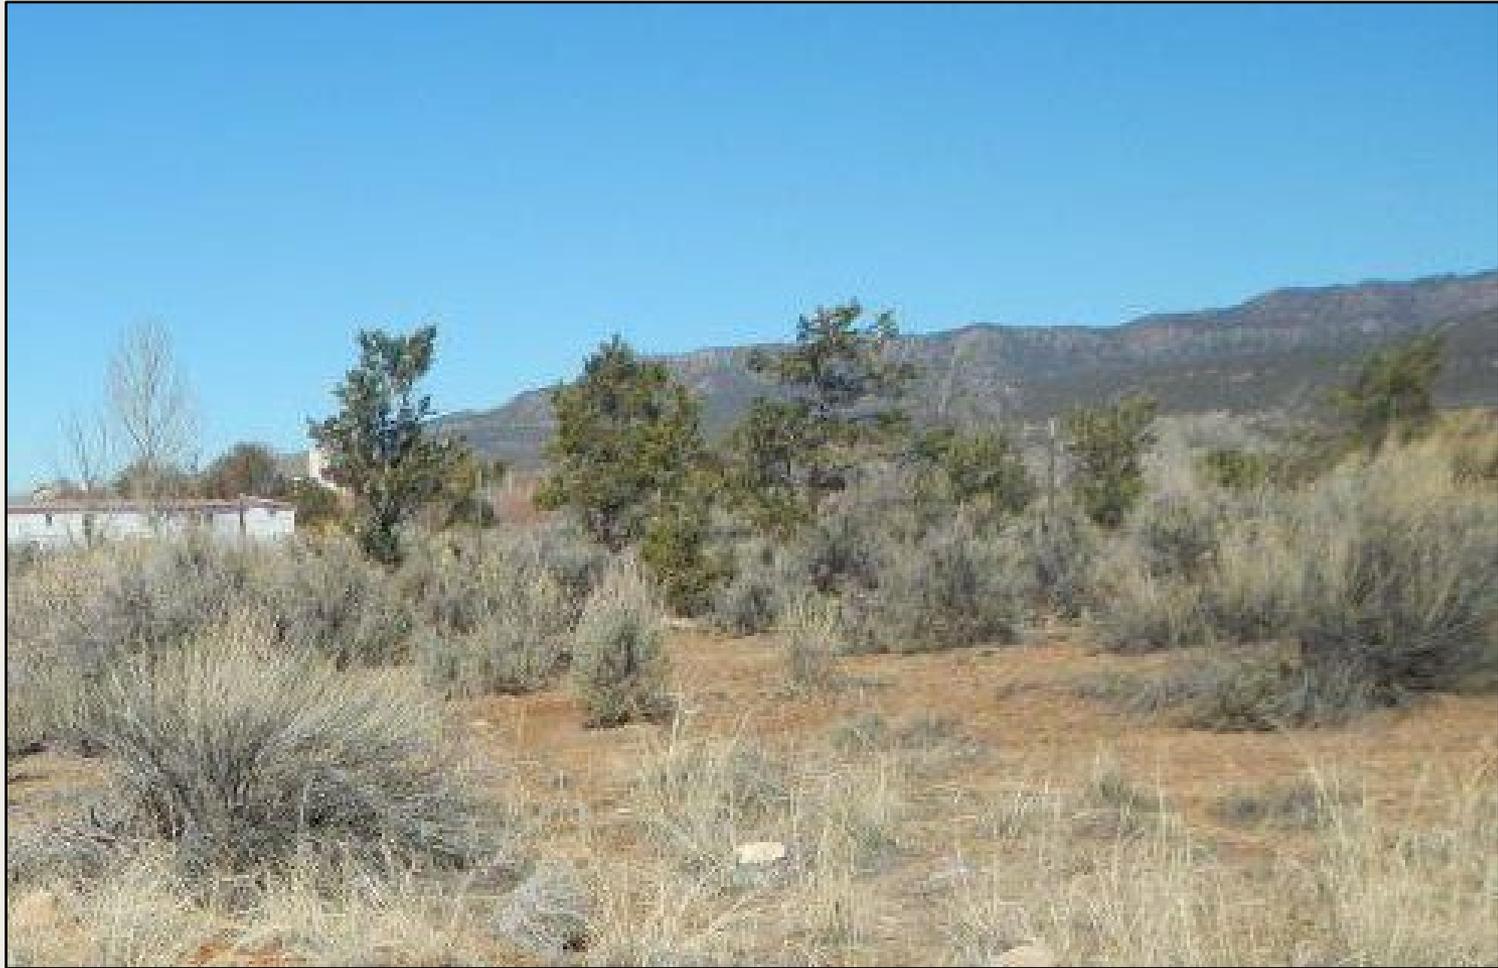
Photo 4. View of reference area comprised of mixed rubber rabbitbrush, sagebrush shrubland with sand dropseed, western wheatgrass, and snakeweed.
