Inspection Photos
Operator: Simcoe
API: 007-06143
Date: 2/28/2022

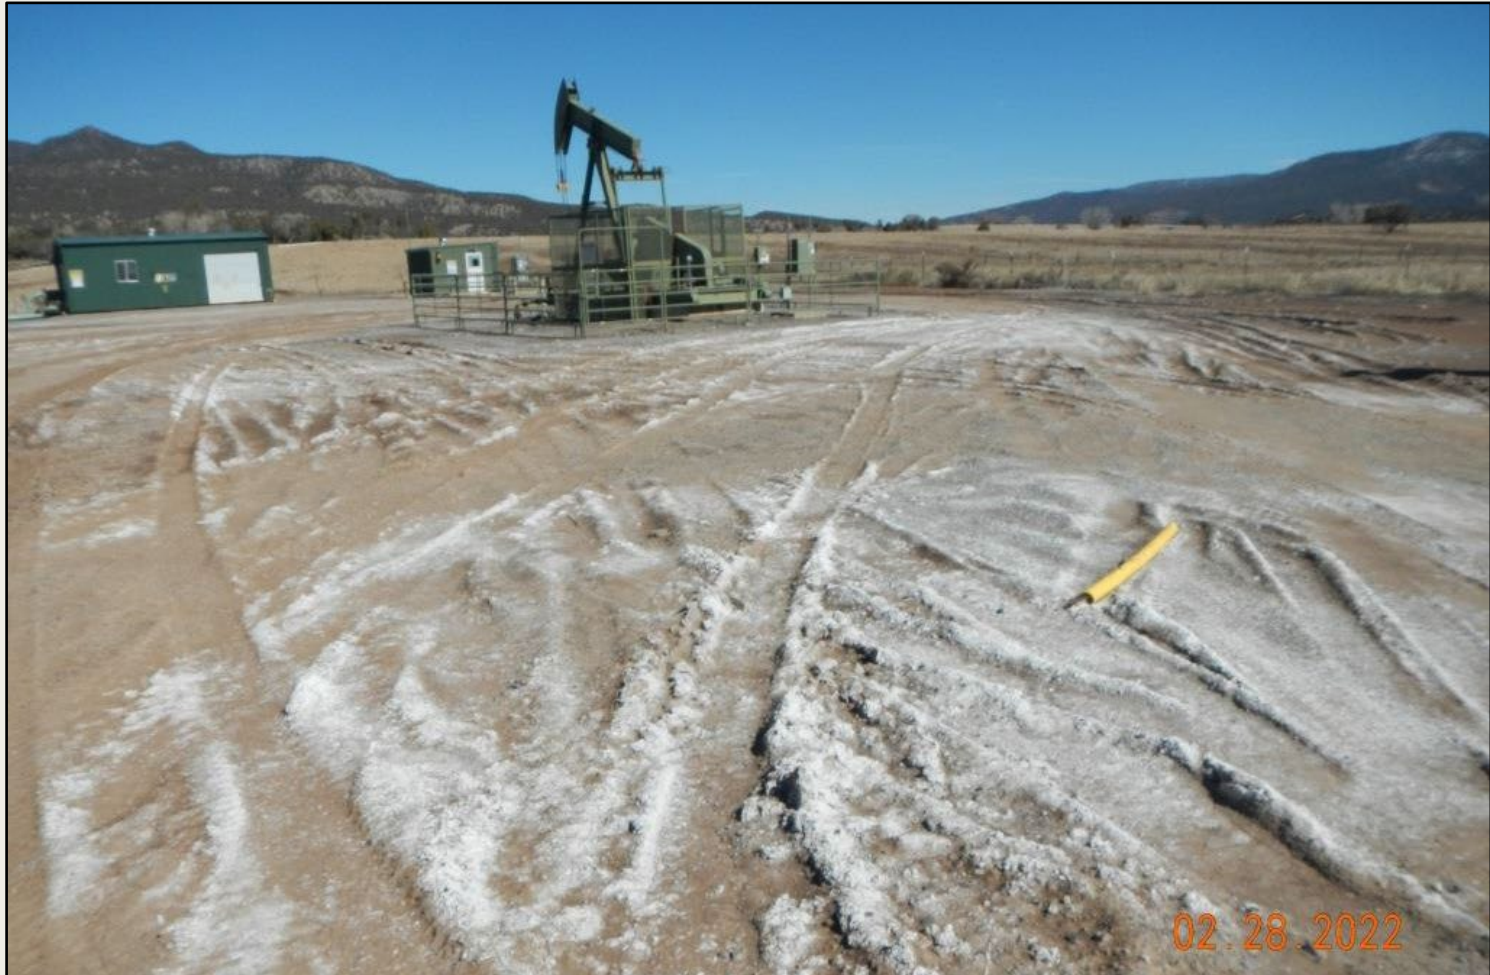
Photo 1. View of project area from the well pad entrance facing center. Significant salt crust observed on the well pad surface.

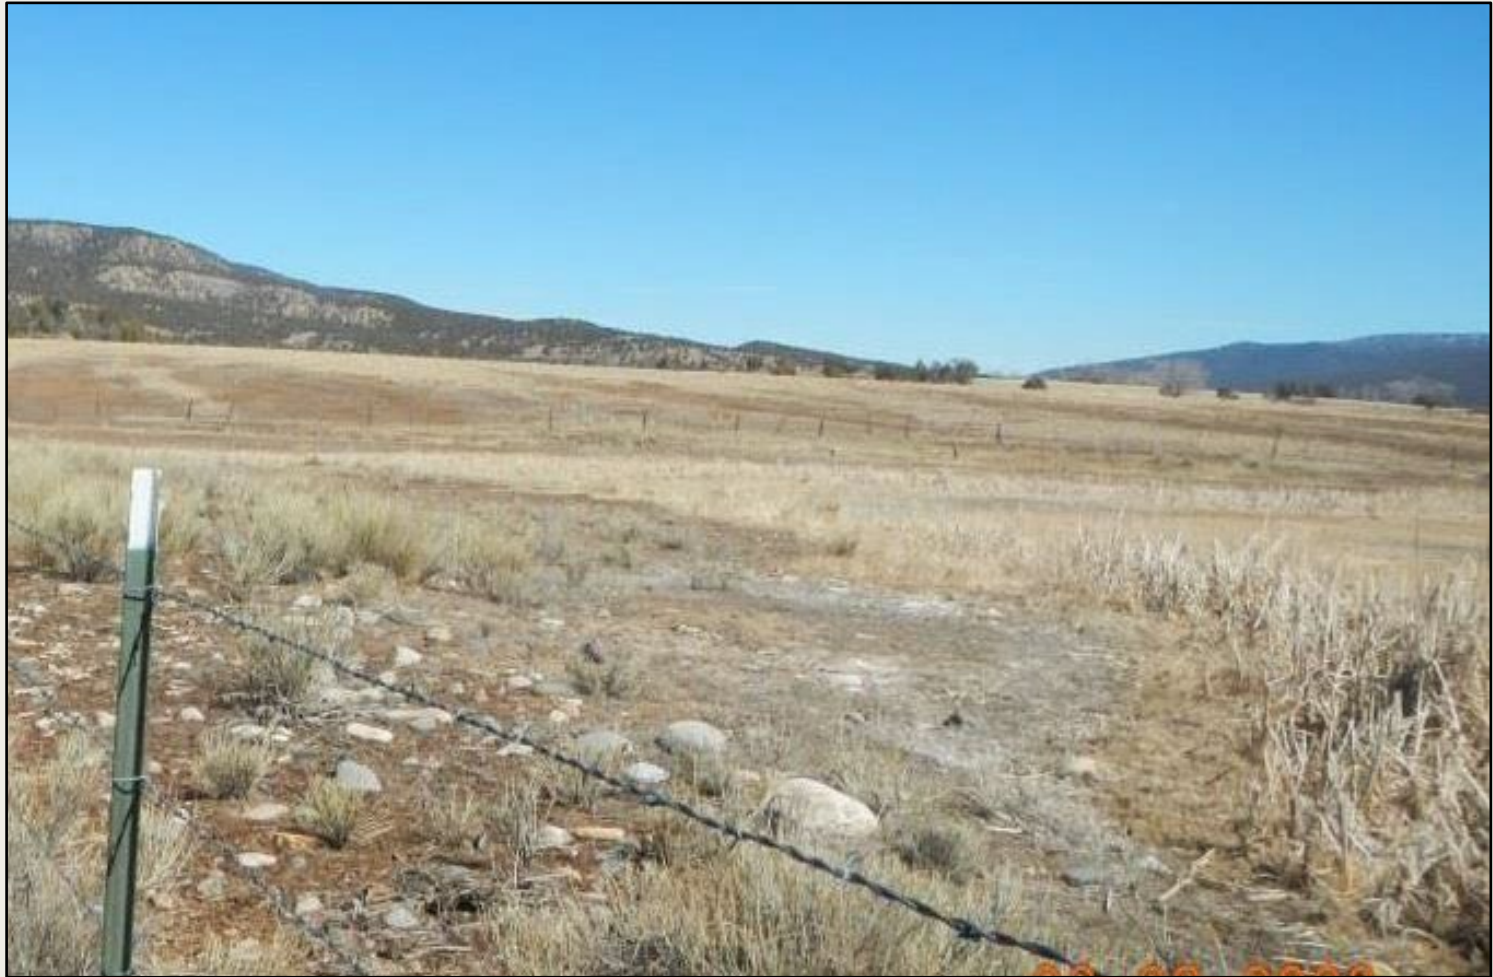
Photo 2. View of revegetation in the eastern project area. Portions of this area appear salt affected>.

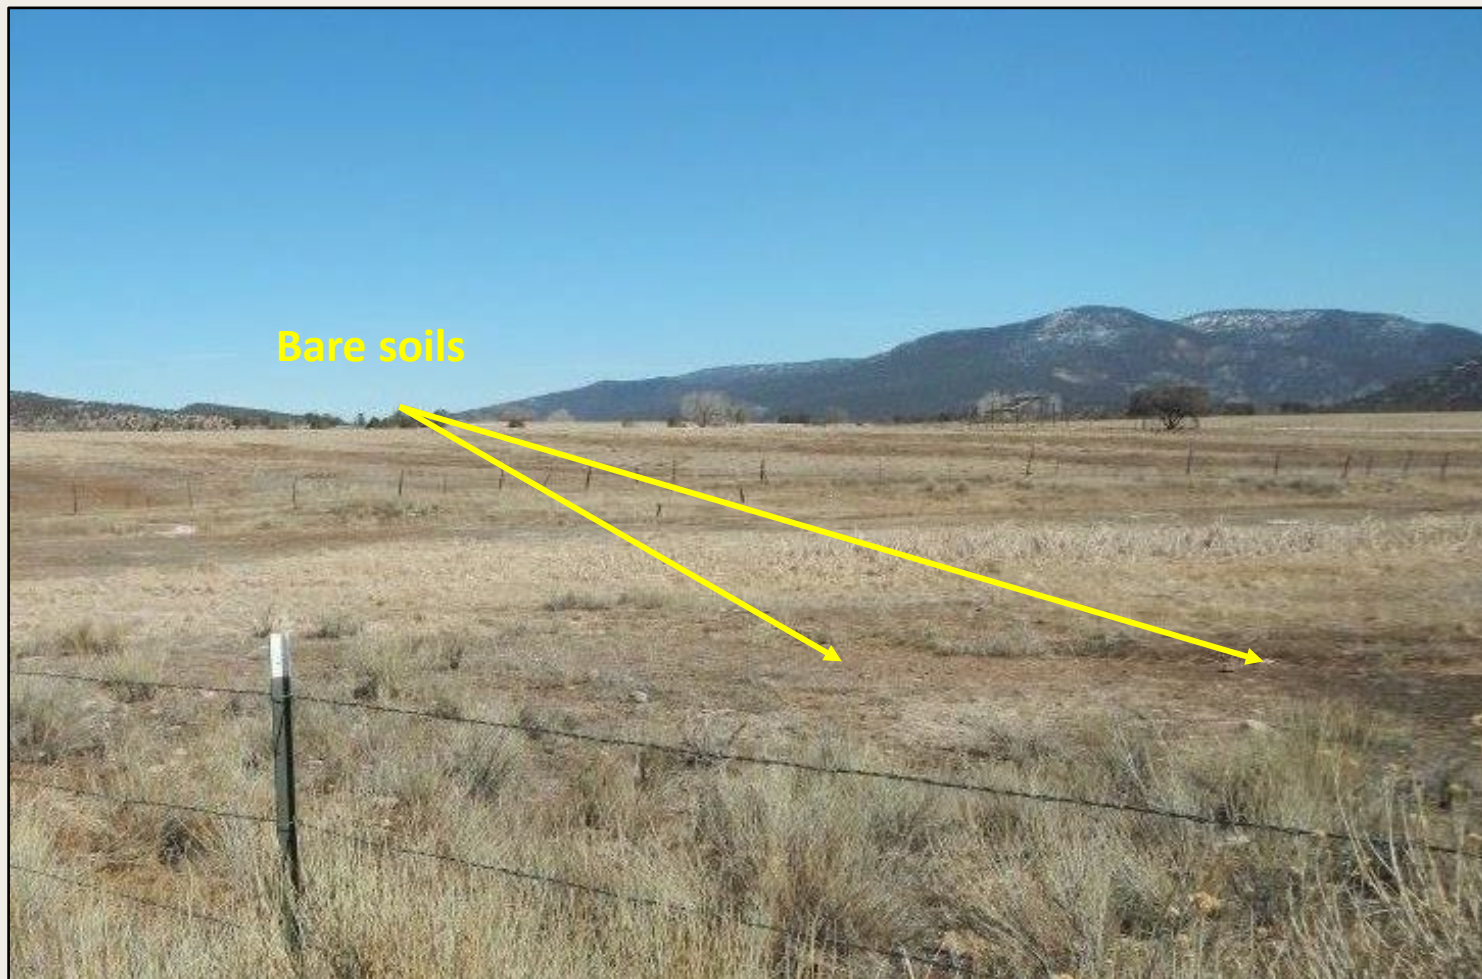
Photo 3. View of bare soils observed within the eastern project area. Revegetation needs to be assessed during the active growing season.

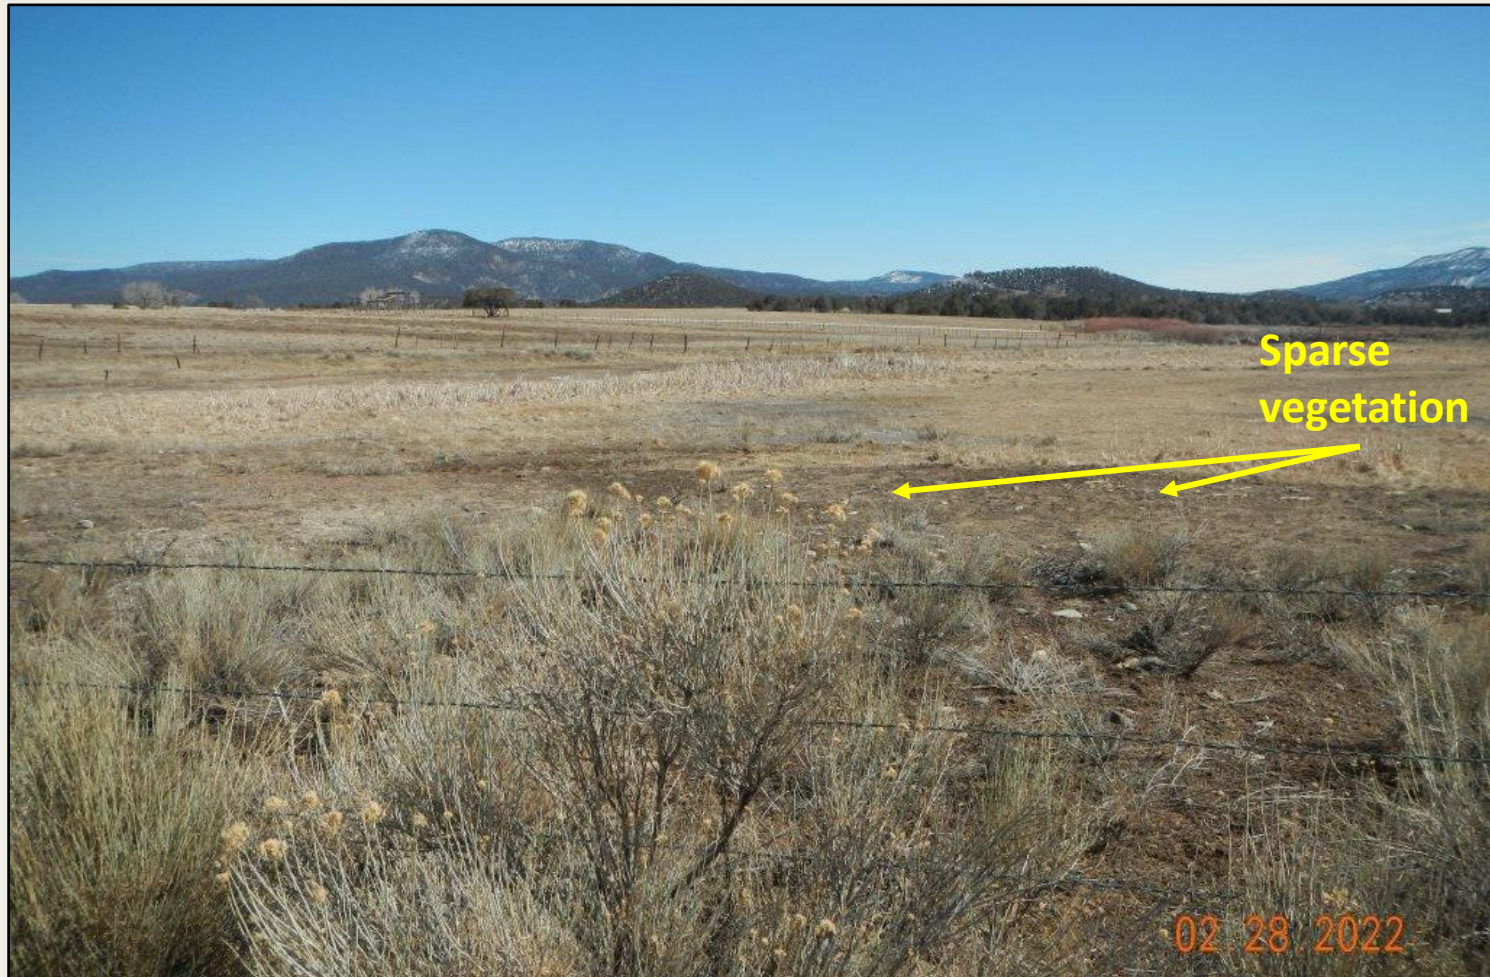
Photo 4. View of the southern project area from the southeastern corner facing westward. Revegetation is progressing with grasses similar to the reference area (irrigated grass field).

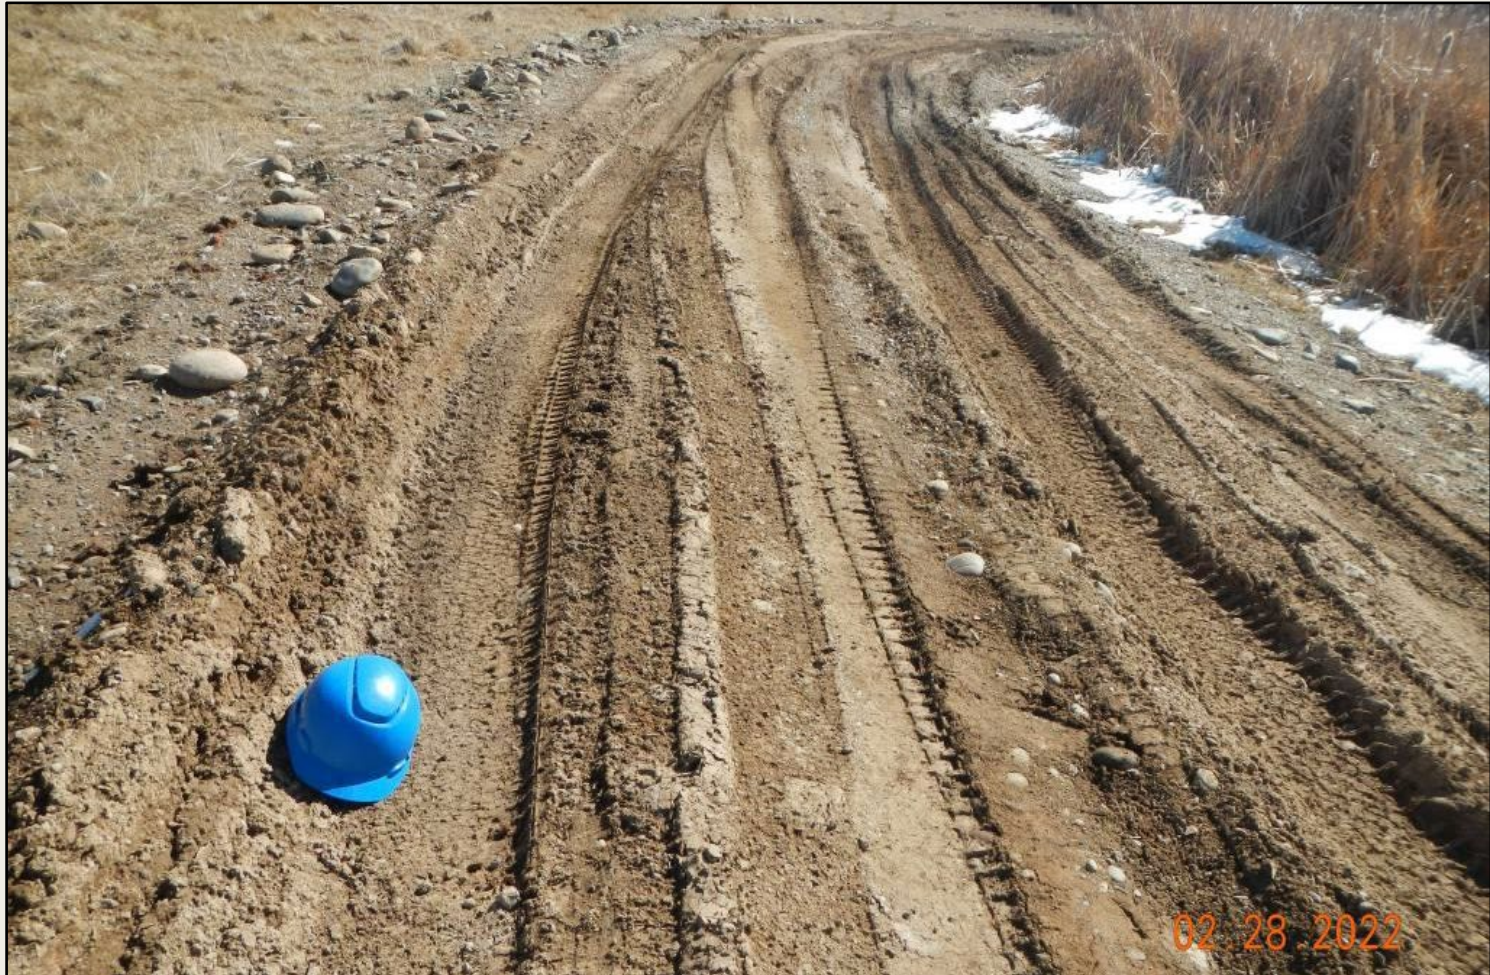
Photo 5. View of deep rutting up to 18 inches deep, observed on the access road, needing stabilization. Hard hat in place for scale.

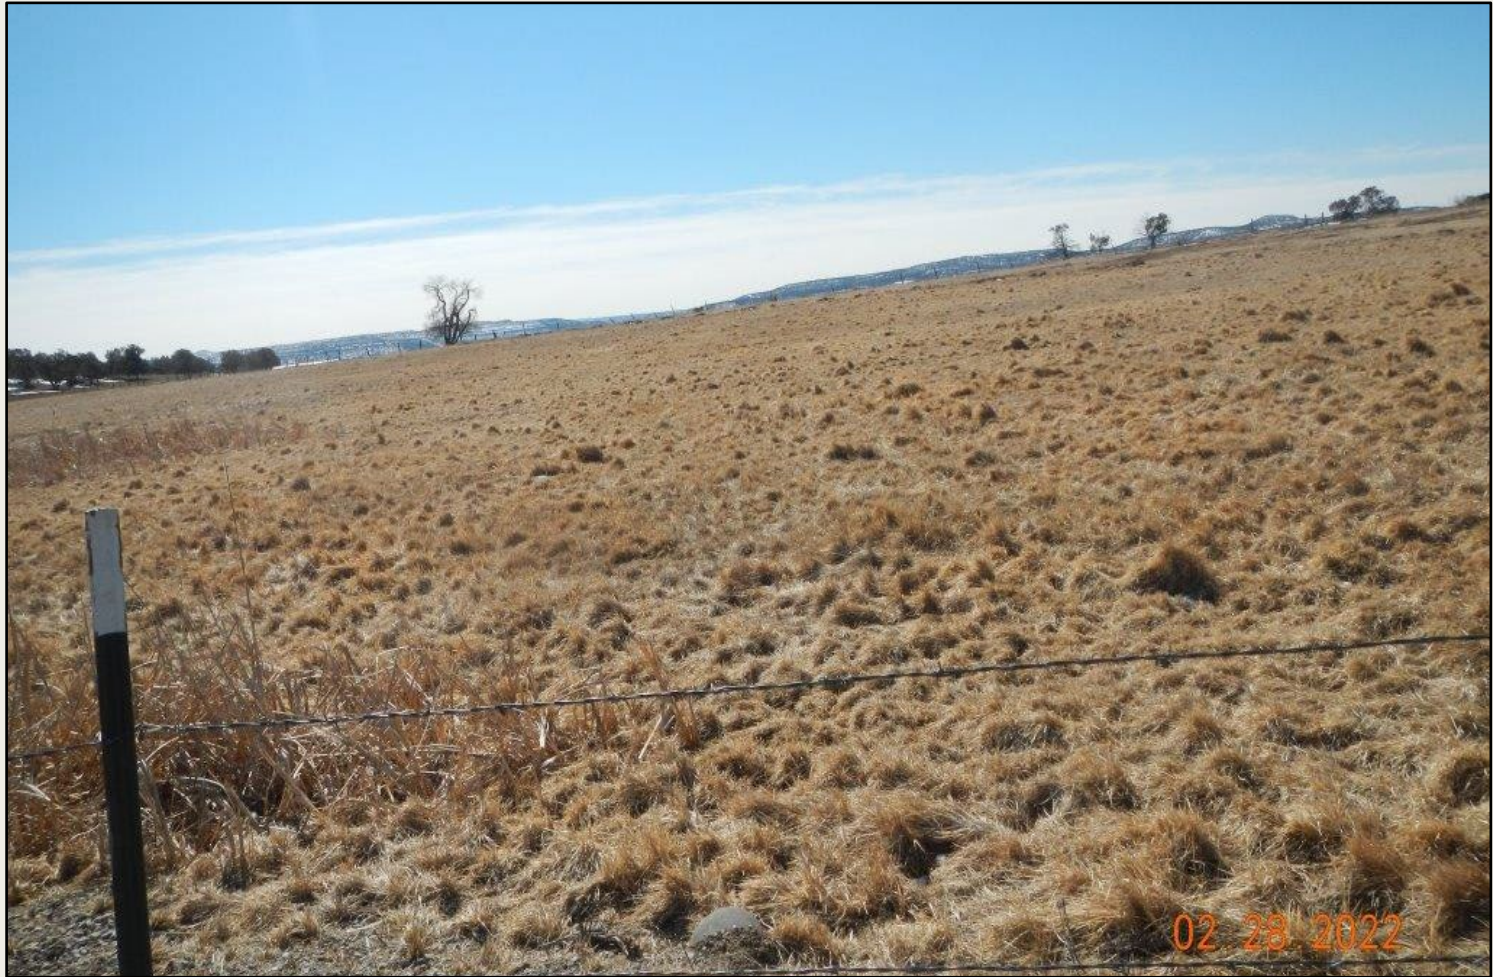
Photo 6. View of reference area comprised of irrigated grassland with grasses and wetland species such as timothy, tall fescue, and cattails.
