Inspection Photos

03/02/2022

Operator: MARALEX RESOURCES INC - 53255

Location ID: 312658

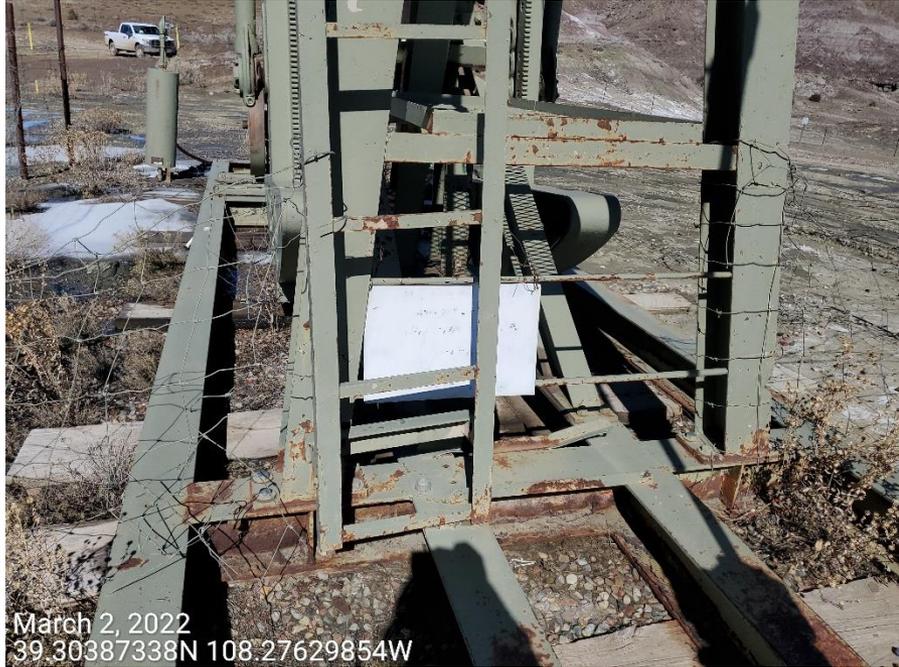
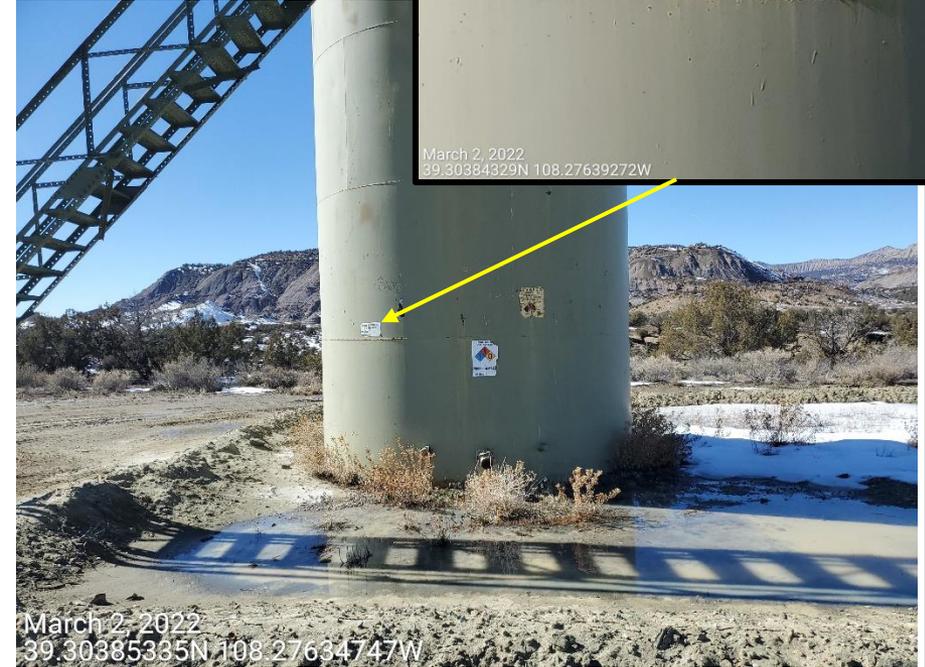
Photo 1: Photo left shows sign at wellhead remains illegible. Photo right shows capacity labels on tank remain inadequate.

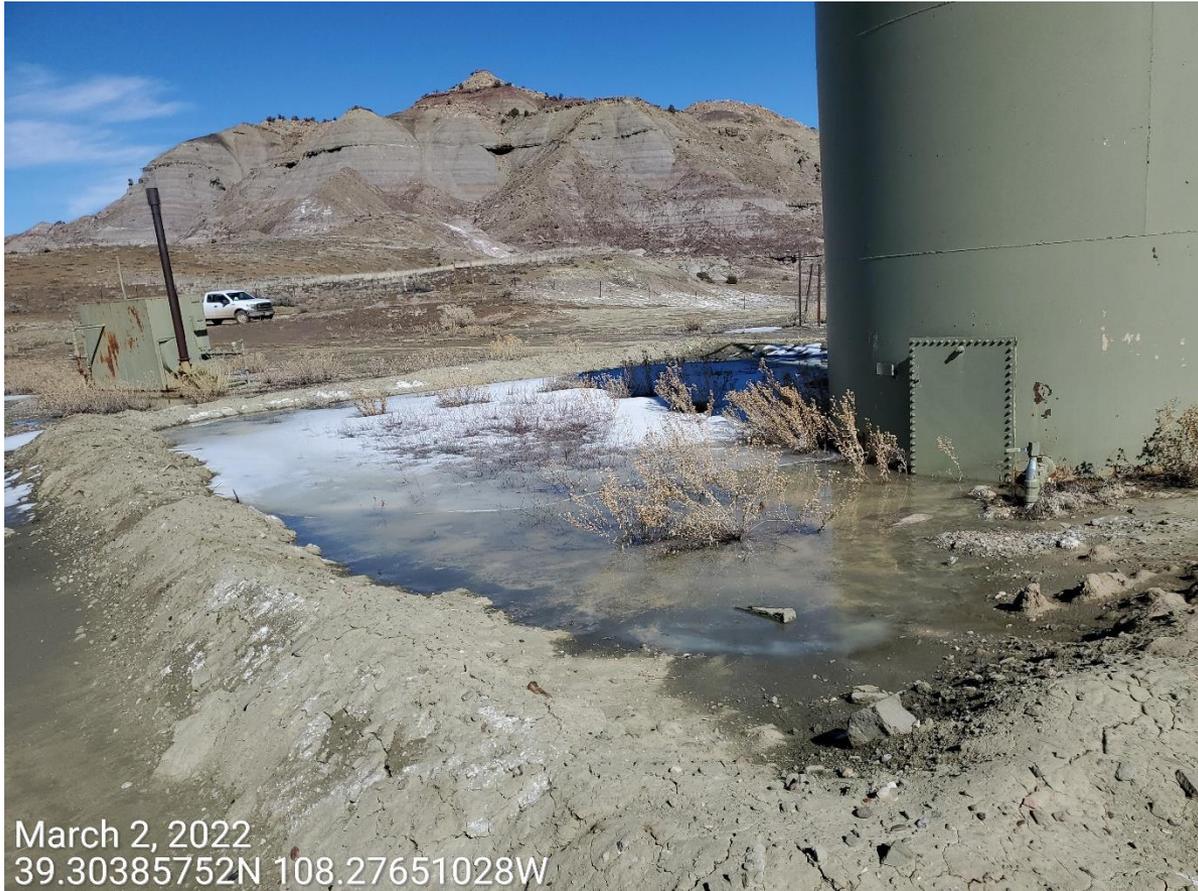
Photo 2: Photo taken from tank on the west end of the Location. Photo shows secondary containment BMP is not in proper functioning condition, or adequate in size to contain a spill from the tank. Photo also shows weed/vegetation establishment have not been removed from the tank containment.

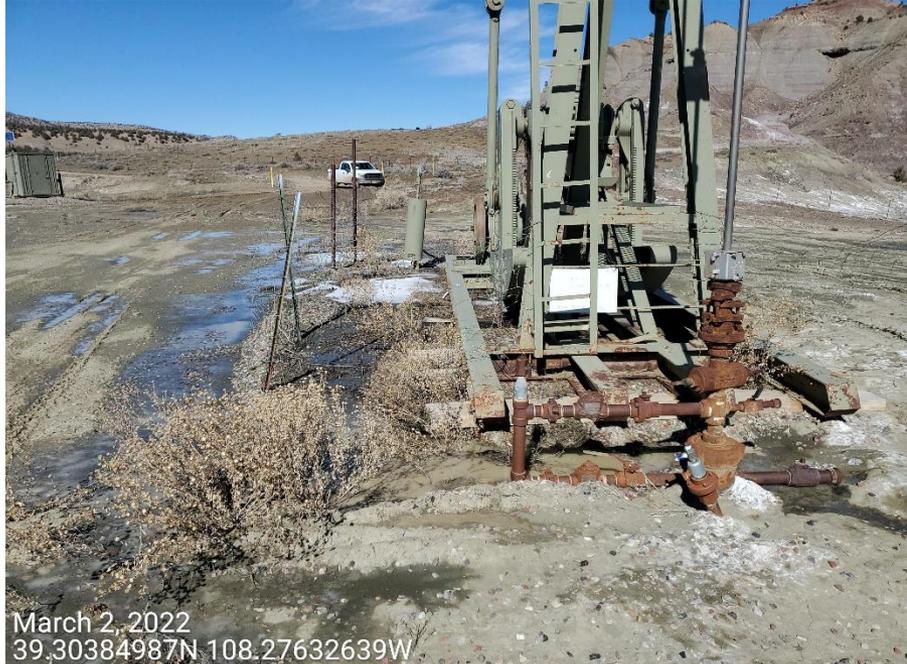
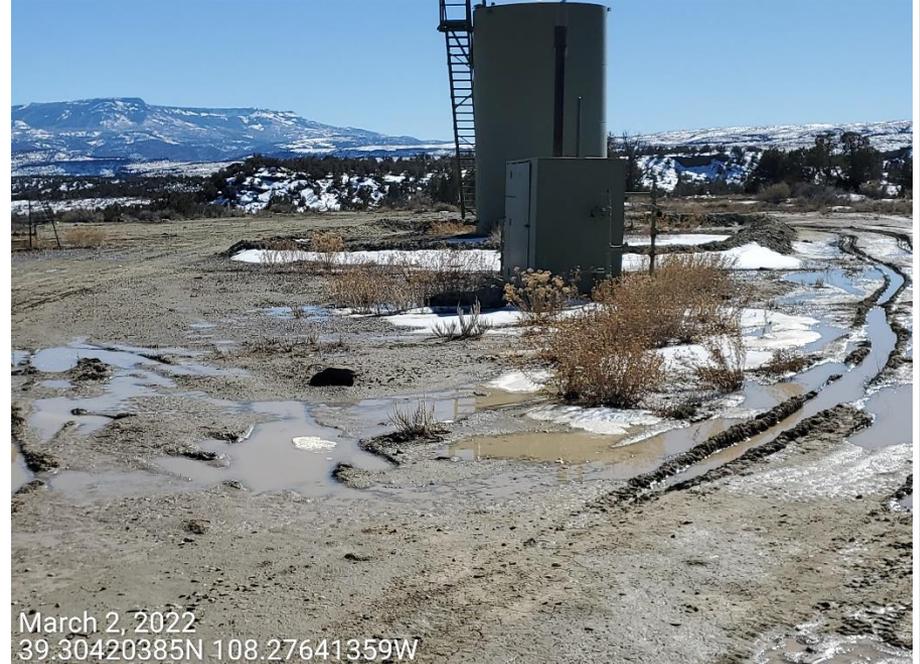
Photo 3: Photo shows vegetation/weeds have not been removed from around equipment.

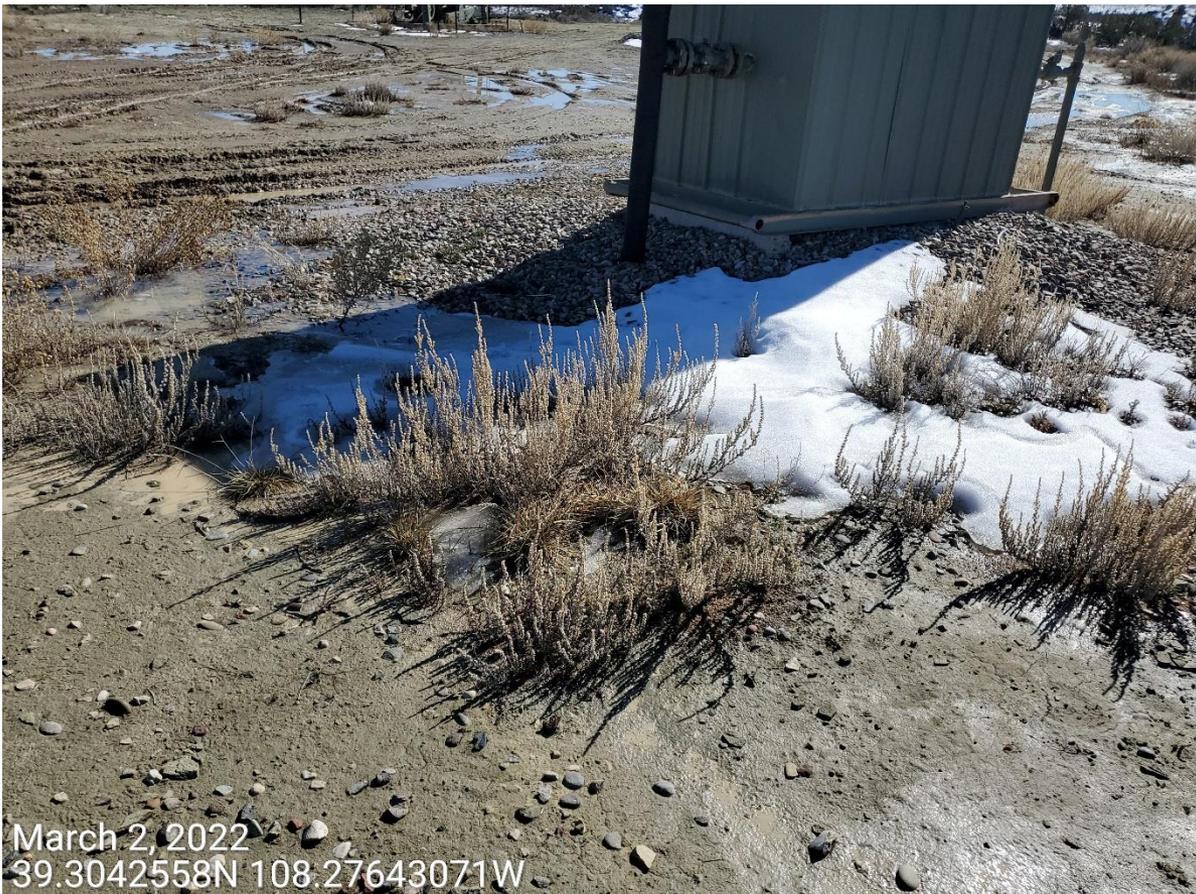
Photo 4: Photo provides example of Halogeton establishment on the location. This is a Colorado State listed noxious weeds that requires management.

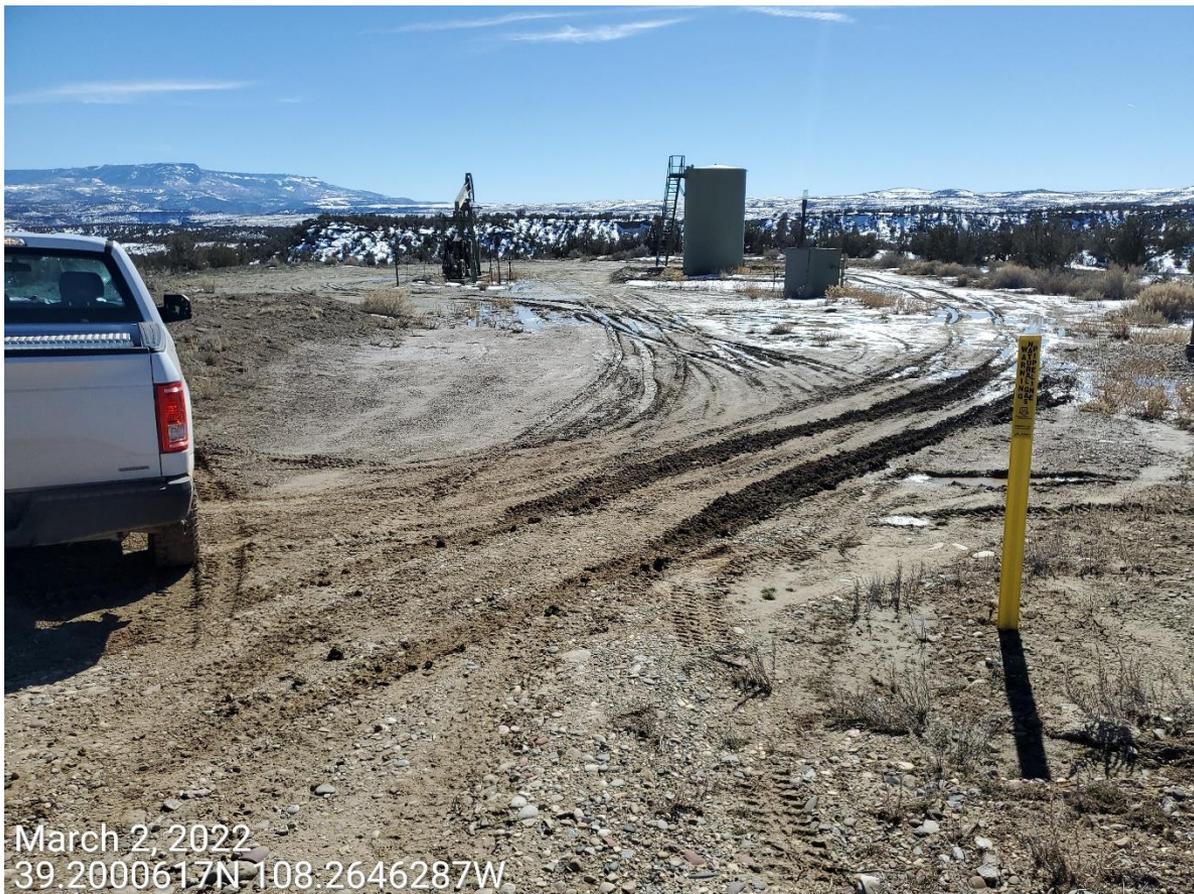
Photo 5: Photo taken from the Location entrance, facing south. Photo shows control measures to stabilize the production areas of the Location, and to mitigate tracking/sediment transport remains missing or insufficient.

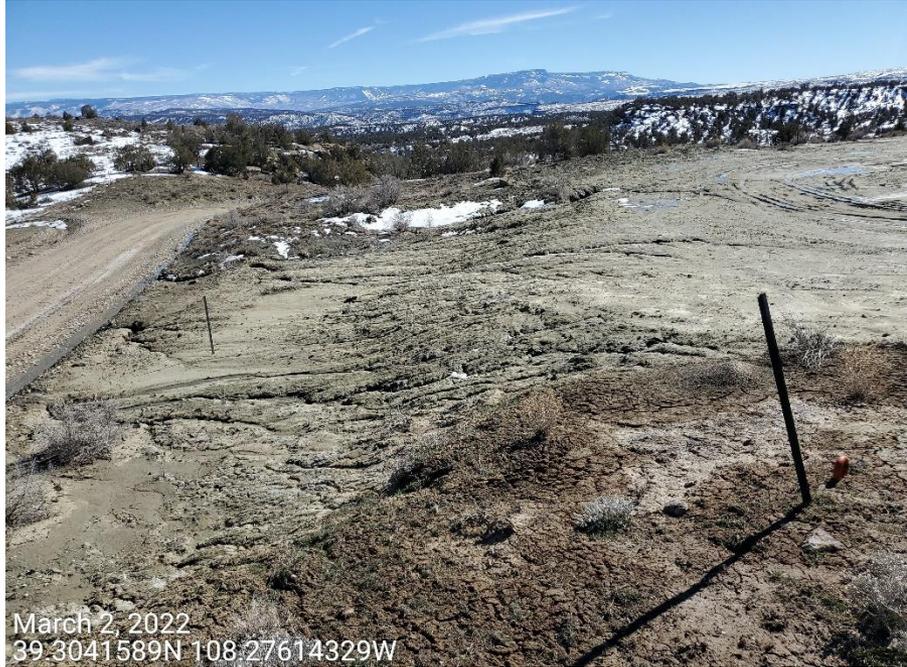
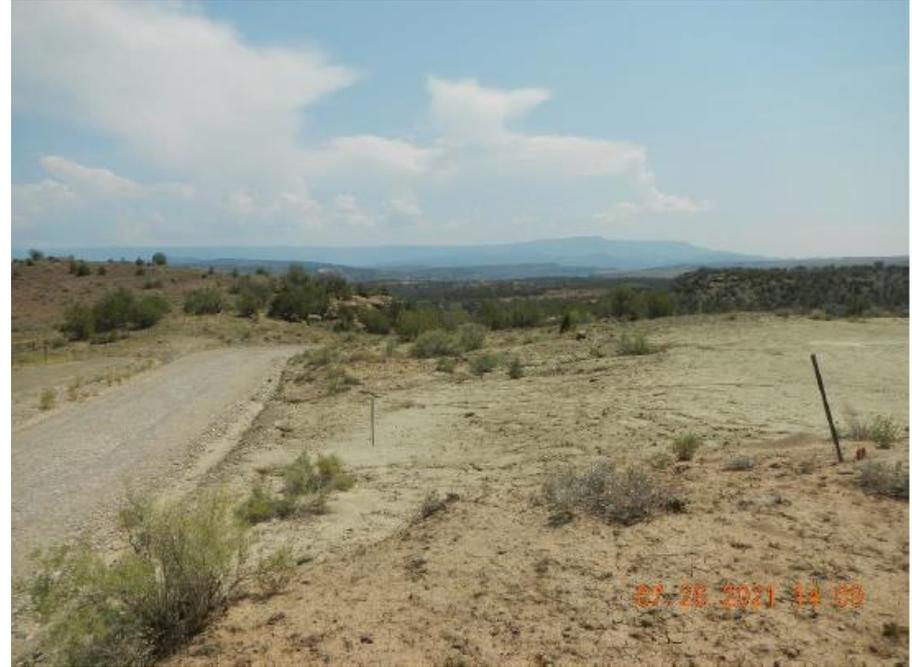
Photo 6: Photos taken from the east end of the Location, facing south. Photo left dated 3/2/2022; photo right dated 7/26/2021. Photos show erosion degradation due to runoff from the location has continued since the previous inspection; control measures to manage runoff and minimize erosion degradation remain missing or insufficient on the Location.

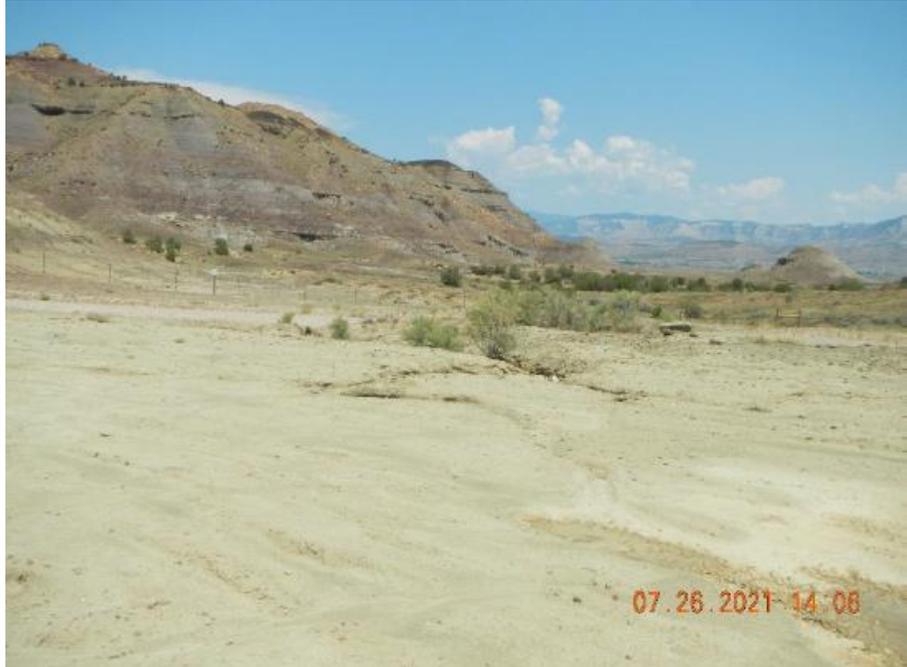
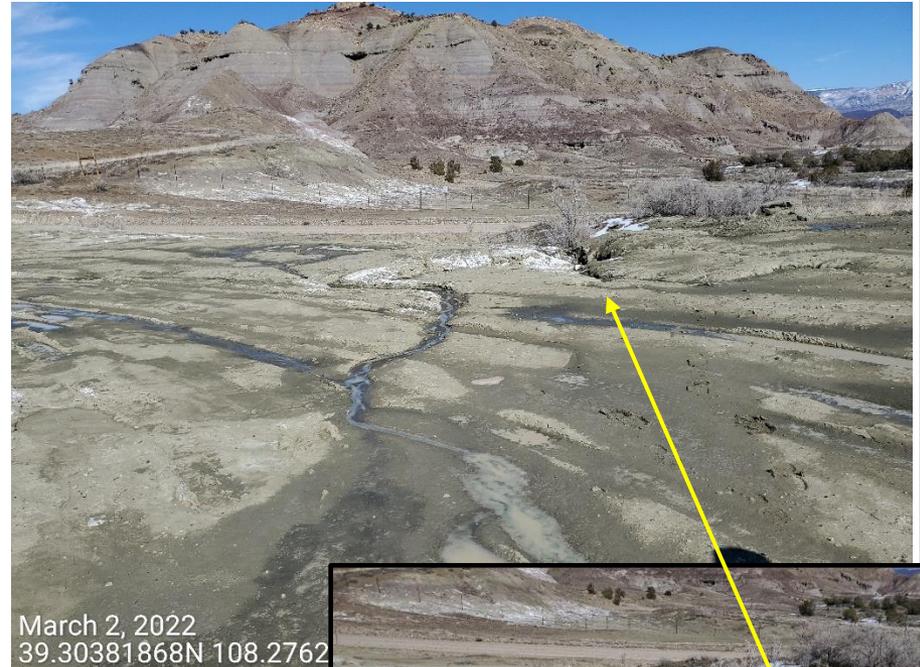
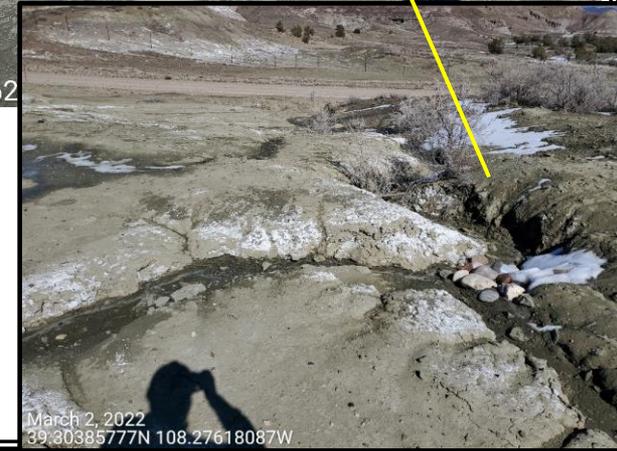
Photo 7: Photos taken from the east end of the Location, facing east. Photo left dated 7/26/2021; photos right 3/2/2022. Photo shows gully erosion degradation due to runoff from the location has continued since the previous inspection; control measures to manage runoff and minimize erosion degradation remain missing or insufficient on the Location.

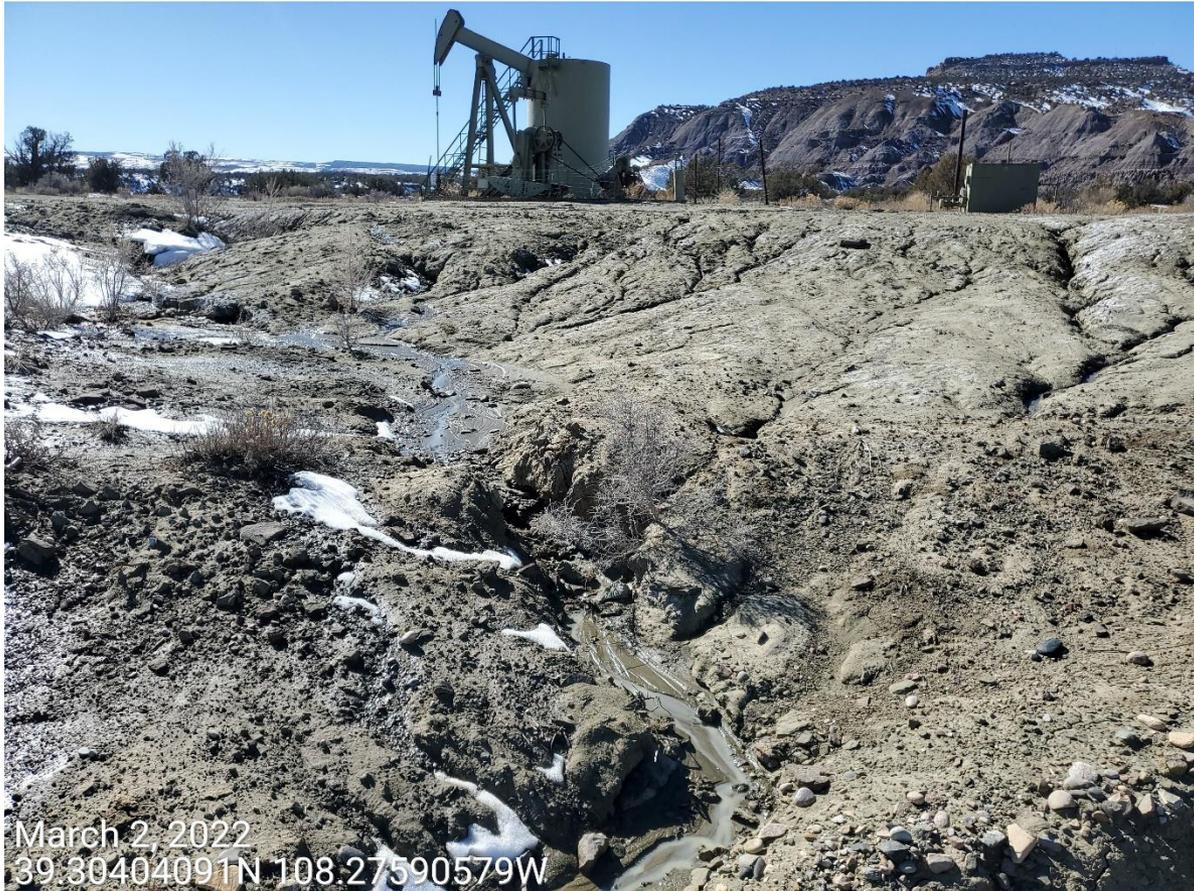
Photo 8: Photo taken from the east end of the Location, facing west. Photo shows erosion degradation due to runoff from the location has continued since the previous inspection; control measures to manage runoff and minimize erosion degradation remain missing or insufficient on the Location.

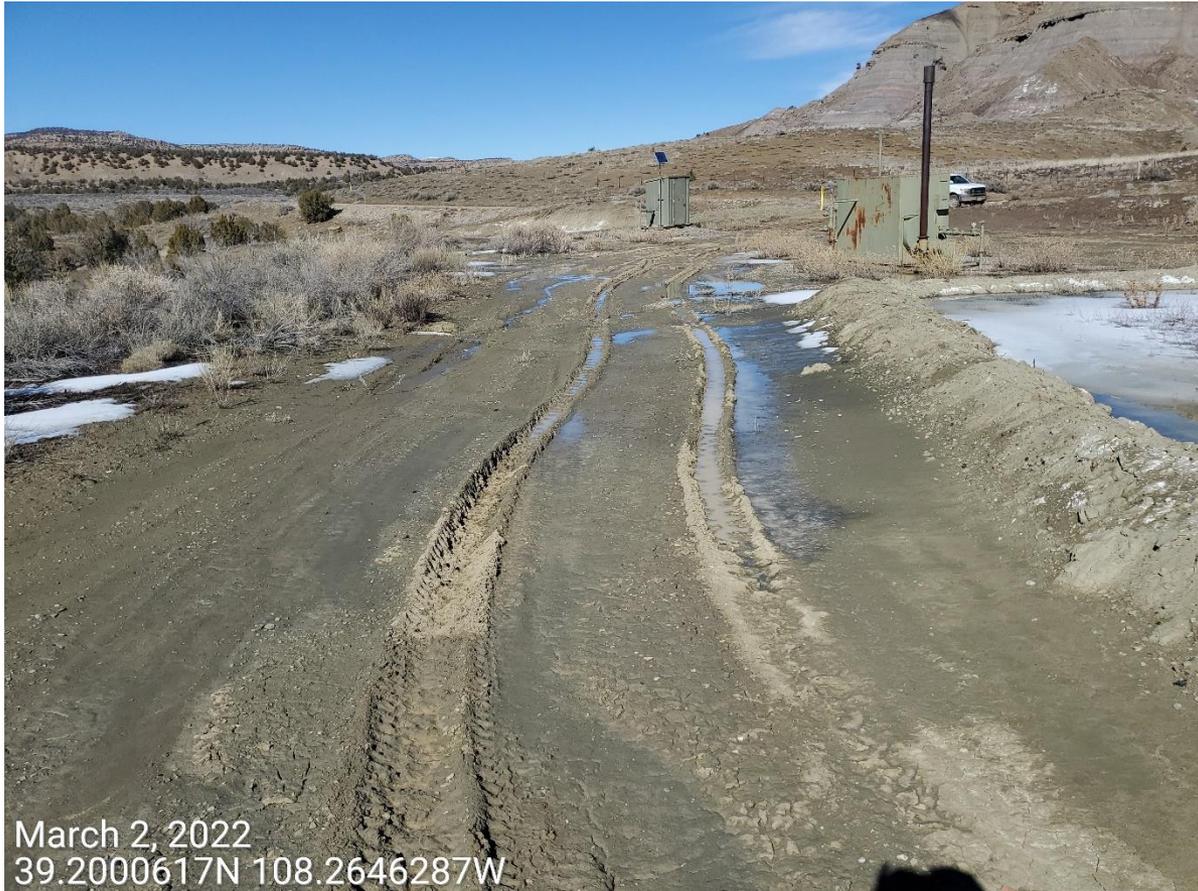
Photo 9: Photo taken from the west end of the Location, facing north. Photo shows control measures to stabilize the production areas of the Location, and to mitigate tracking/sediment transport remains missing or insufficient.

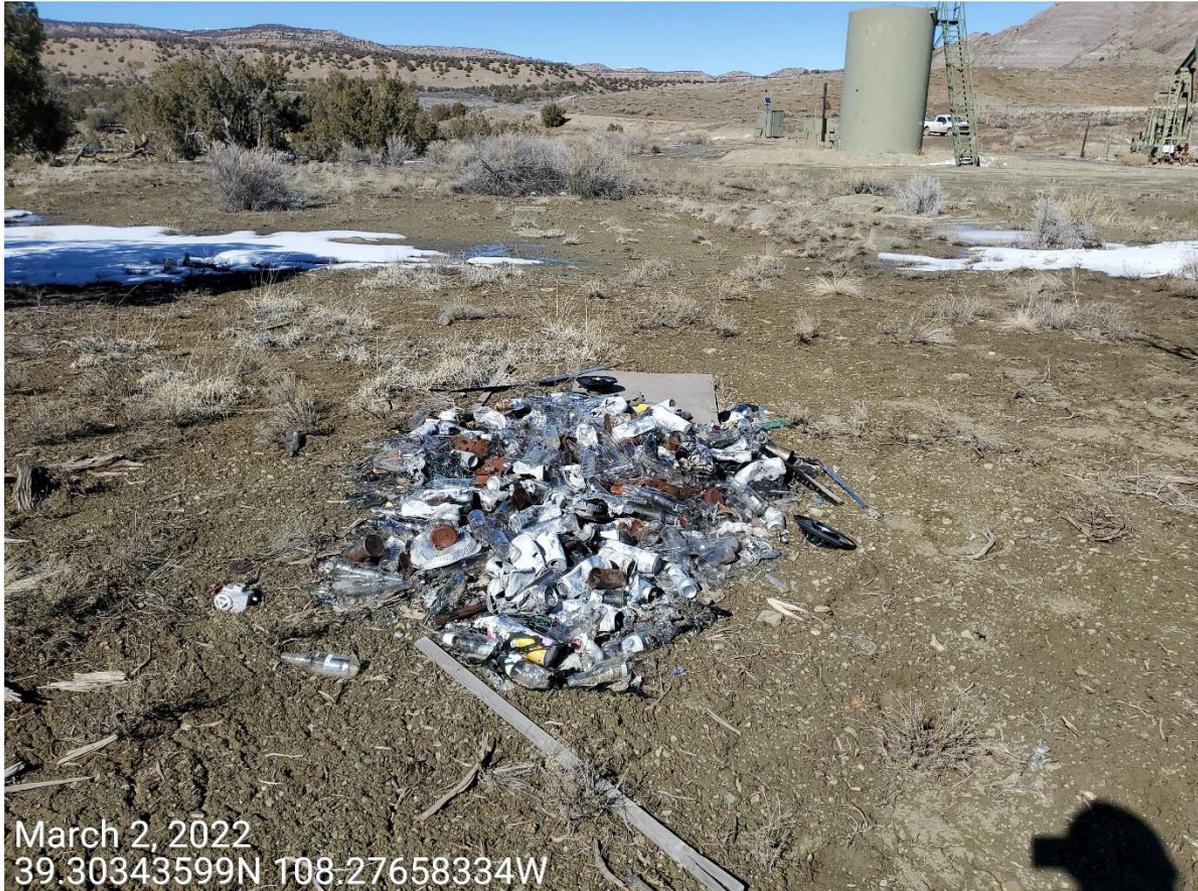
Photo 10: Photo shows trash debris observed on the south end of the Location.

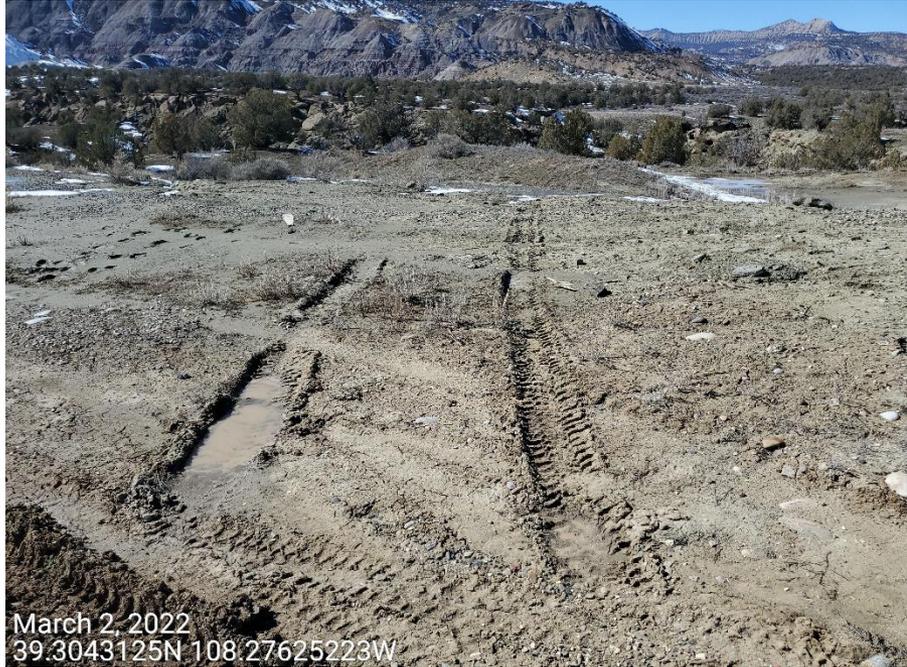
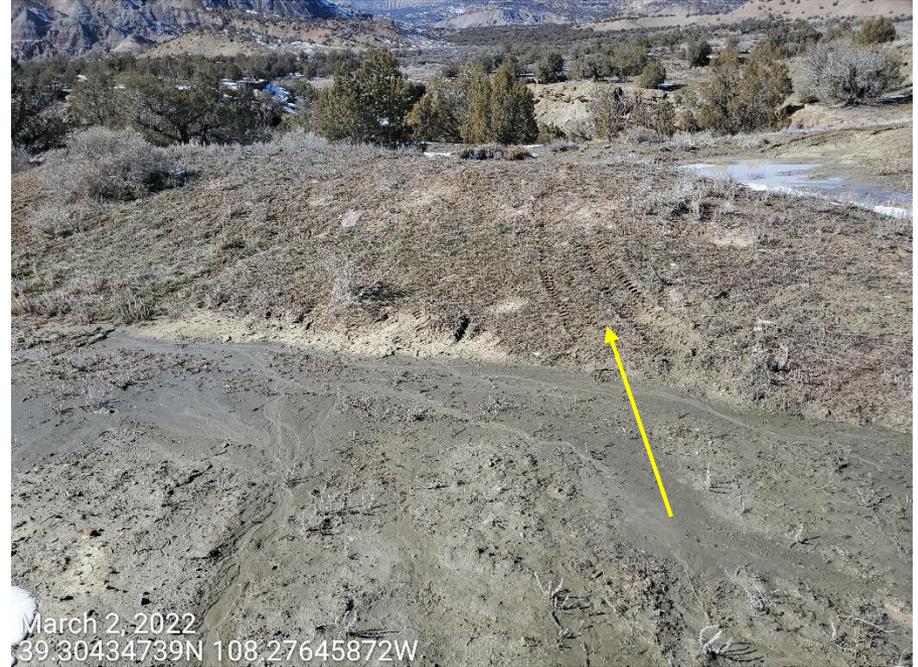
Photo 11: Photos taken from the northwest end of the Location. Photos 11-12 show vehicle travel from the production pad leading offsite north of the Location, and traveling to “V 2/10 Rd” northeast of the Location to the Location. This does not comport to 1002.e surface disturbance requirements.
