Inspection Photos  
Operator: Simcoe  
API: 067-08733  
Date: 3/2/2022

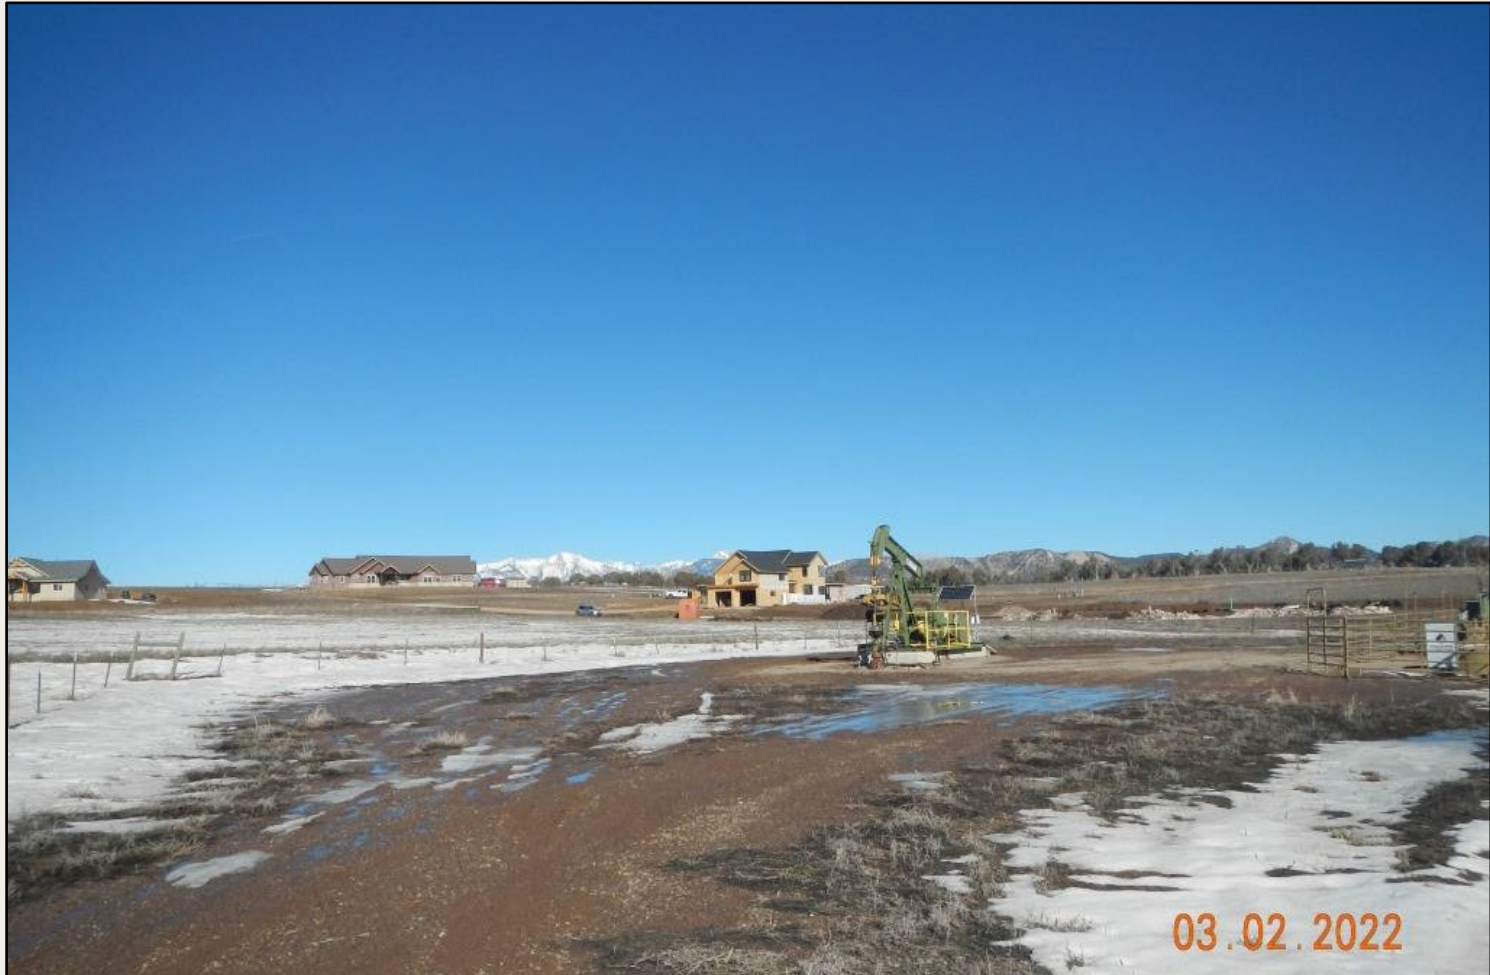
Photo 1. View of project area from the well pad entrance facing center.

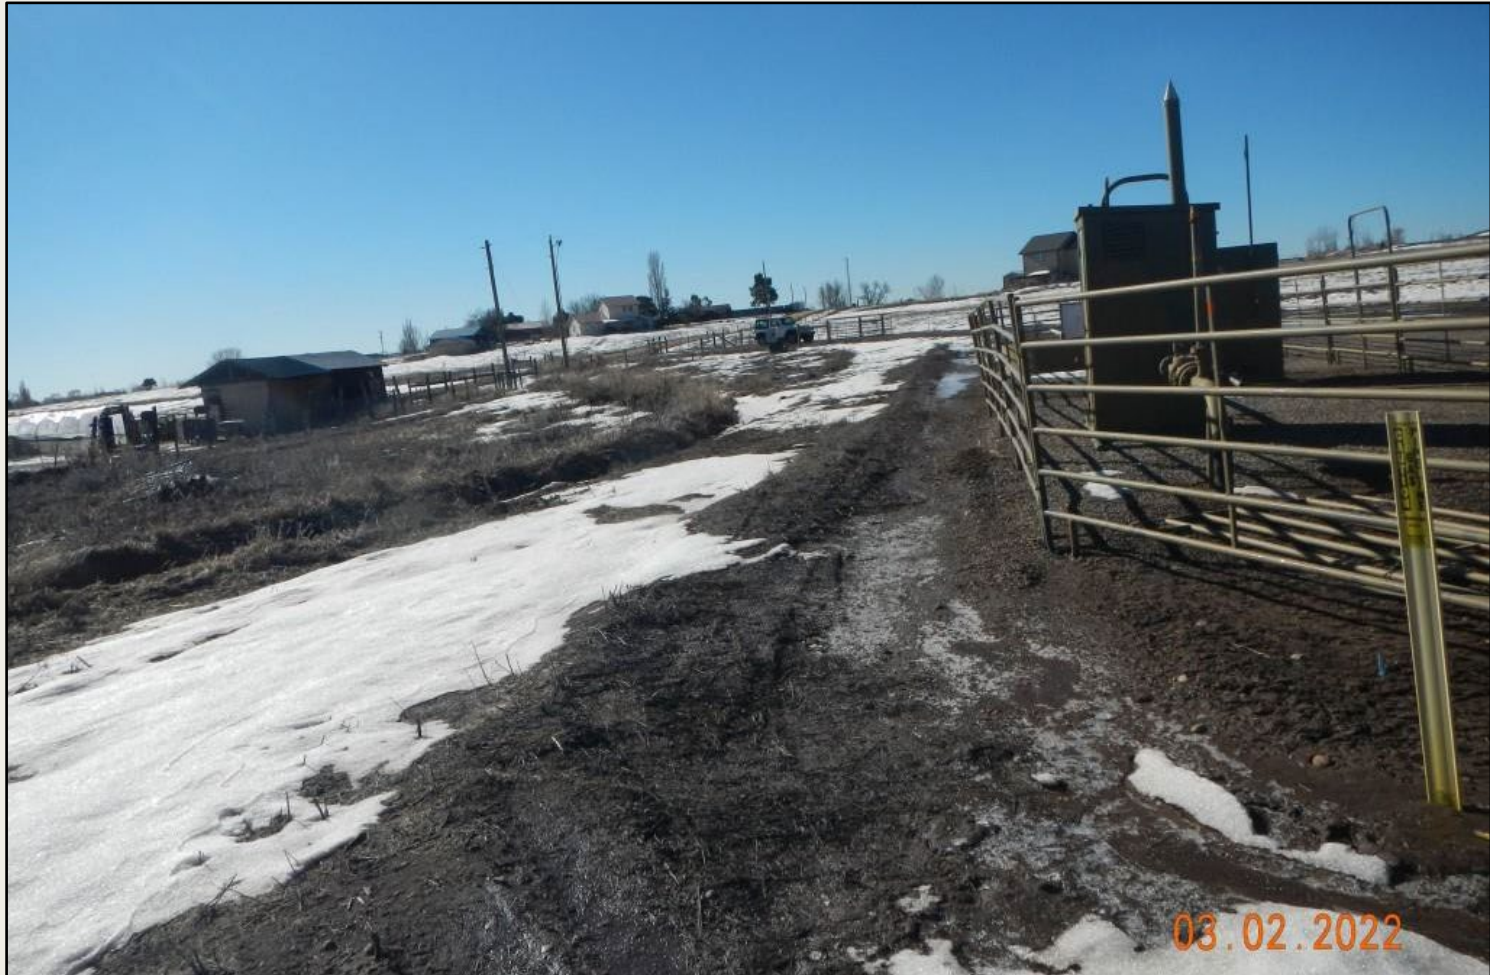
Photo 2. View of the eastern project area from the northeastern corner facing southward. Revegetation is progressing largely with smooth brome, western wheatgrass, and crested wheatgrass.

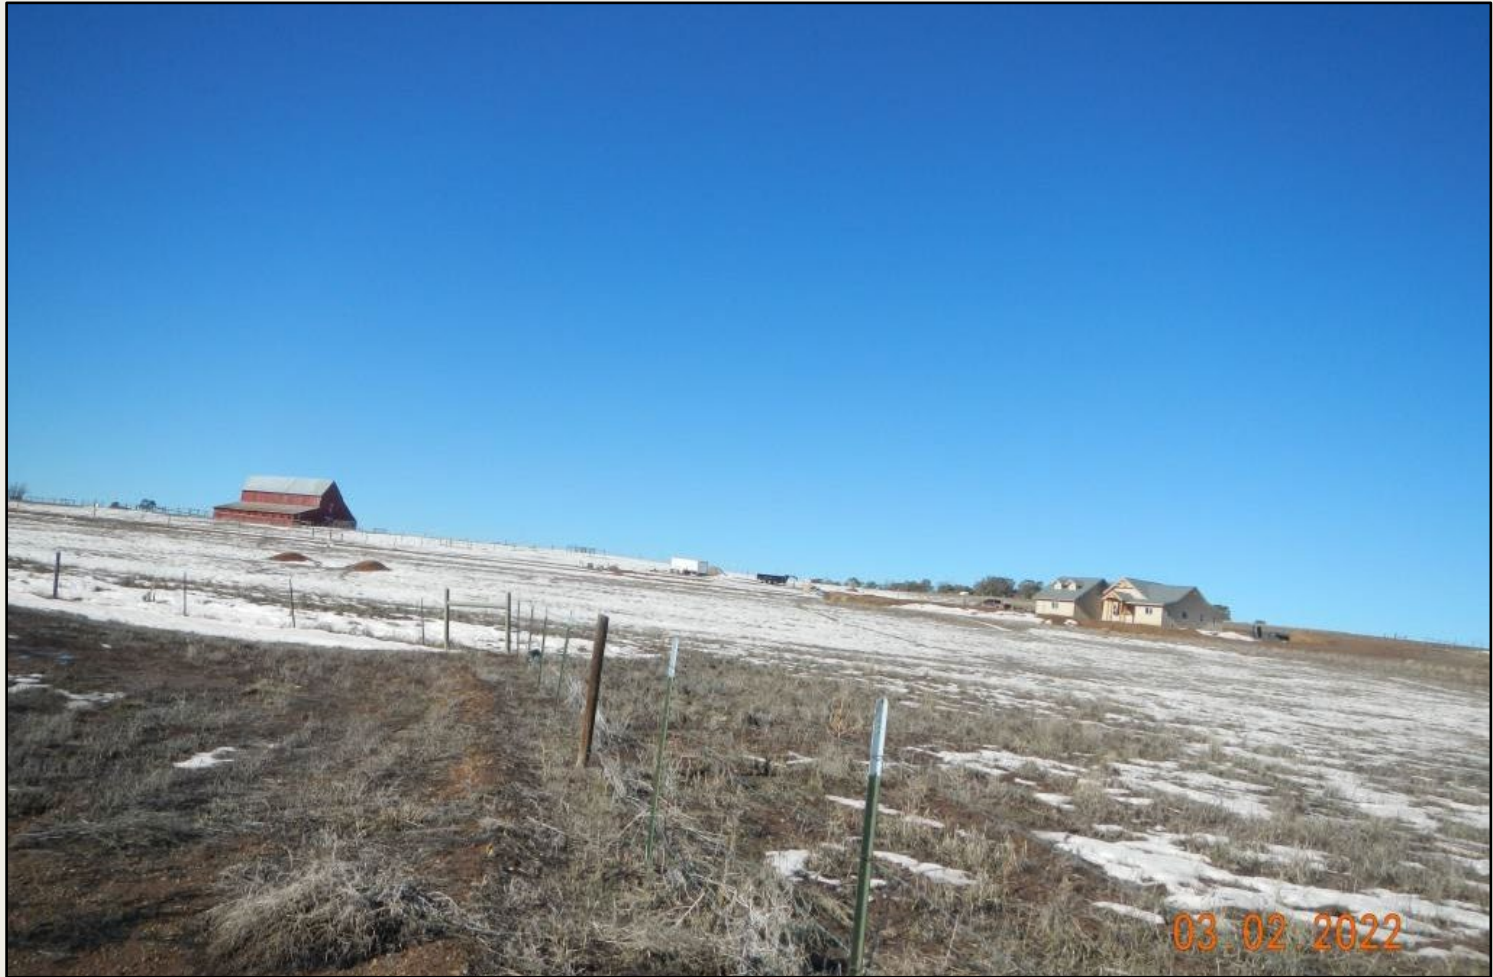
Photo 3. View of the northern project area from the northeastern corner facing westward. Working area is fenced.

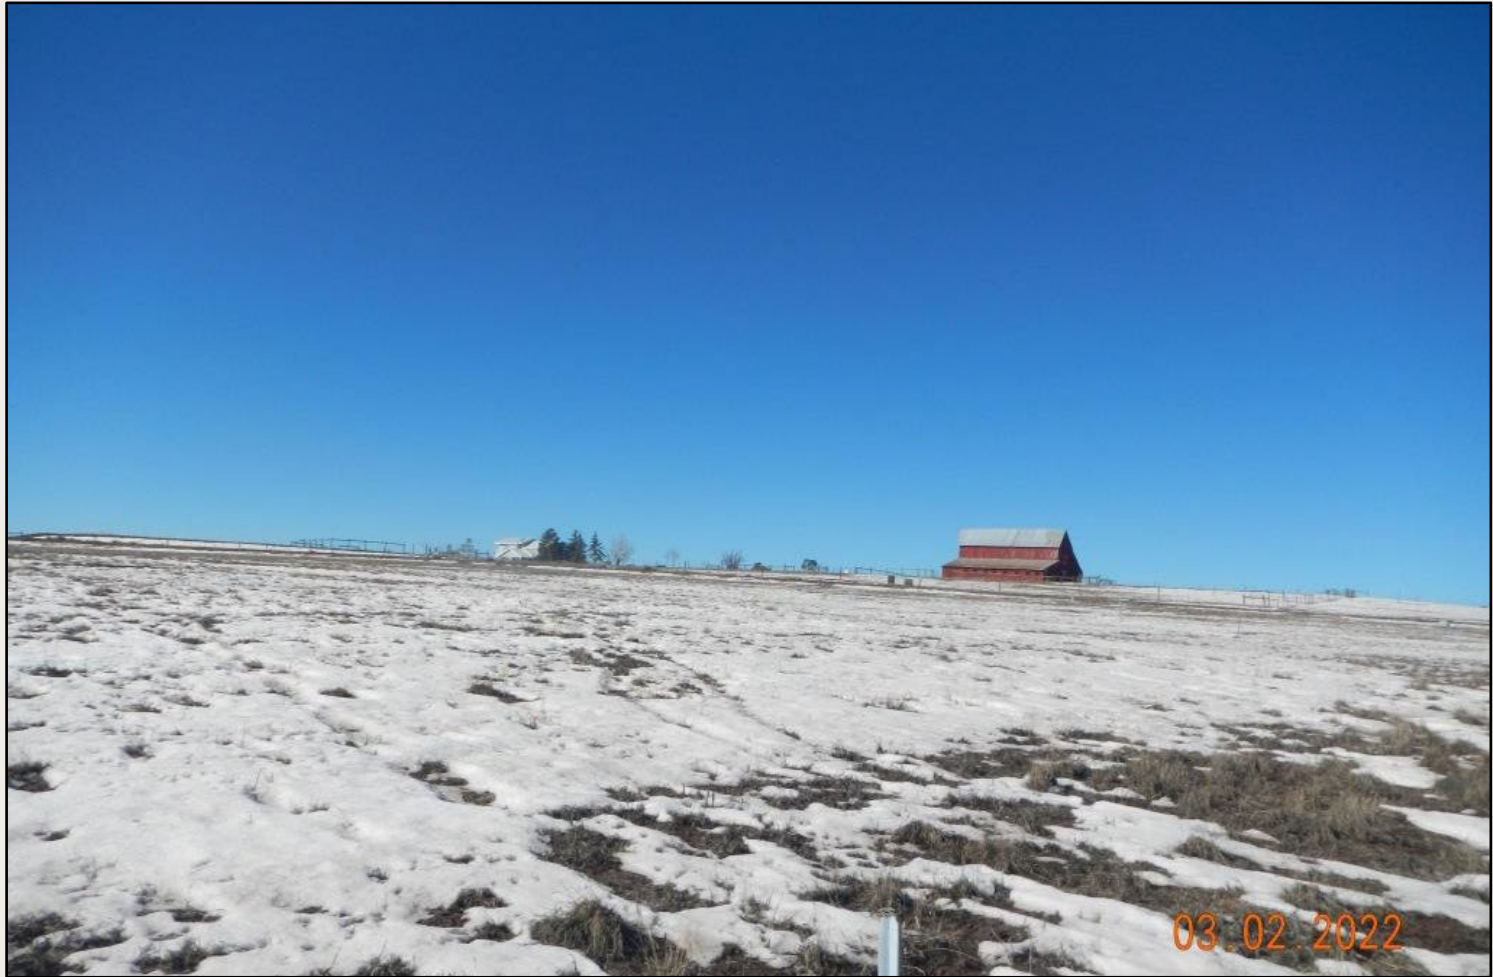
Photo 4. View of reference area comprised of irrigated grass field with grasses such as smooth brome and western wheatgrass observed.
