Inspection Photos
Operator: Simcoe
API: 067-07379
Date: 3/2/2022

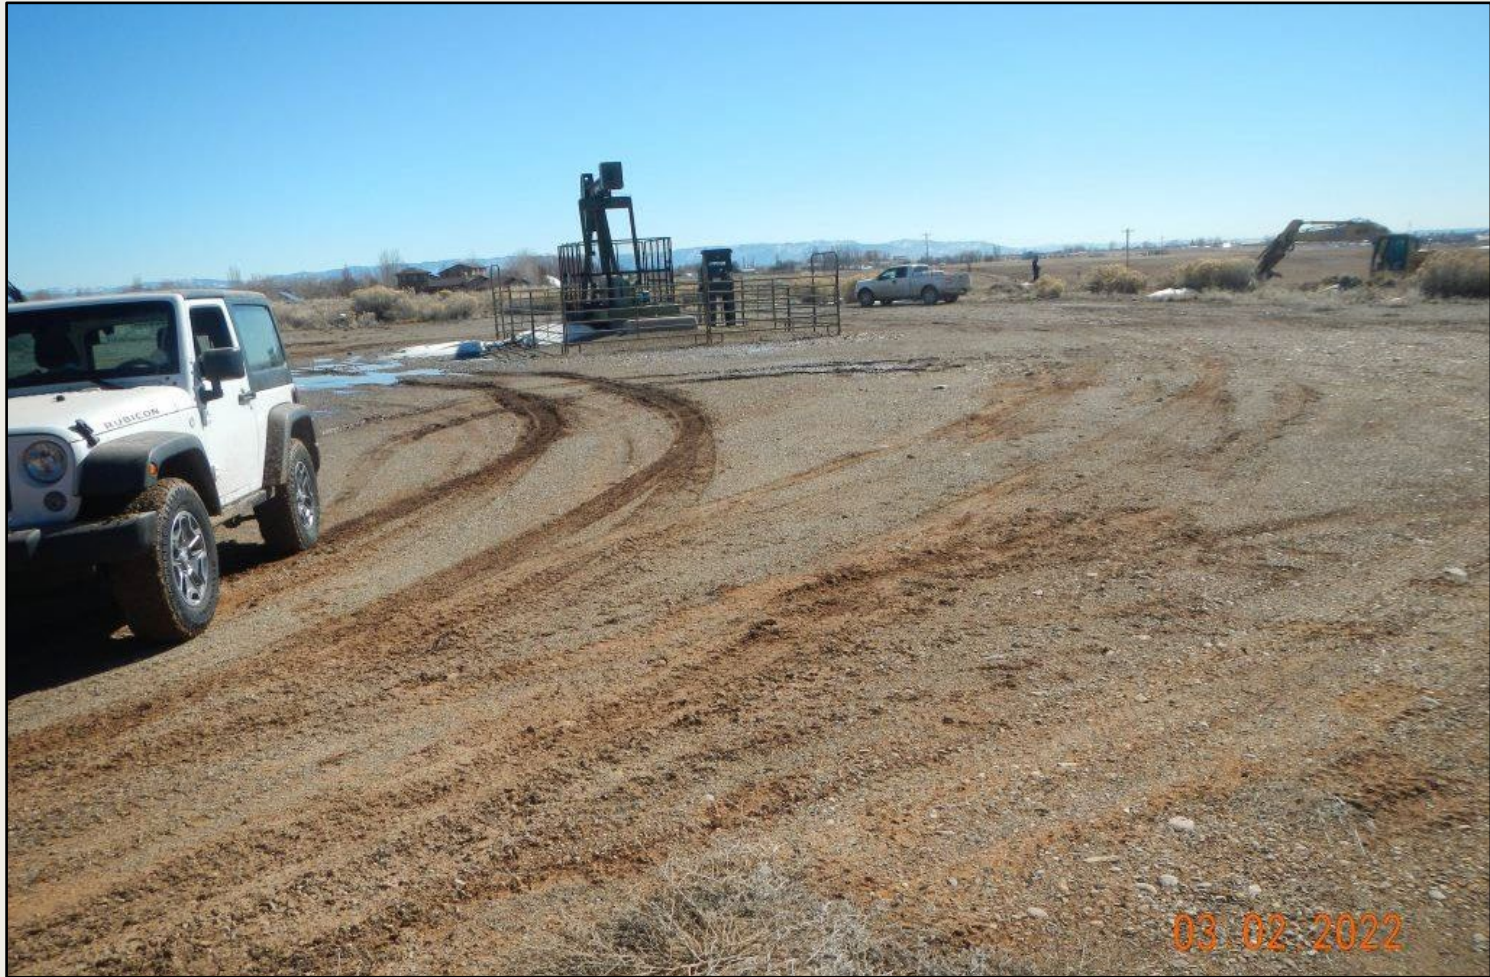
Photo 1. View of project area from the well pad entrance facing center.

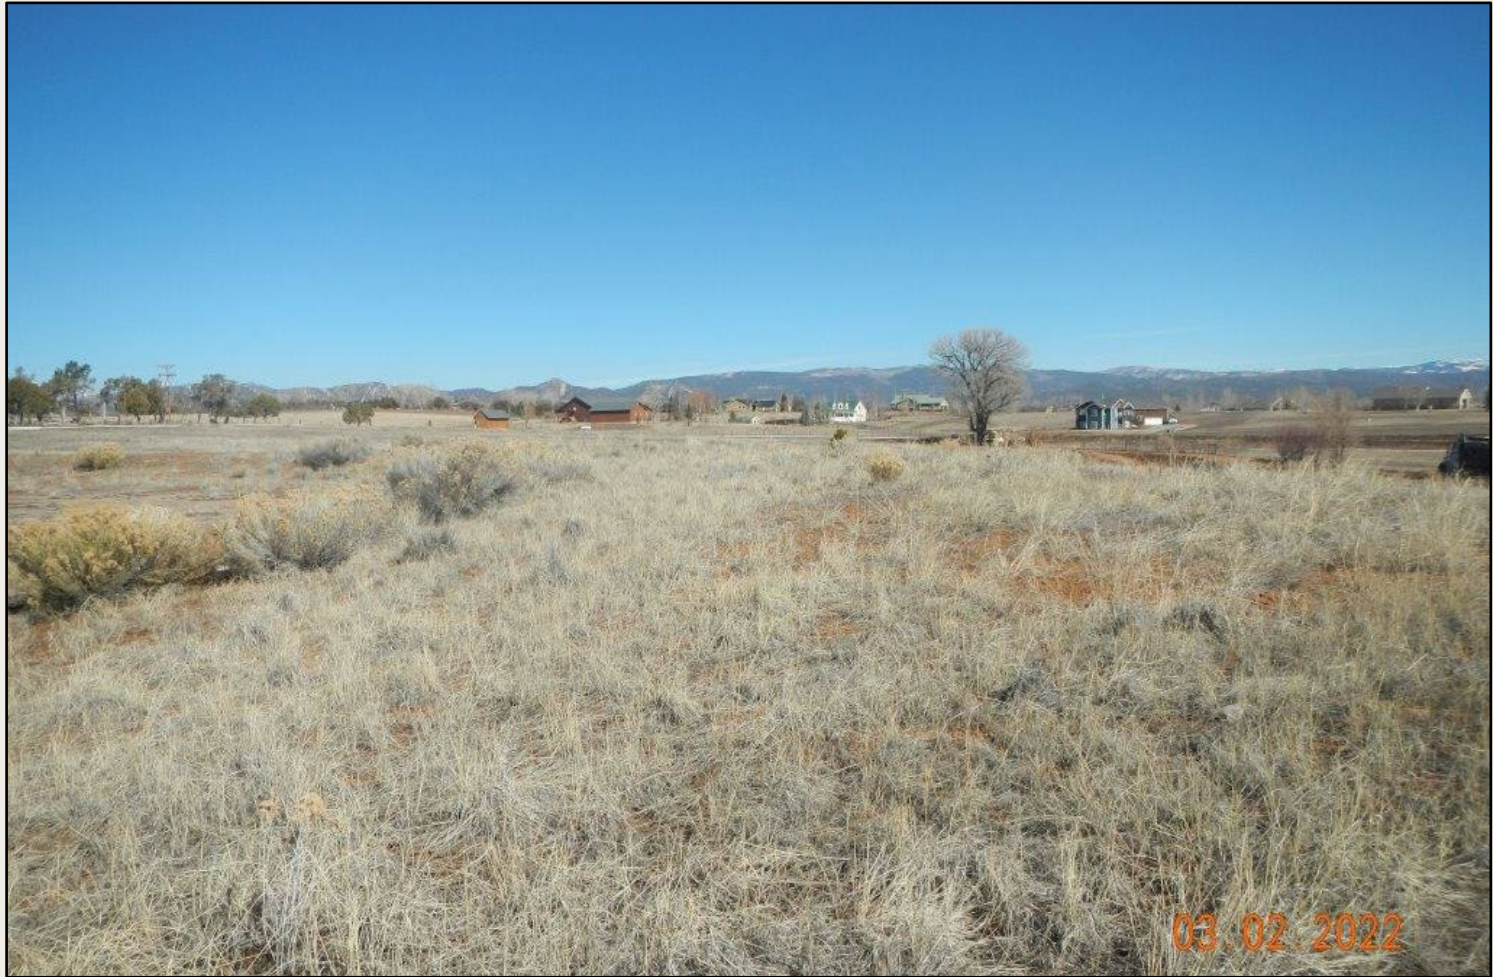
Photo 2. View of the eastern project area from the southeastern corner facing northward. Revegetation is progressing largely with western wheatgrass, crested wheatgrass, and smooth brome.

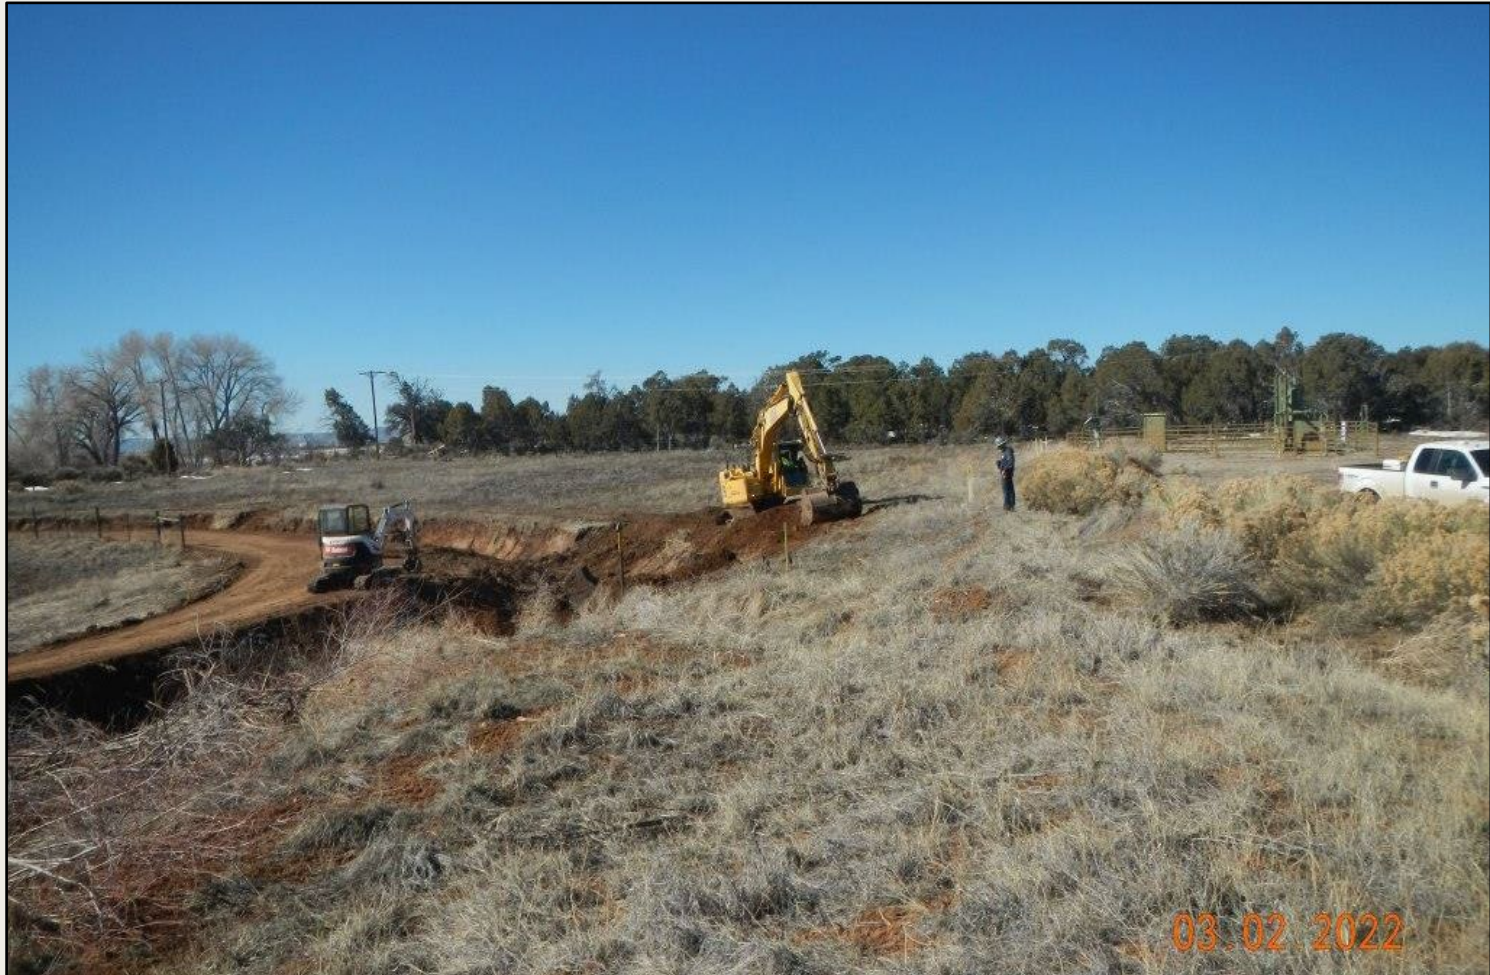
Photo 3. View of the southern project area from the southeastern corner facing westward. Per communication with onsite contractors, excavation work is being conducted by the US Bureau of Reclamation to dredge and maintain irrigation canal that runs adjacent to the southern project area.

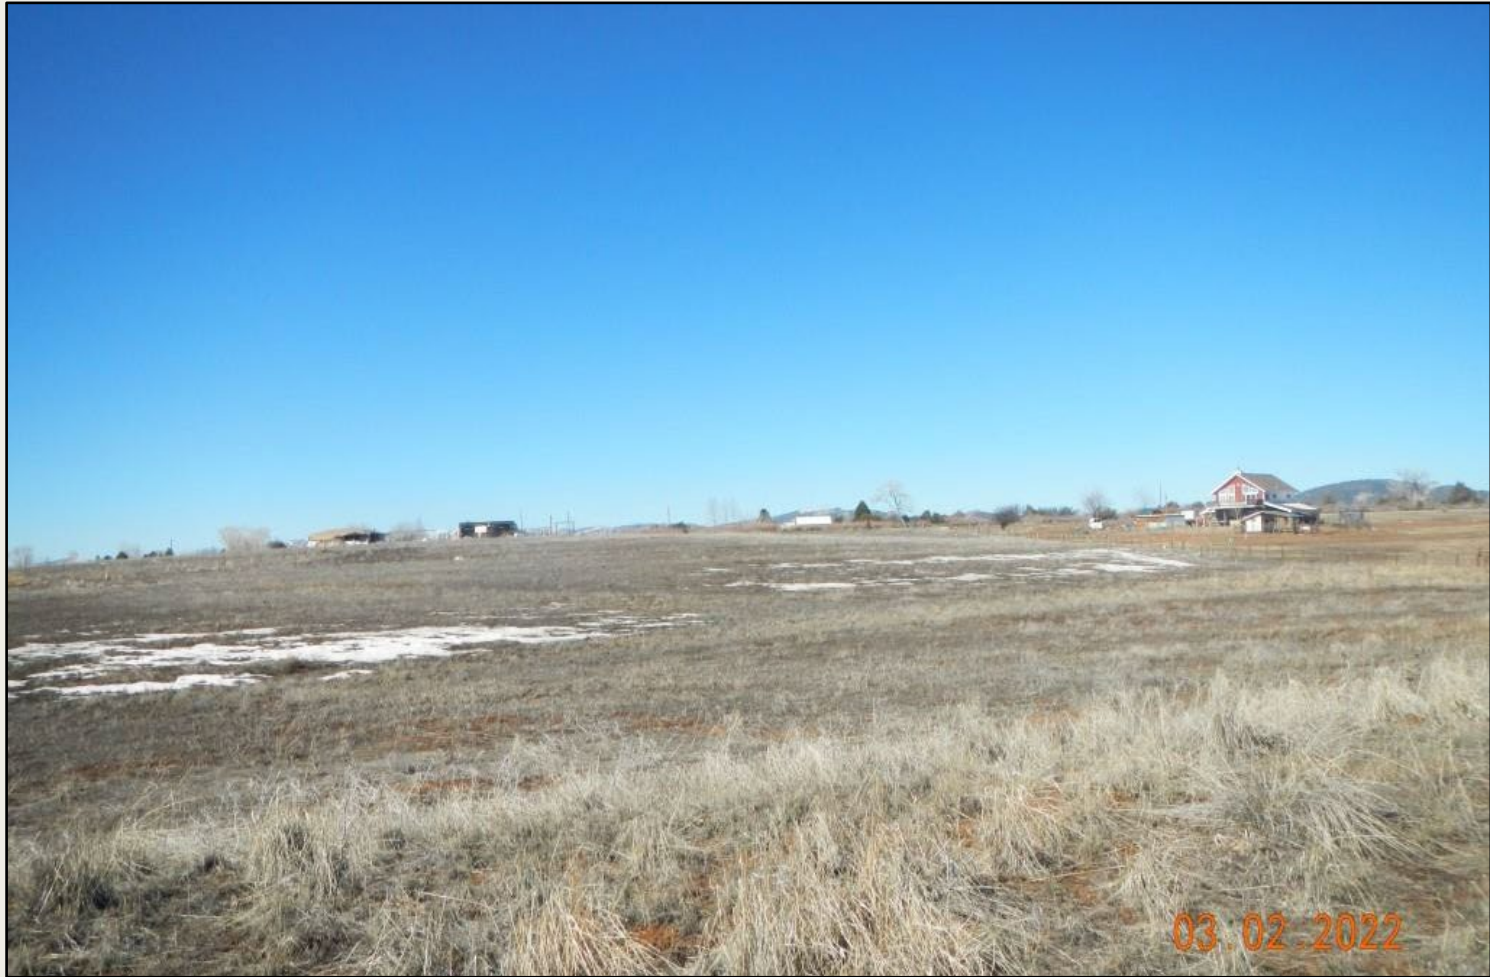
Photo 4. View of reference area comprised of open grass field with smooth brome, crested wheatgrass, and western wheatgrass observed.
