Interim Reclamation and Stormwater Inspection

March 7, 2022

Location Name: McPherson A Pad

Inspection Document #: 702800004

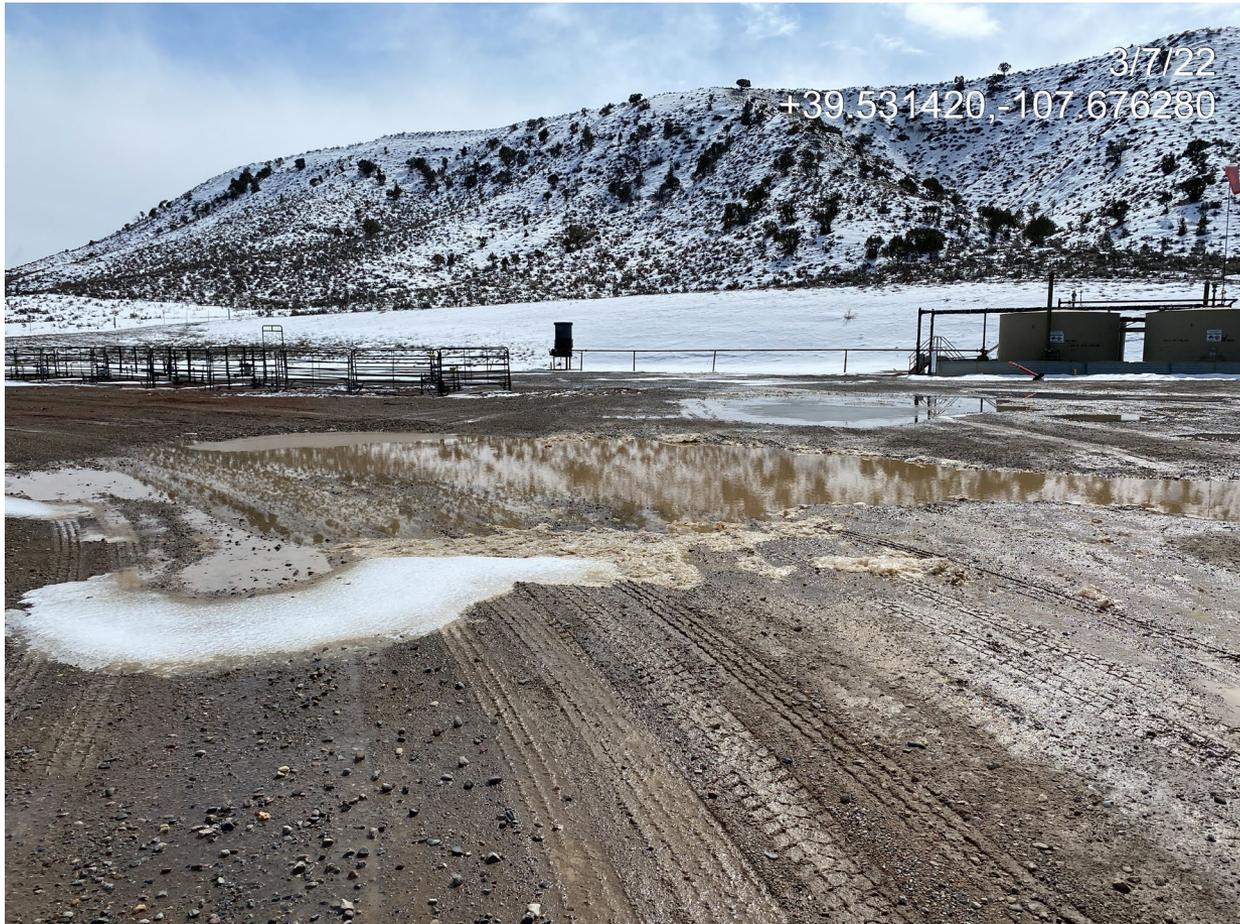
Photo 1. Photo taken from the northwest corner of the Location facing southeast shows an overview of the Location.

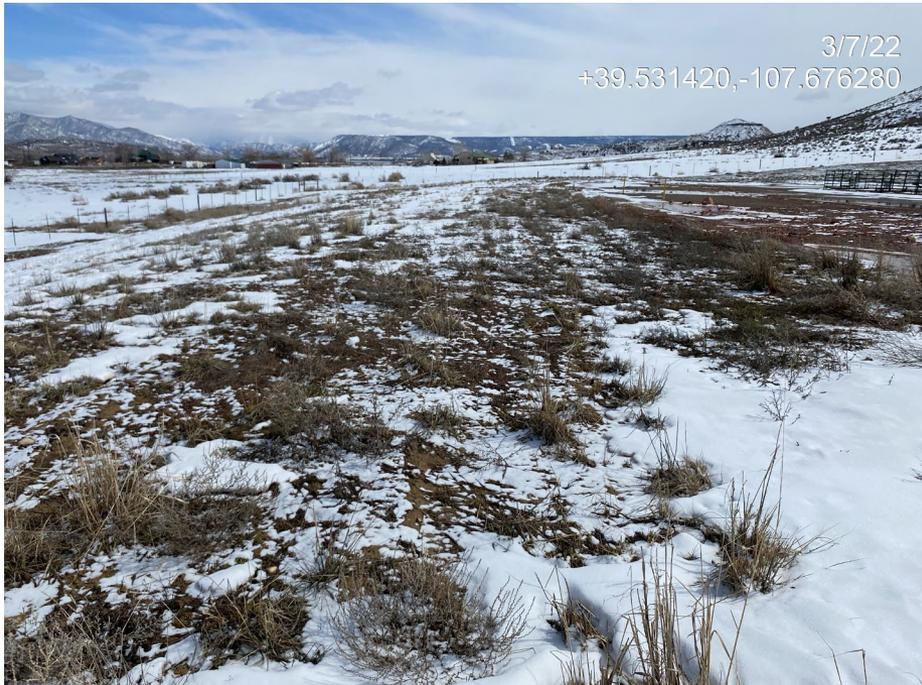
Photo 2. Photo taken from the northwest corner of the Location facing east shows areas of interim reclamation. A follow up inspection is necessary to properly assess interim reclamation when snow is not obscuring areas and vegetation is not dormant.

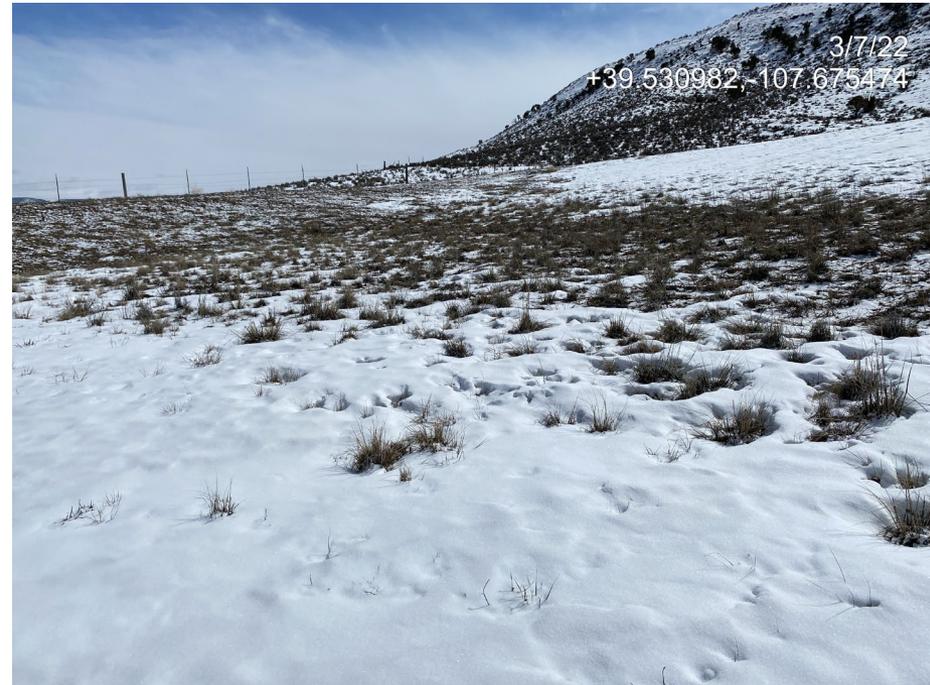
Photo 3. Photo taken from the southeast corner of the Location facing southeast shows areas of interim reclamation. See additional comments under Photo 2.

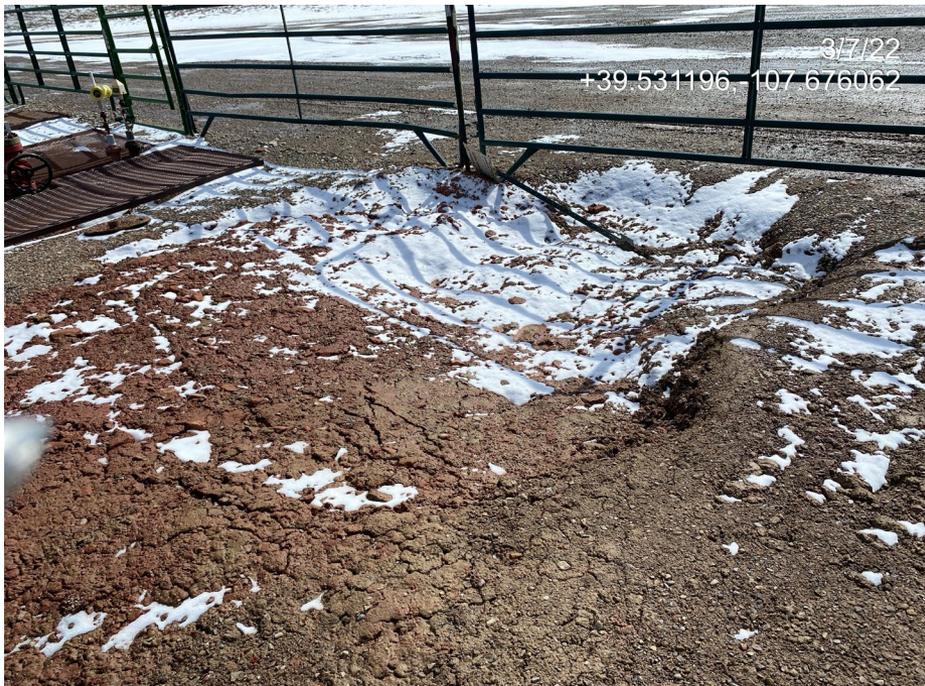
Photo 4. Photo taken of subsidence occurring at dry and abandoned well that has been filled.

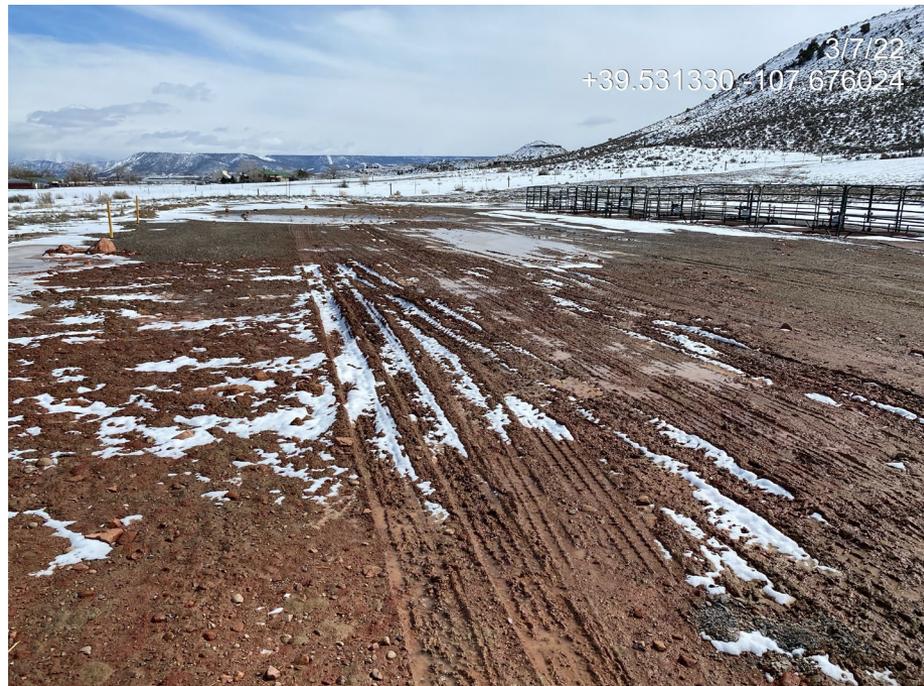
Photo 5. Photo taken at the northwest corner of the Location facing east where sediment from the dry and abandoned well appears to have been dumped on the pad, covering the gravel.

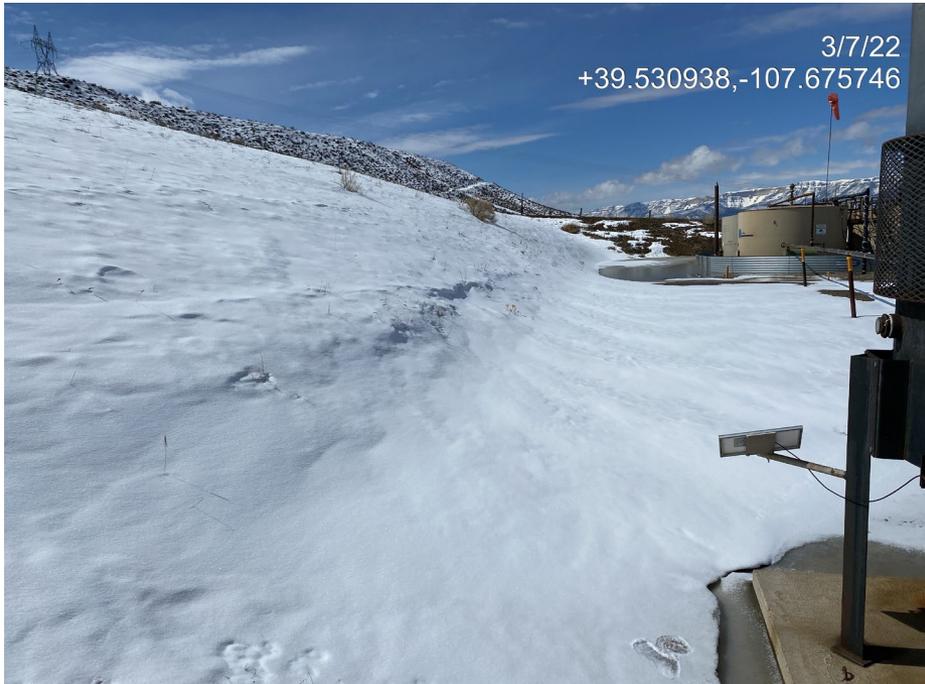
Photo 6. Photo taken from the south corner of the Location facing west shows cut slopes covered in snow. A follow up inspection is necessary to properly asses stormwater management.

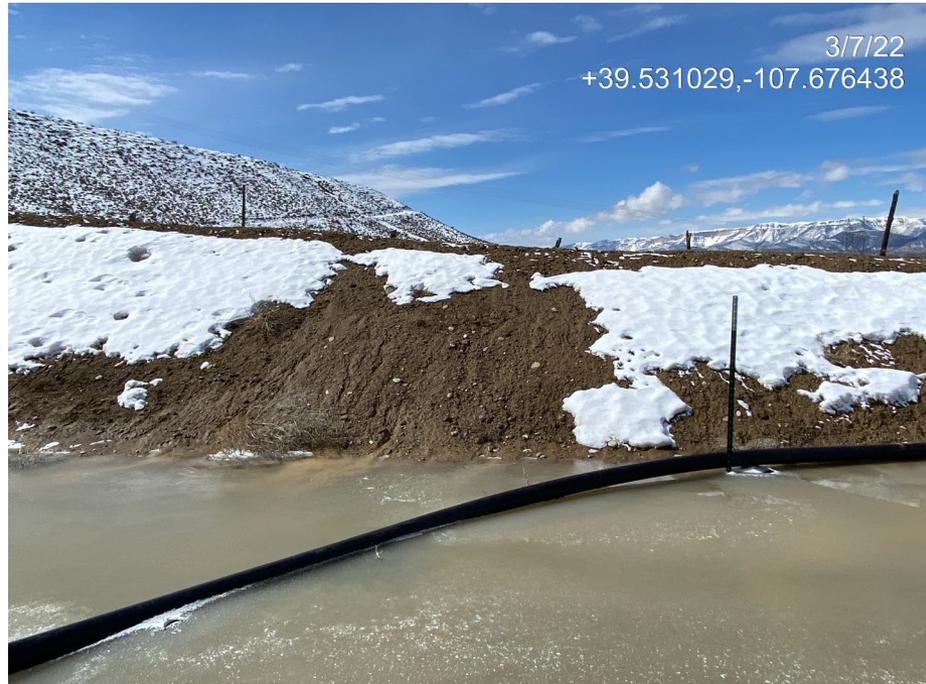
Photo 7. Photo taken from the southwest corner of the Location facing west shows erosion occurring on unprotected slopes.

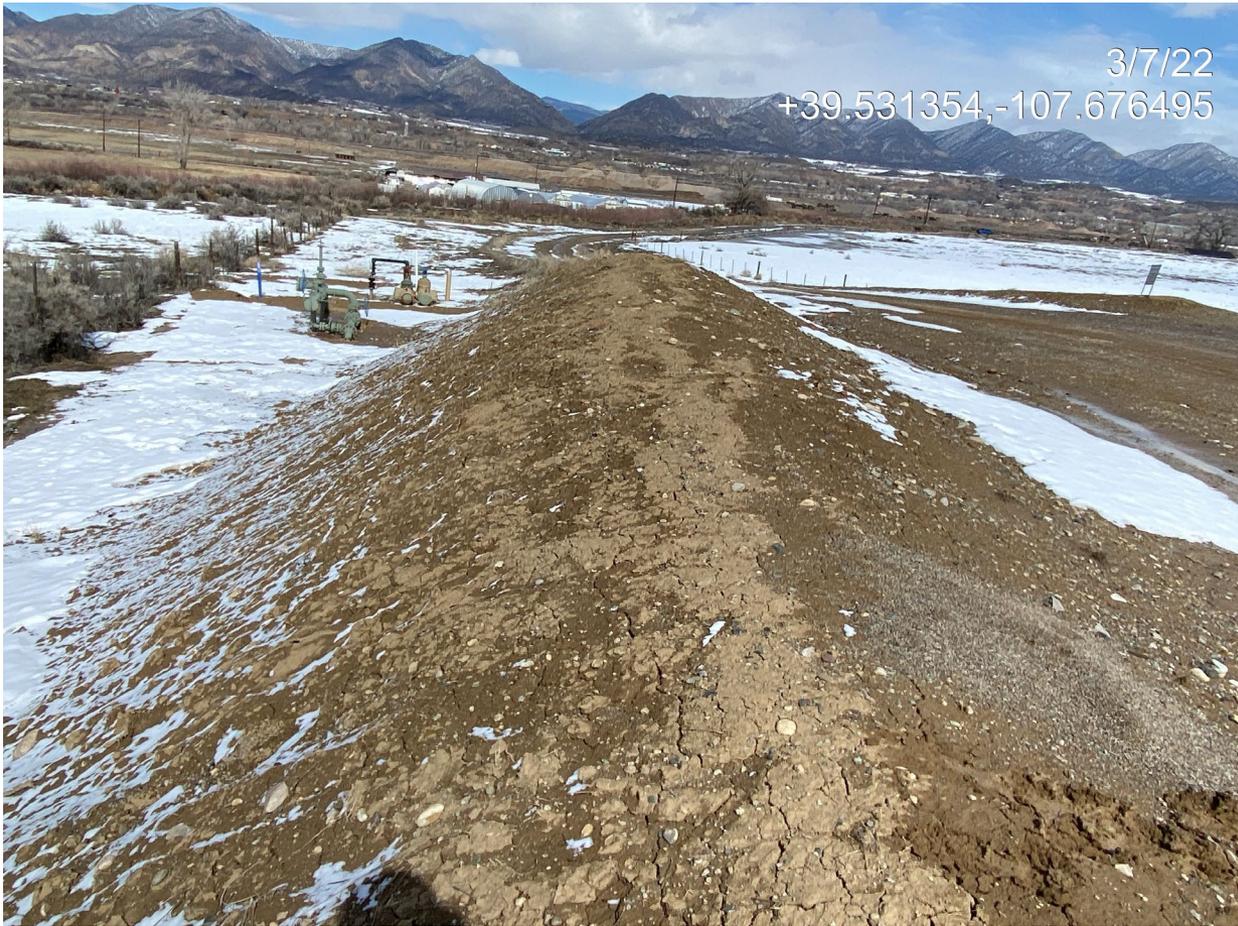
Photo 10. Photo taken from the northeast of the Location facing north showing an unstabilized berm.

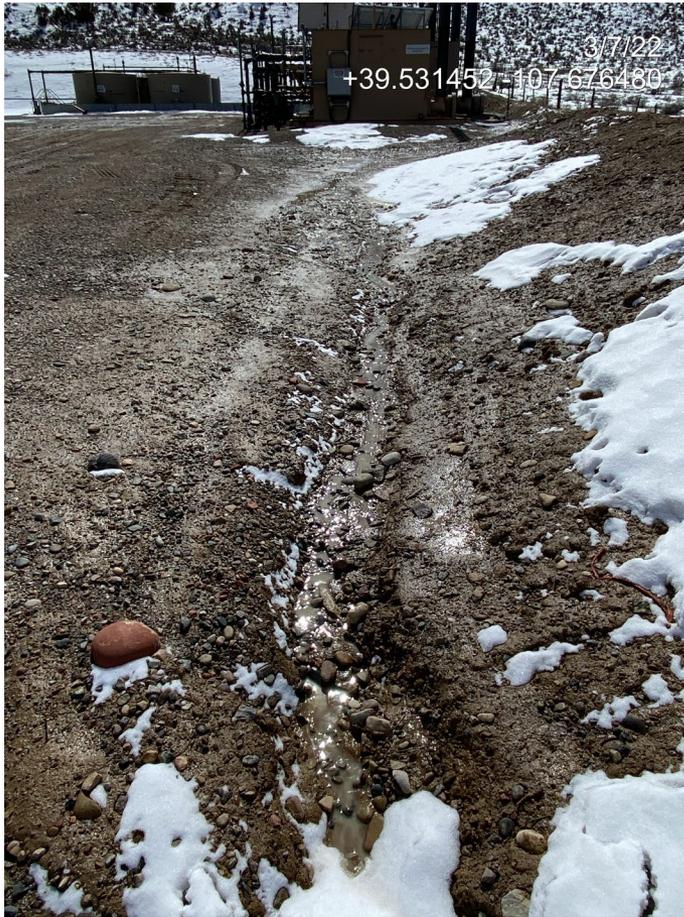
Photo 8. Photo taken from the north at the Location entrance facing south shows rills formed by water flowing through the Location.

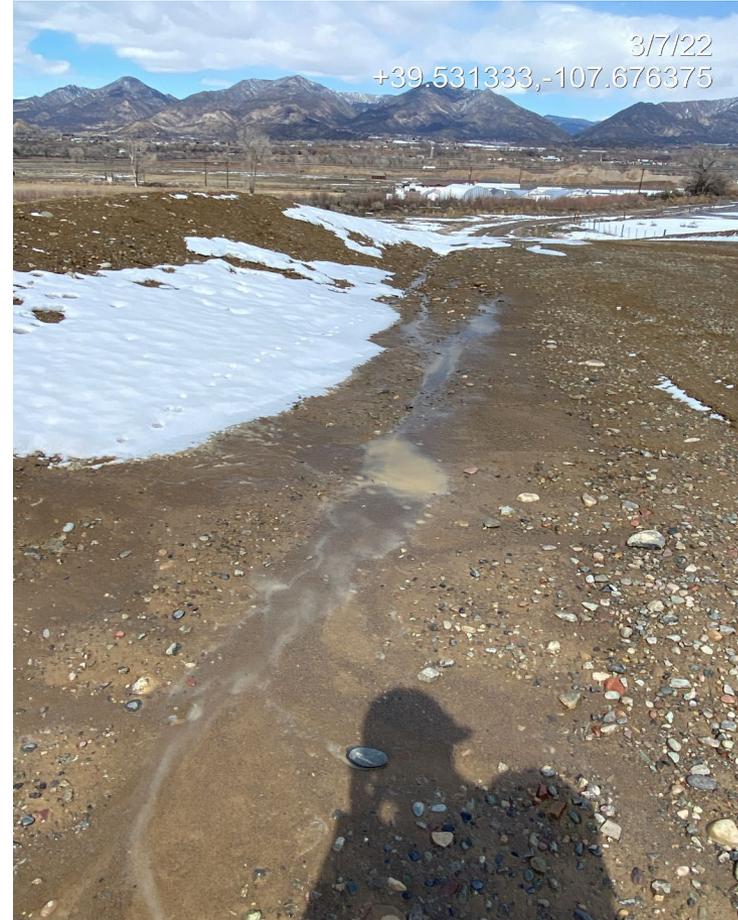
Photo 9. Photo taken from the north at the Location entrance facing north shows sediment laden runoff leaving the location.

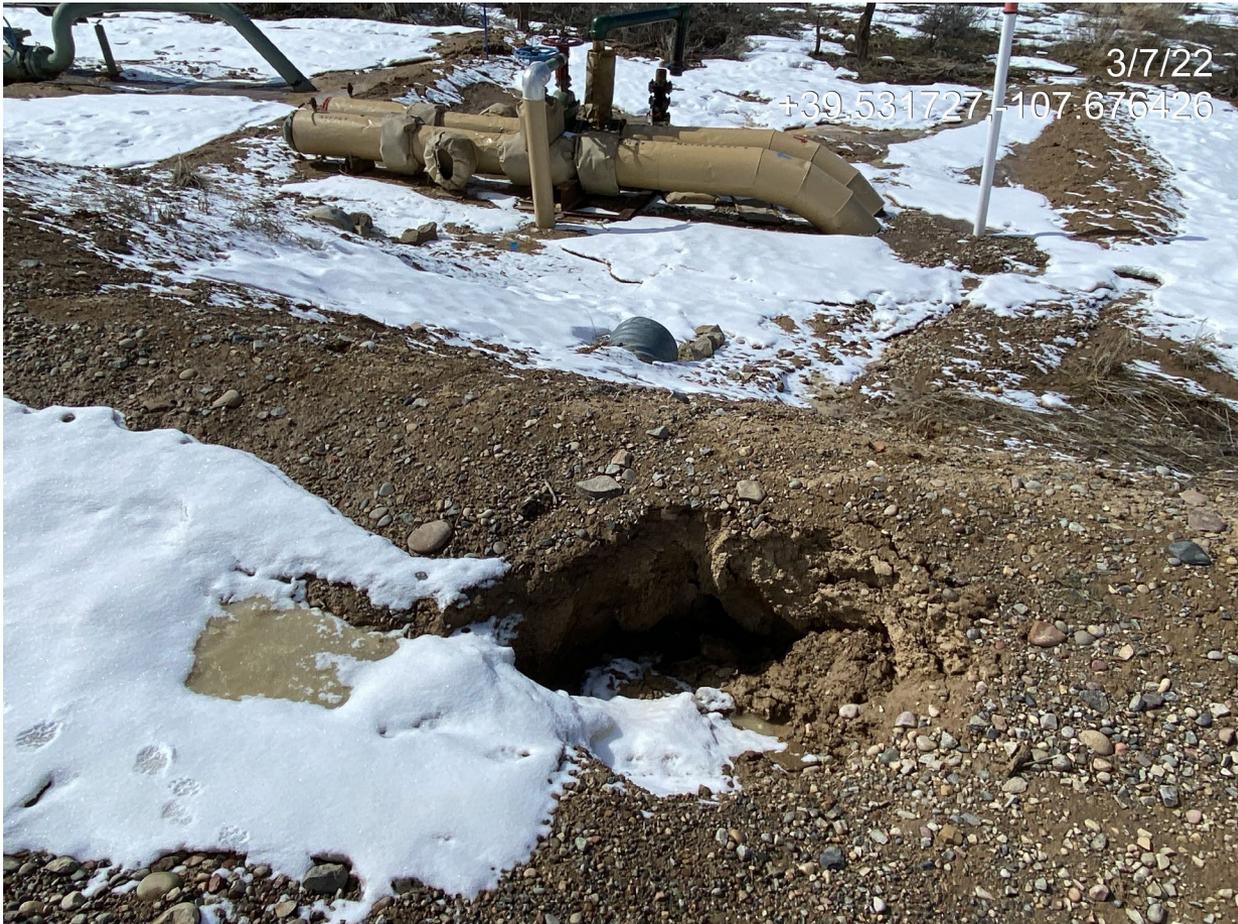
Photo 10. Photo taken from the access road directly north of the Location entrance facing west showing where runoff is cutting into a berm adjacent to a culvert.

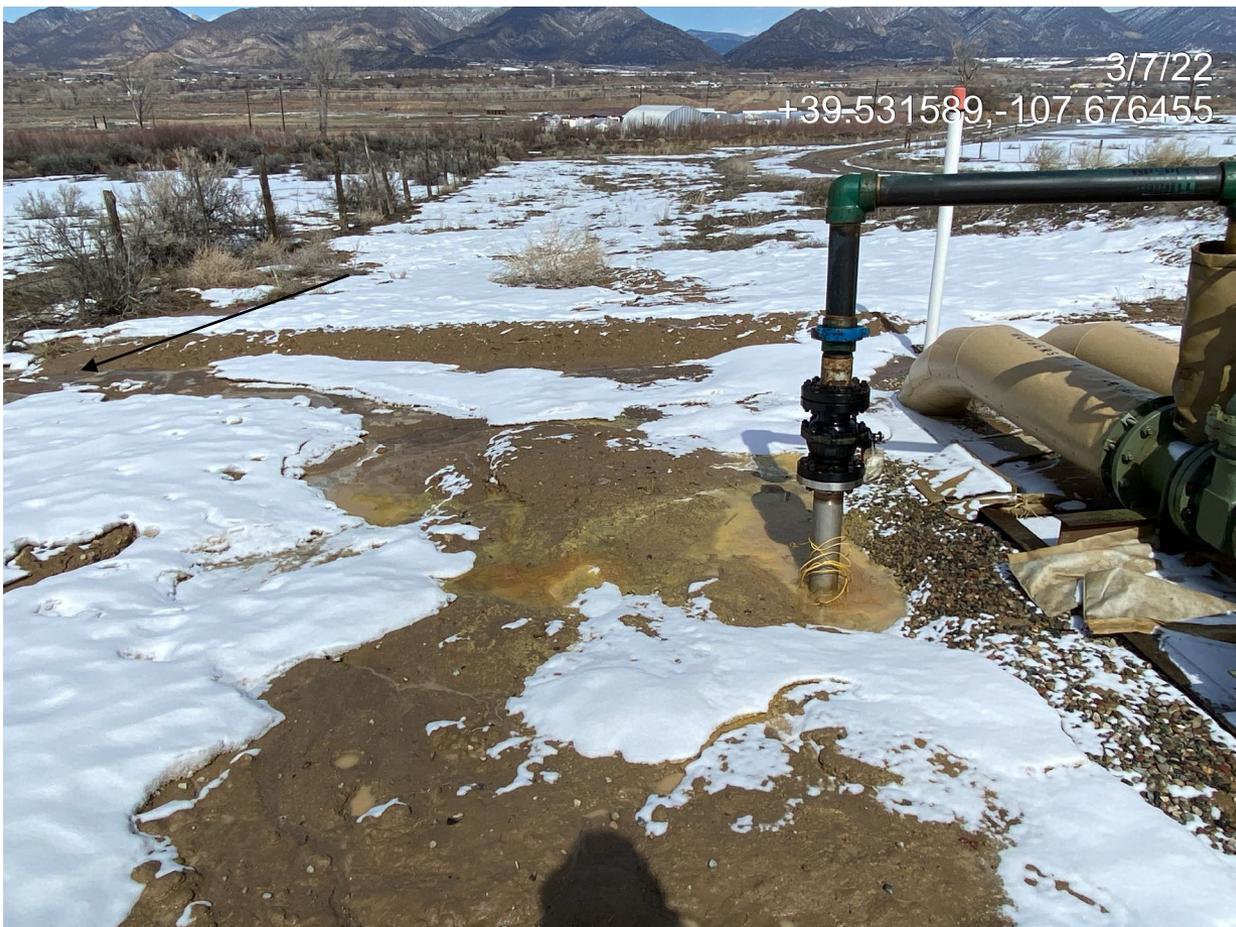
Photo 11. Photo taken from north of the Location facing North. Photo shows an overview of the tie in point on a flowline (# 466720) with potentially impacted fluids accumulating around the tie in point. Note the arrow showing where potentially impacted fluids are flowing around the secondary containment berm and offsite with stormwater runoff.

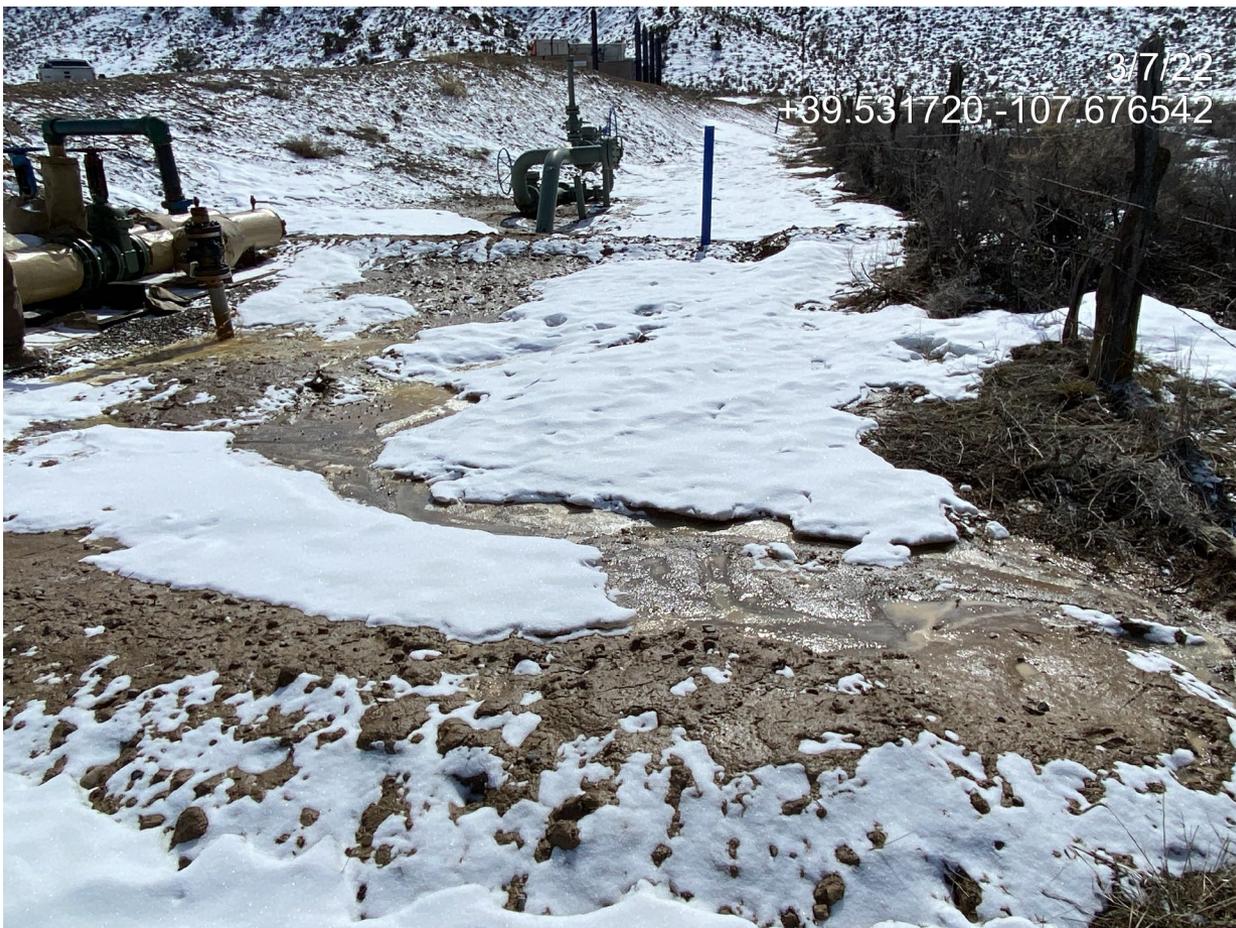
Photo 12. Photo taken from north of the Location facing south. Photo shows the tie in point on a flowline (# 466720) where potentially impacted fluids are flowing around the secondary containment berm and offsite with stormwater runoff.

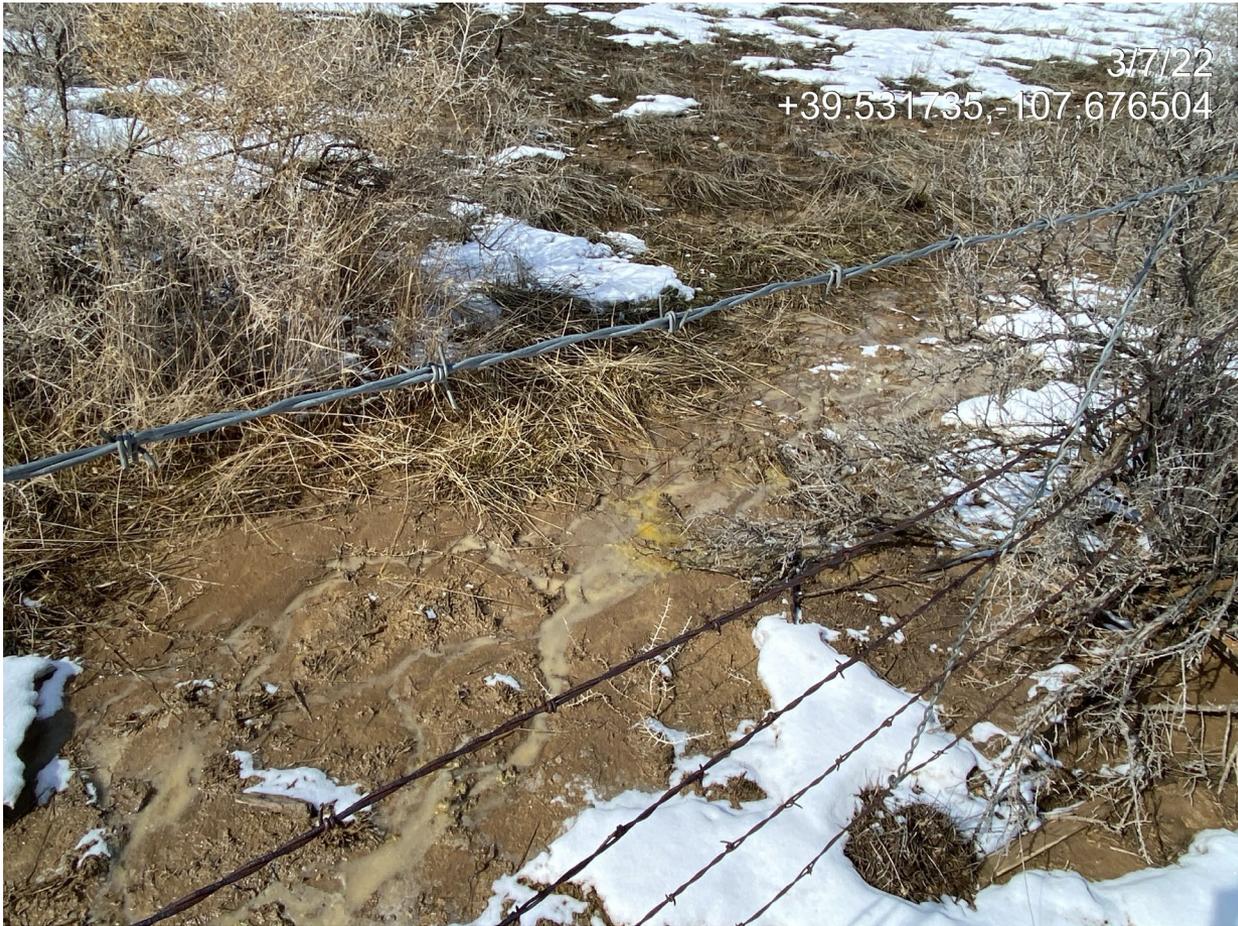
Photo 12. Photo taken from north of the Location shows potentially impacted fluids flowing offsite with stormwater and through the adjacent property.
