Interim Reclamation and Stormwater Inspection

March 7, 2022

Location Name: Valley Farms B

Inspection Document #: 702800006

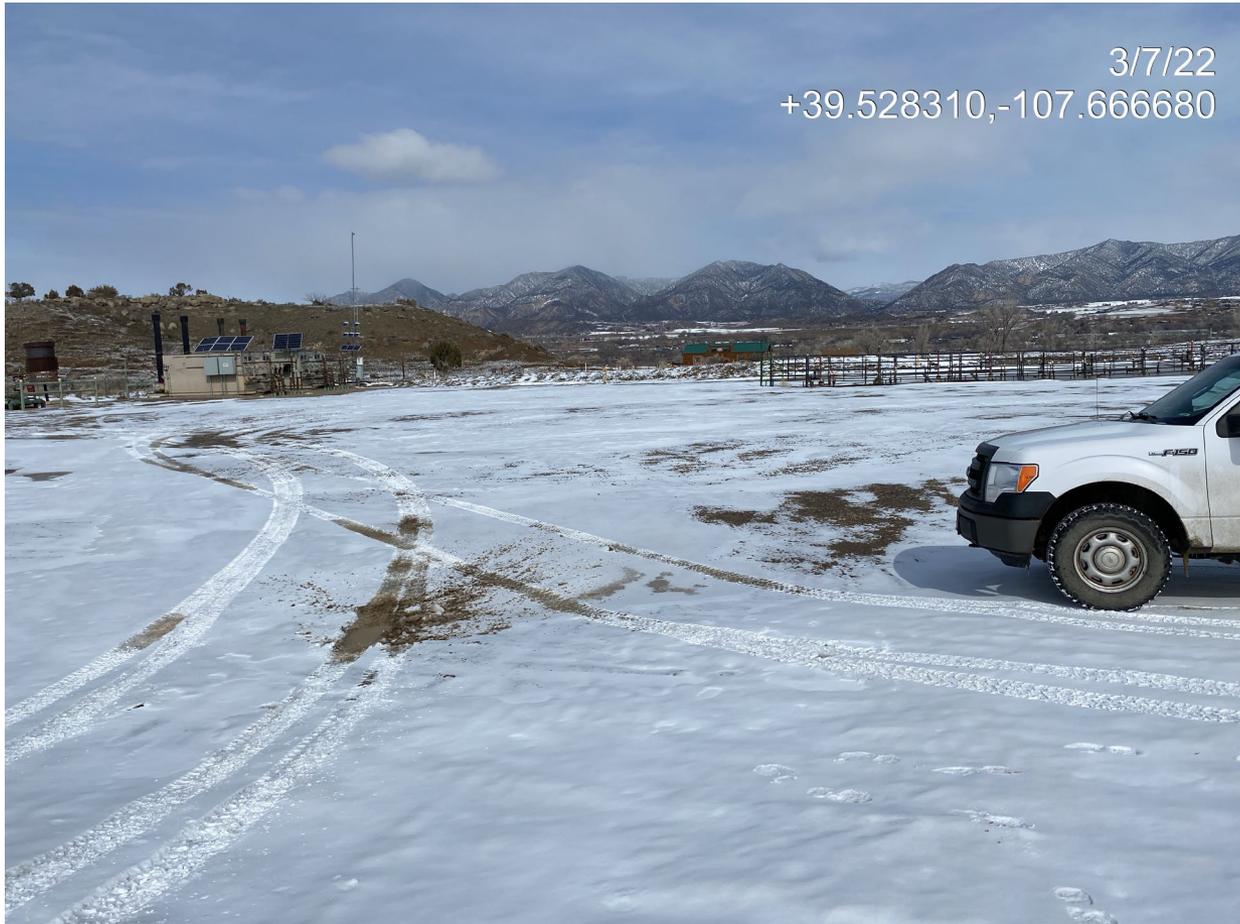
Photo 1. Photo taken from the southwest entrance to the location facing north shows an overview of the Location.

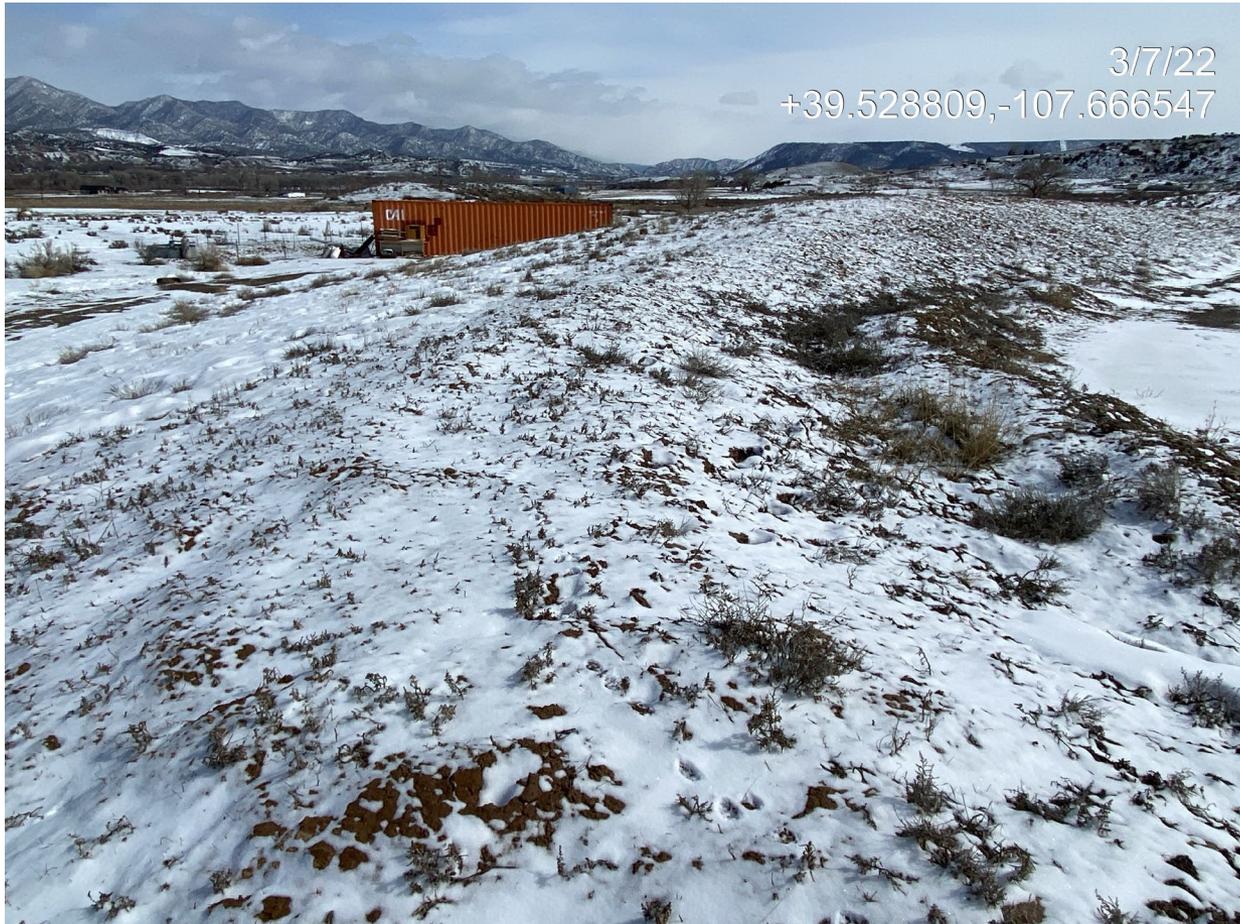
Photo 2. Photo taken from the north of the Location facing northeast shows interim reclamation areas. Presently, it appears that interim reclamation areas are dominated by bare ground and weeds (kochia and cheatgrass) and are not progressing towards reclamation standards.

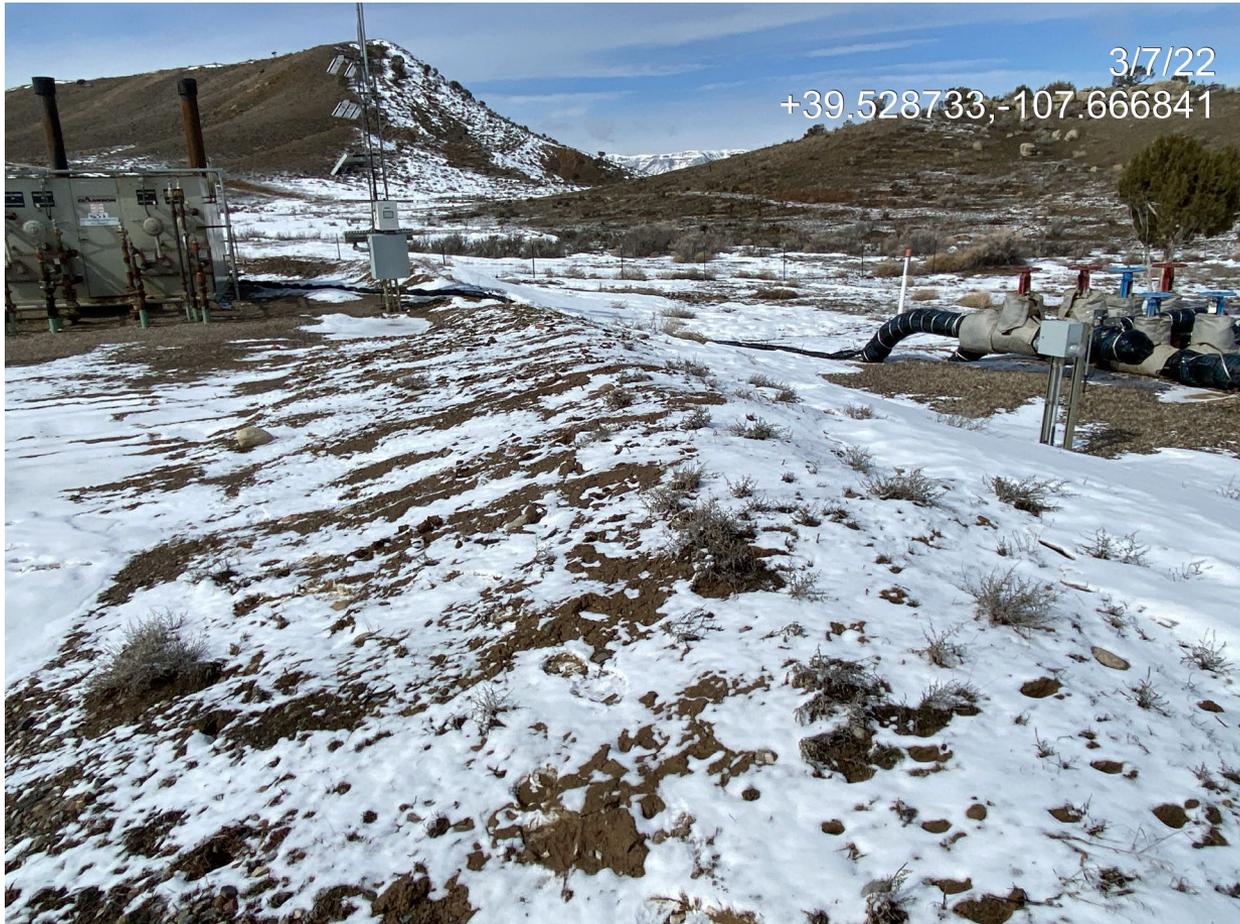
Photo 3. Photo taken at the north of the location facing west shows unstabilized slopes not progressing towards reclamation standards. See additional comments under photo 2.

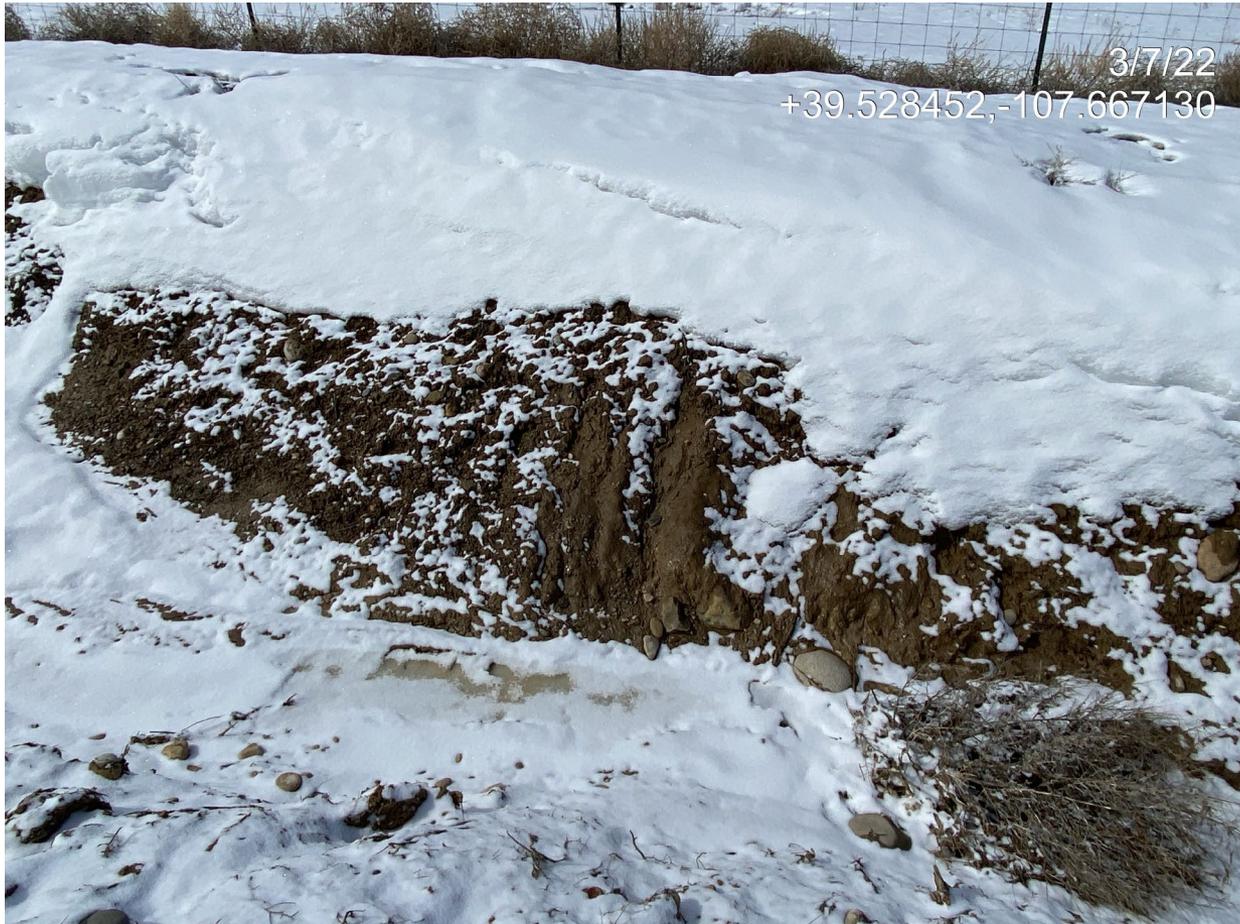
Photo 4. Photo taken at the southwest corner of the pad facing west shows slopes covered in snow. A follow up inspection is necessary to properly asses stormwater management. Exposed slopes show signs of rill erosion.

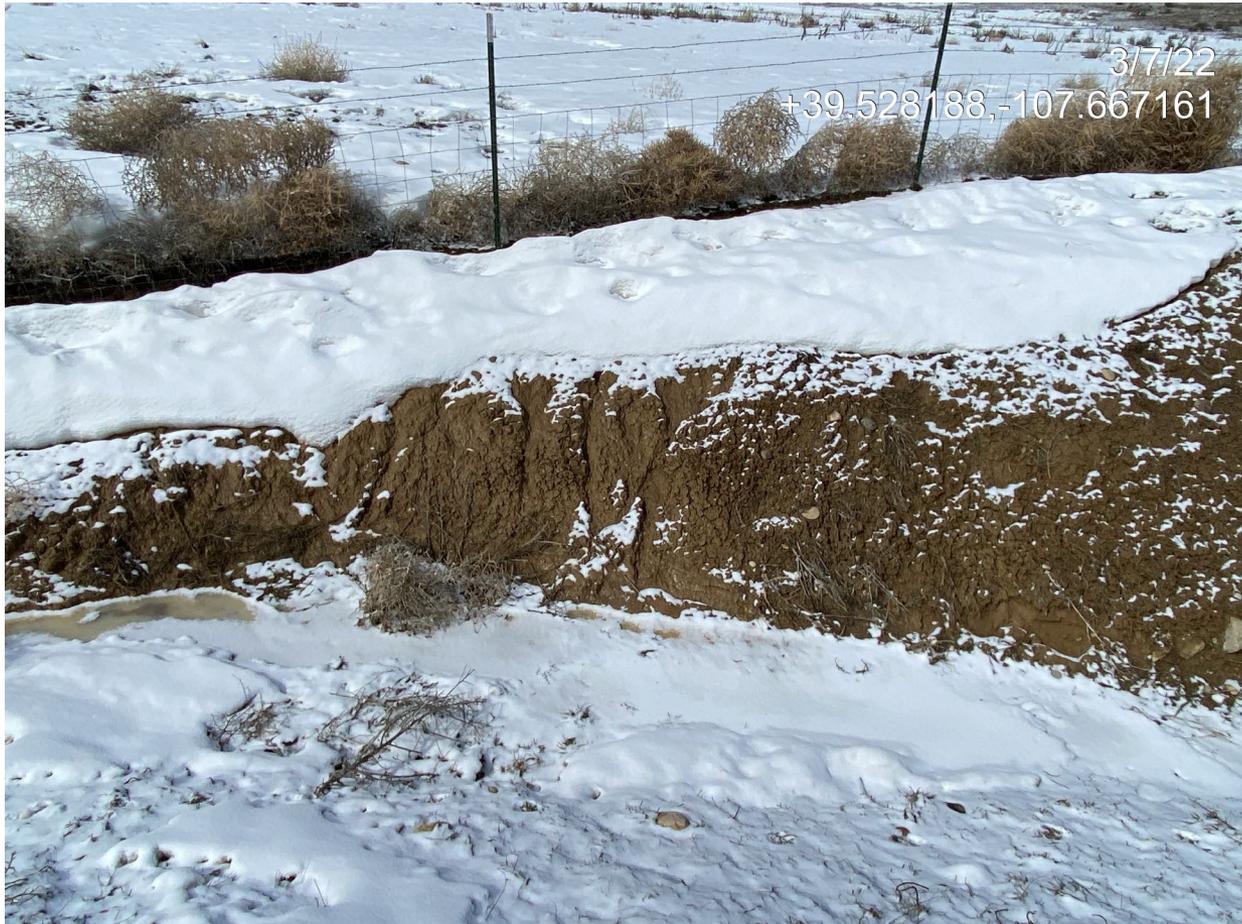
Photo 5. Photo taken at the southwest corner of the pad facing west shows rill erosion occurring on unstabilized slopes of the sediment trap.

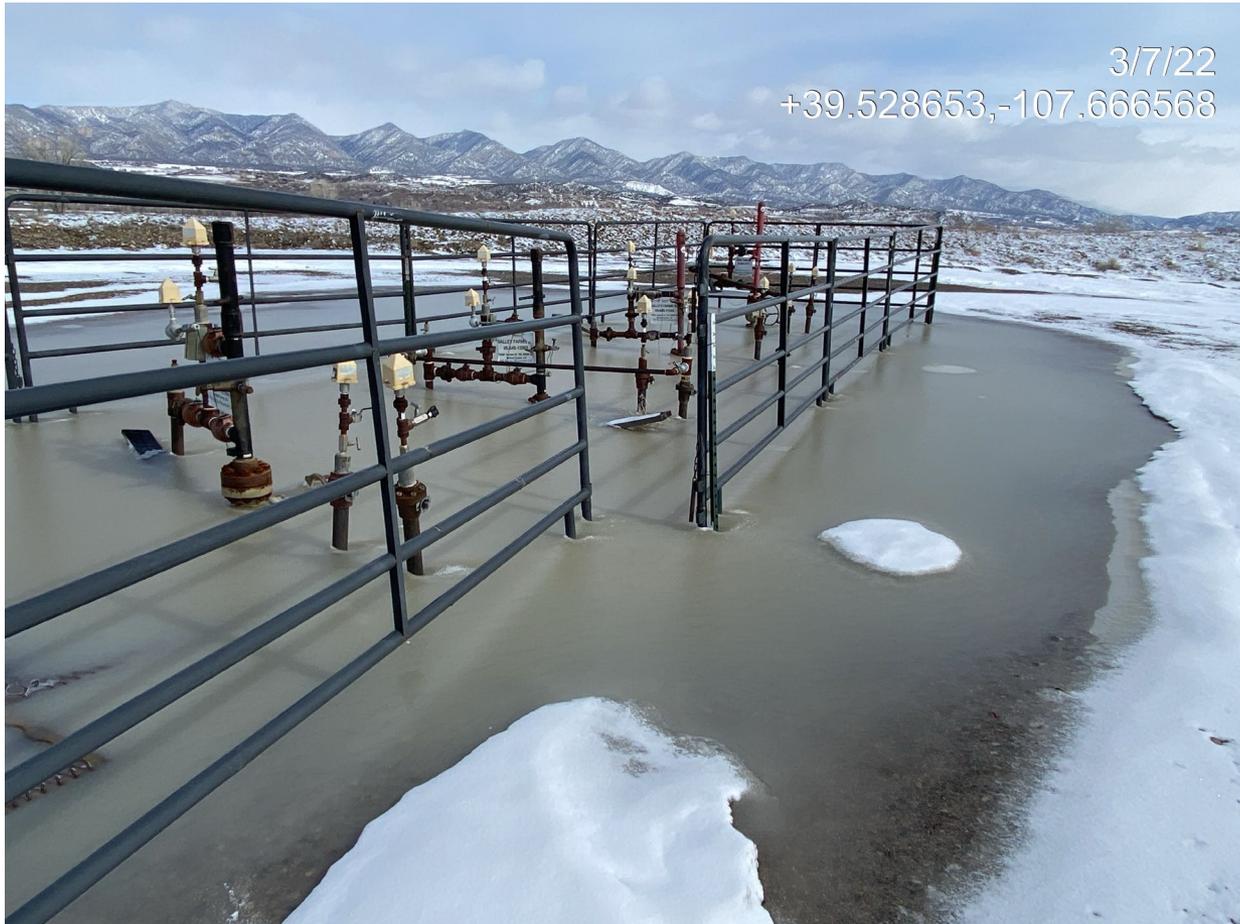
Photo 6. Photo taken at the wells facing northeast shows wells completely inundated with stormwater.

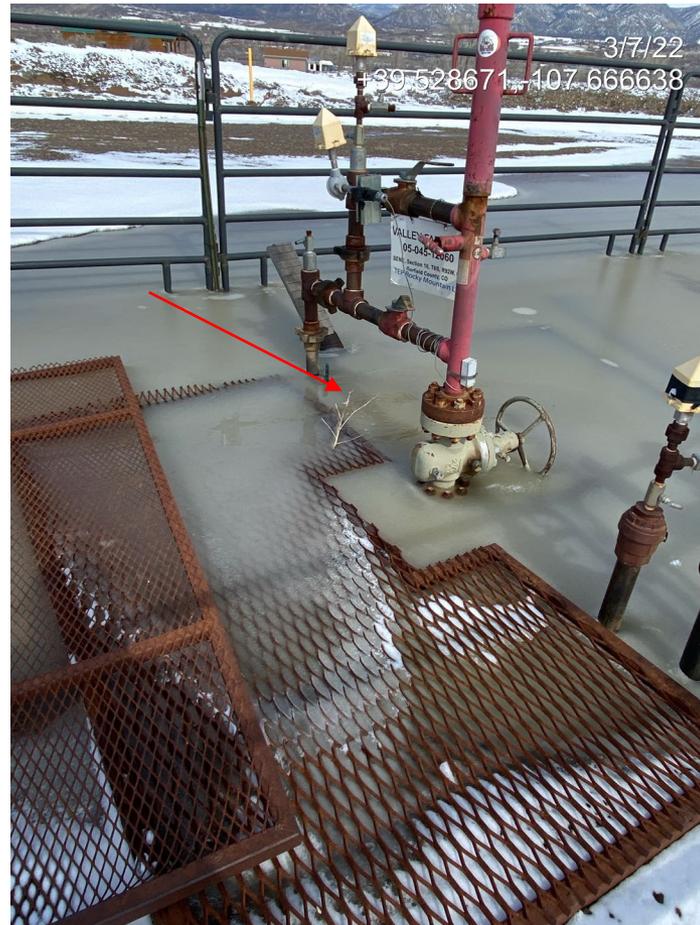
Photo 7. Photo taken at the wells facing north shows well API # 05-045-12060. The arrow points to gas bubbling up in the water indicative of a potential leak.

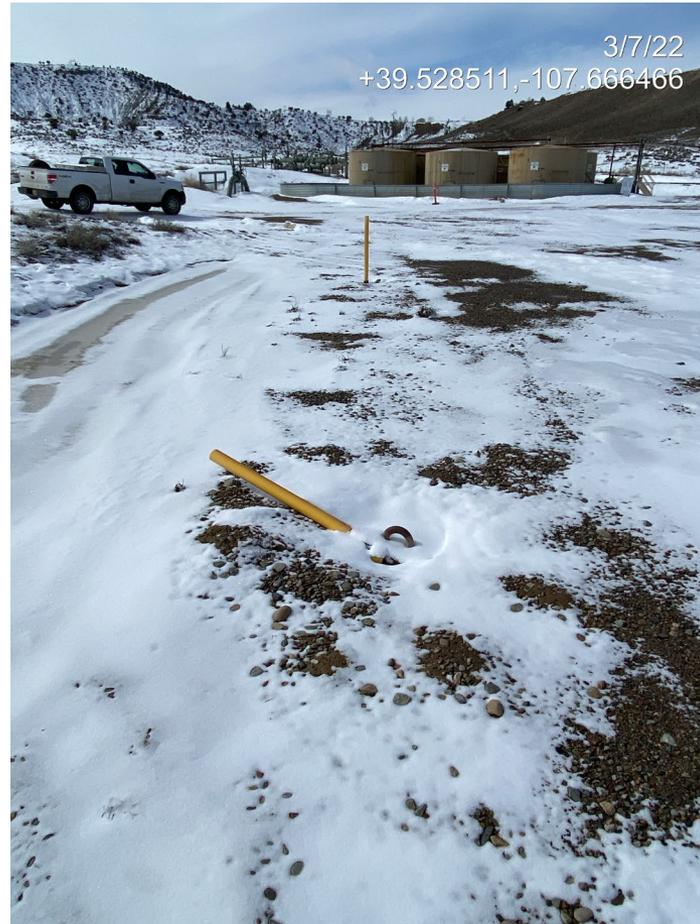
Photo 8. Photo taken at the south of the Location facing southwest shows an anchor marker in disrepair. 3 of 7 counted anchor markers were in disrepair.
