MCLAUGHLIN AC 14  
INSPECTION REPORT DATED 28 FEBURARY 2022  
DOCUMENT NUMBER 701'S101786

COGCC Routine Inspection Report Summary

**CHEVRON USA INC**  
**A. C. MCLAUGHLIN-62N103W 14NWNE**  
**Location # 314263**

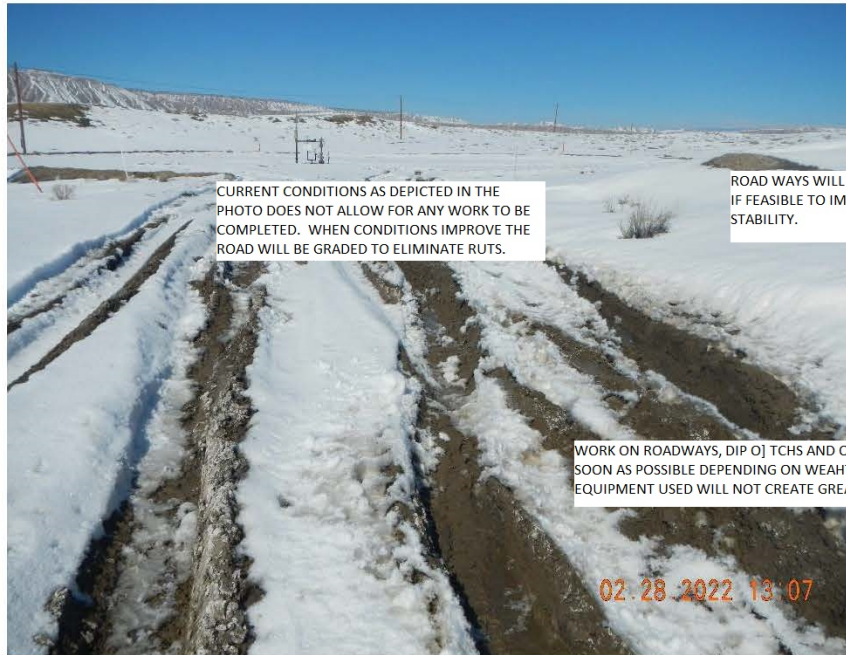
**Access road lacks compaction/stability**

Install or repair required BMPs per Rule 1002.f.(2)C

1. RE-ESTABLISH ROAD SIDE DITCHES (RSD'S)
2. GRADE ROADS AND FILL, REMOVE ALL RUTS
3. POSSIBLE WATER BAR TO DIVERT WATER FROM ROADWAY
4. DIVERSION DITCH AS NEEDED TO CONROL THE FLOW OF WATER ONTO ROADWAY AND WELL PAD
5. ADDITIONAL BMP'S AS DETERMINED WHEN CONDITIONS ALLOW A COMPLETE REVIEW OF THE STORMWATER NEEDS.

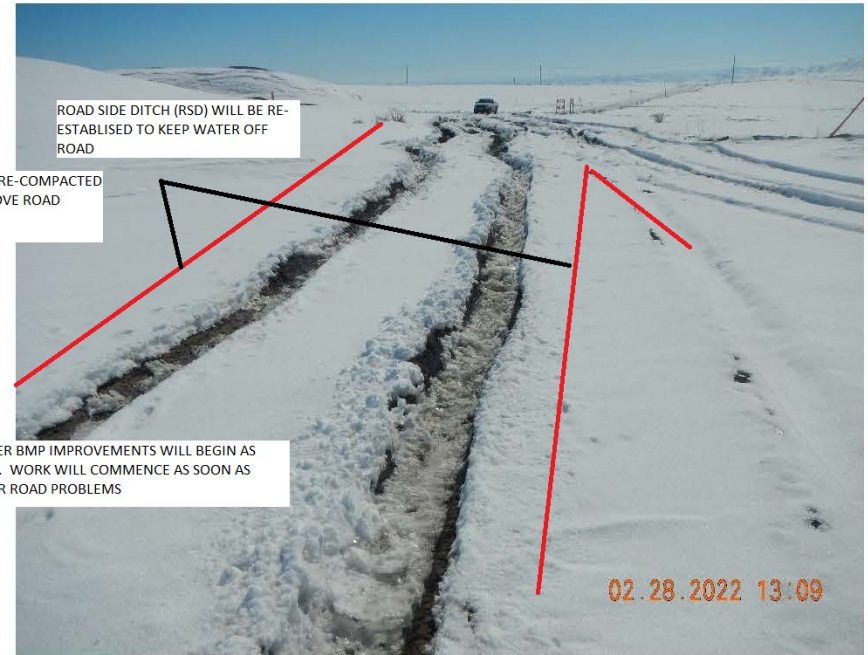
**Location lacks compaction/stability**

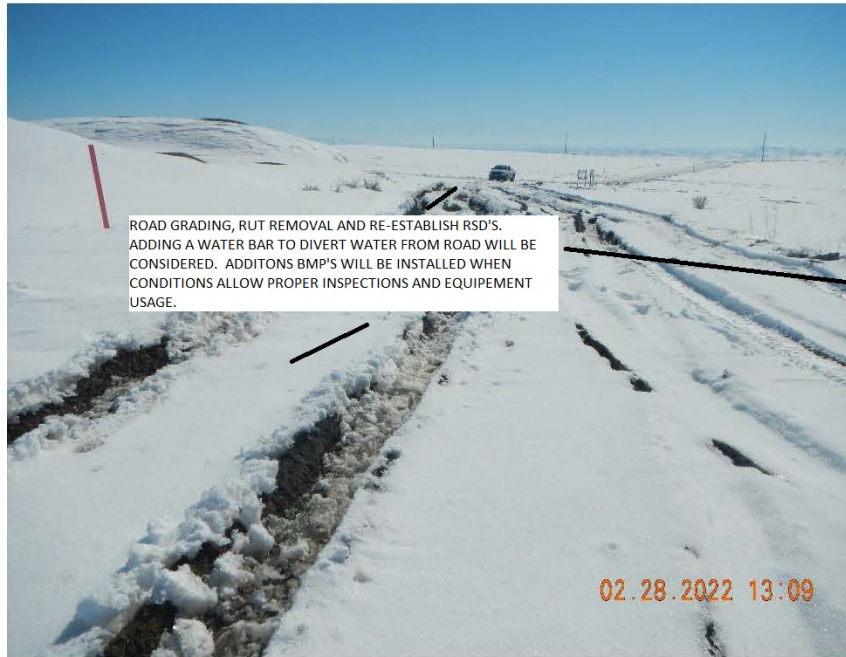
**Location lacks compaction/stability**

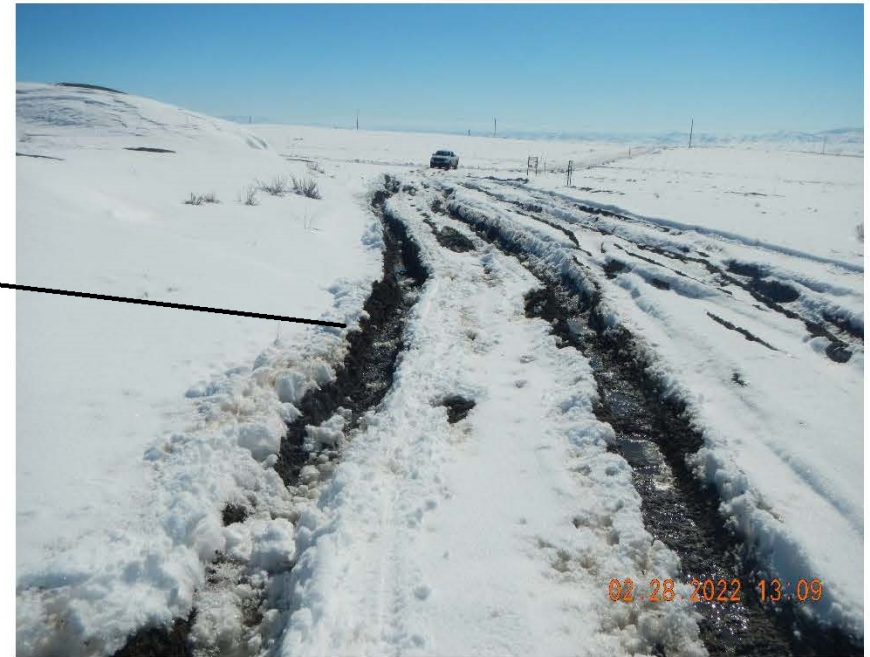
**Location lacks compaction/stability**
