Inspection Photos

Operator: TEP Rocky Mountain LLC - #96850

Location Name: Burckle A Pad

Inspection Document #: 702800015

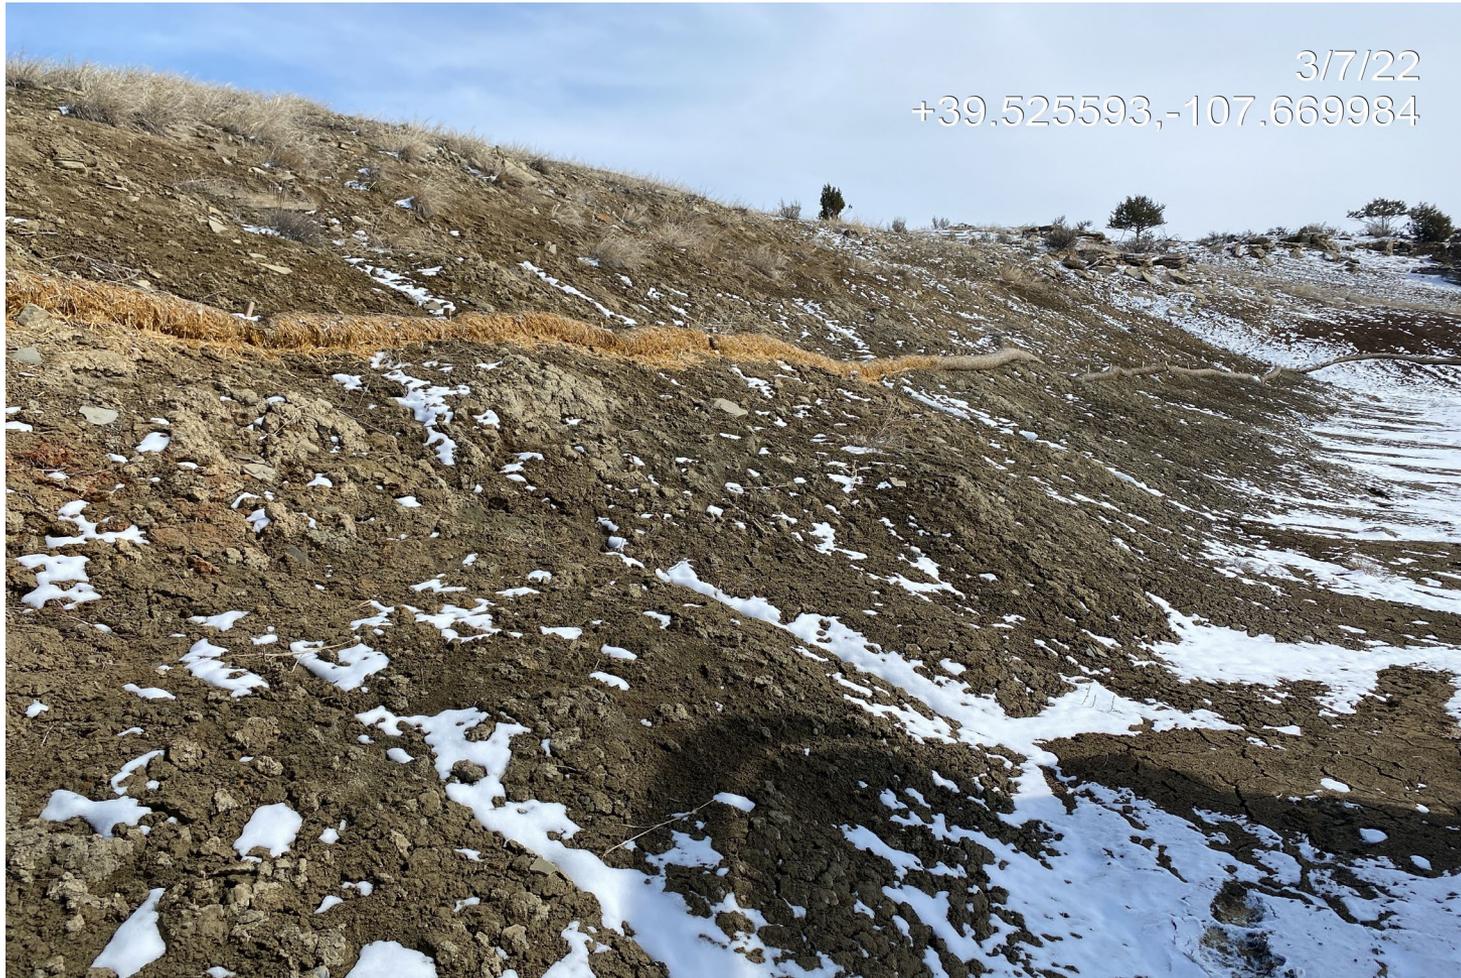
Photo 1. Photo taken from the north of the location facing east shows rill erosion occurring on cut slopes.

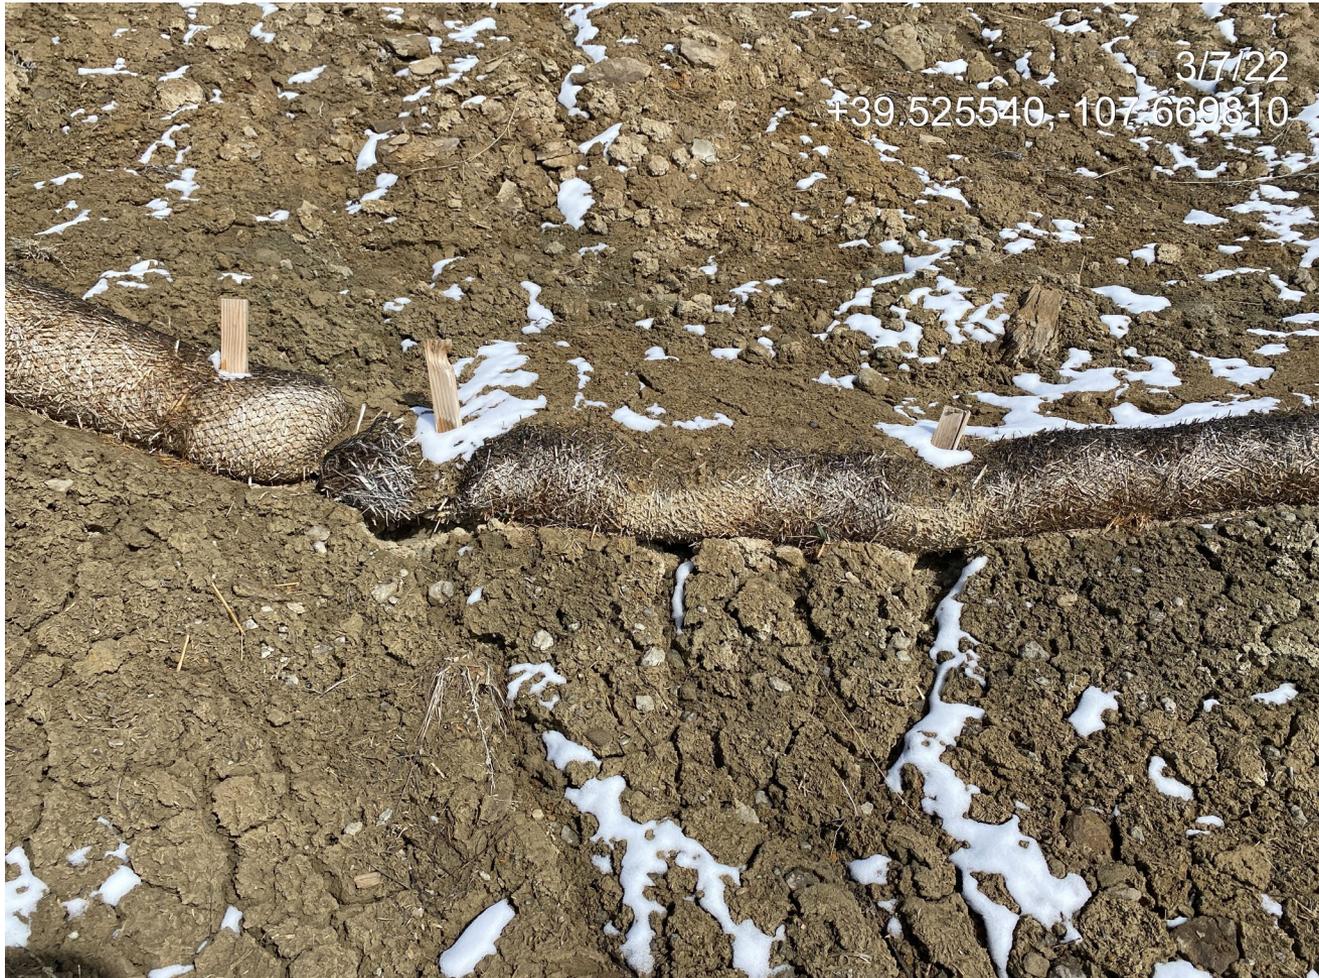
Photo 2. Photo taken from the north of the location shows rill erosion occurring on cut slopes.

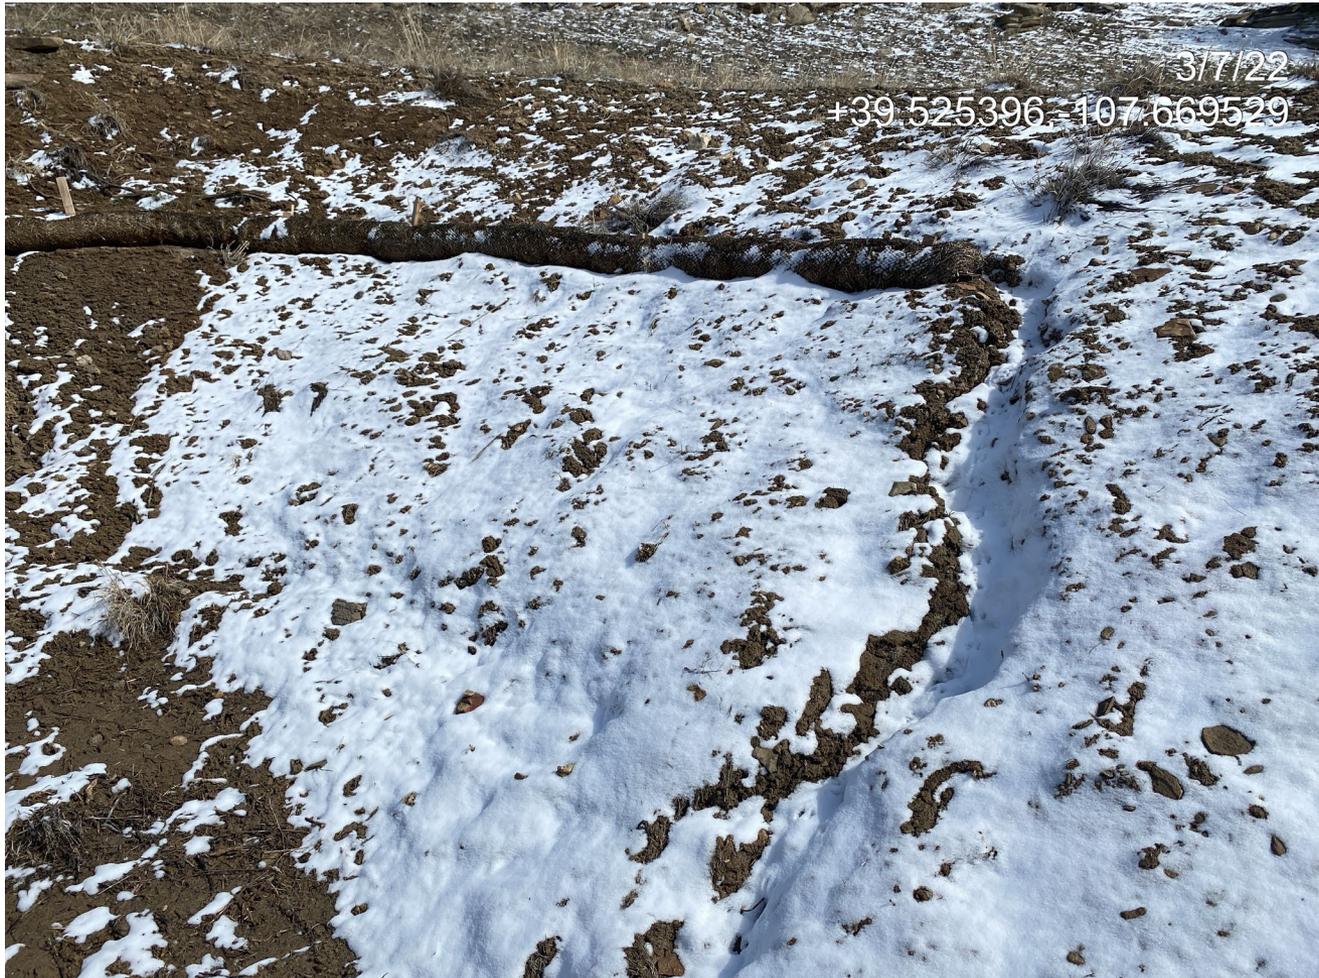
Photo 3. Photo taken from the north of the location shows rill erosion occurring on cut slopes.

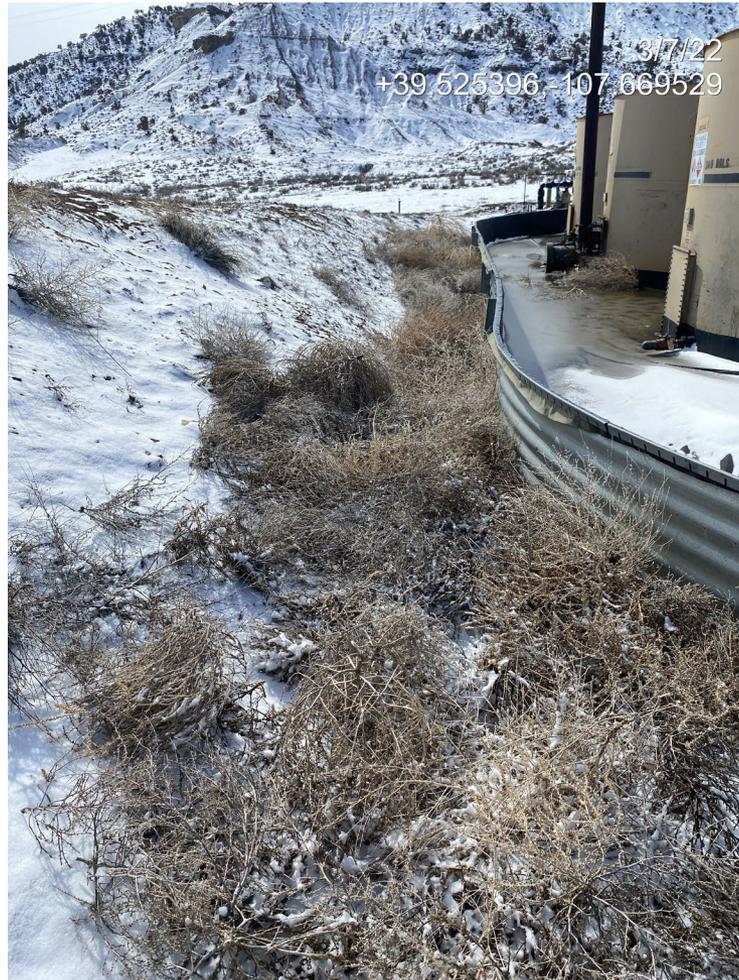
Photo 4. Photo taken from the east of the location facing south shows undesirable plant species/weed debris accumulating on the location.

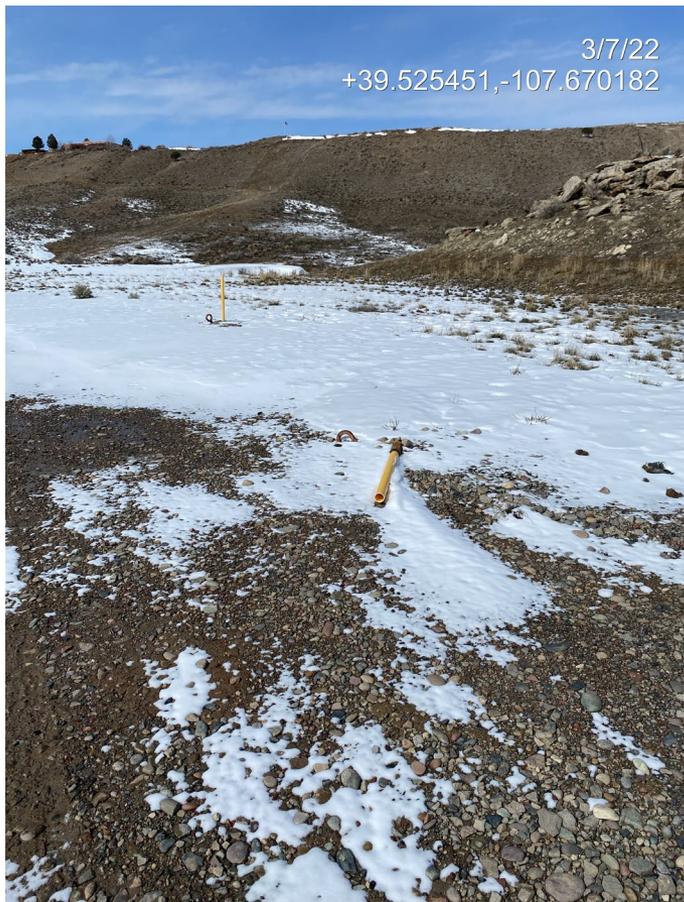
Photo 5. Photo taken from the northern production area shows an anchor marker in disrepair.

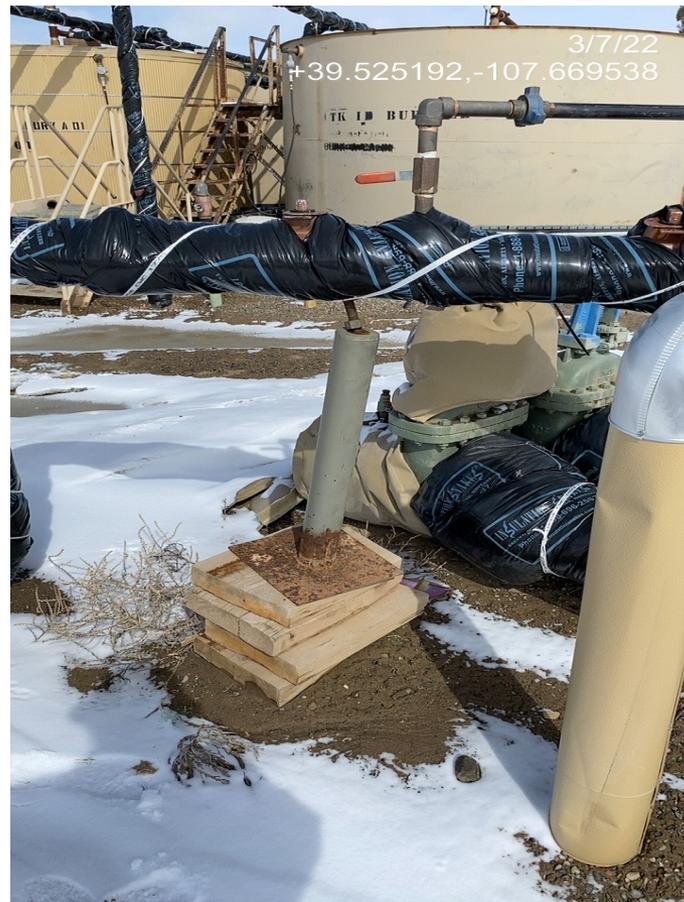
Photo 6. Photo taken from the southeast of the location shows a support beam that is not in proper functioning condition.

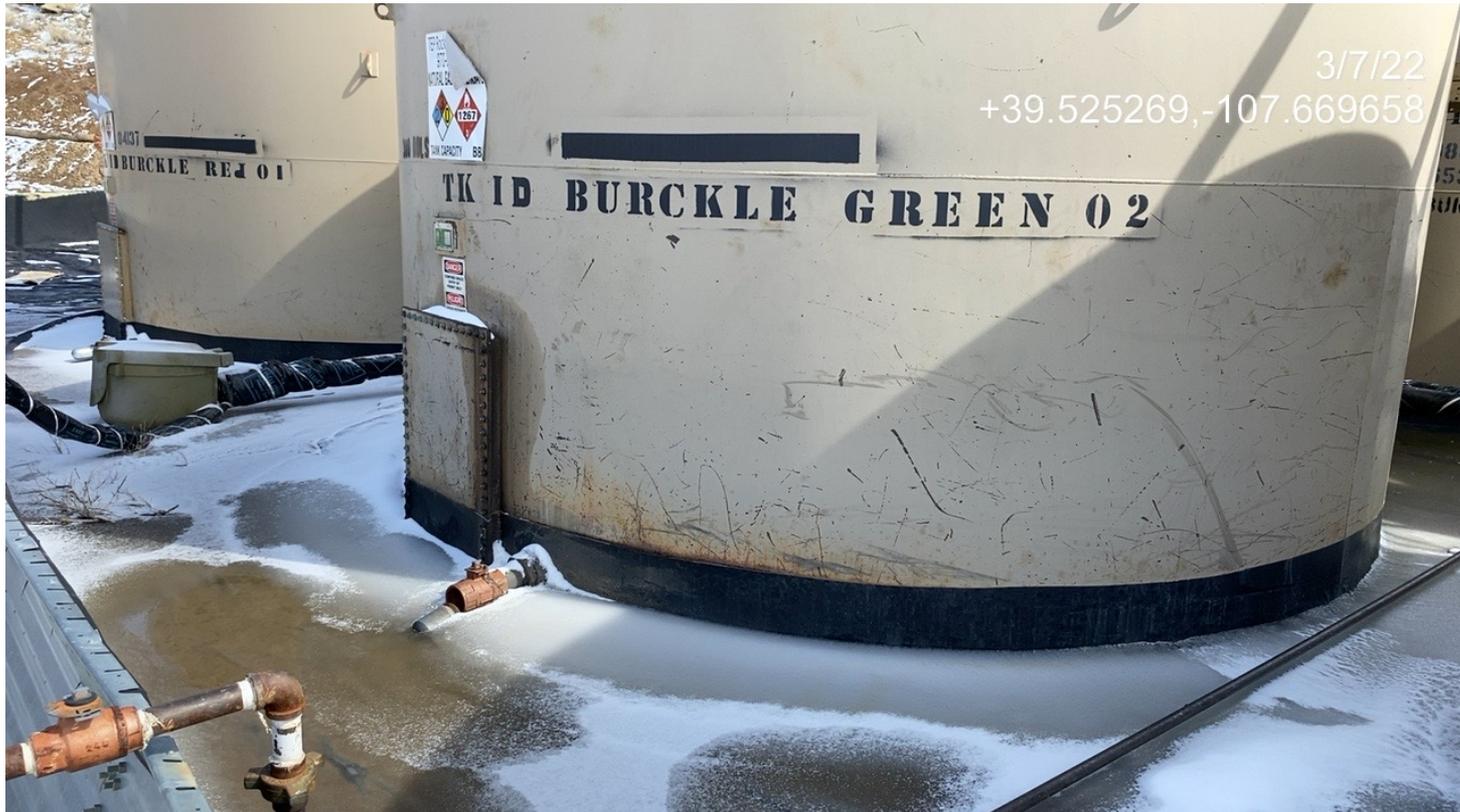
Photo 7. Photo taken from the tank battery shows tank “Burckle Green 02” without a bull plug.

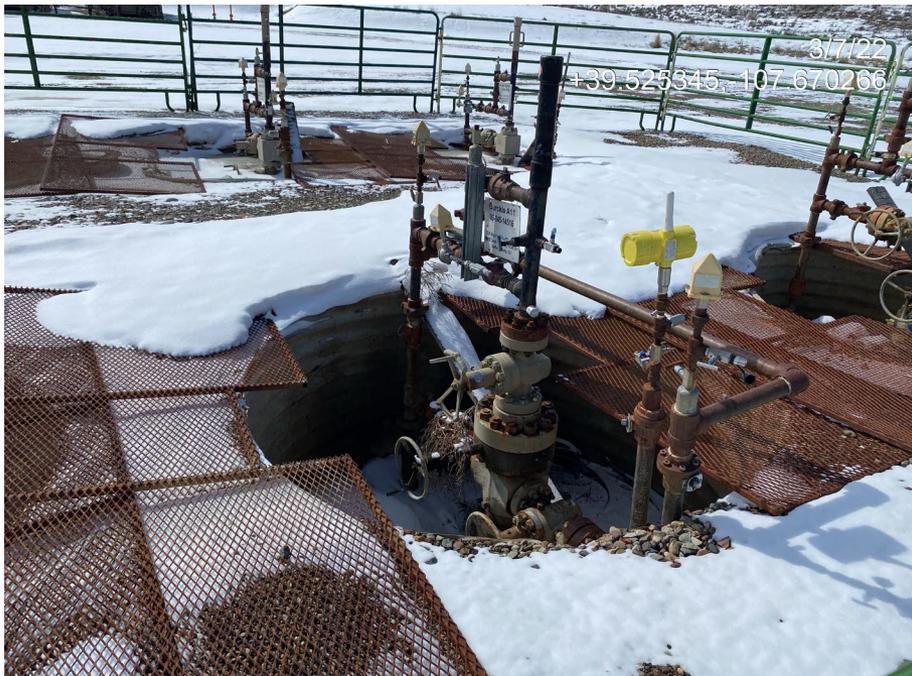
Photo 8. Photo taken at the well location shows wildlife protection control measures on well cellar are not properly installed.

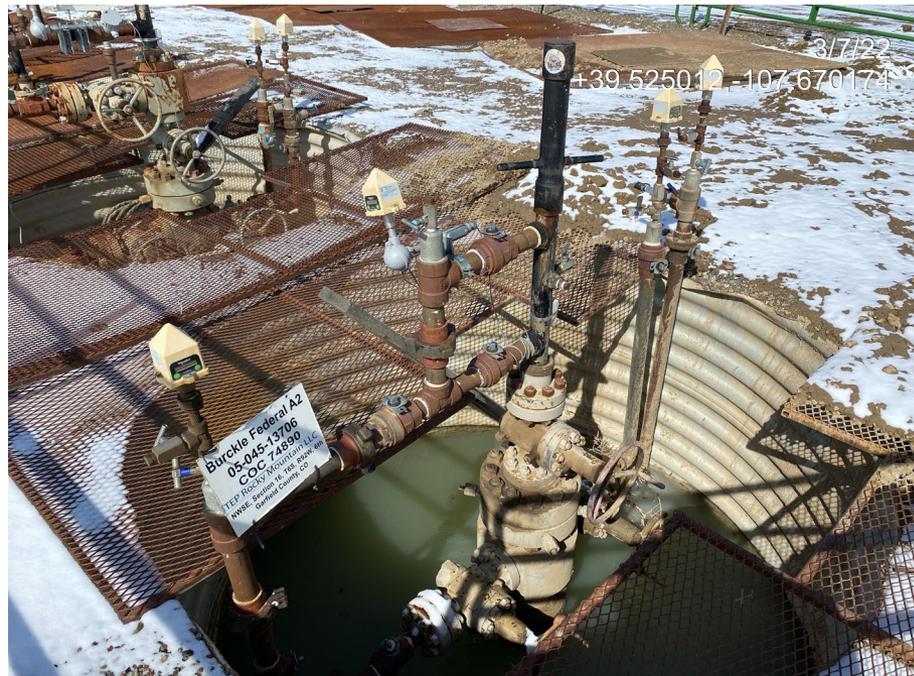
Photo 9. Refer to comment under photo 8.

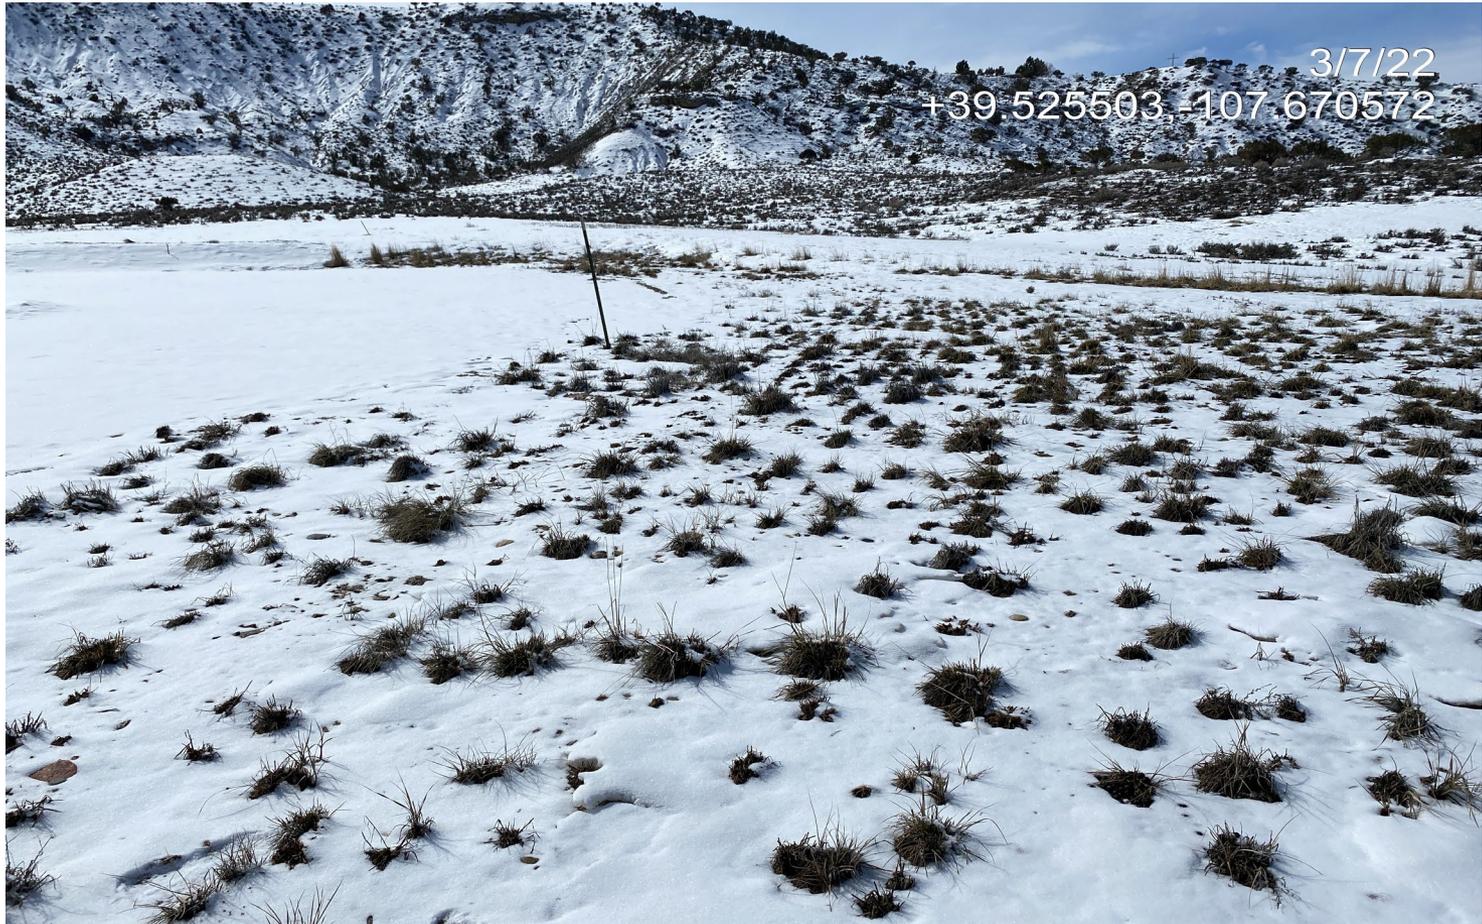
Photo 10. Photo taken from the northeast of the Location facing southeast shows interim areas covered in snow. A follow up inspection is necessary to properly assess interim reclamation.
