Inspection Photos

Operator: TEP ROCKY MOUNTAIN LLC #96850

Location Name: HANGS-66S92W /9SWSW

Inspection Document #: 702800019

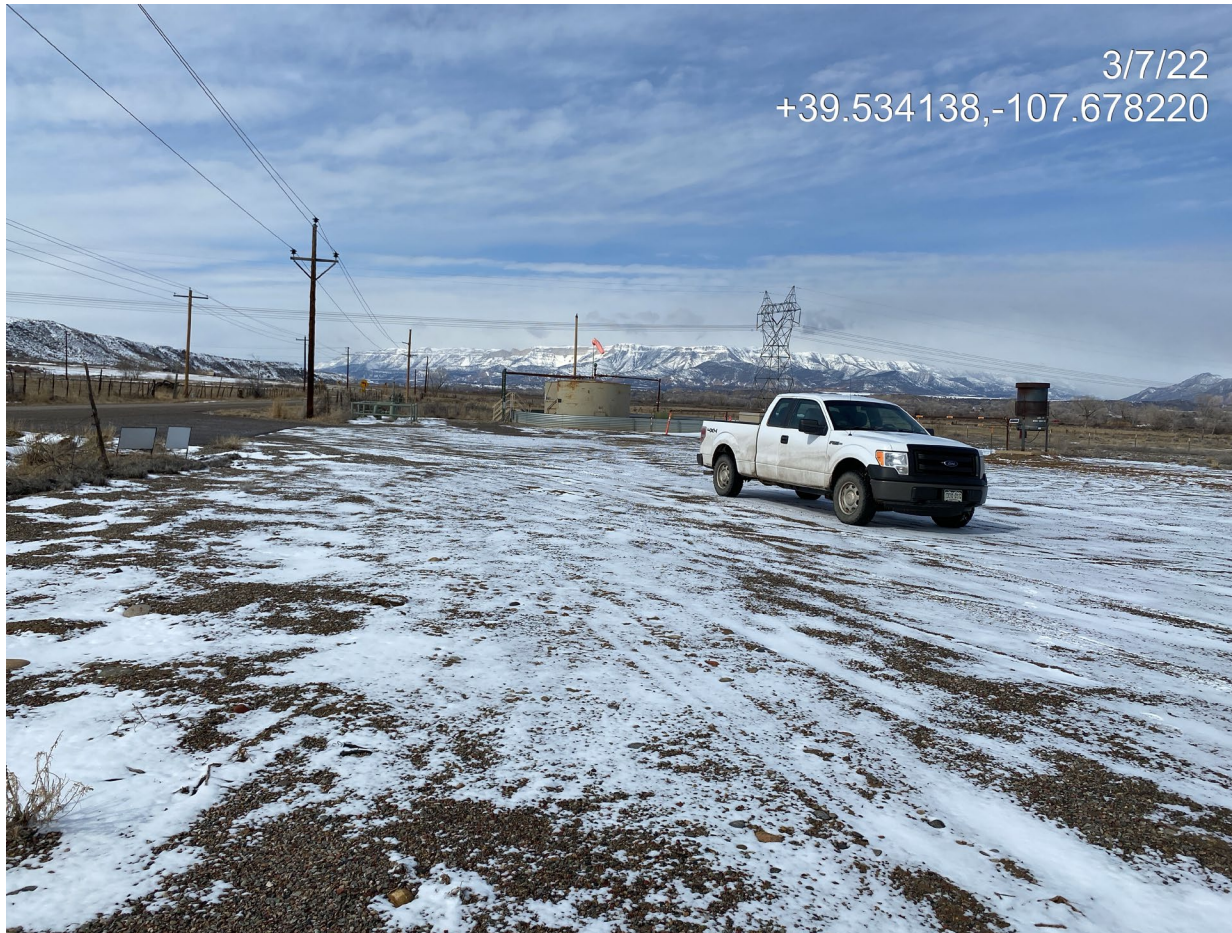
Photo 1. Photo taken from the south of the Location, facing west showing an overview of the Location.

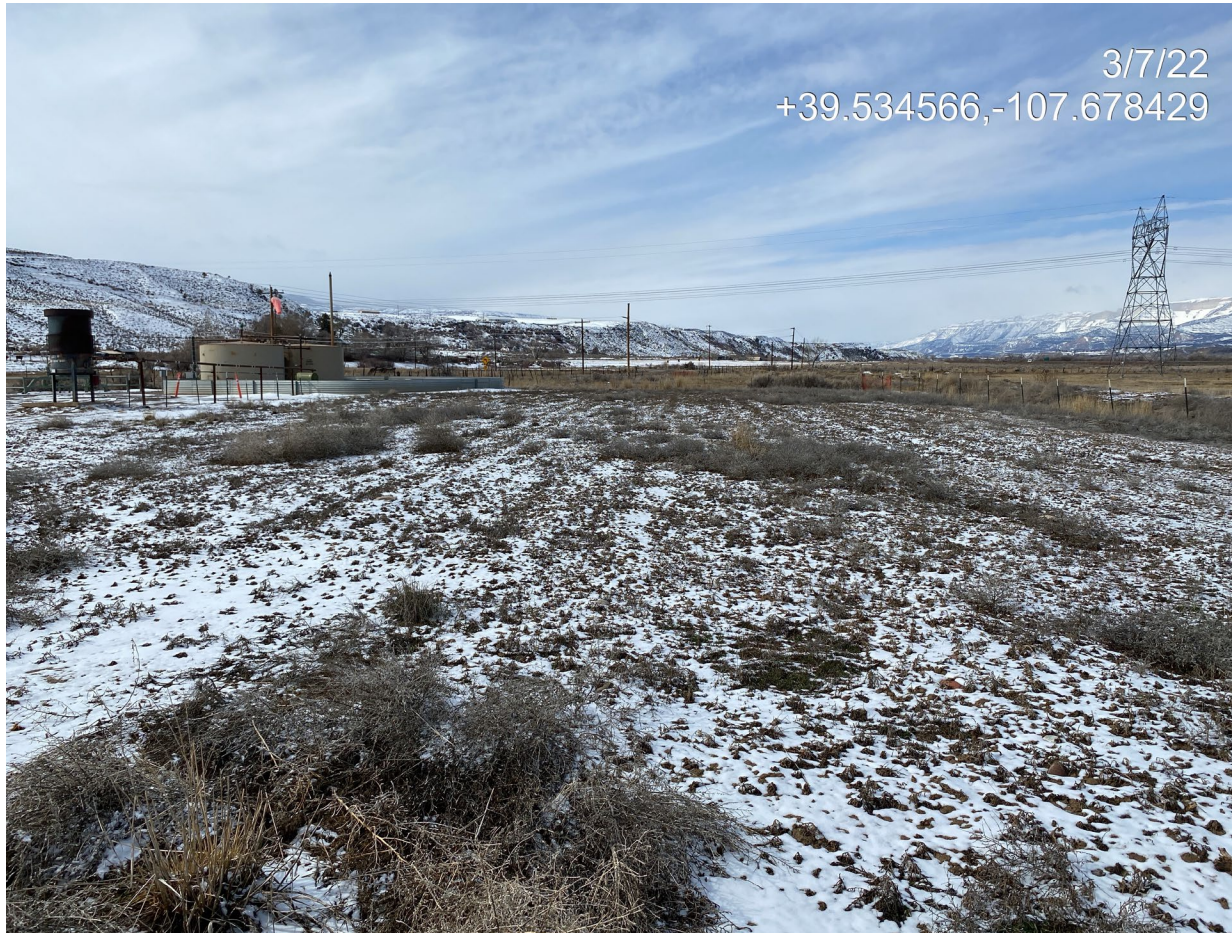
Photo 2. Photo taken from the northern interim areas of the Location, facing west showing undesirable plant species/weeds (kochia). Weeds have died and will soon break off and be considered debris. Debris from undesirable plant species/weeds was observed accumulating on the Location.

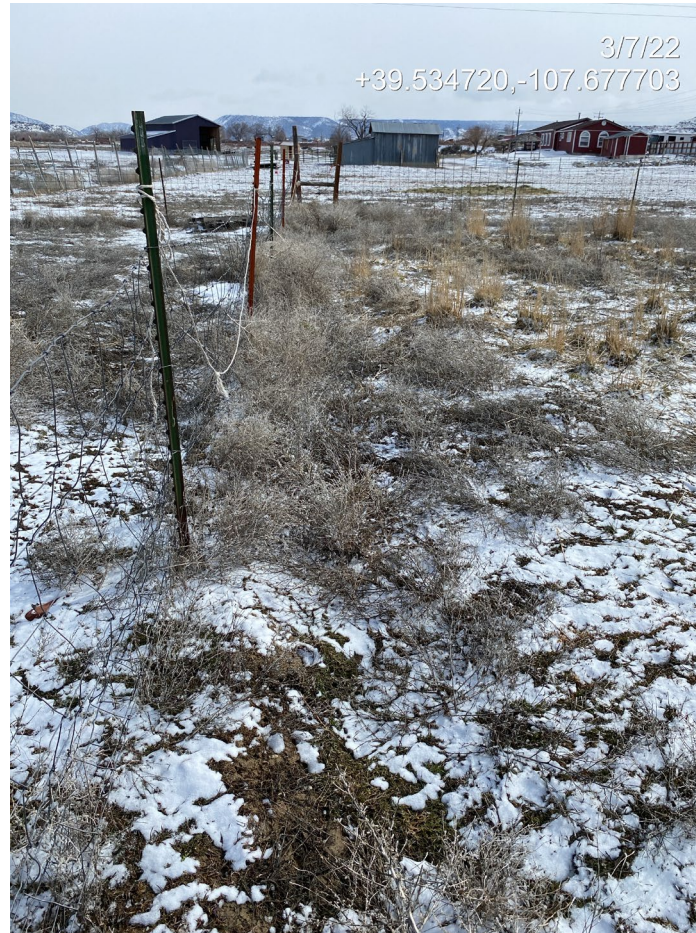
Photo 3. Photo taken from the northeastern interim areas of the Location facing east shows debris from undesirable plant species/weeds accumulating on the Location.

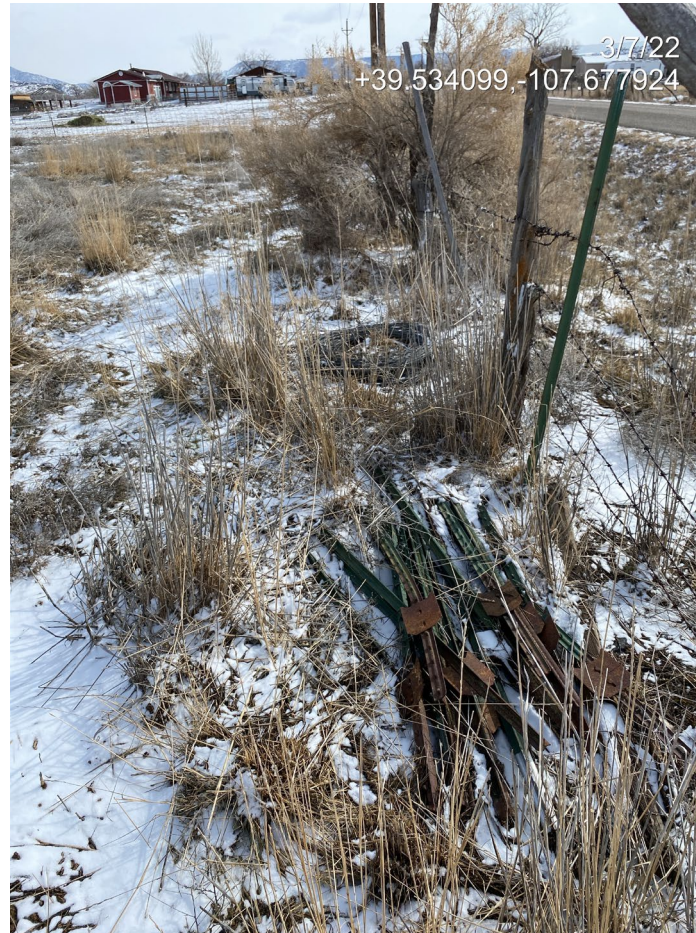
Photo 4. Photo taken from the southern perimeter of the Location shows t-posts and fence wire being stored on Location.

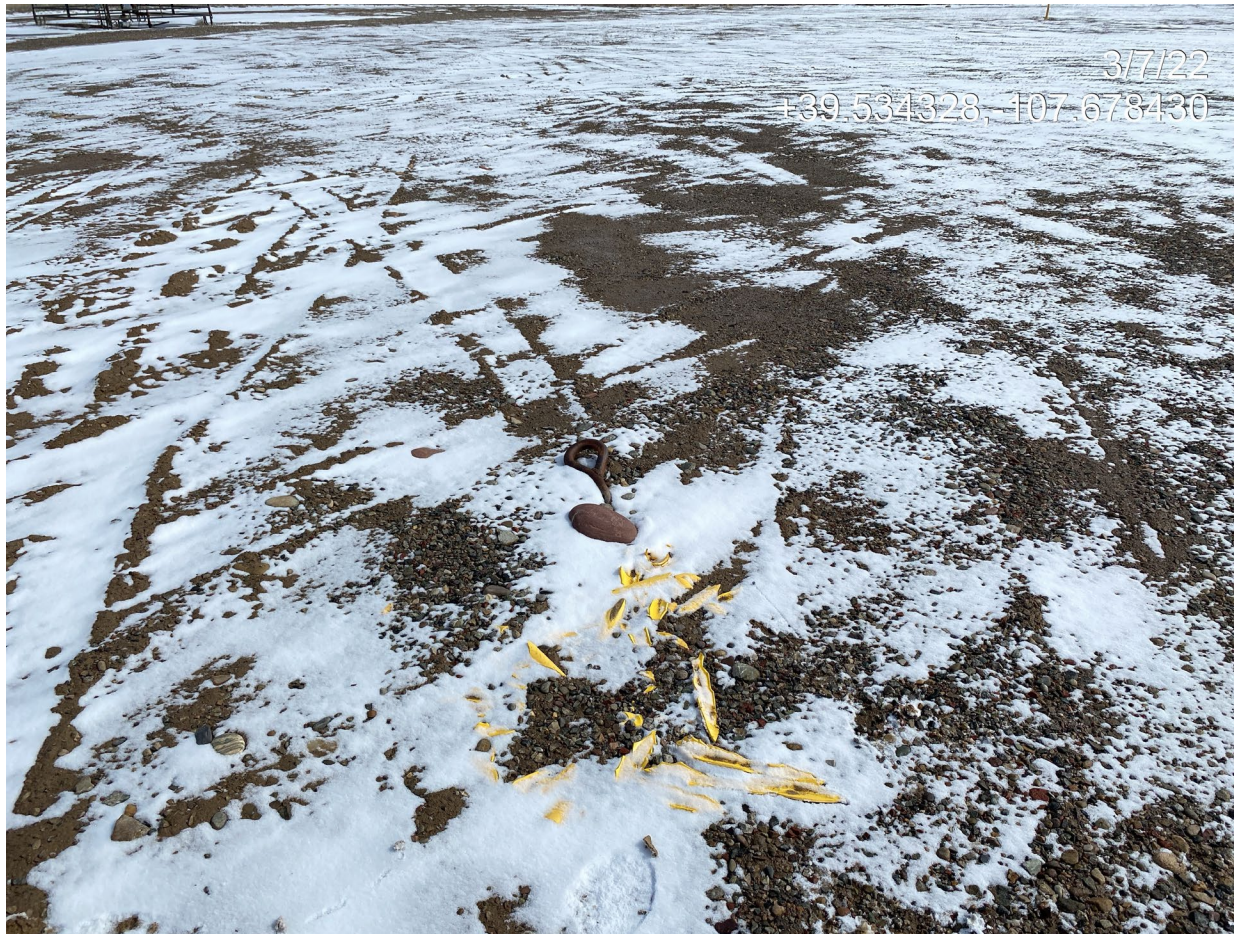
Photo 5. Photo taken from the southern production area of the pad shows an anchor marker in disrepair.

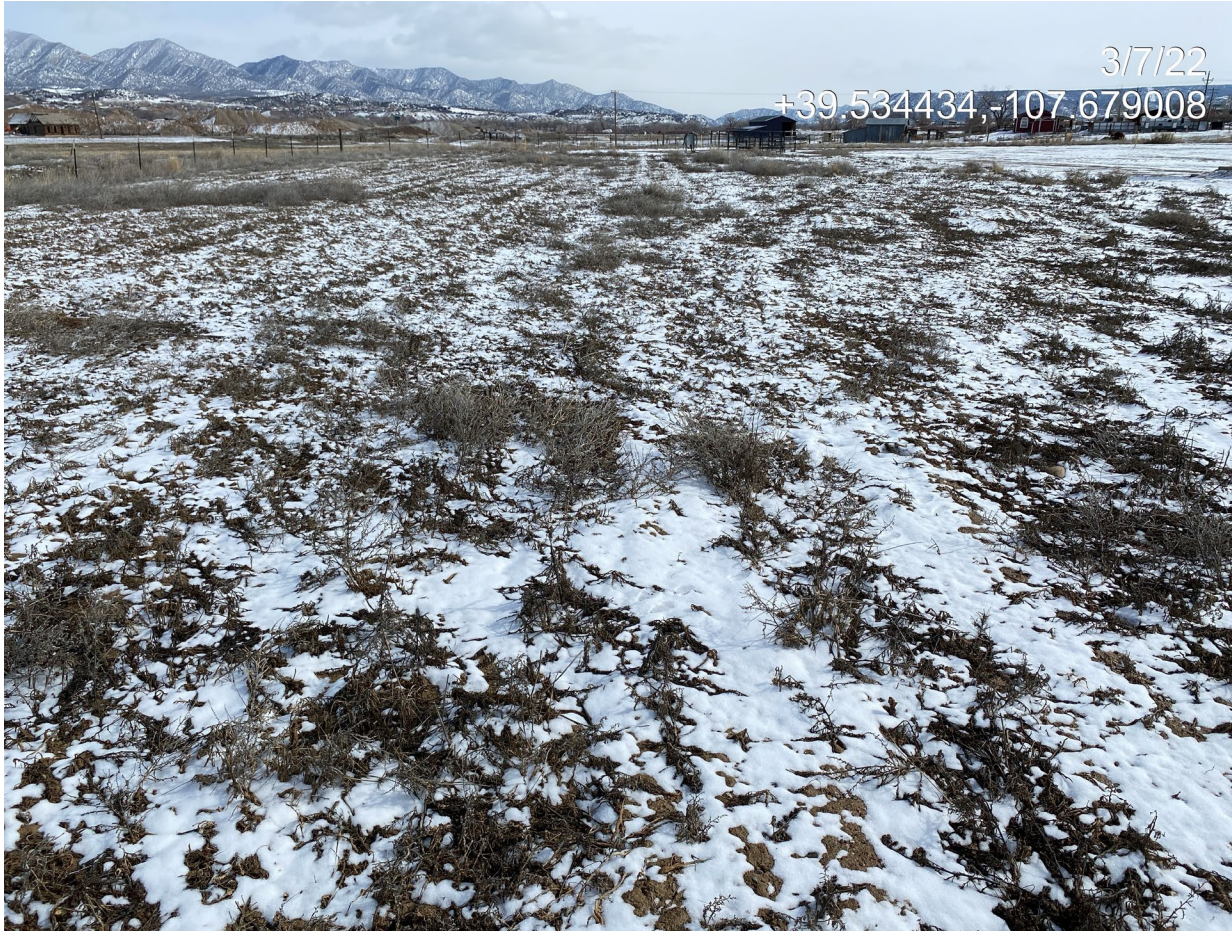
Photo 6. Photo taken from the northwestern interim areas of the Location facing east. The western portion of the project area does not appear to be progressing towards 1003 standards. Revegetation and establishment of desirable perennial grasses appears sparse.
