Inspection Photos
Location Name: Ann 34-12
Location ID: 320040

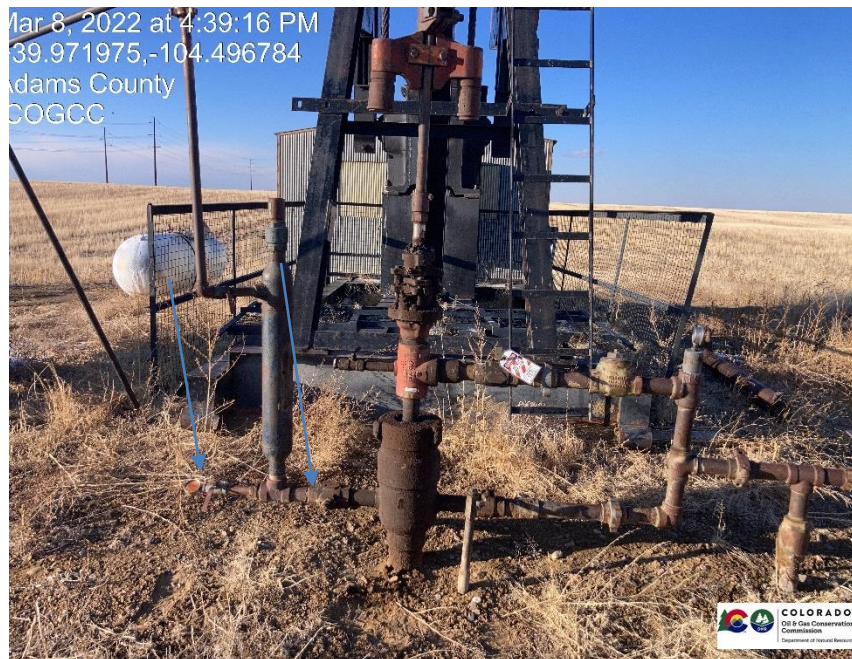
Pic 1 Casing valve is venting gas. 2" ball valve is seized slightly open, and the ½" ball valve has a crack in the back of the valve that is venting gas. All other valves are in the close position.

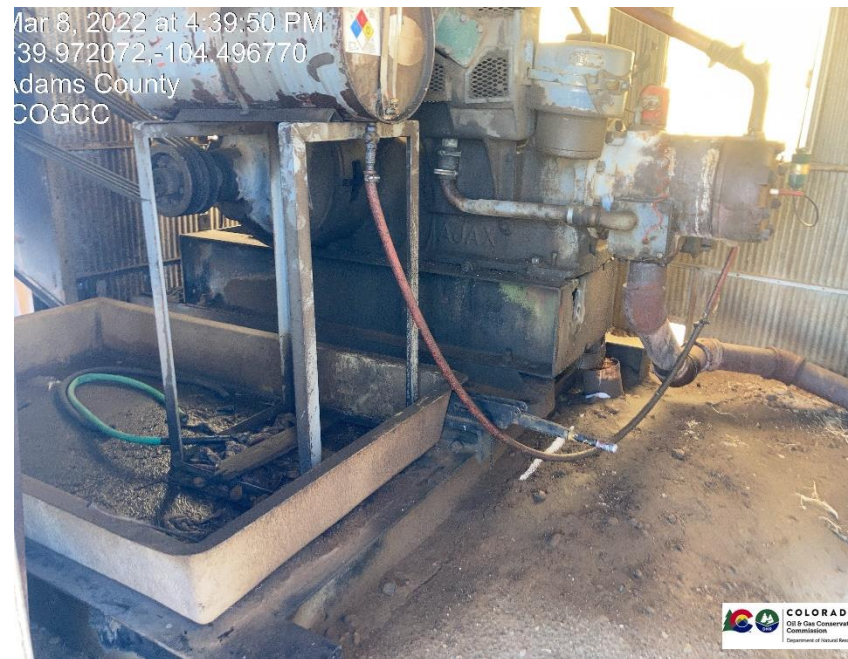
Pic 2 motor house has stained soil around gas motor.

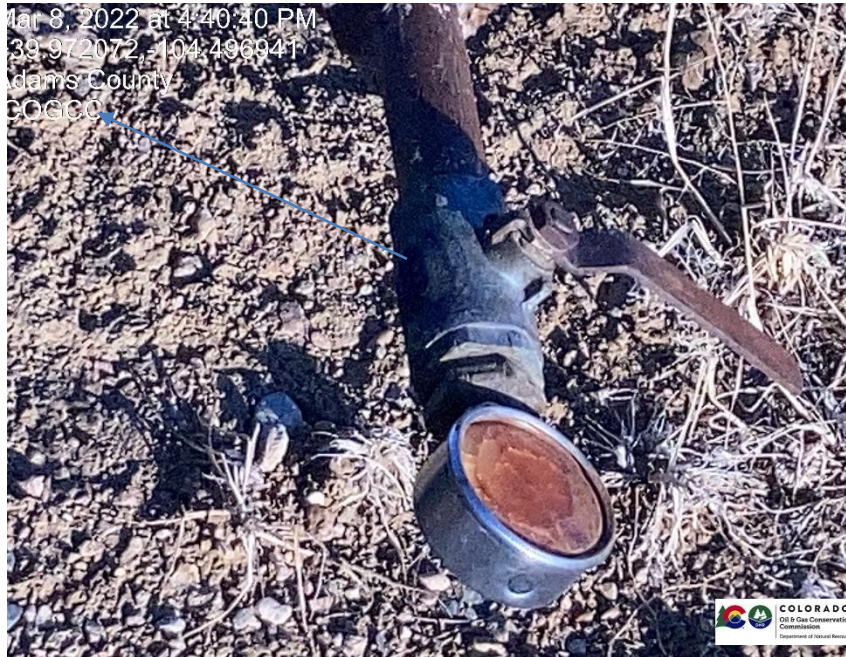
Pic 3 cracked ball valve. Venting gas.
