Inspection Photos
Location Name: Horth 41-15 1
Location ID: 320112

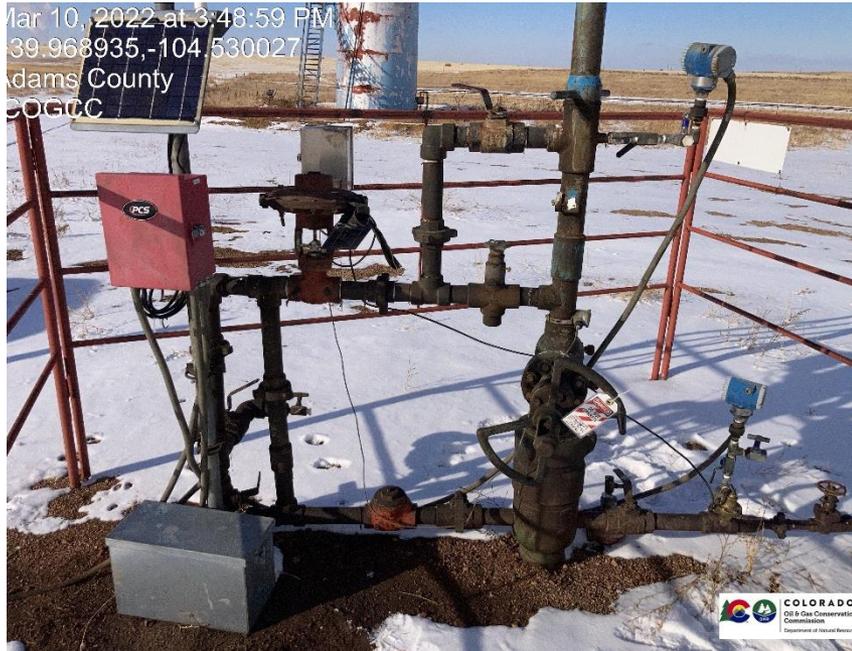
Pic 1 wellhead, All flowline valves, and master valve are in the close position. One flowline off of the top of the lubricator is seized slightly open. Flowlines downstream of valve are in the close position. Stained soil by wellhead.

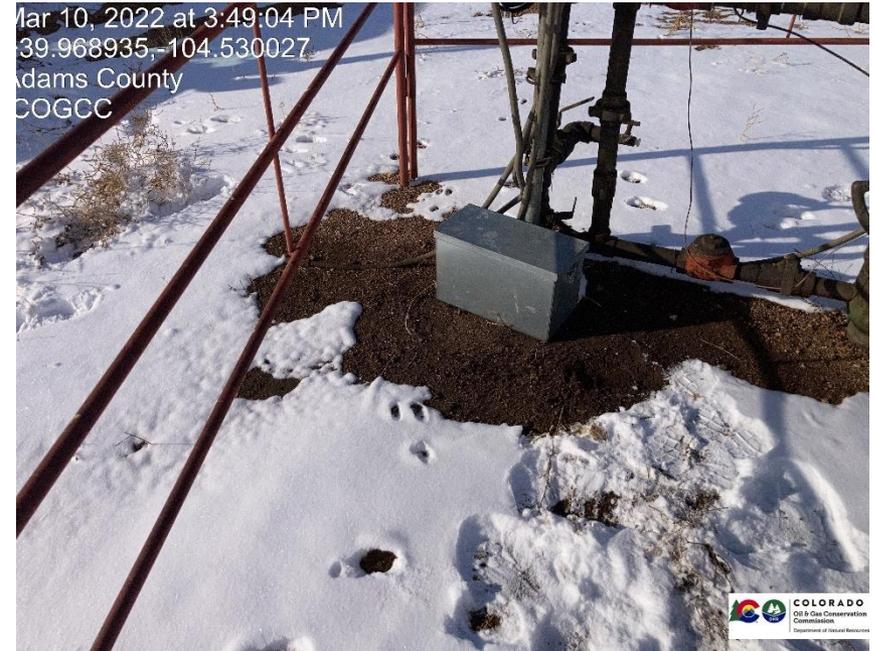
Possible flowline leak by wellhead. Stained soil around flowline.

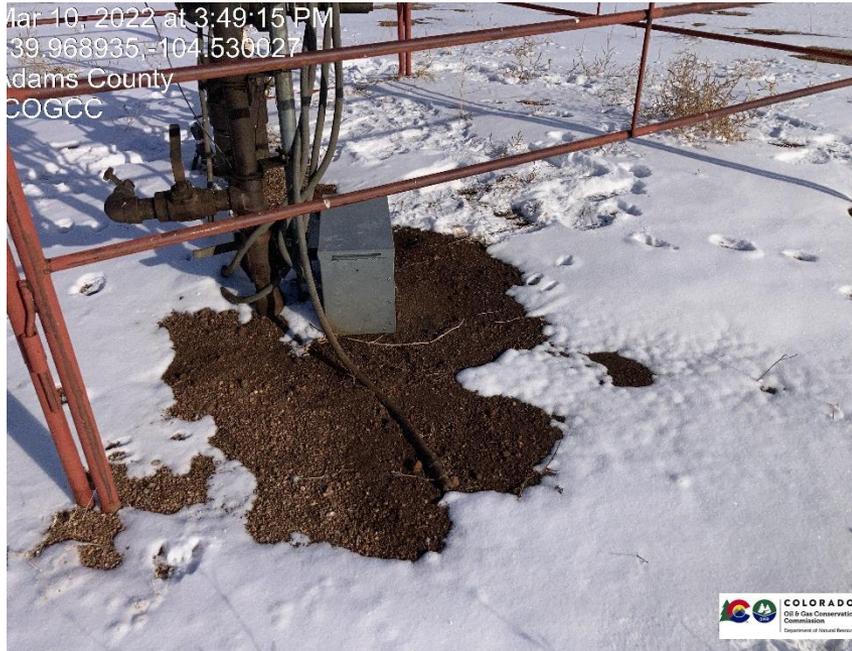
Pic 3 possible flowline leak by flowline going into ground.

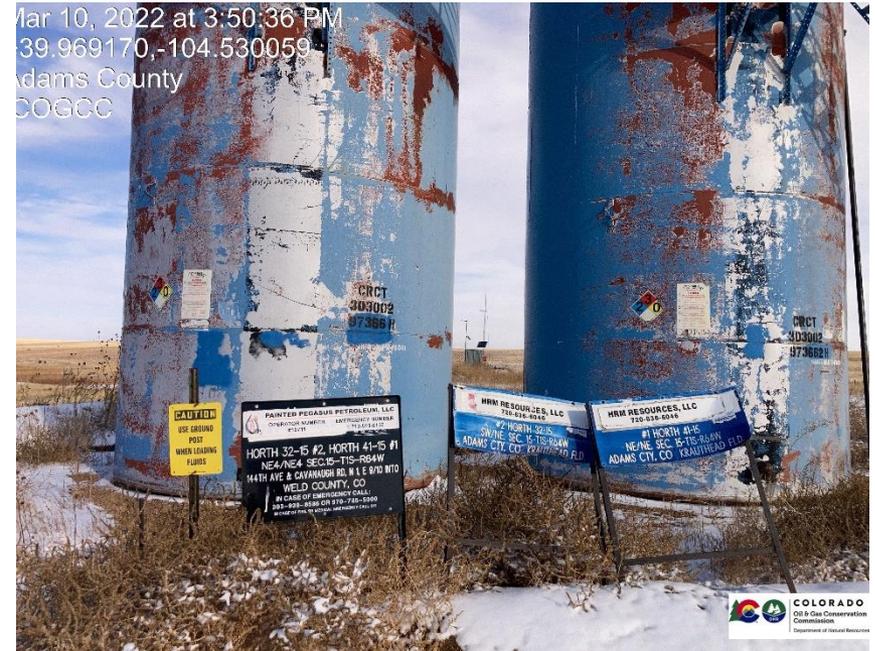
Pic 4 tanks, weeds unmanaged.

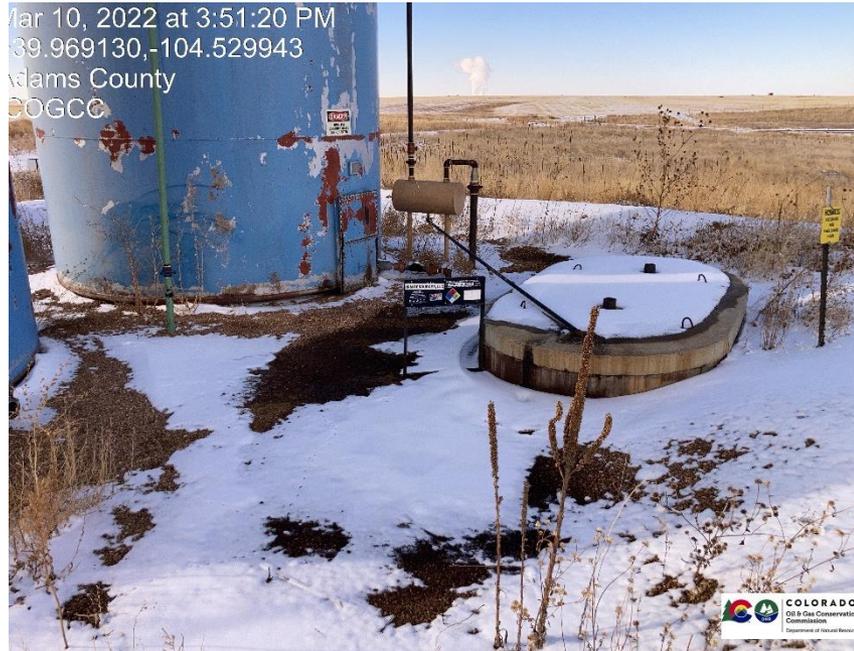
Pic 5 Stained soil around water tank, spill was never cleaned up from previous inspections. Water tank, and 1 oil tank appear to have fluid in them.

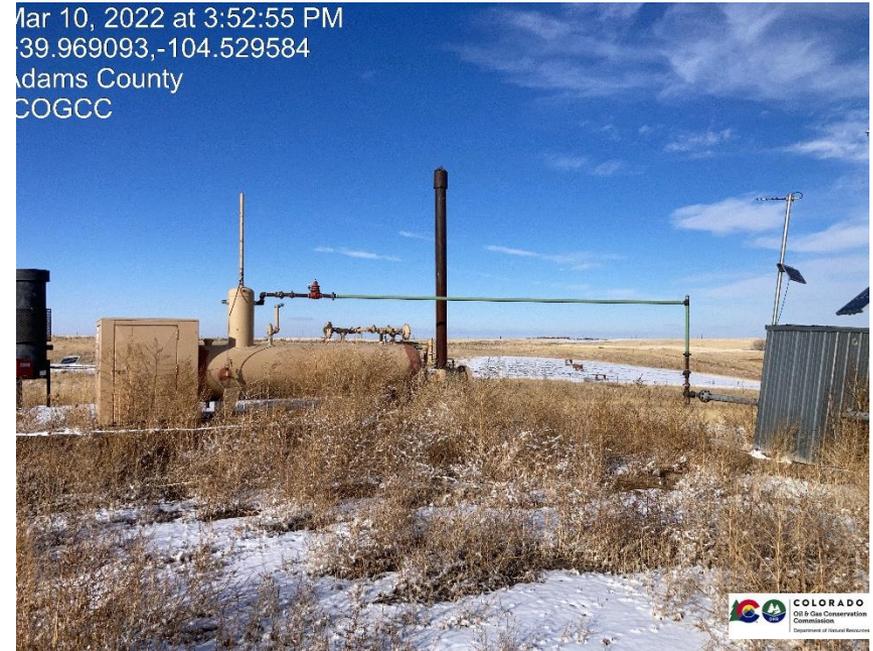
Pic 6 ECD, Separator, Gas meter run, weeds unmanaged on location.
