**Inspection Photos**  
**Location Name: Roy Annala A #2**  
**API: 05-067-08334**

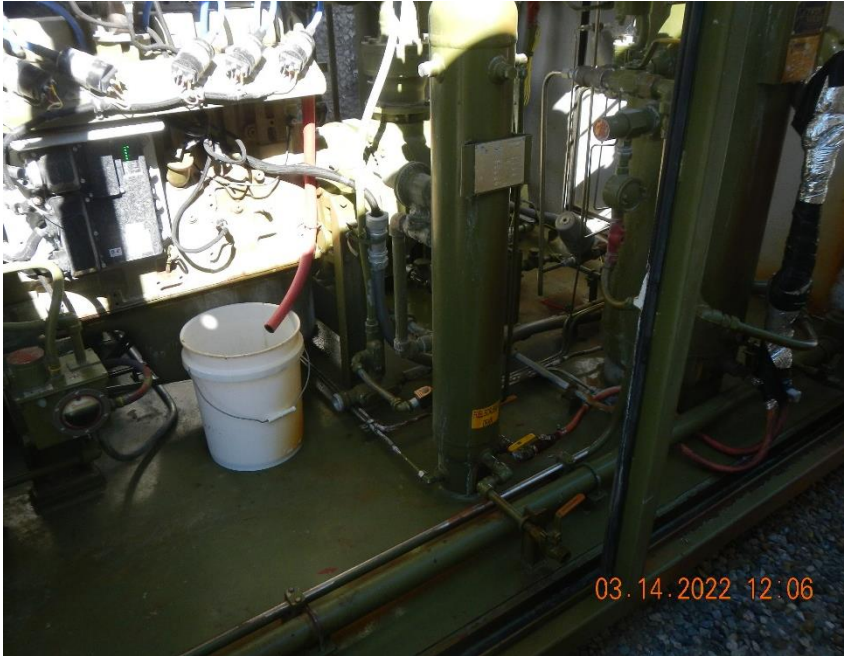
**Compressor equipment has been cleaned up since last inspection.**

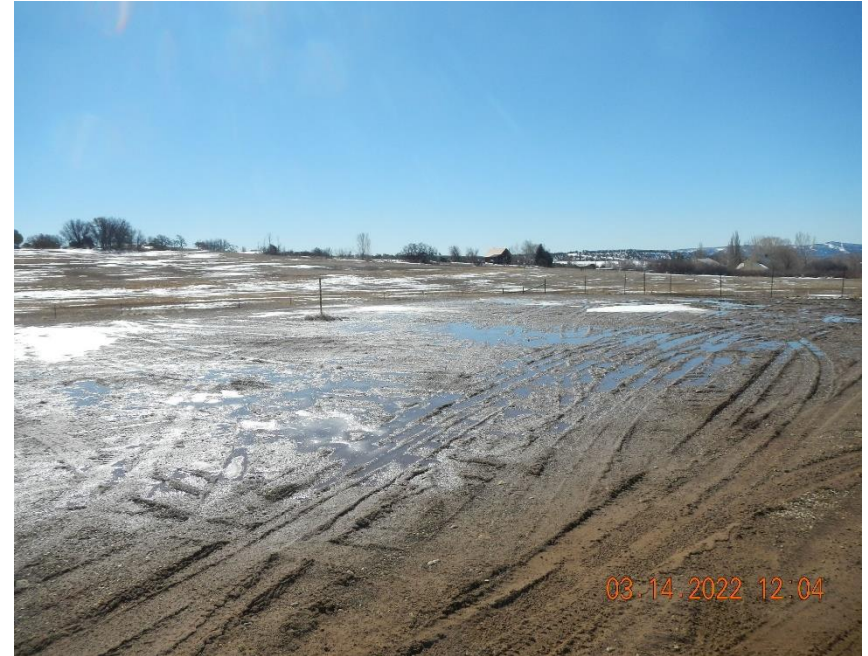
**Storm water in SW corner of location.**

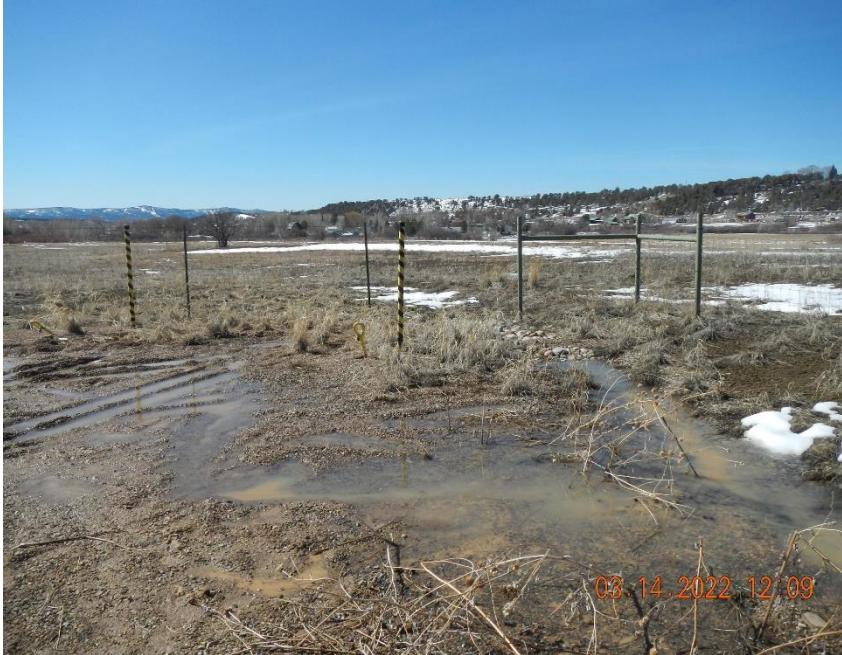
**Southwest corner of location where Spill/Release Point ID #481340 left the location. Storm water present during this inspection.**

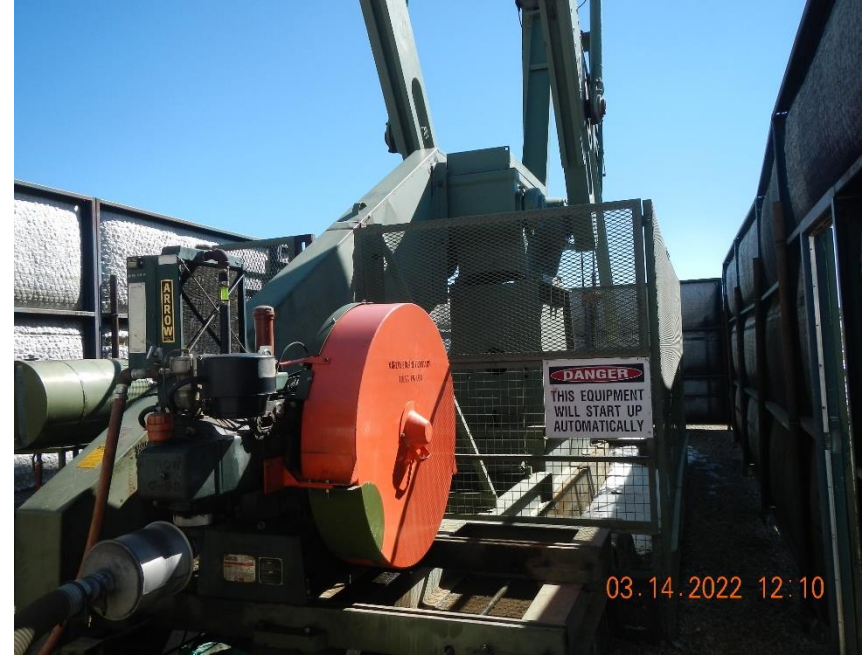
**Prime mover and concrete foundation have been cleaned up since last inspection.**
