Inspection Photos
Operator: Simcoe
API: 067-06845
Date: 3/14/2022

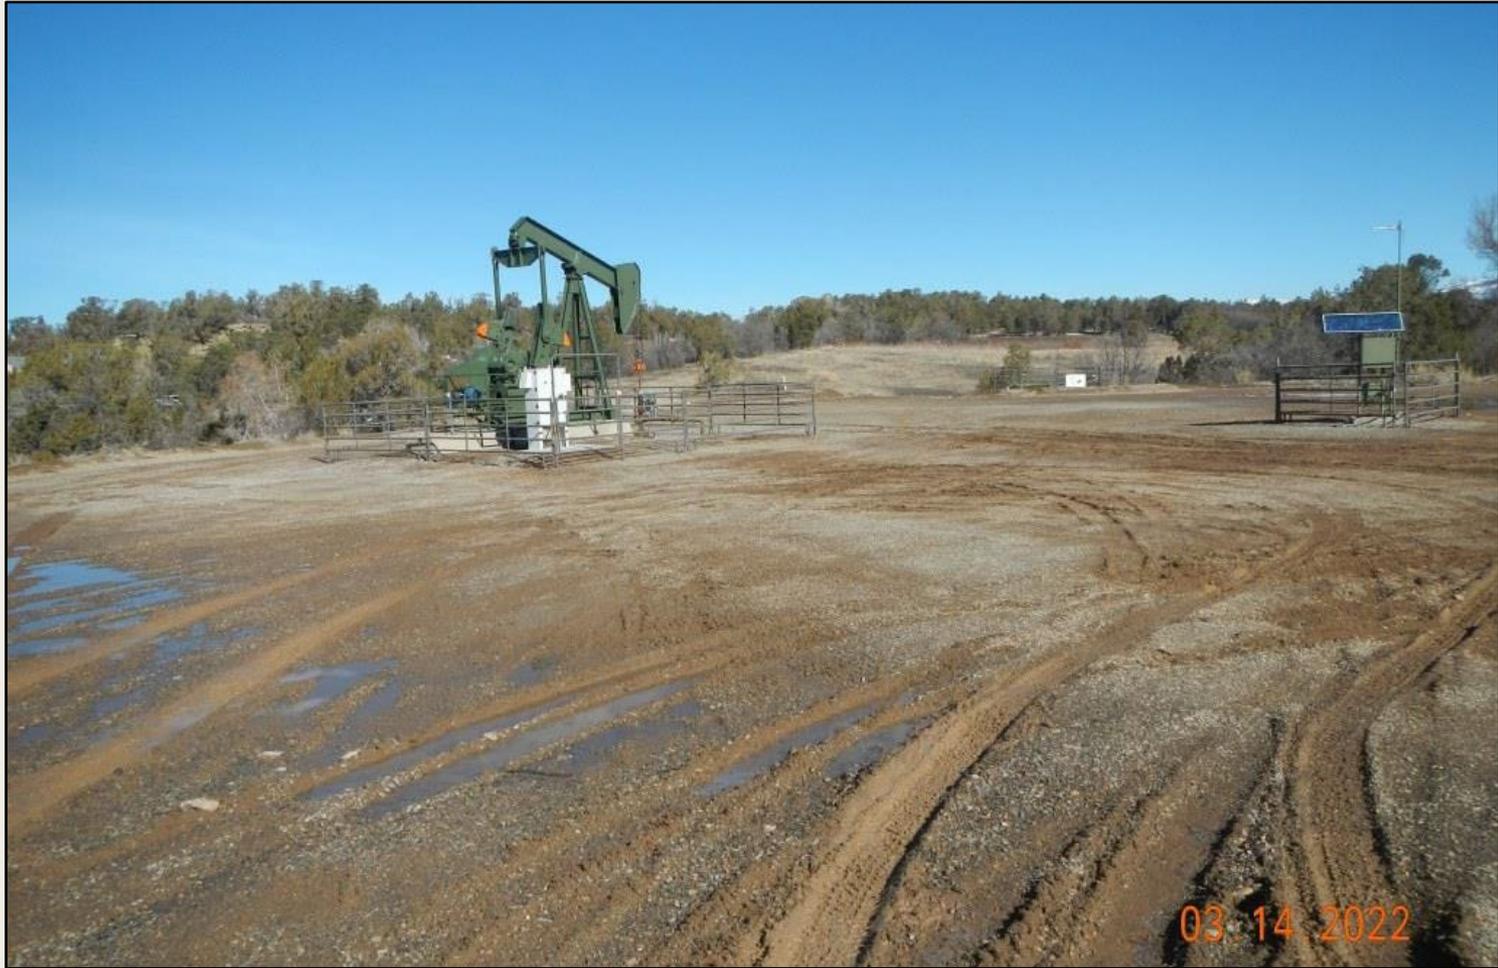
Photo 1. View of project area from the well pad entrance facing center.

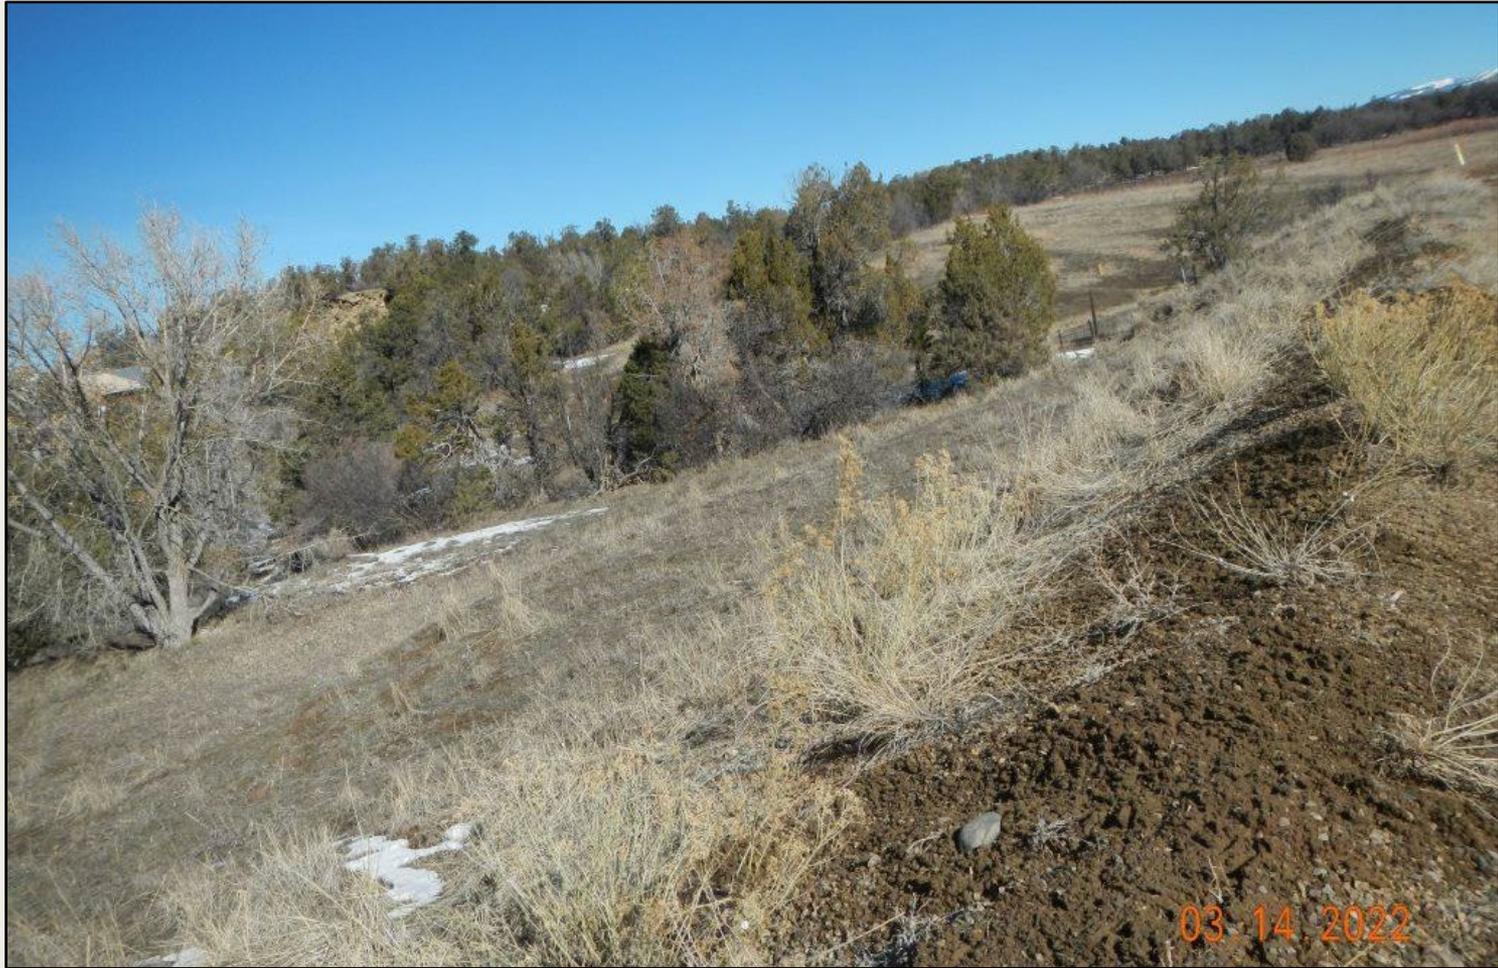
Photo 2. View of the western project area from the southwestern corner facing northward. Revegetation is progressing with grasses such as western wheatgrass, crested wheatgrass, and sand dropseed.

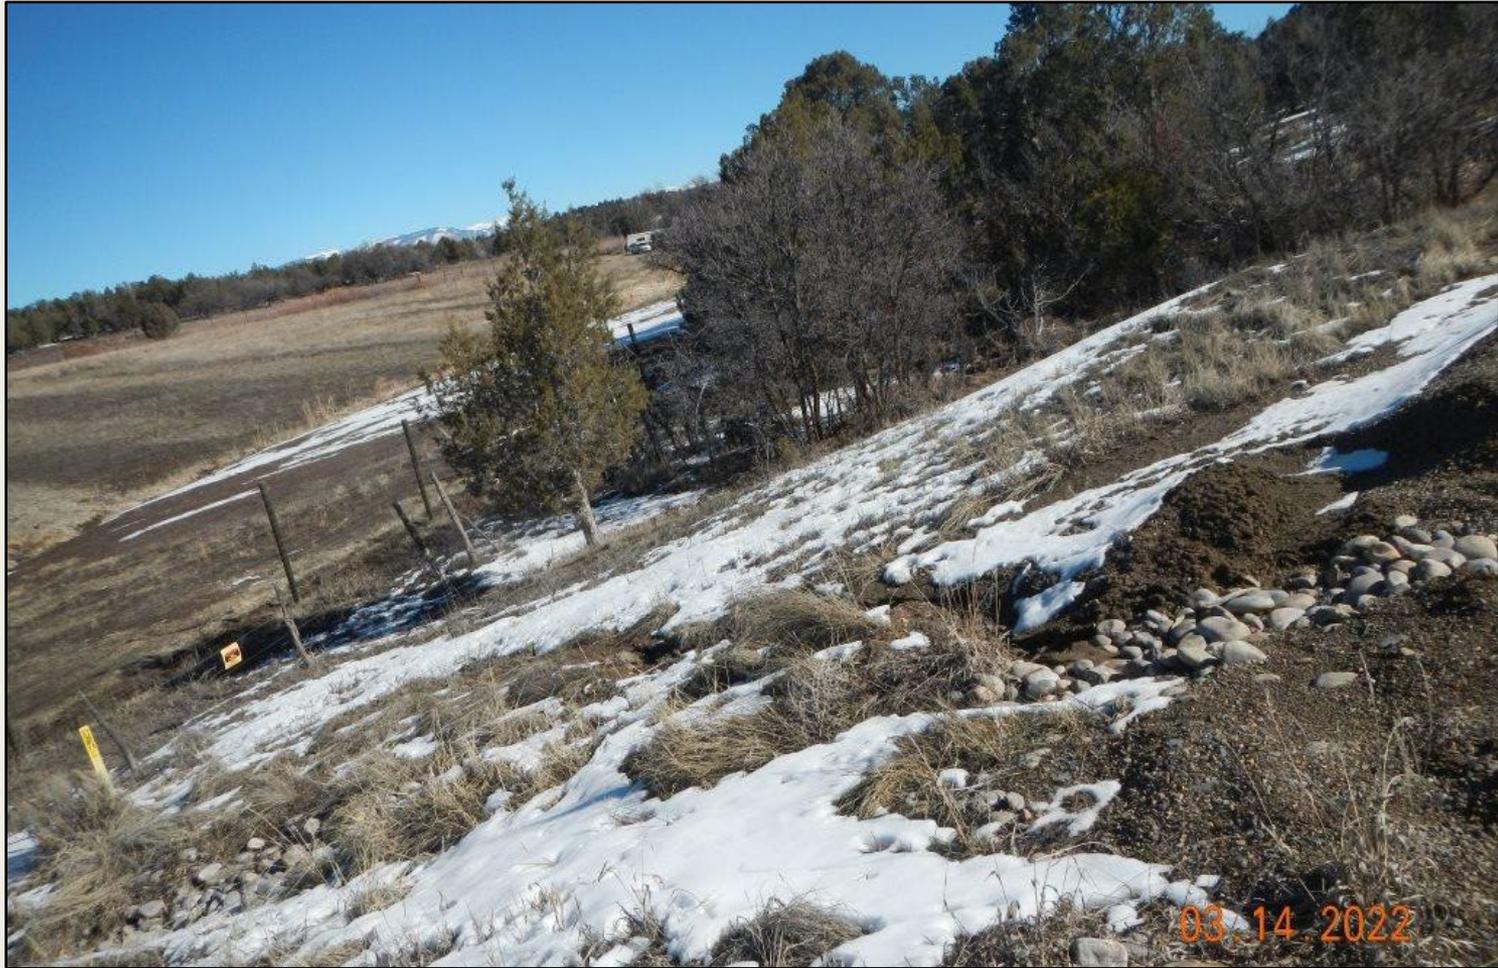
Photo 3. View of the northern project area from the northwestern corner facing eastward.

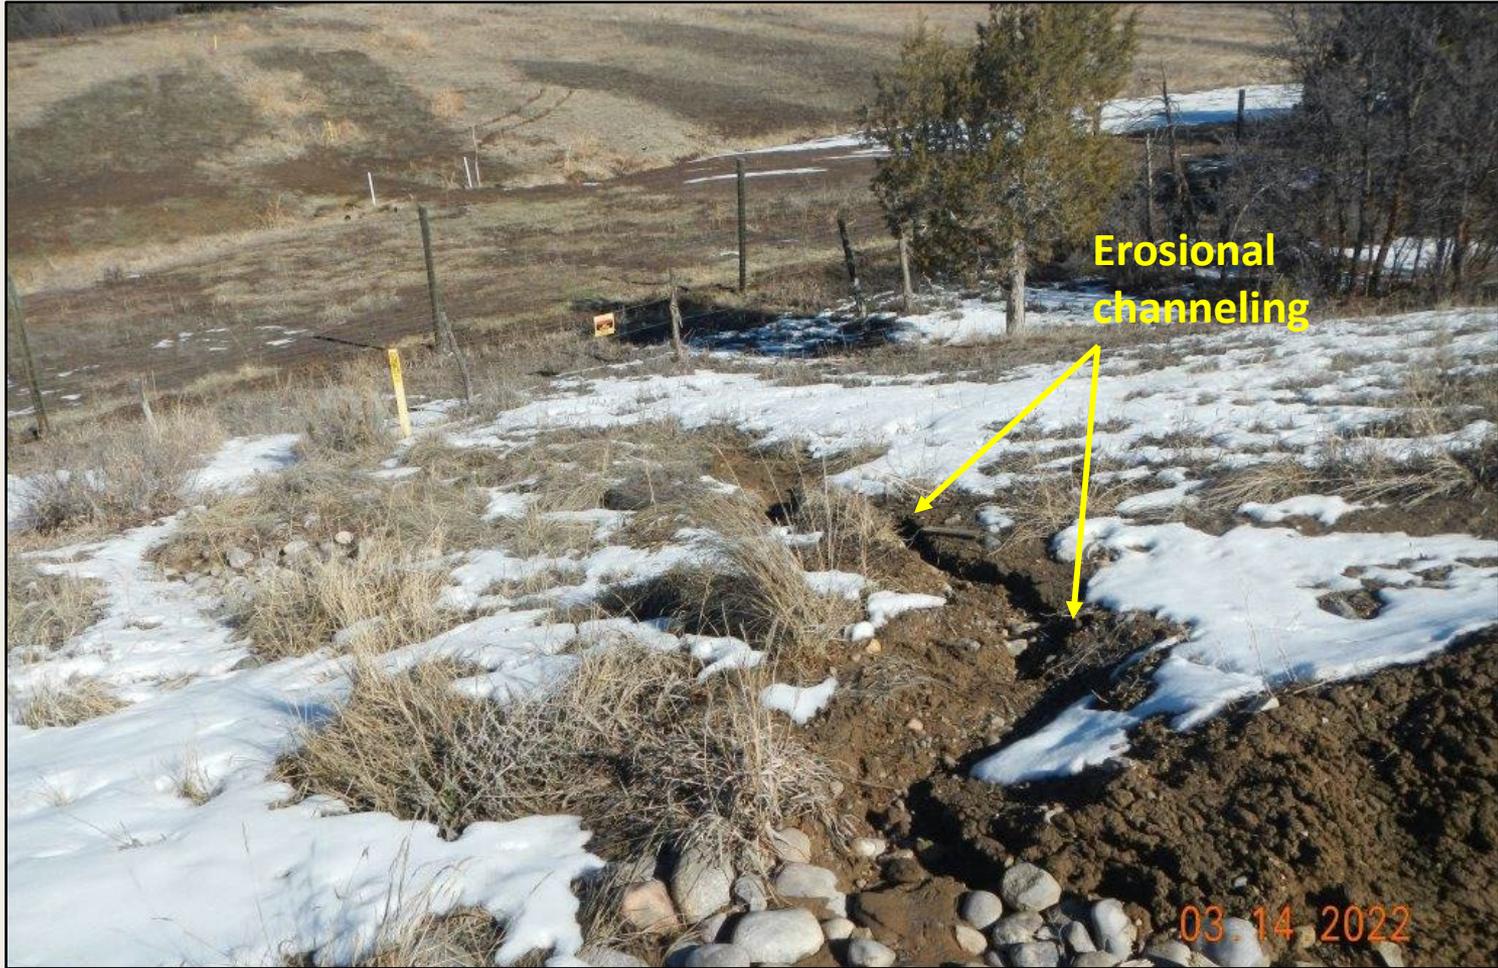
Photo 4. View of area in the northern project area where stormwater flows around a cobble BMP and is eroding the fill slope.

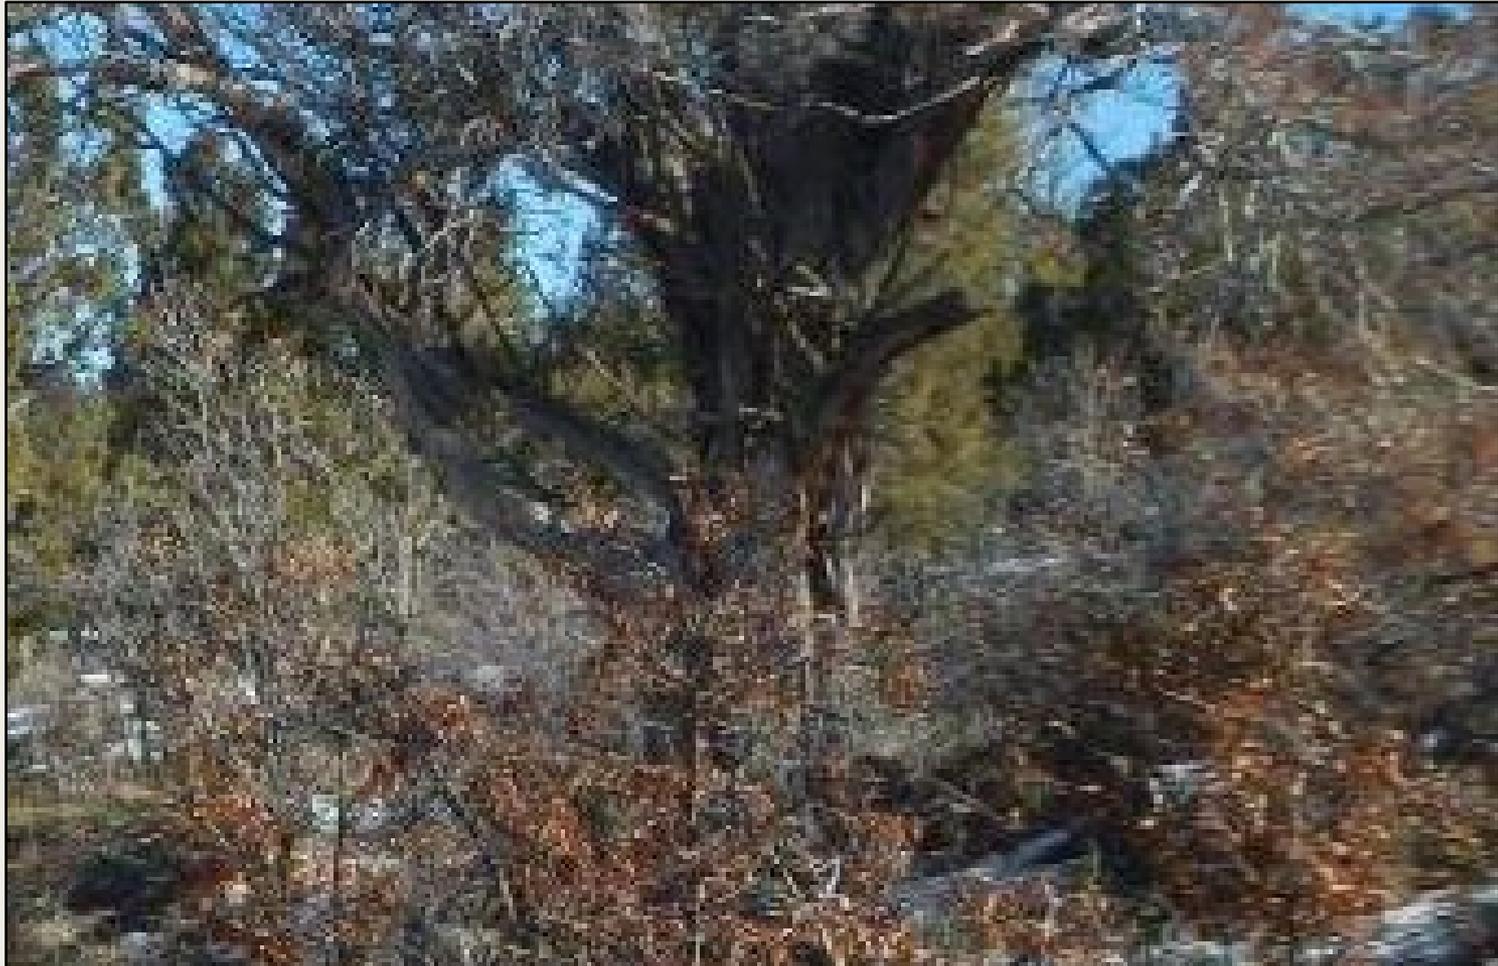
Photo 5. View of reference area comprised pinyon and juniper woodland with gambel oak, sagebrush, mountain mahogany and Indian ricegrass in the understory.
