Inspection Photos
Operator: Simcoe
API: 067-07916
Date: 3/14/2022

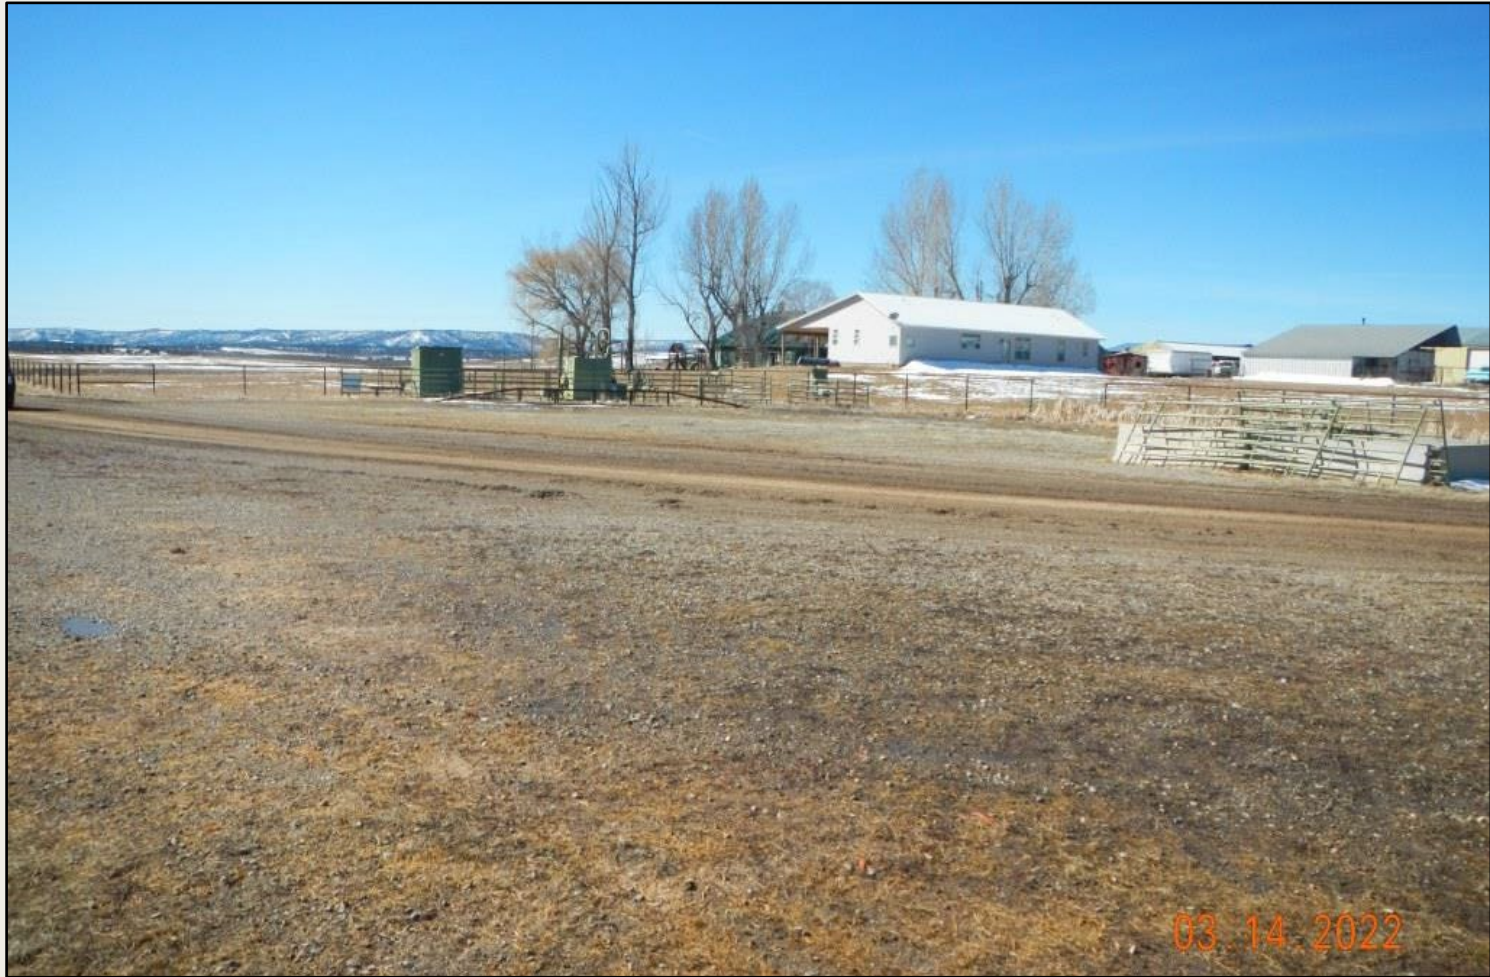
Photo 1. View of project area from the northeastern corner facing center.

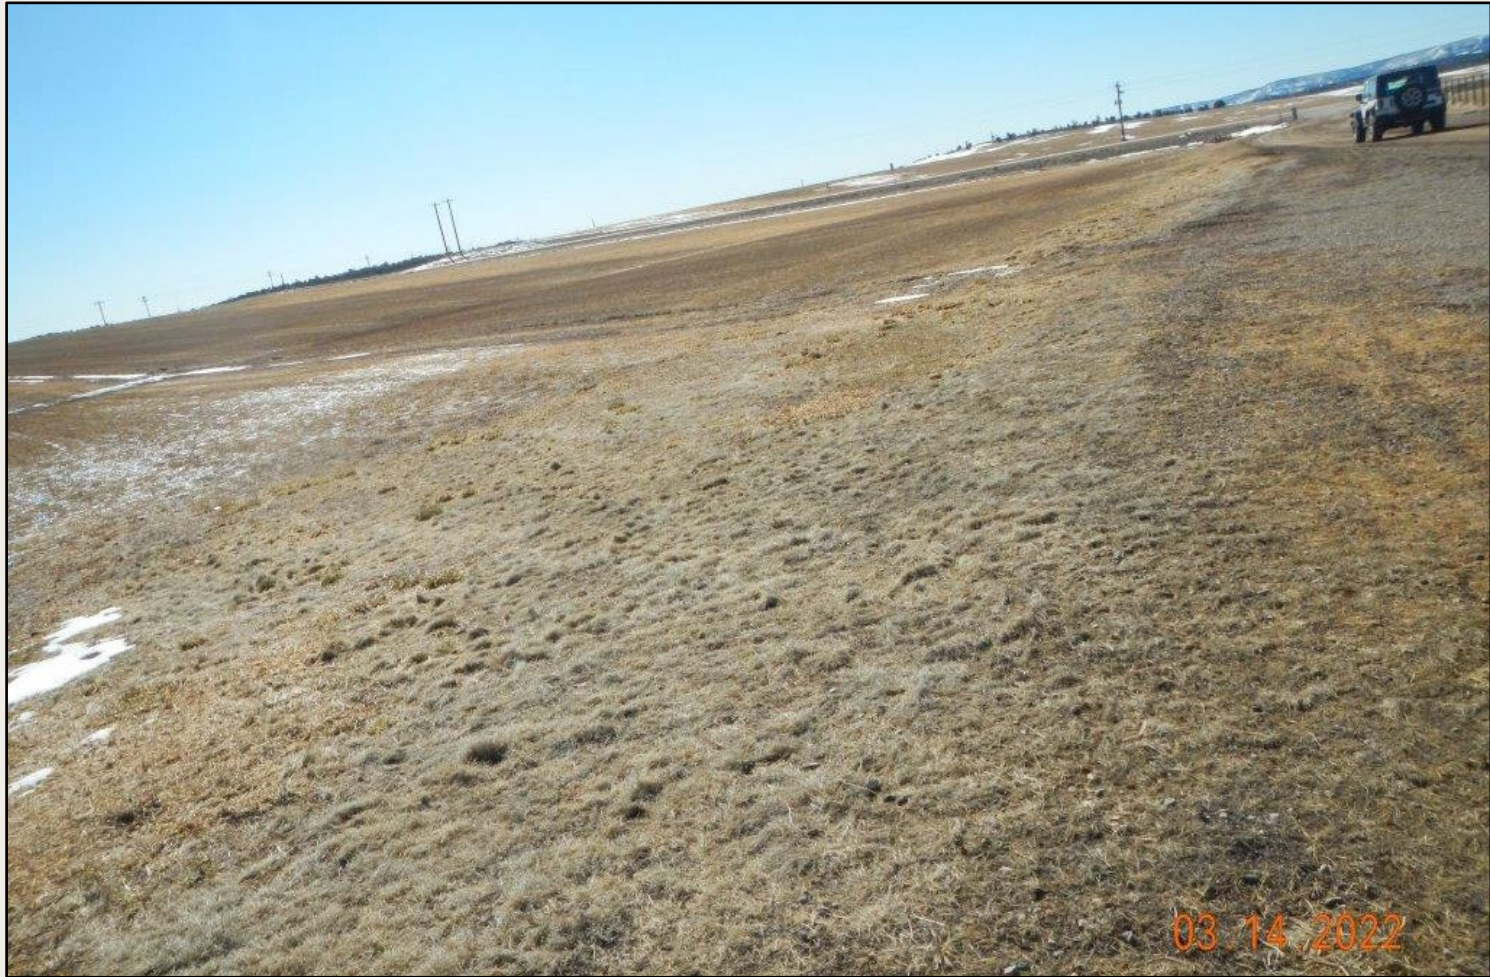
Photo 2. View of the eastern project area from the northeastern corner facing southward. Revegetation is progressing with grasses in a dormant vegetative condition such as thickspike wheatgrass and sand dropseed.

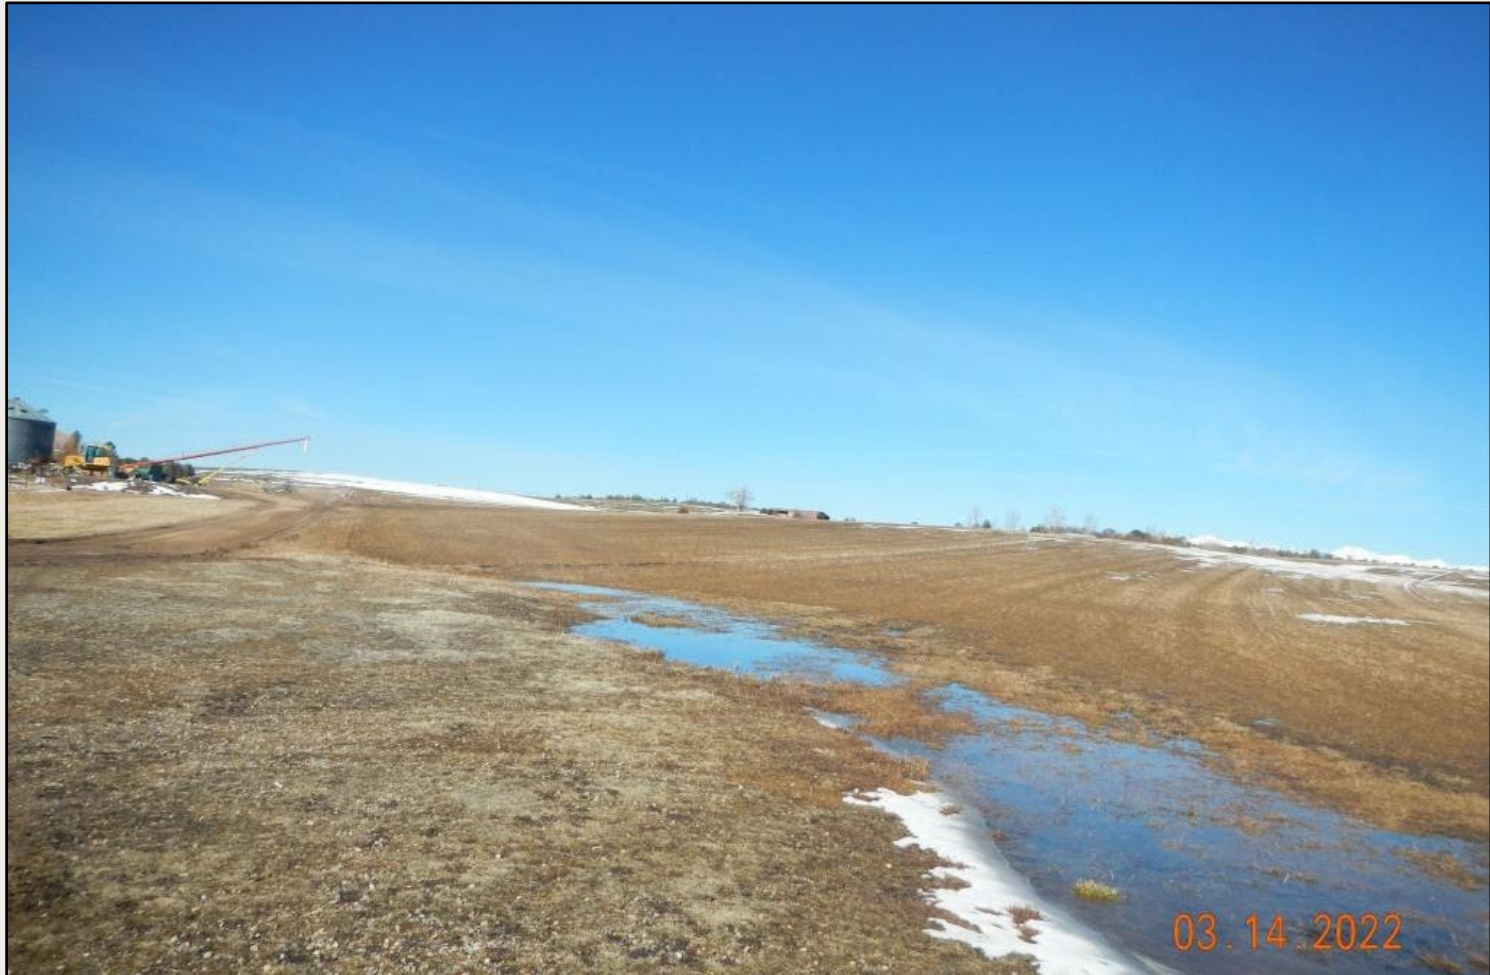
Photo 3. View of the northern project area from the northeastern corner facing westward.

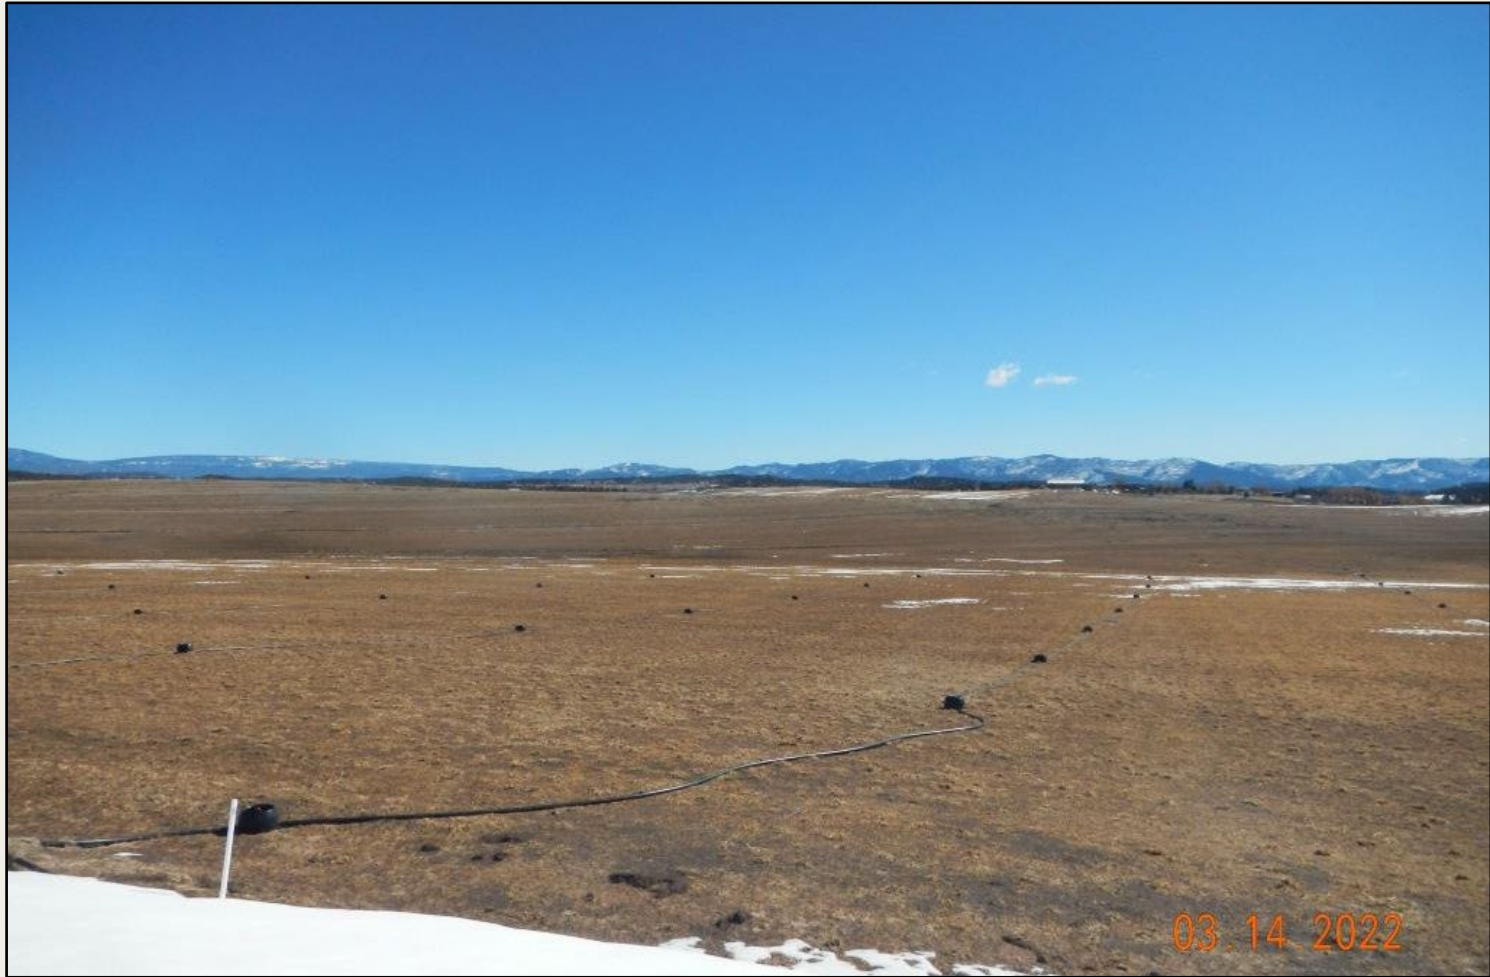
Photo 4. View of reference area comprised of irrigated grass field. Grasses are in a dormant vegetative condition.
