Inspection Photos

API: 043-06219

Operator: AUSCO PETROLEUM INC

Inspection Date: 3/15/2022

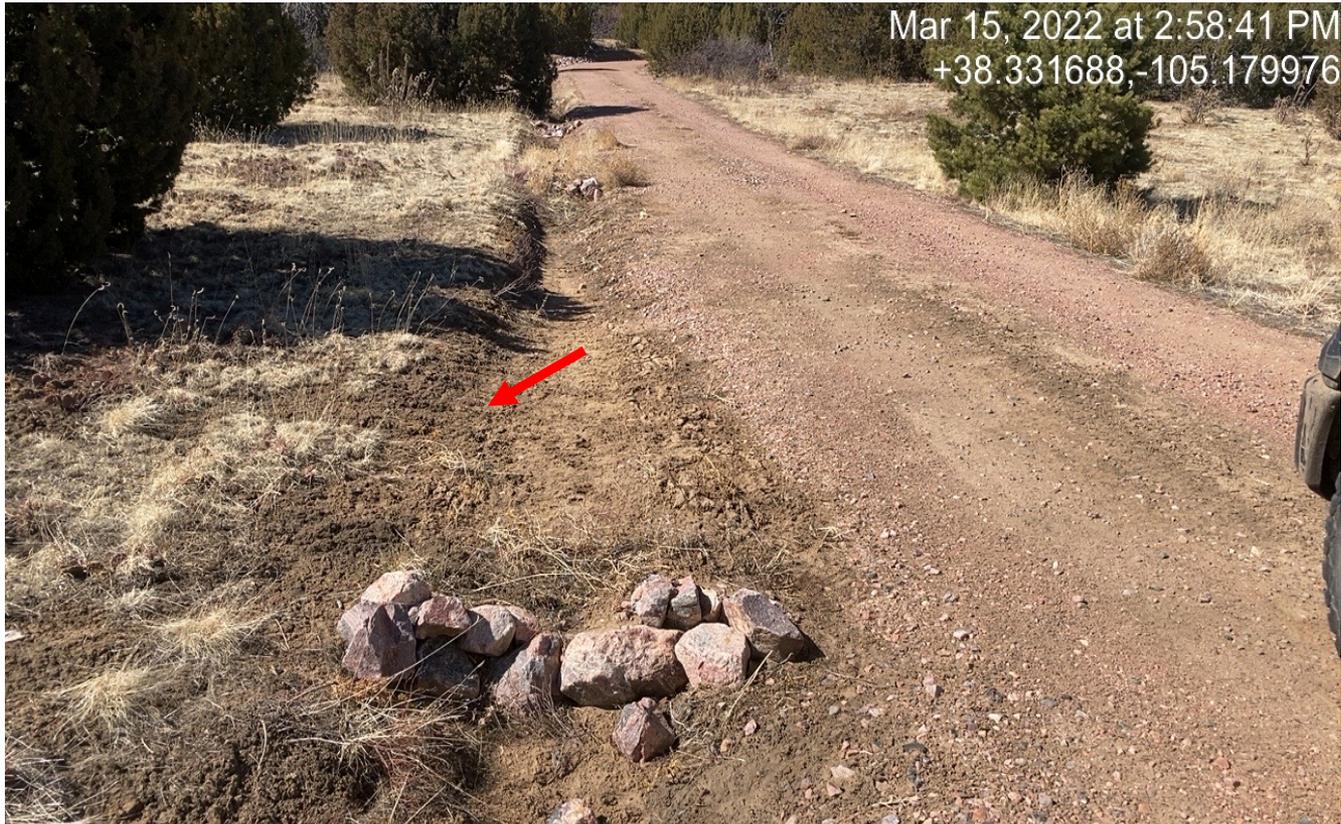
Photo 1. Facing northwest along the access road. The check dams along the road have filled in with sediment and need to be maintained.

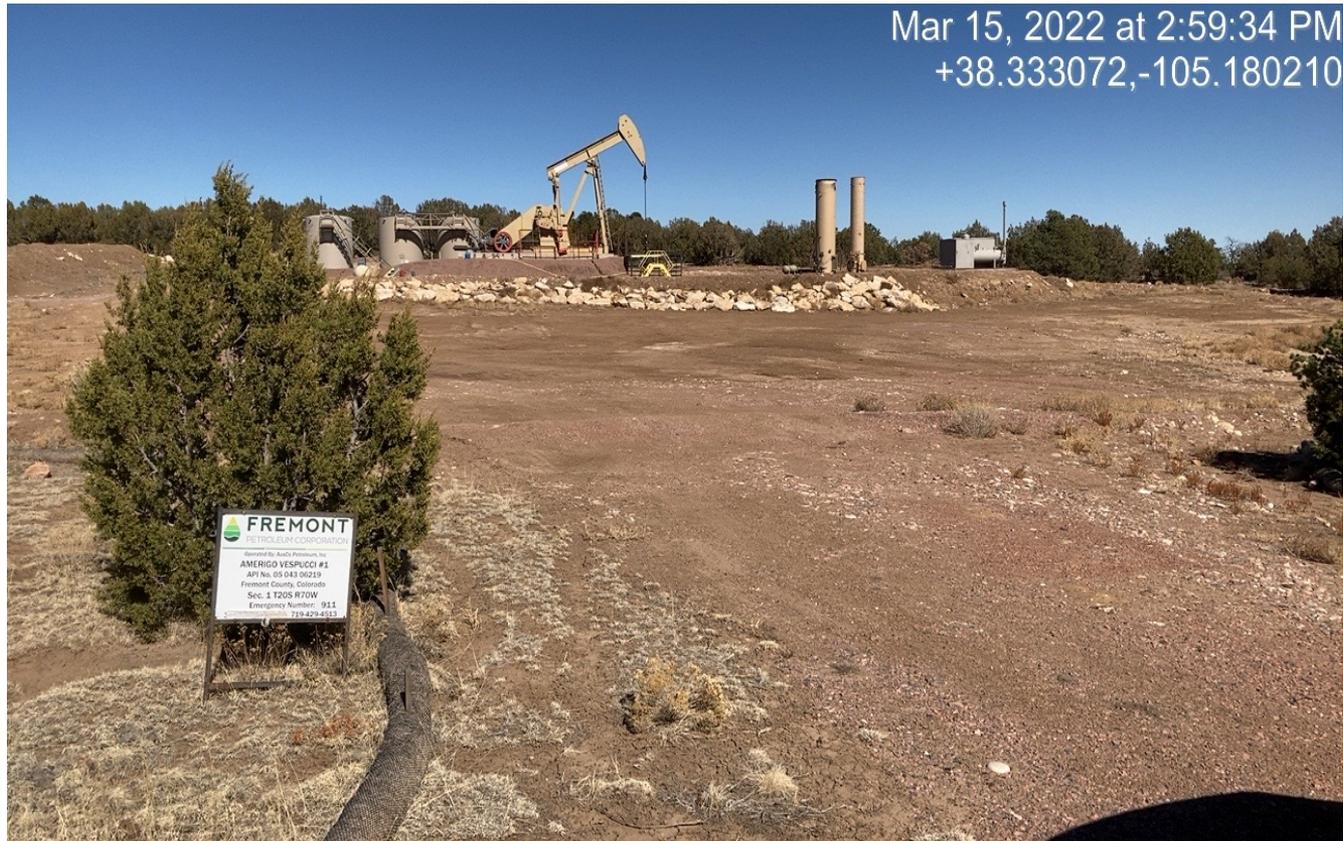
Photo 2. Facing northeast toward the location. Interim reclamation has not been performed.

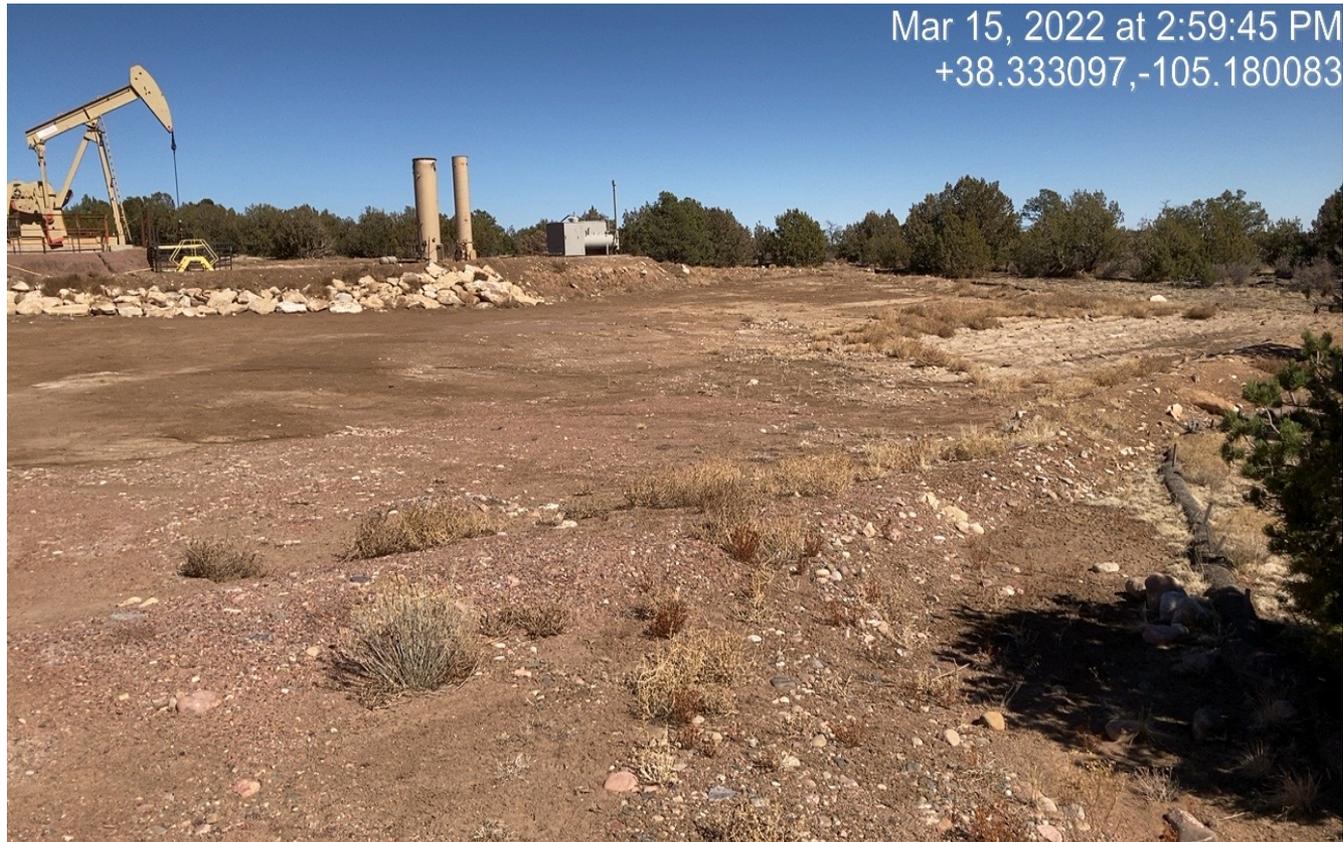
Photo 3. Facing northeast at the location. The frac tank previously observed have been removed. Unused areas of the location have not been reclaimed. Previous corrective actions have not been performed.

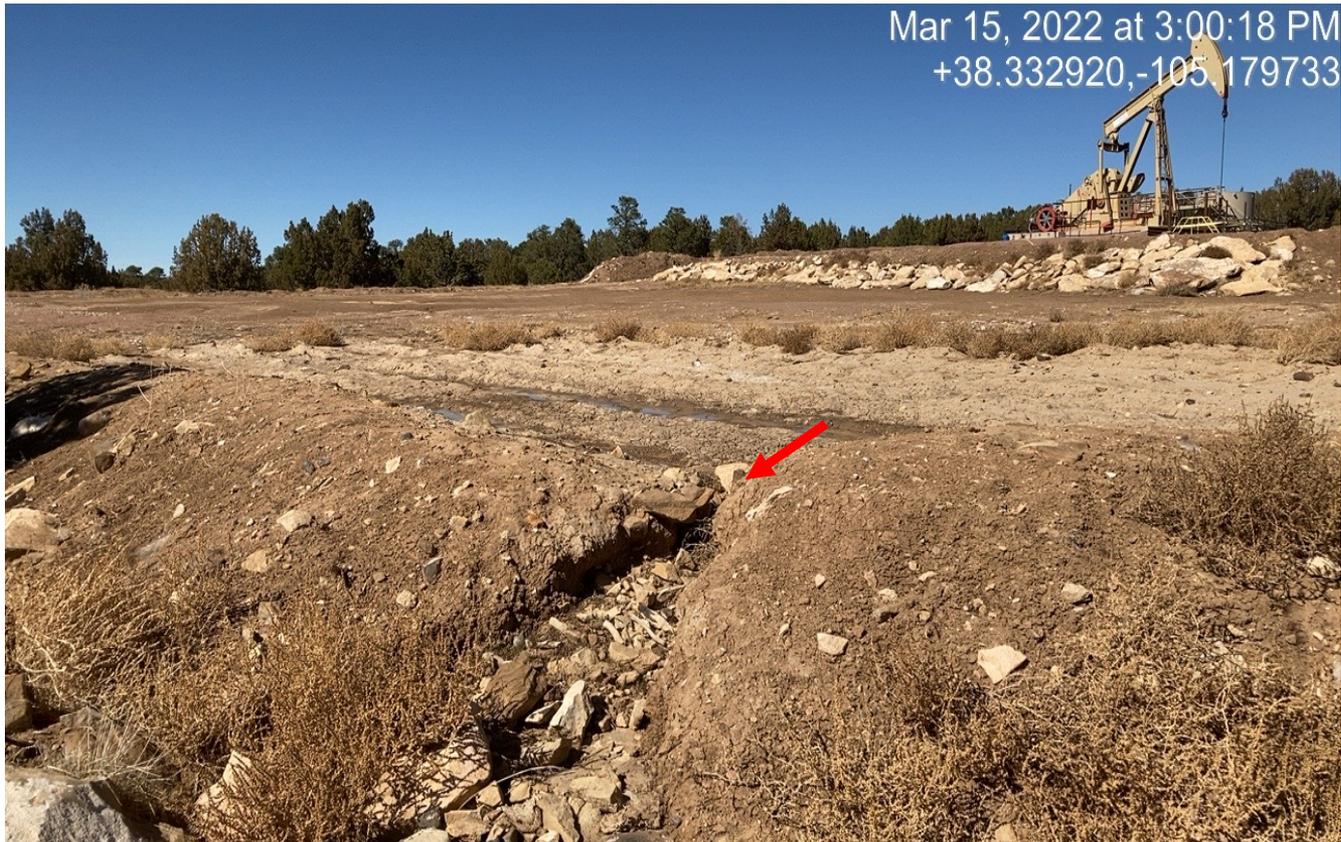
Photo 4. Facing northwest at the southeast corner of the location. There is erosion occurring from the disturbed pad site which is filling in the perimeter wattles. Previous corrective action has not been performed.

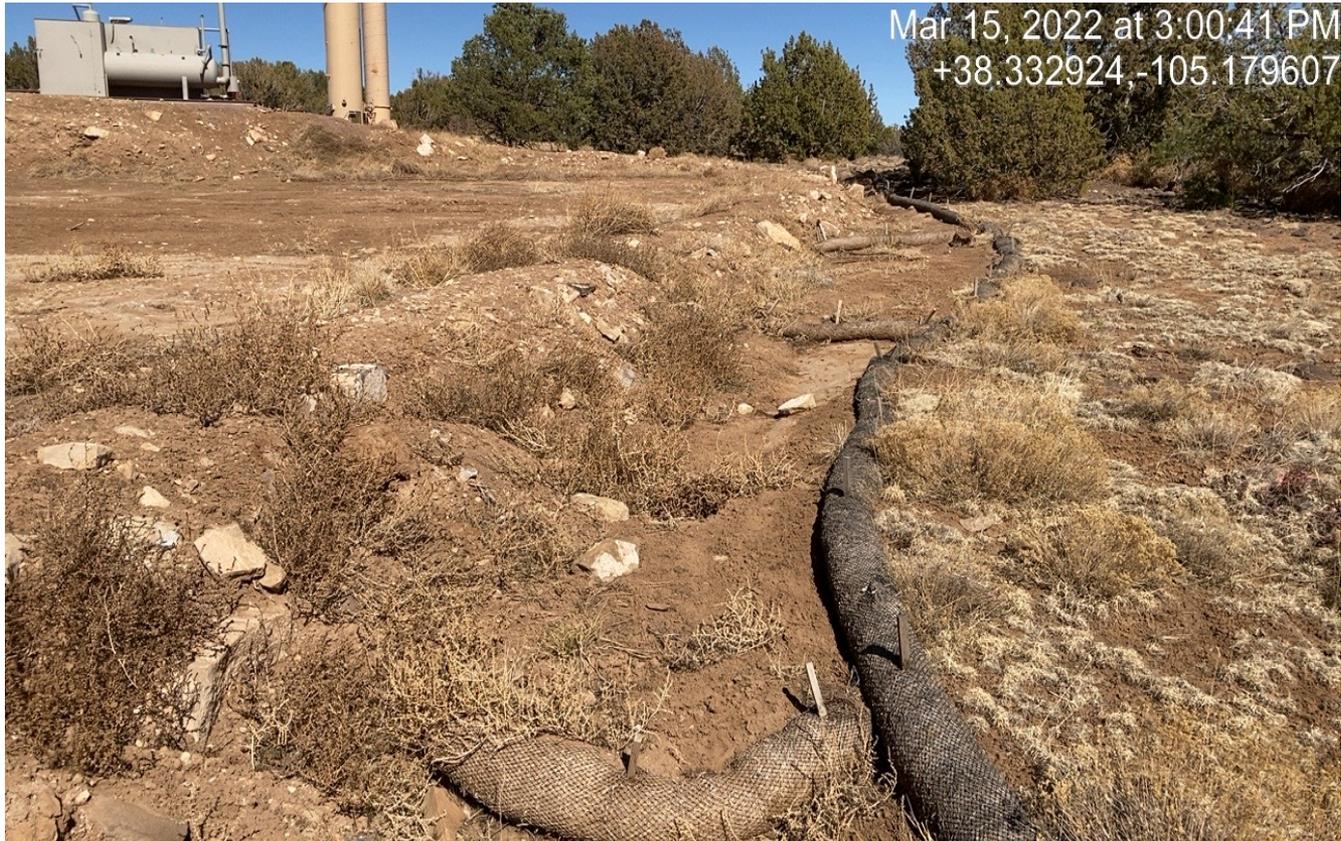
Photo 5. The wattles are degraded and are filled in with sediment. Previous corrective action has not been performed.

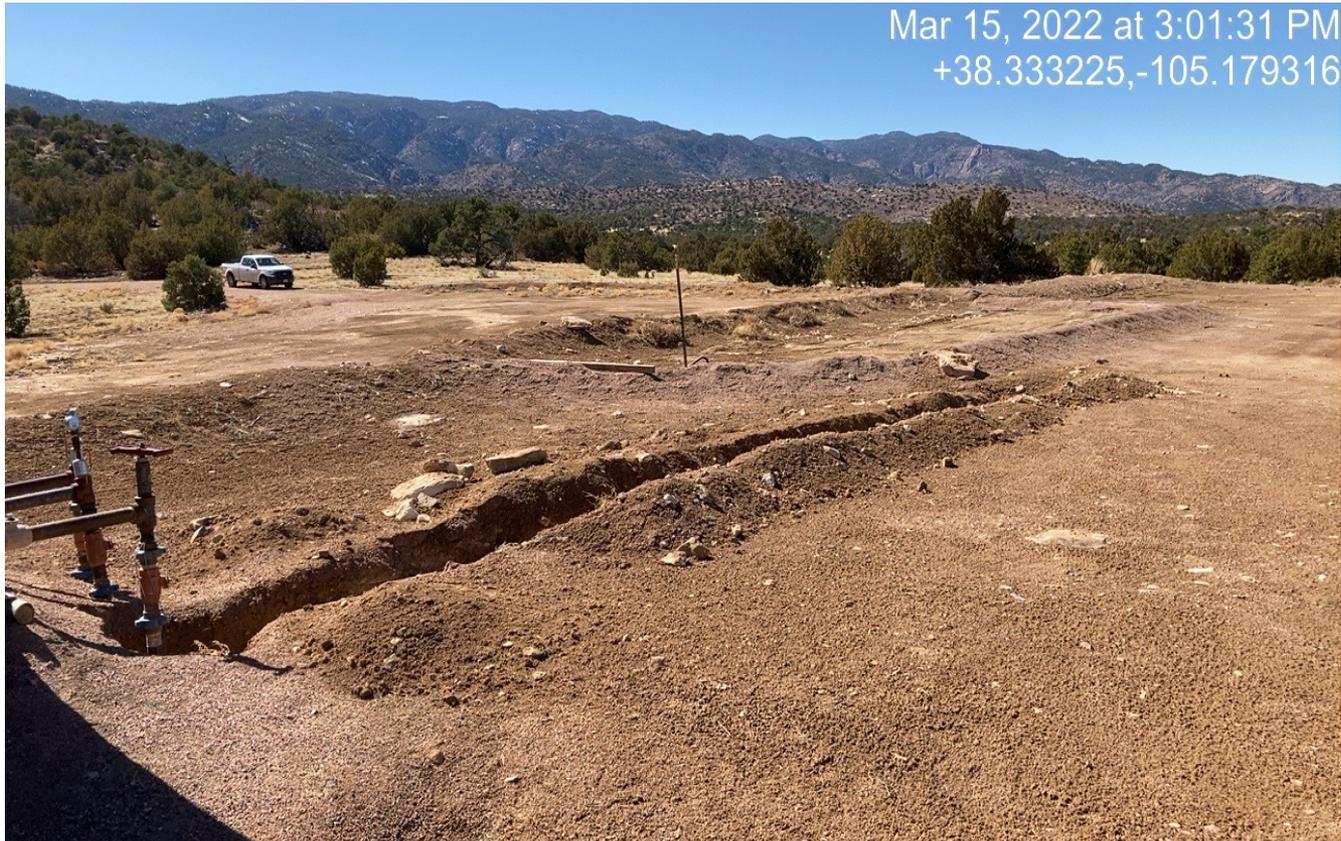
Photo 7. There is an open trench at the location that has been excavated.

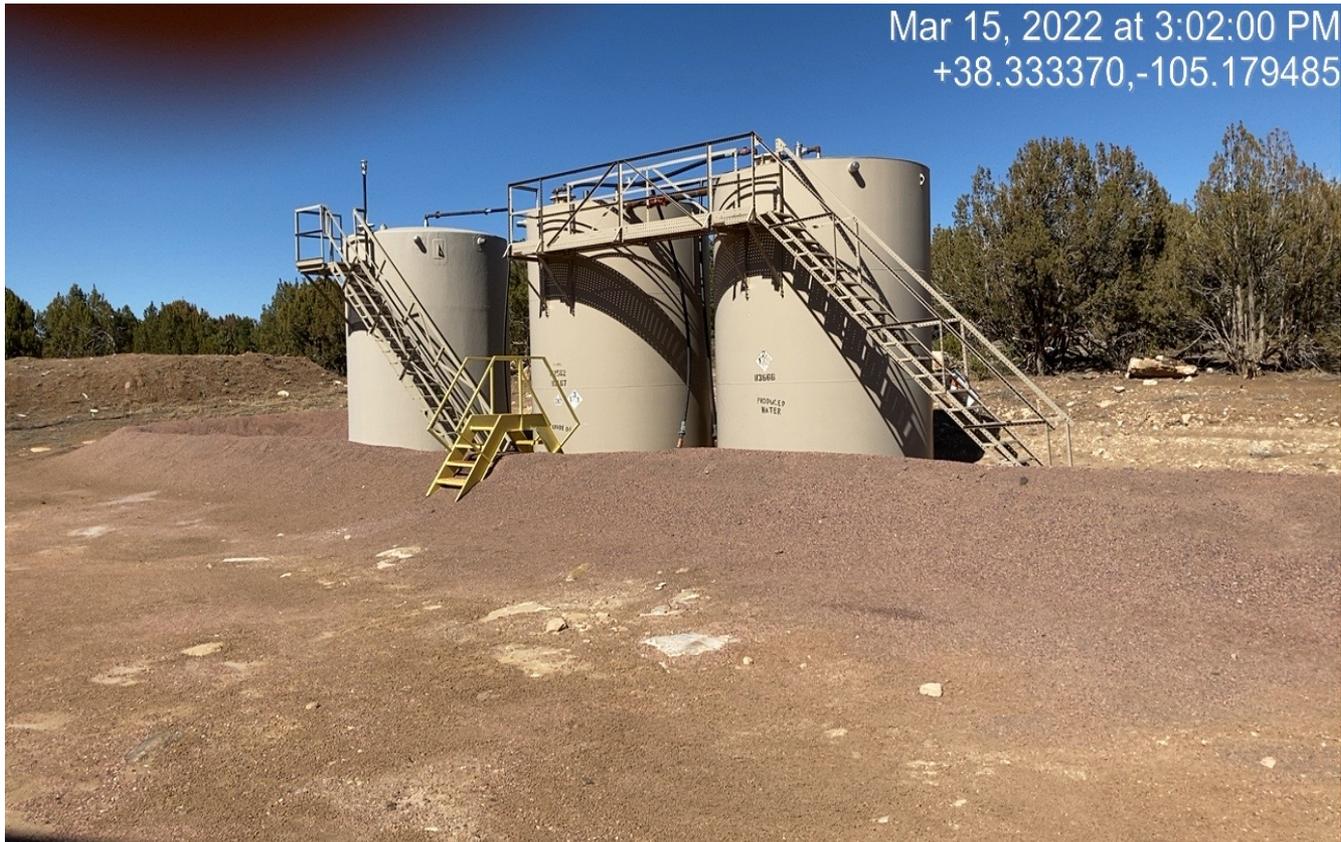
Photo 8. The tanks at north side of the location are not properly labeled.

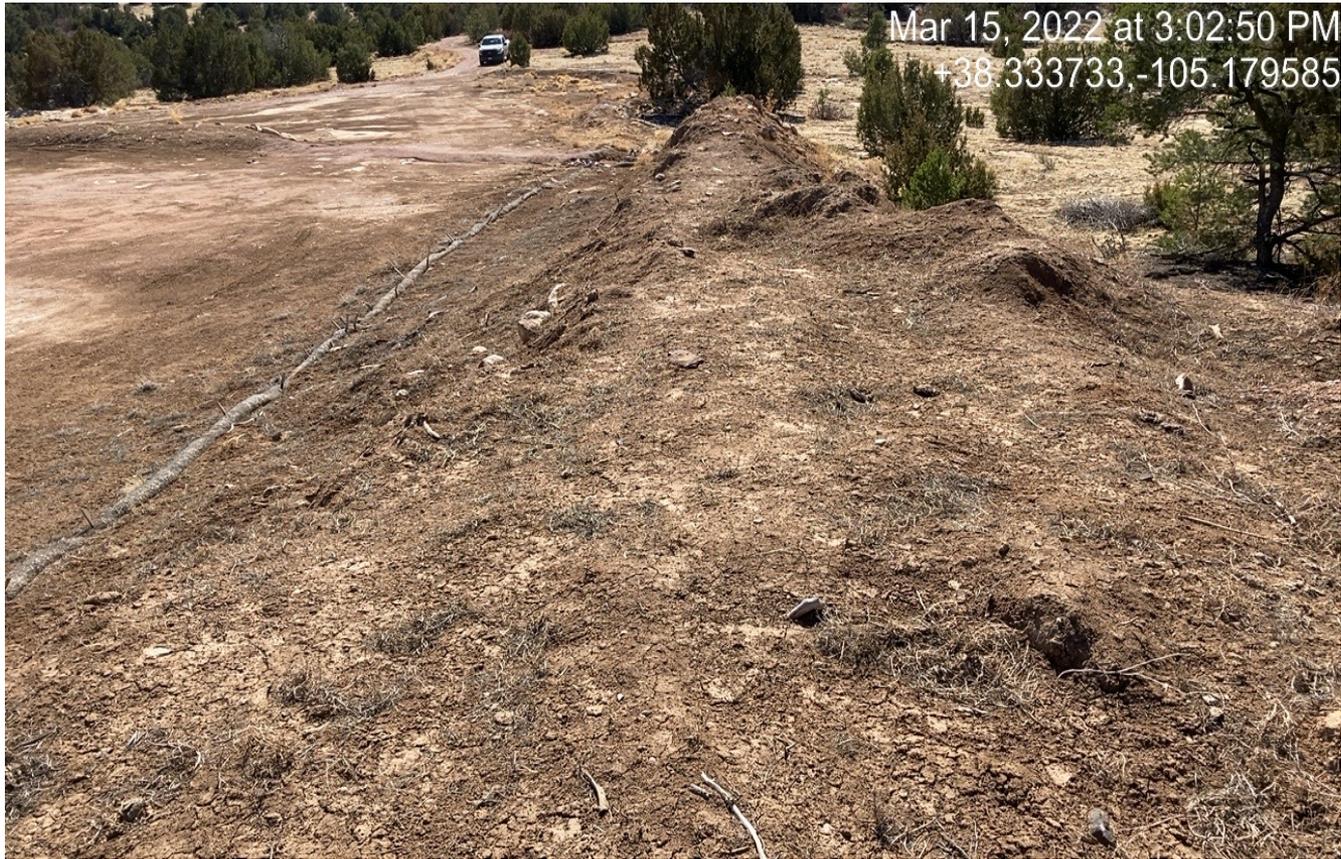
Photo 10. Facing toward the topsoil pile. The topsoil piles are not stabilized and protected. Topsoil piles have not been replaced for interim reclamation. Previous corrective action has not been performed.

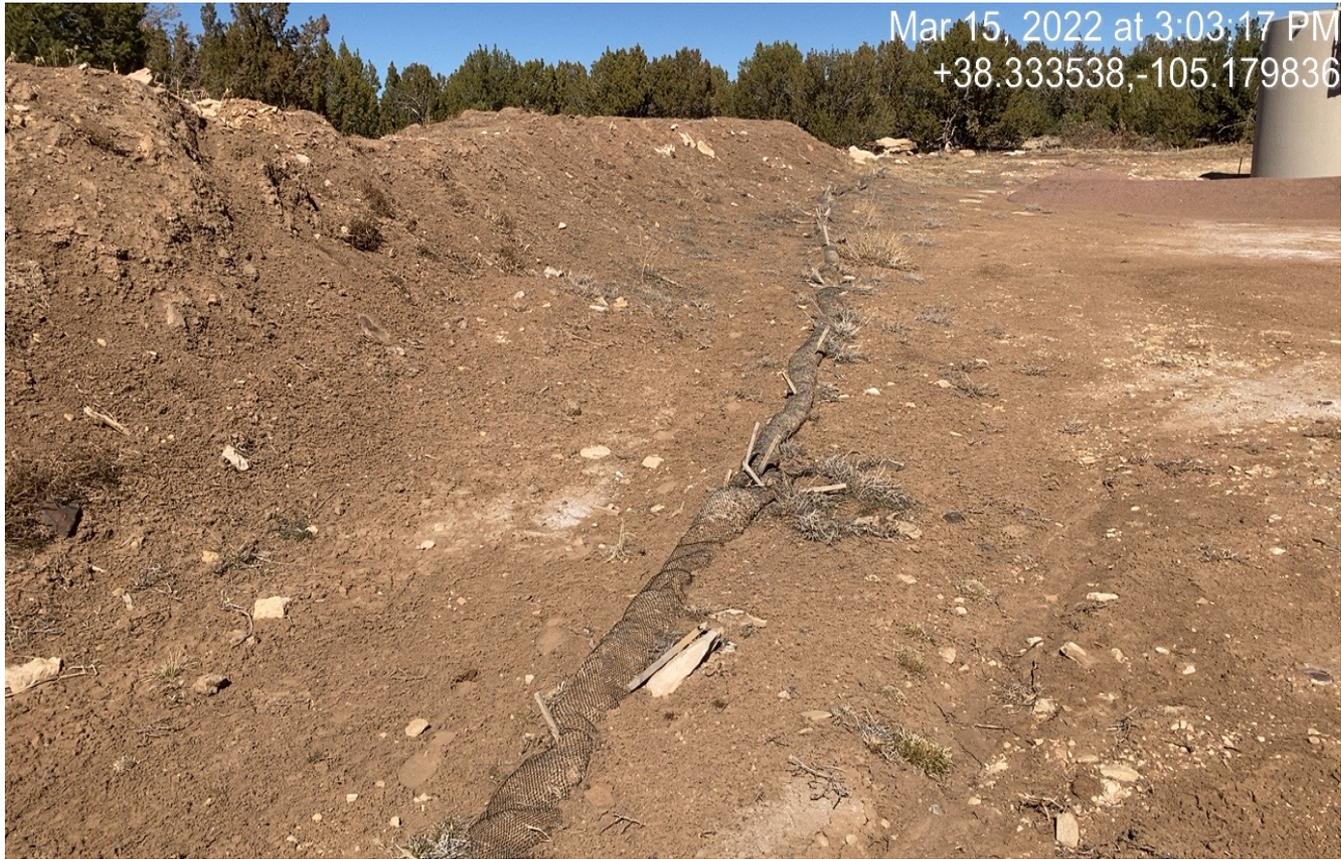
Photo 11. The wattles around the topsoil are degraded and not maintained.

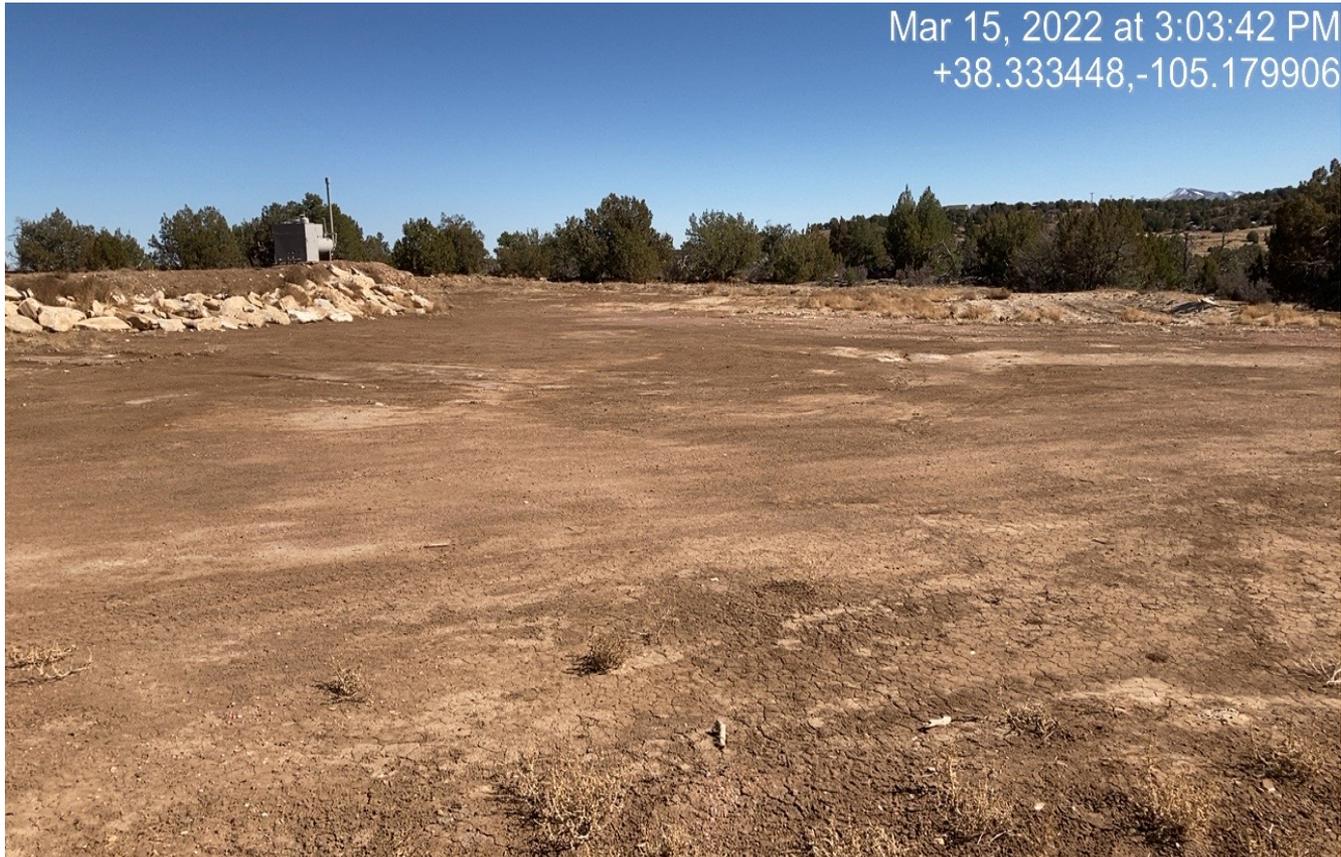
Photo 12. Facing northeast toward the location. Unused areas of the location need to be recontoured and reclaimed. Previous corrective actions have not been performed.
