Inspection Photos
Location Name: Gretchen Raglund 2-14
Location ID: 320322

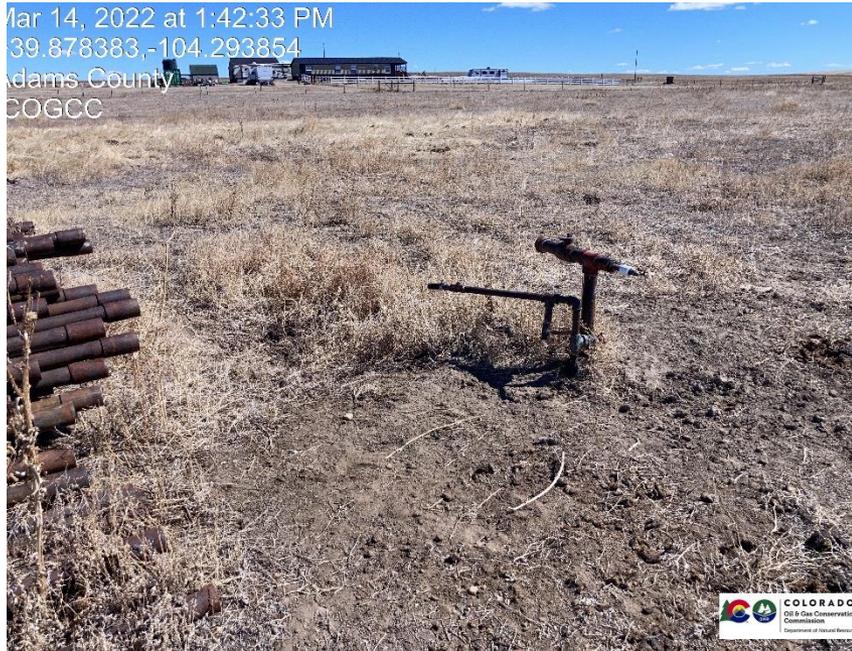
Pic 1 flowlines from where well is located.

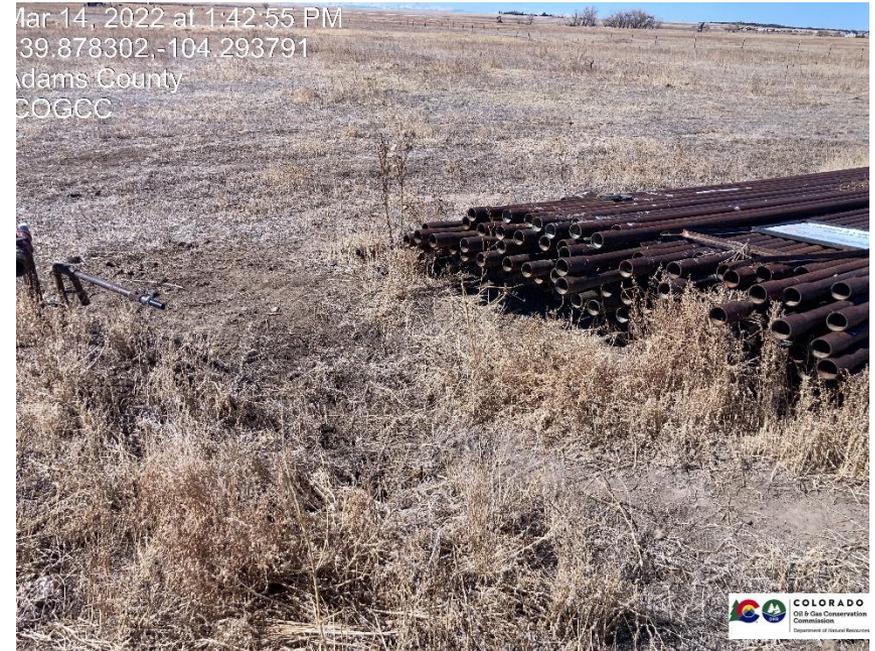
Pic 2 flowlines/tubing on location.

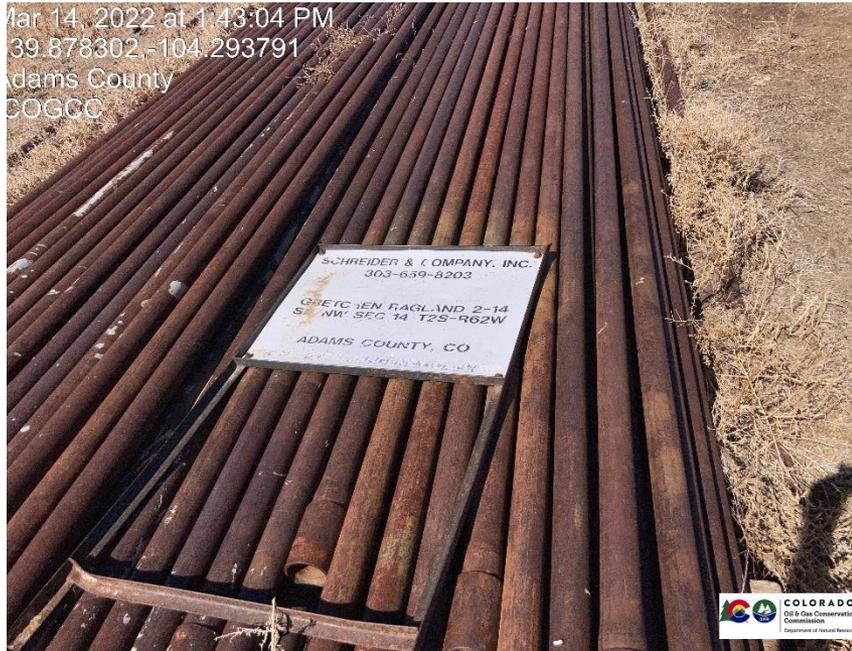
Pic 3 wellhead sign on top of tubing

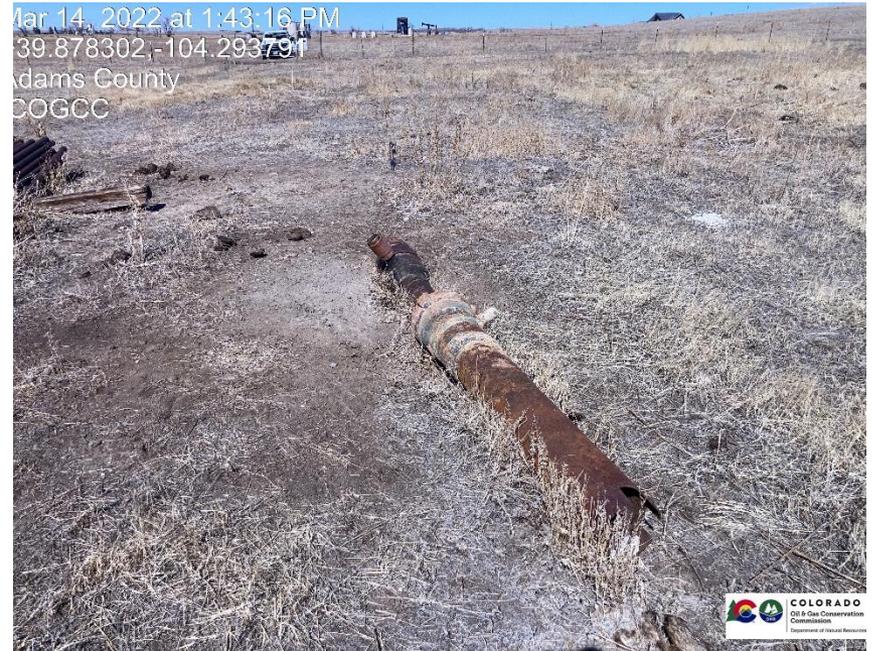
Pic 4 wellhead cut off on location.

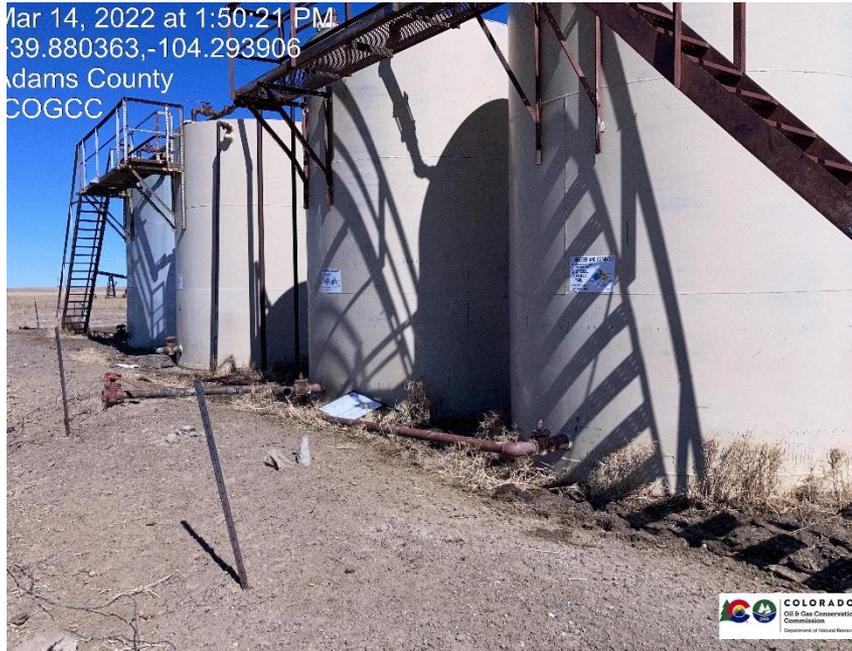
Pic 5 tanks, berms are not adequate.

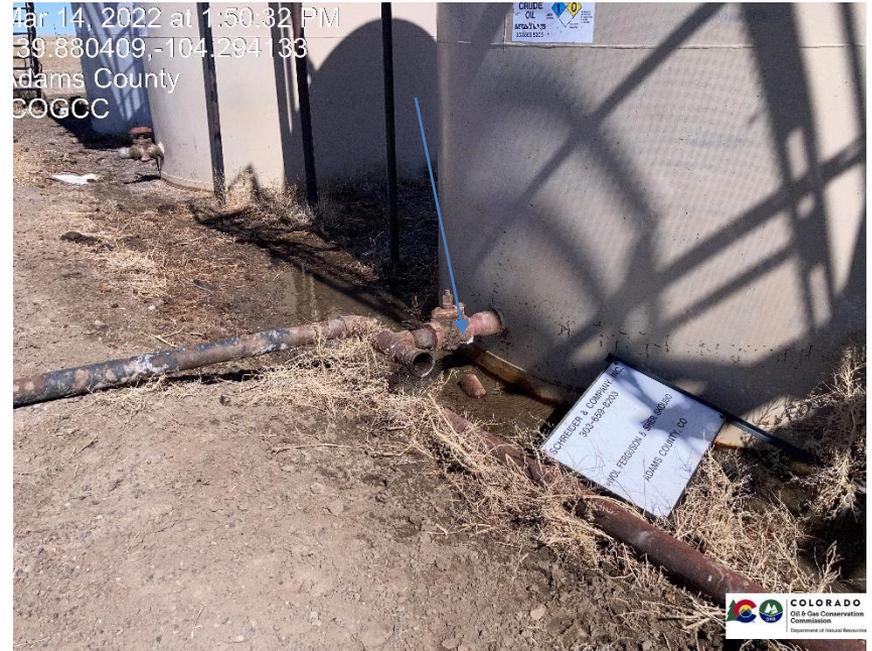
Pic 6 middle tank has a leak on valve

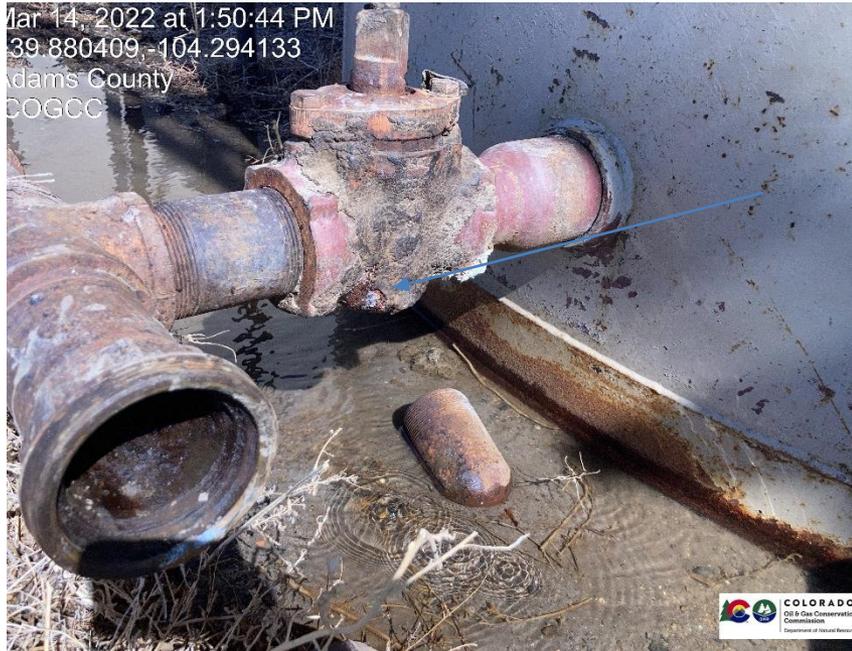
Pic 7 valve is leaking on middle steel tank

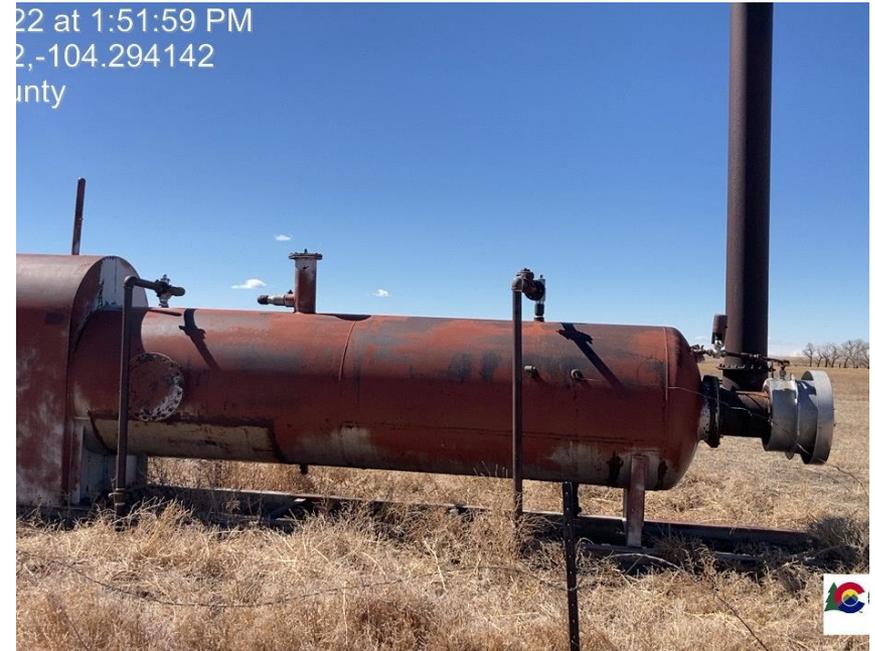
Pic 8 separator

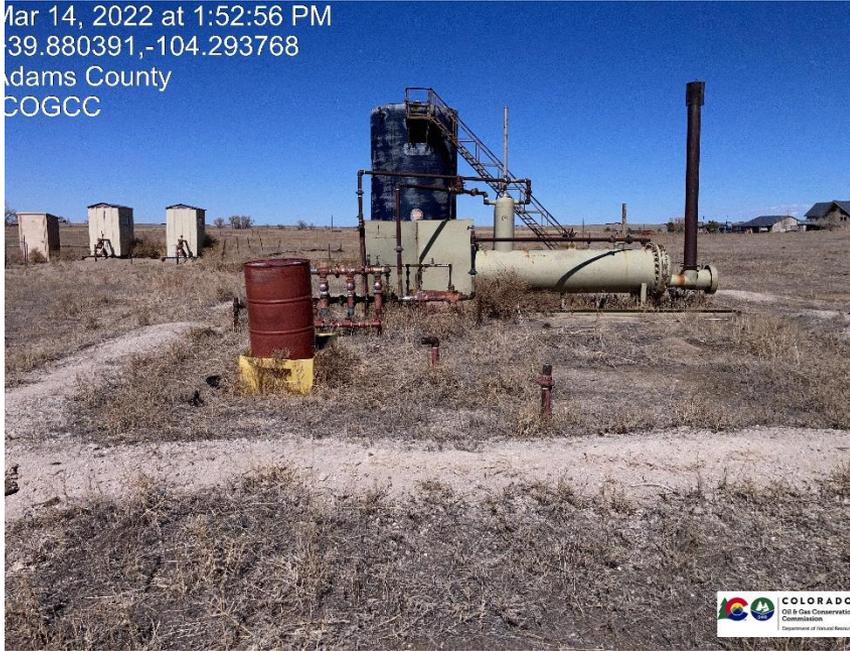
Pic 9 Separator, trash on location, weeds unmanaged.

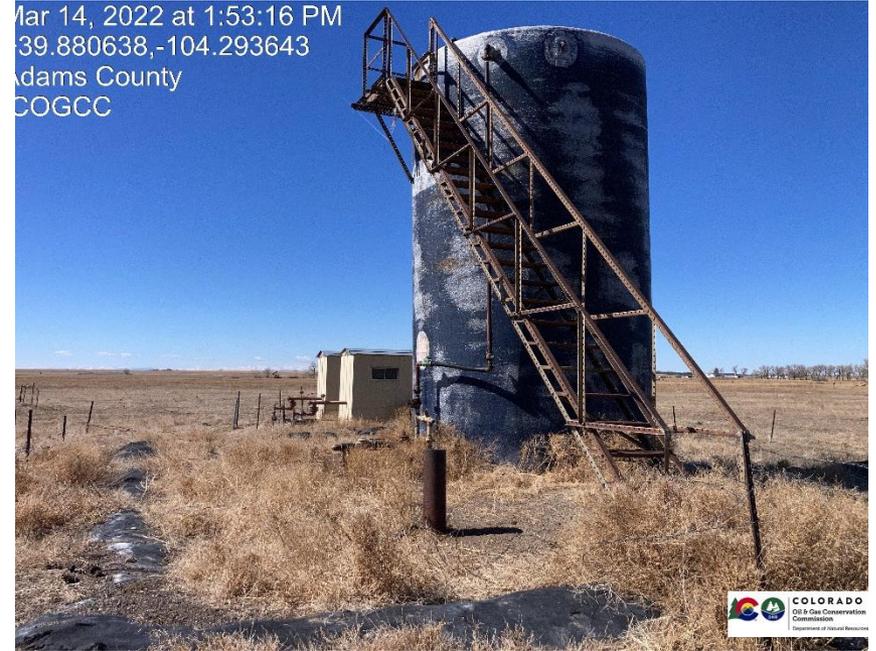
Pic 10 tank does not have any signage. Berms are not adequate.

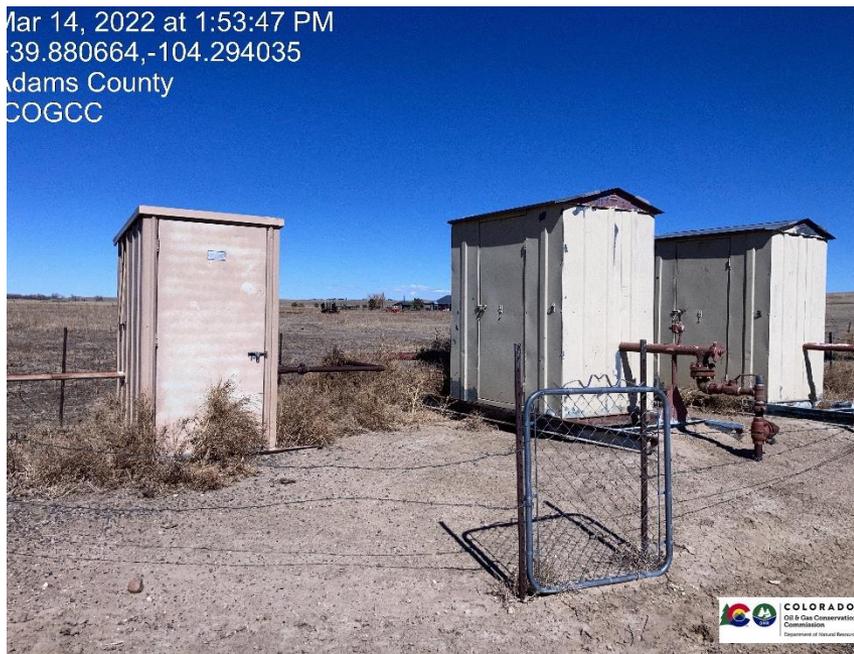
Pic 3 gas meter run, all have chart inside. Appear to be unused.
