Inspection Photos
Operator: Simcoe
API: 067-05115
Date: 3/15/2022

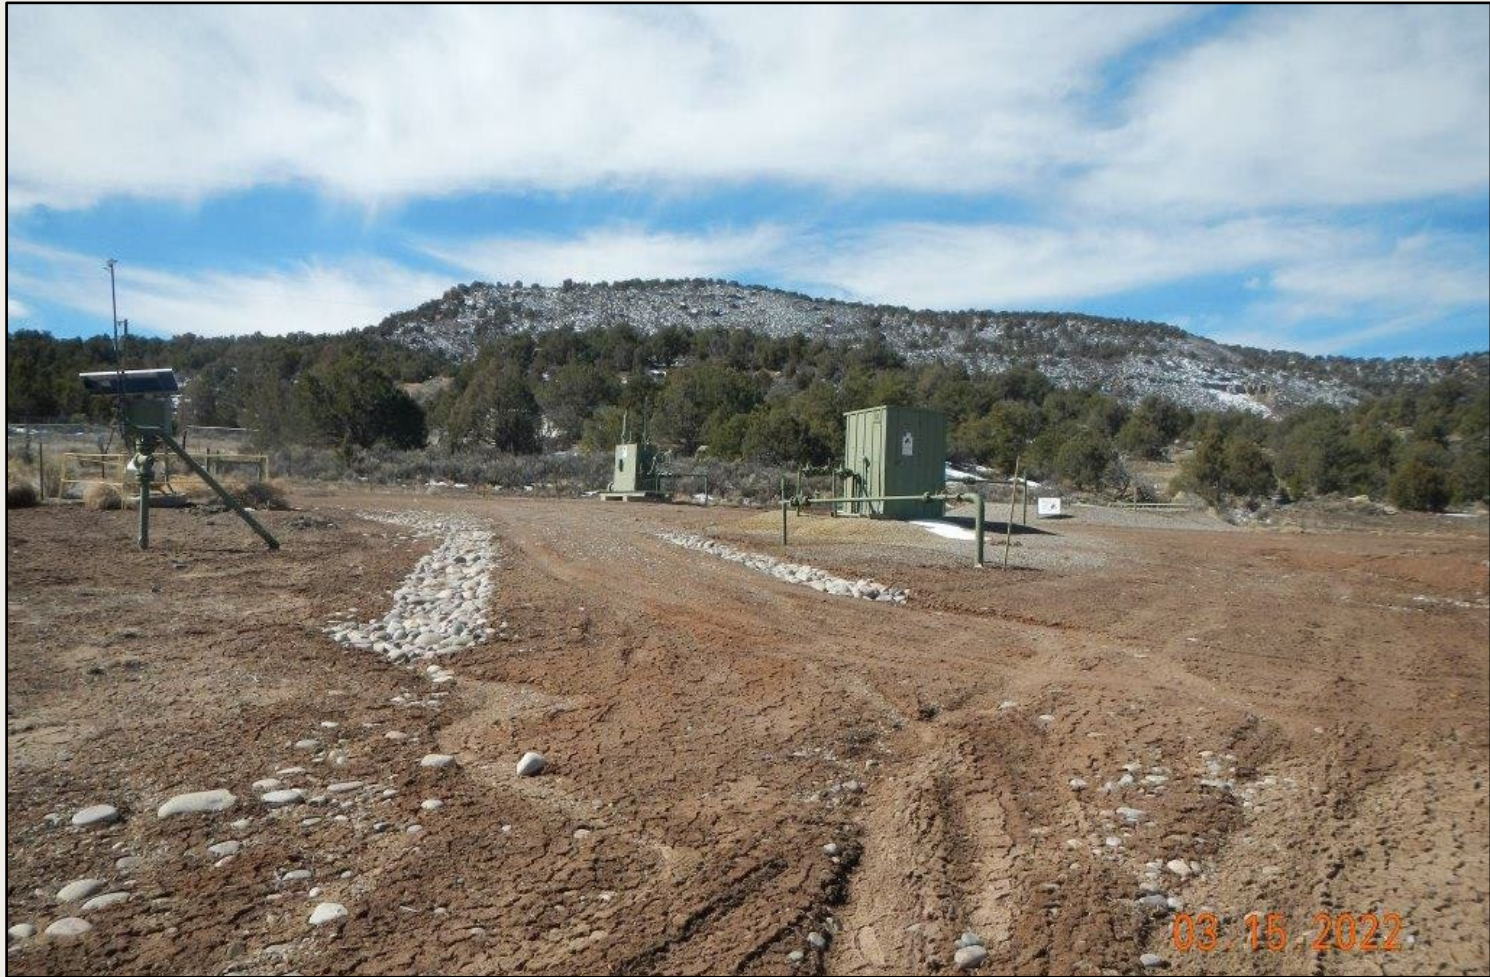
Photo 1. View of the southern project area from the southern entrance facing center.

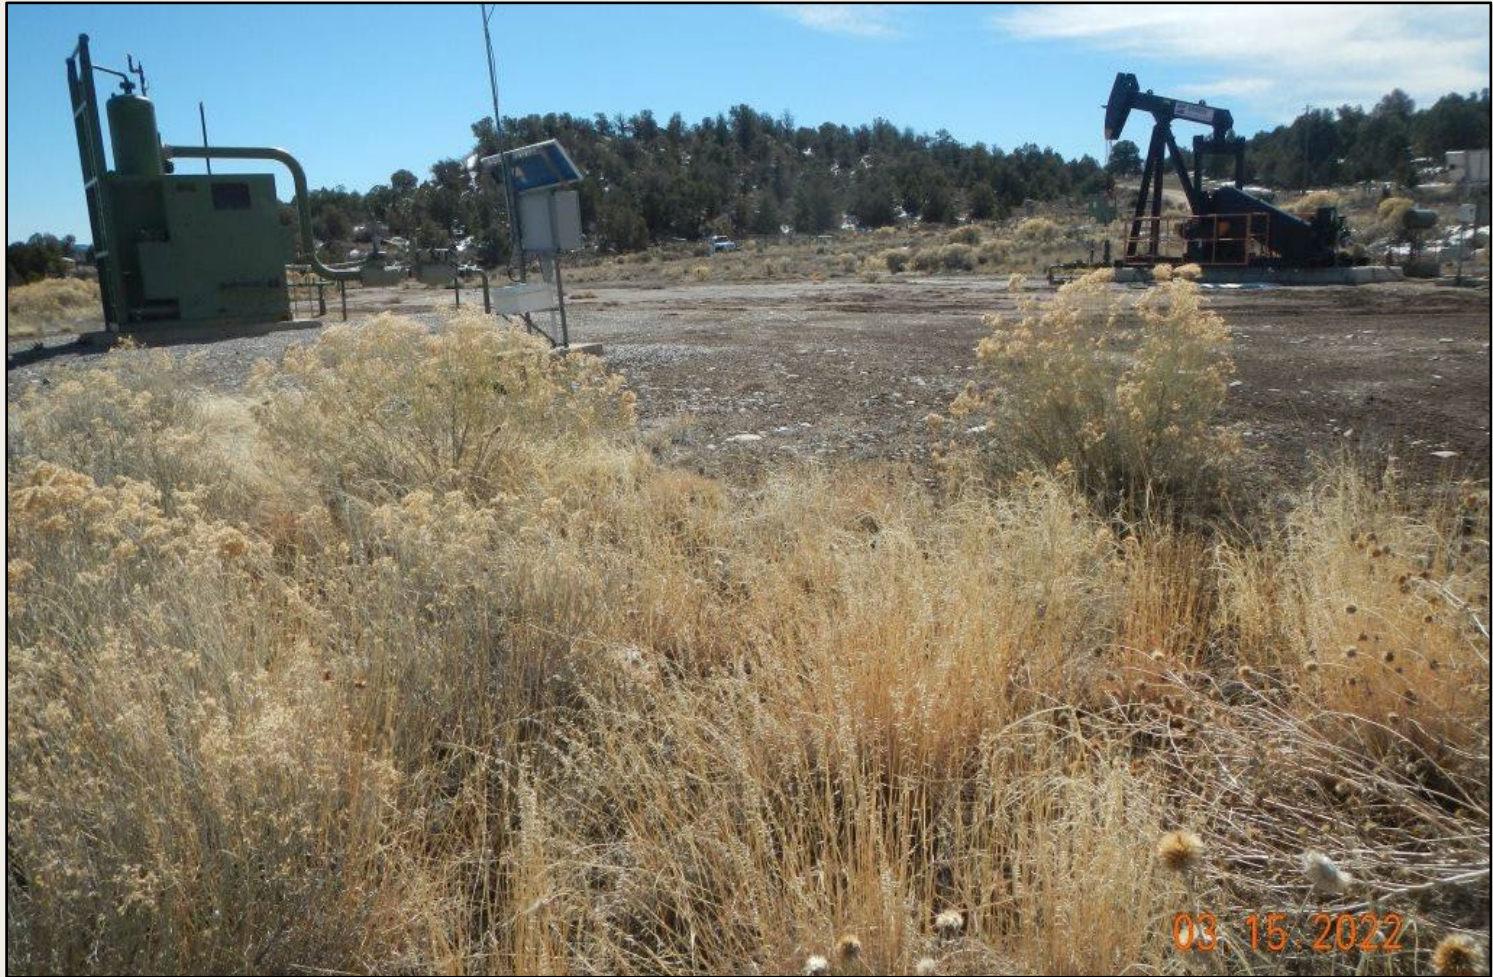
Photo 2. View of the northern project area from the northwestern corner facing center.

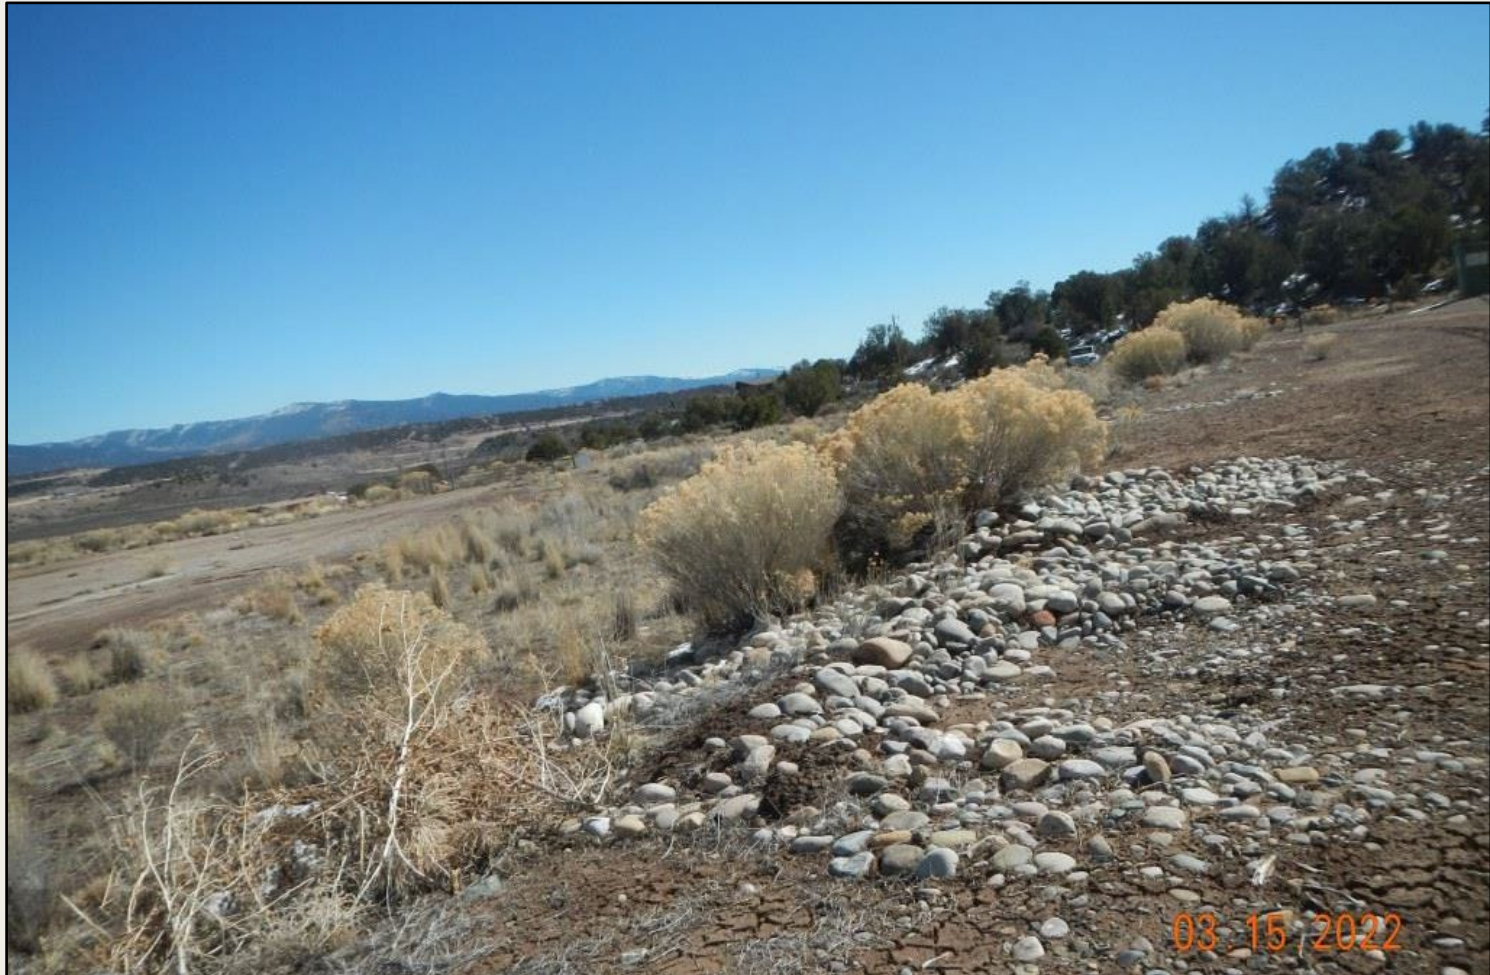
Photo 3. View of the central fill slope with grasses and shrubs such as sand dropseed, Indian ricegrass, and rubber rabbitbrush. Cobble placed to stabilize rilling is not adequate BMP rilling observed in several areas.

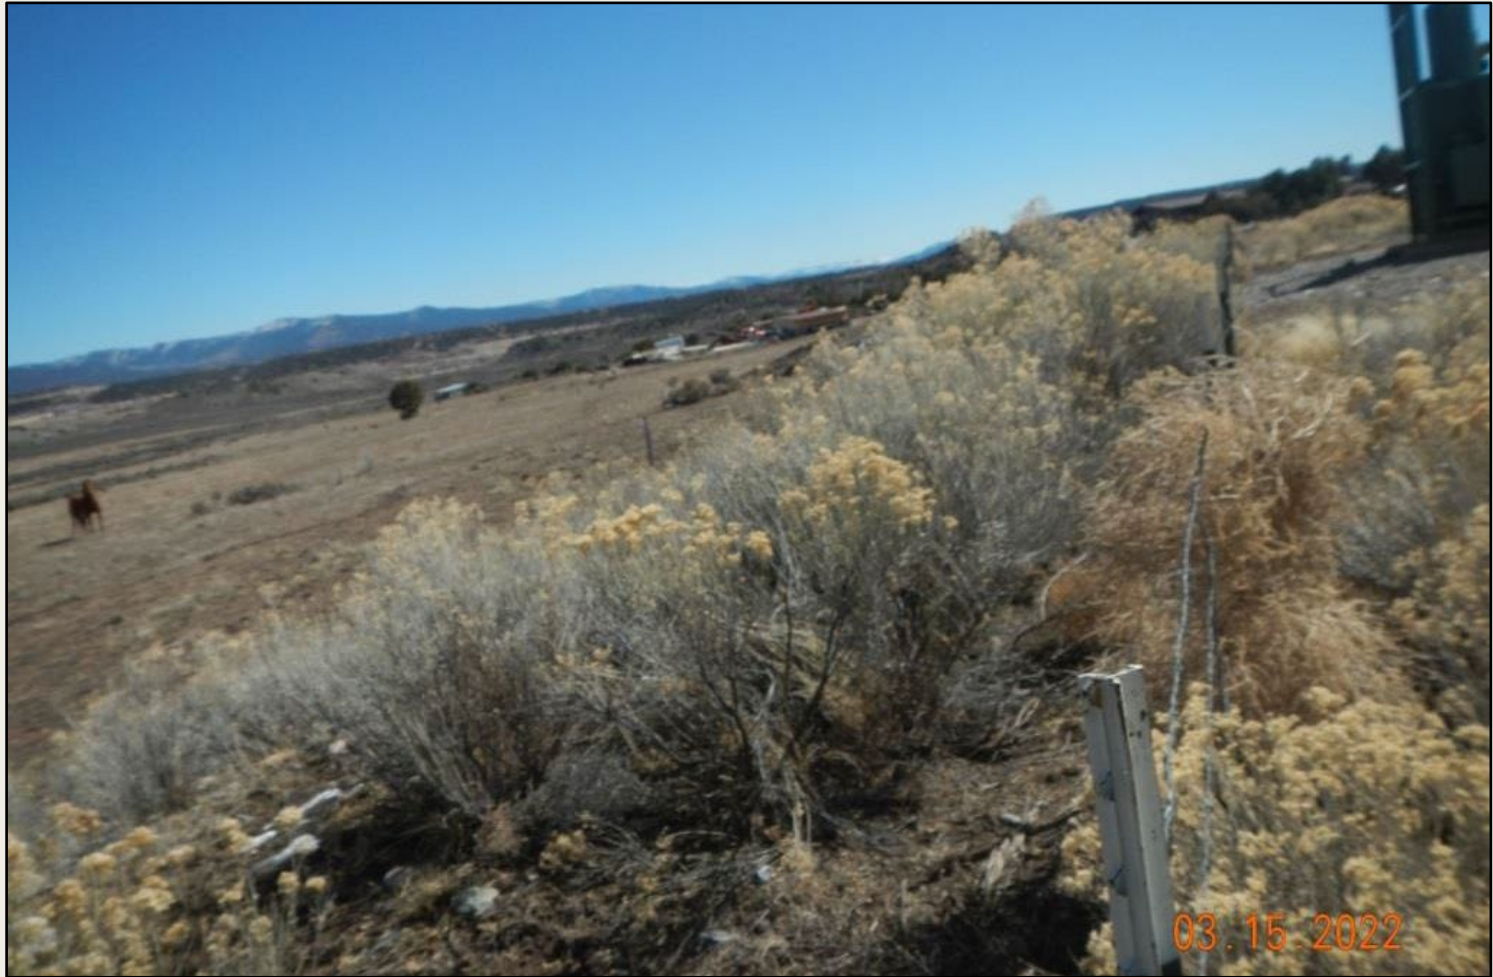
Photo 4. View of the northern project area from the northwestern corner facing eastward. Revegetation is progressing with rubber rabbitbrush, sand dropseed, and sideoats grama.

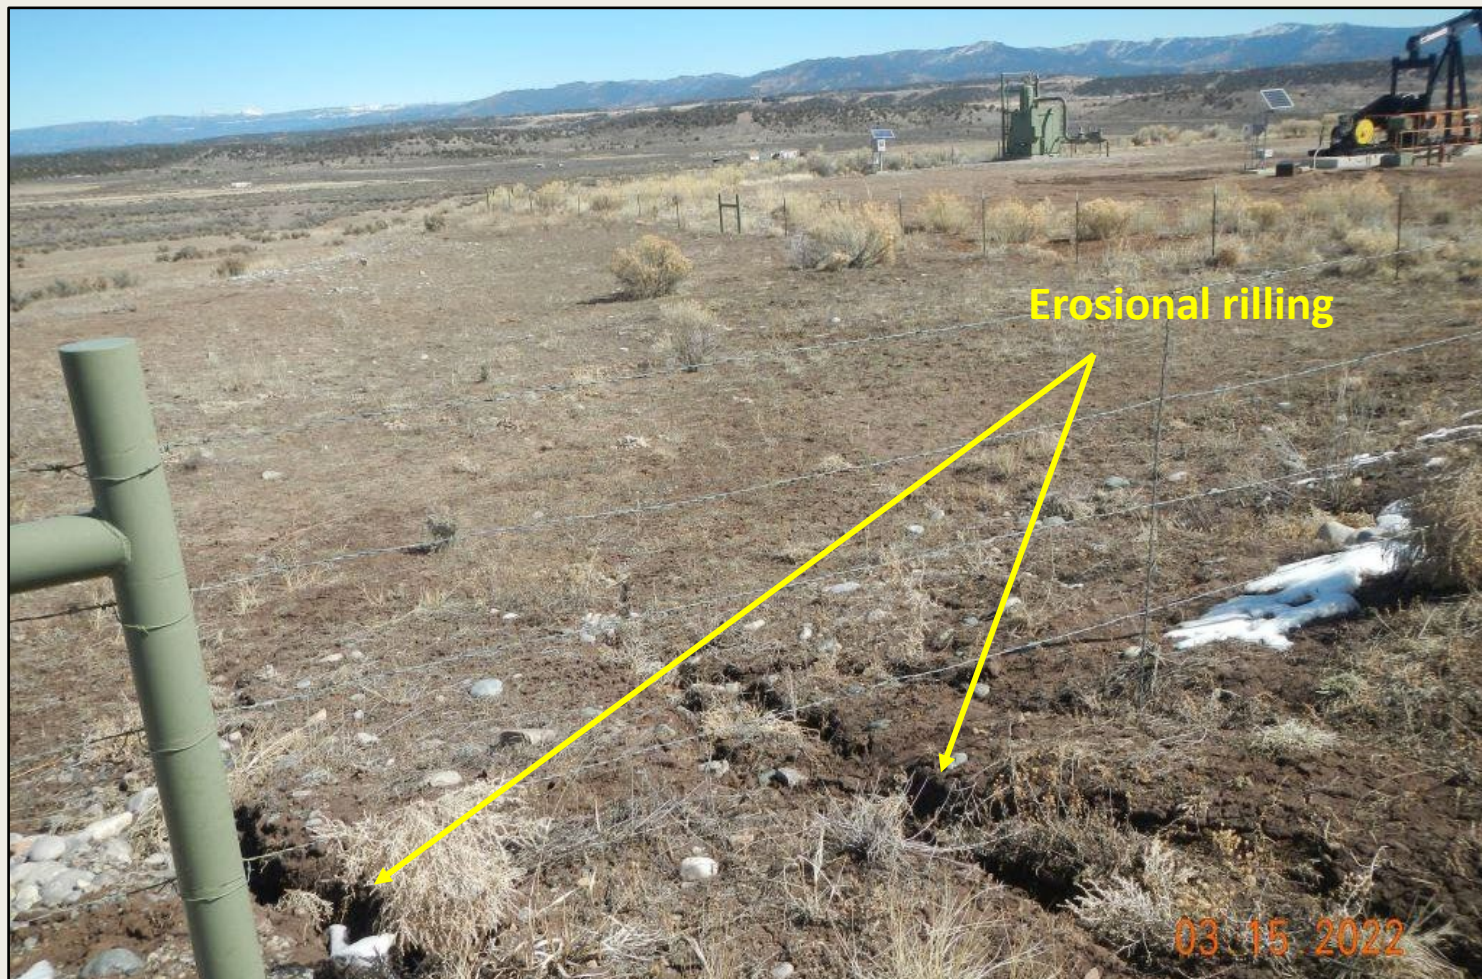
Photo 5. View of erosional rilling approx 6-8 inches wide and deep, in the central fill slope.

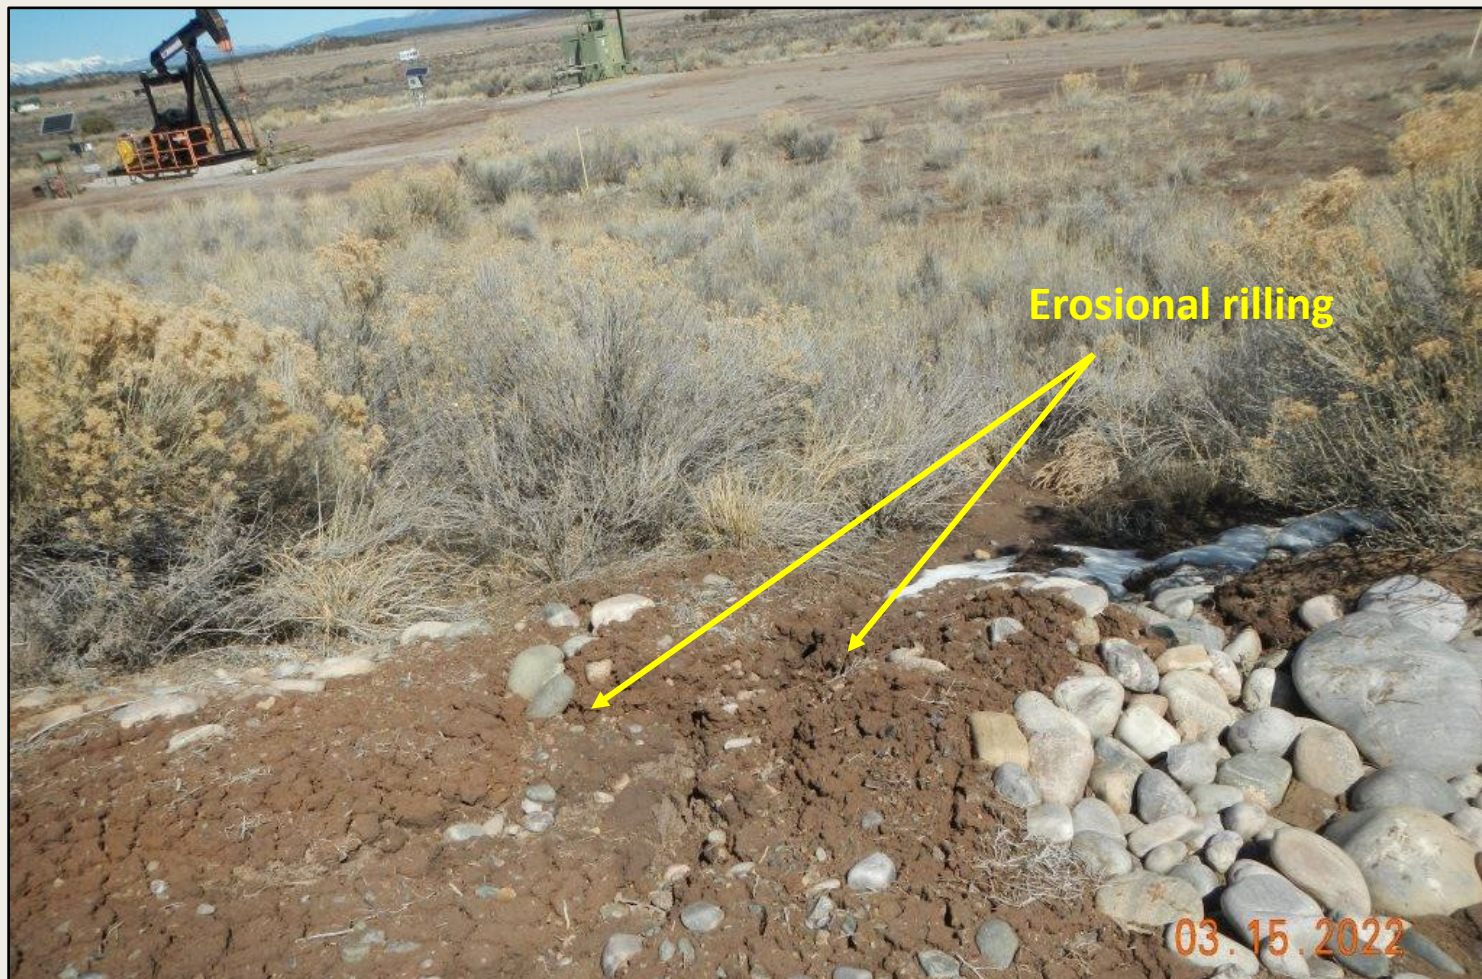
Photo 6. View of more erosional rilling observed in the central/southern fill slope.

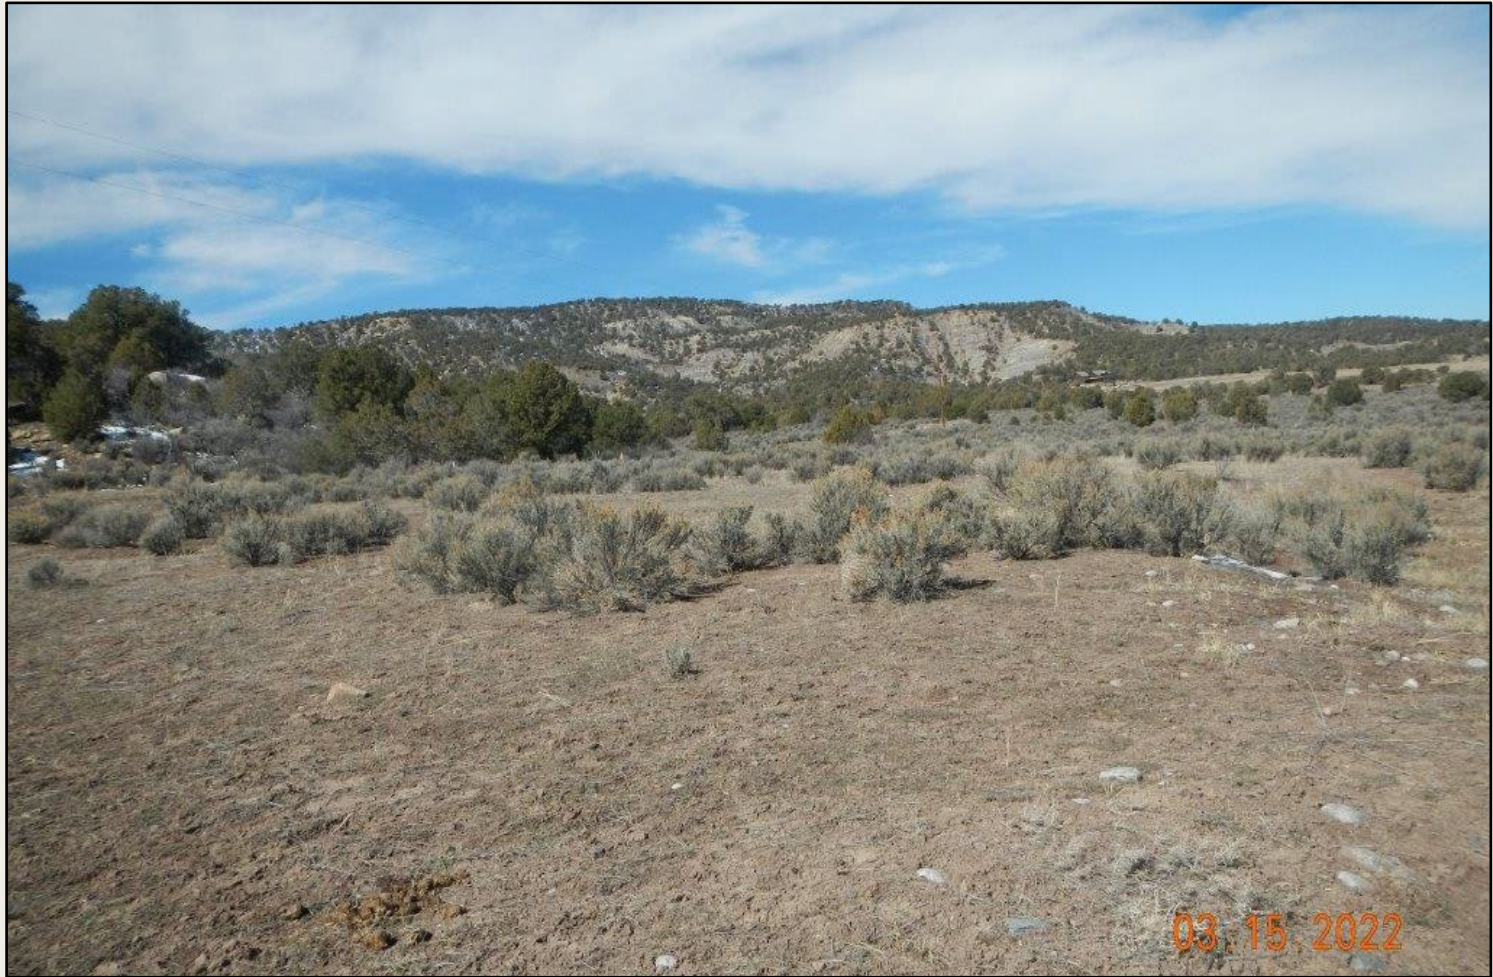
Photo 7. View of reference area comprised of open sagebrush and grassland with western wheatgrass and James galleta observed.
