Inspection Photos
Operator: Simcoe
API: 067-06326
Date: 3/15/2022

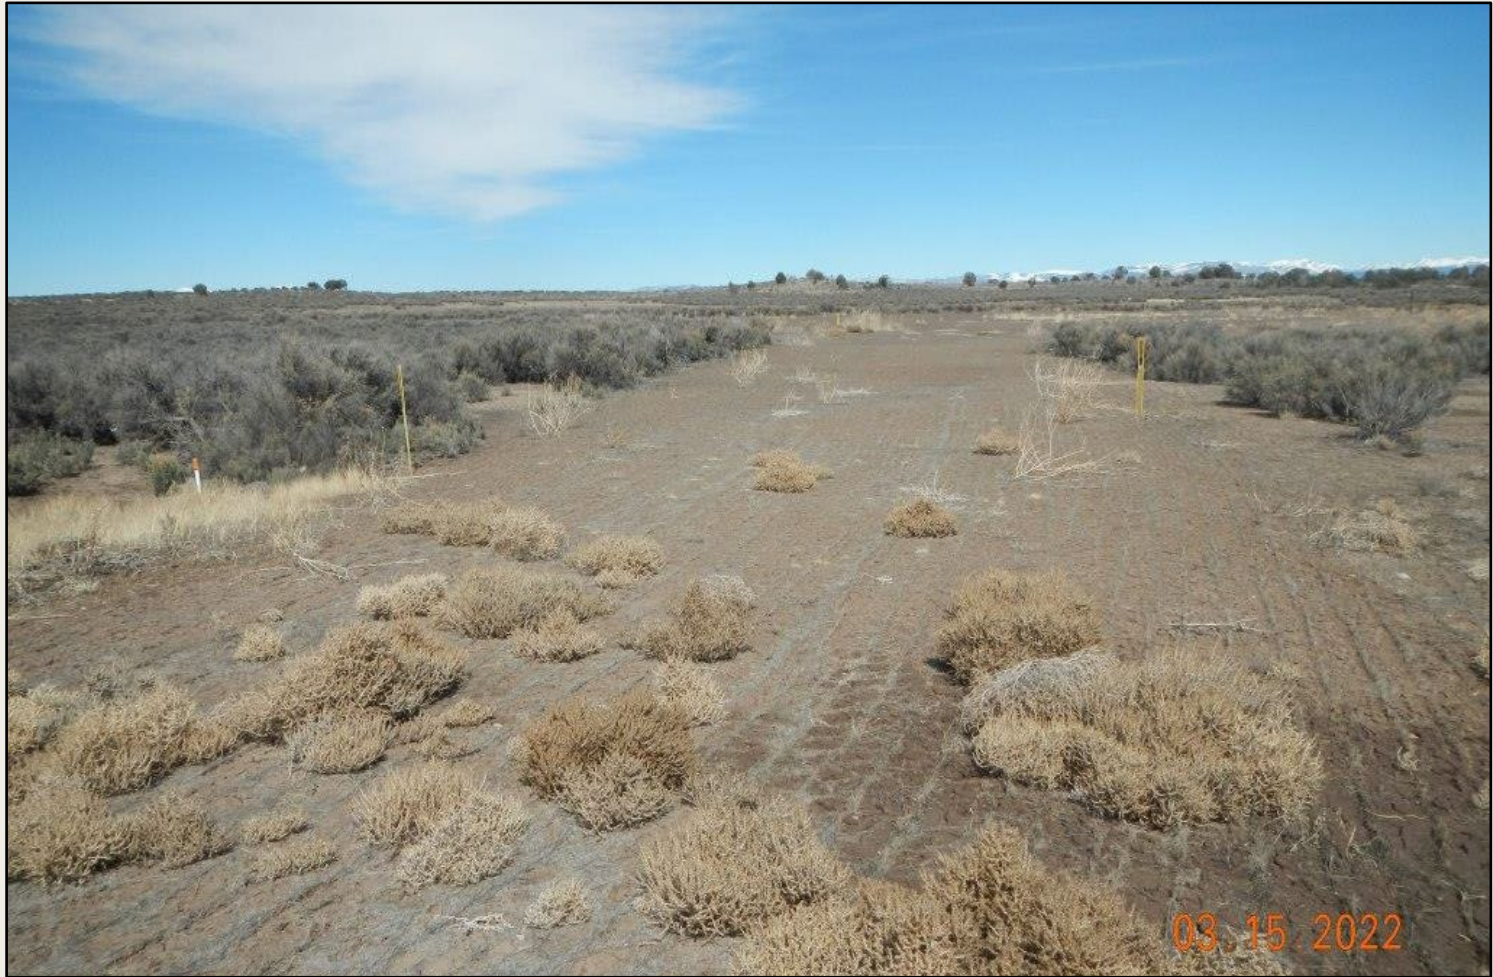
Photo 1. View of the reclaimed access road from the road entrance facing northward.

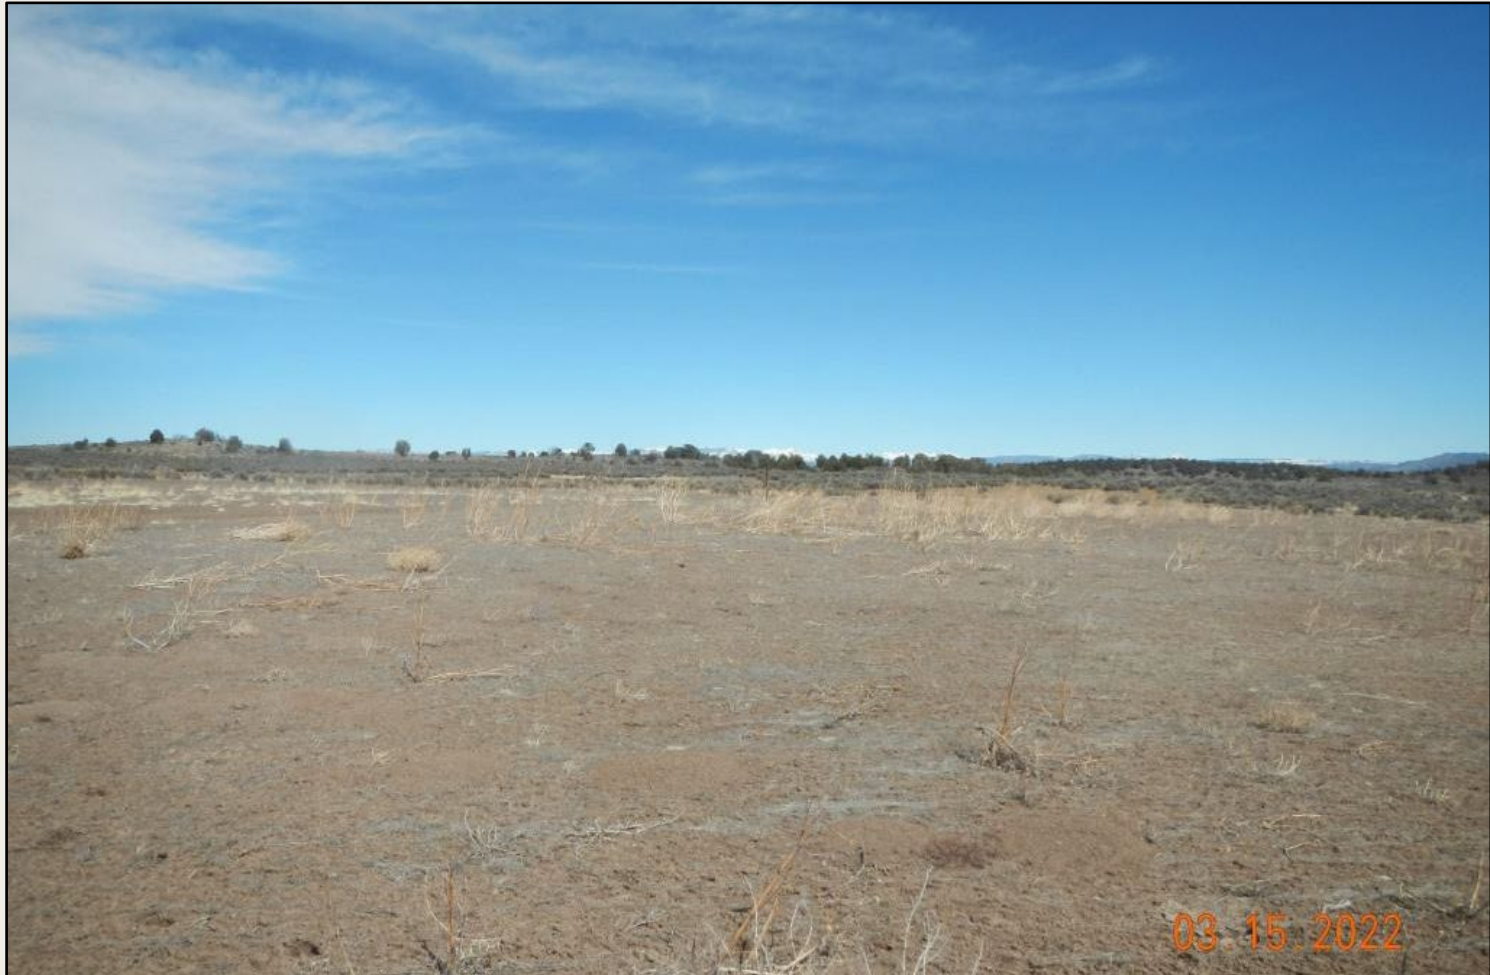
Photo 2. View of the reclaimed project area from the southeastern corner facing center. Reclamation is conducted. Hay mulch and seeding rows observed. Germination and revegetation needs to be monitored during the active growing season.

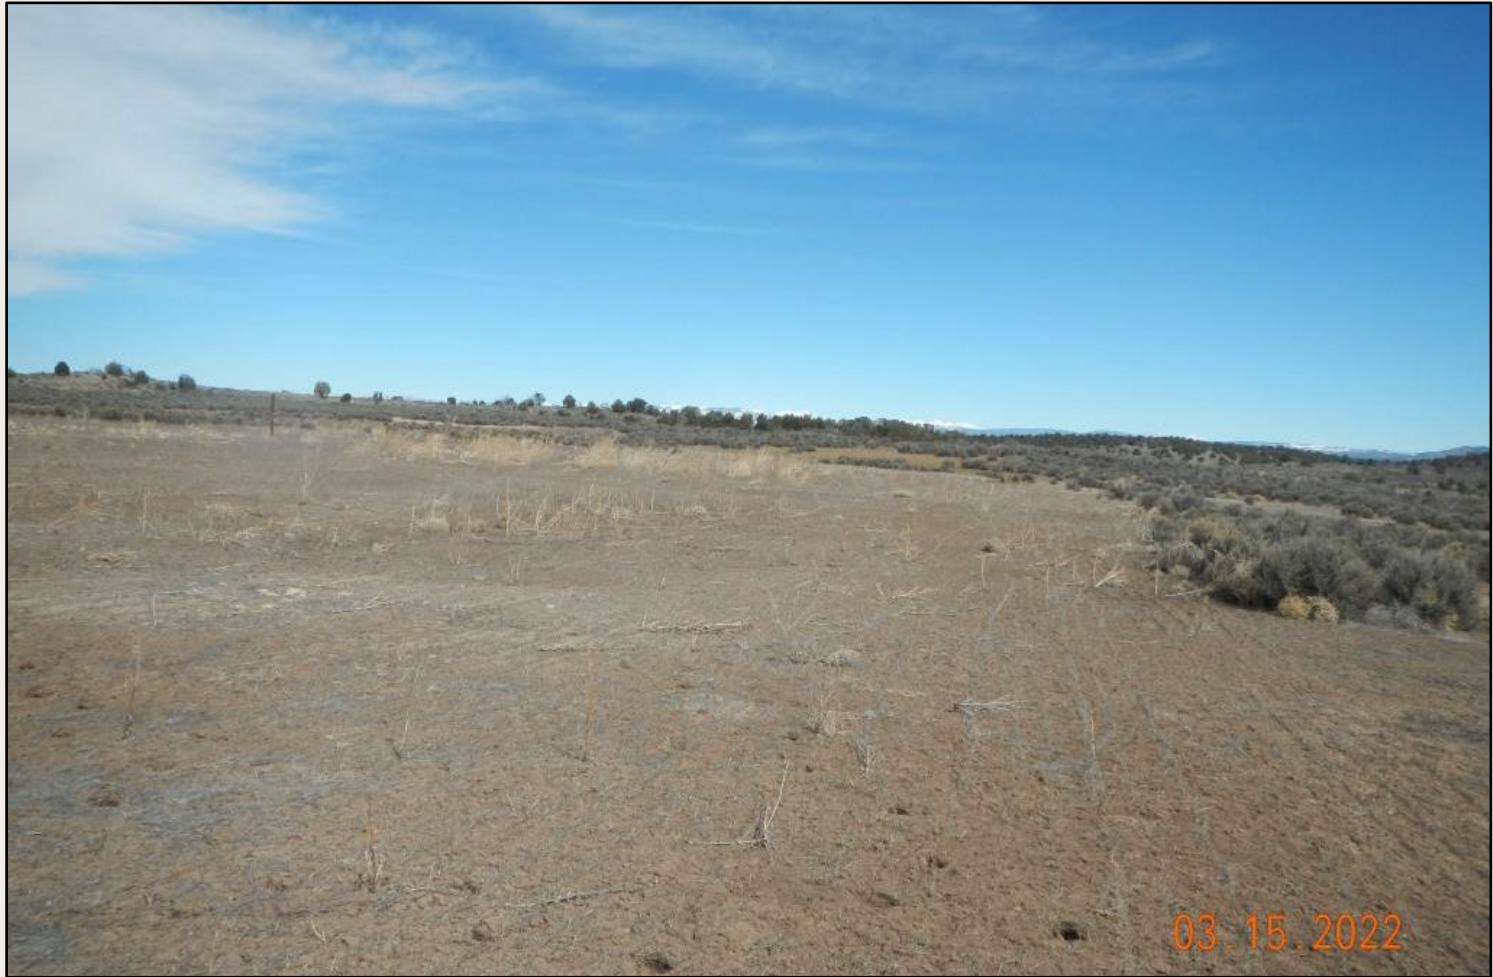
Photo 3. View of the eastern project area from the southeastern corner facing northward.

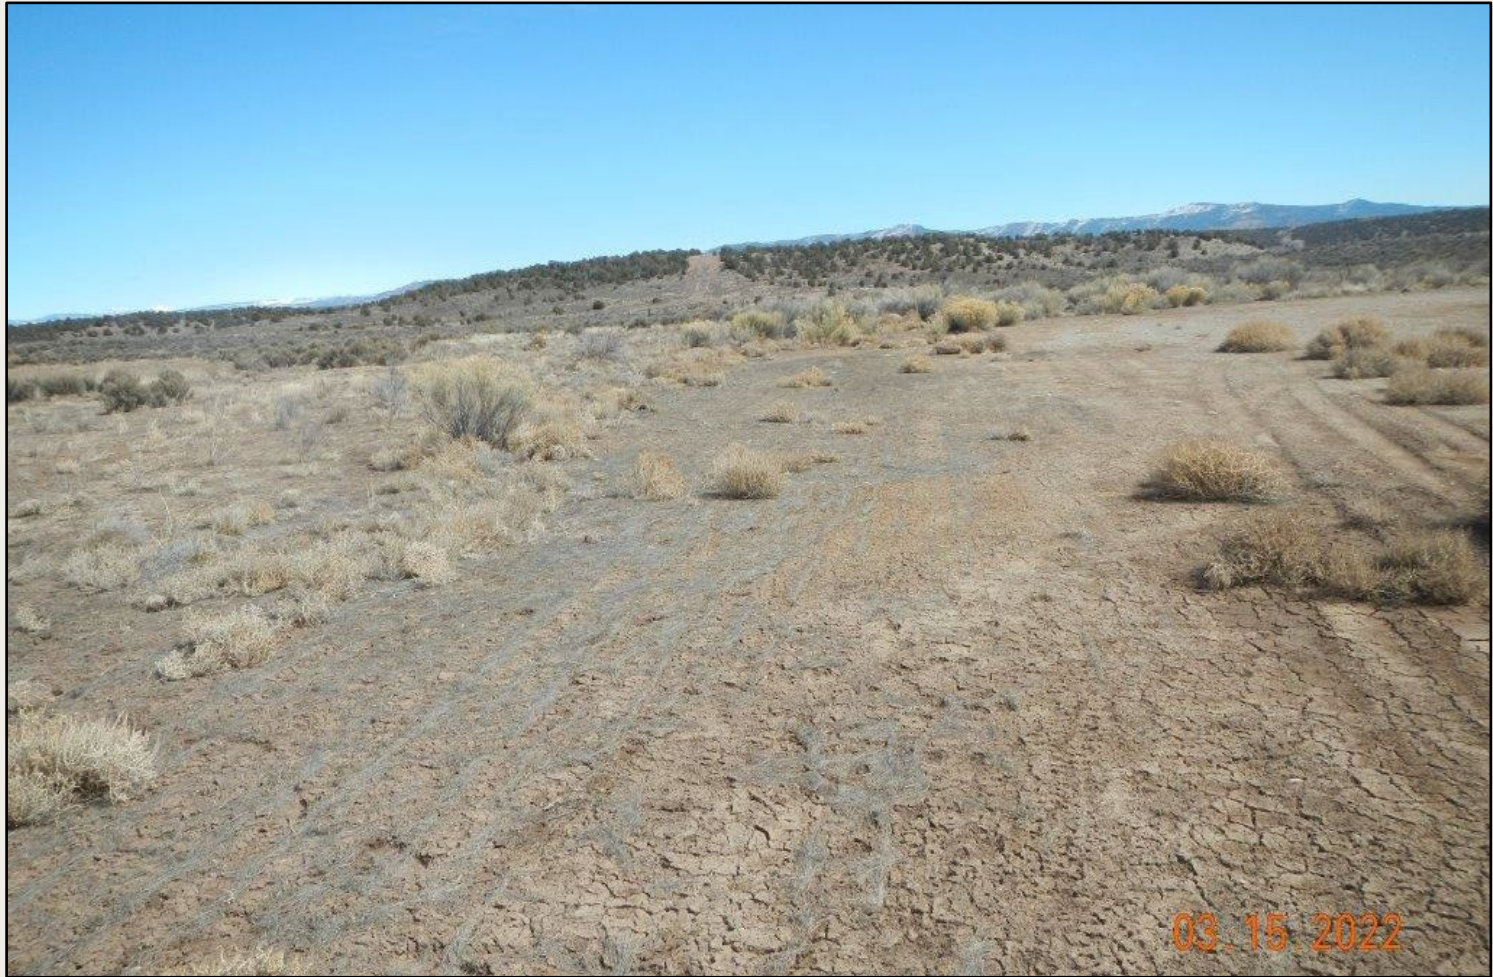
Photo 4. View of the southern project area from the southeastern corner facing westward.
