Inspection Photos  
Operator: Simcoe  
API: 067-09700  
Date: 3/15/2022

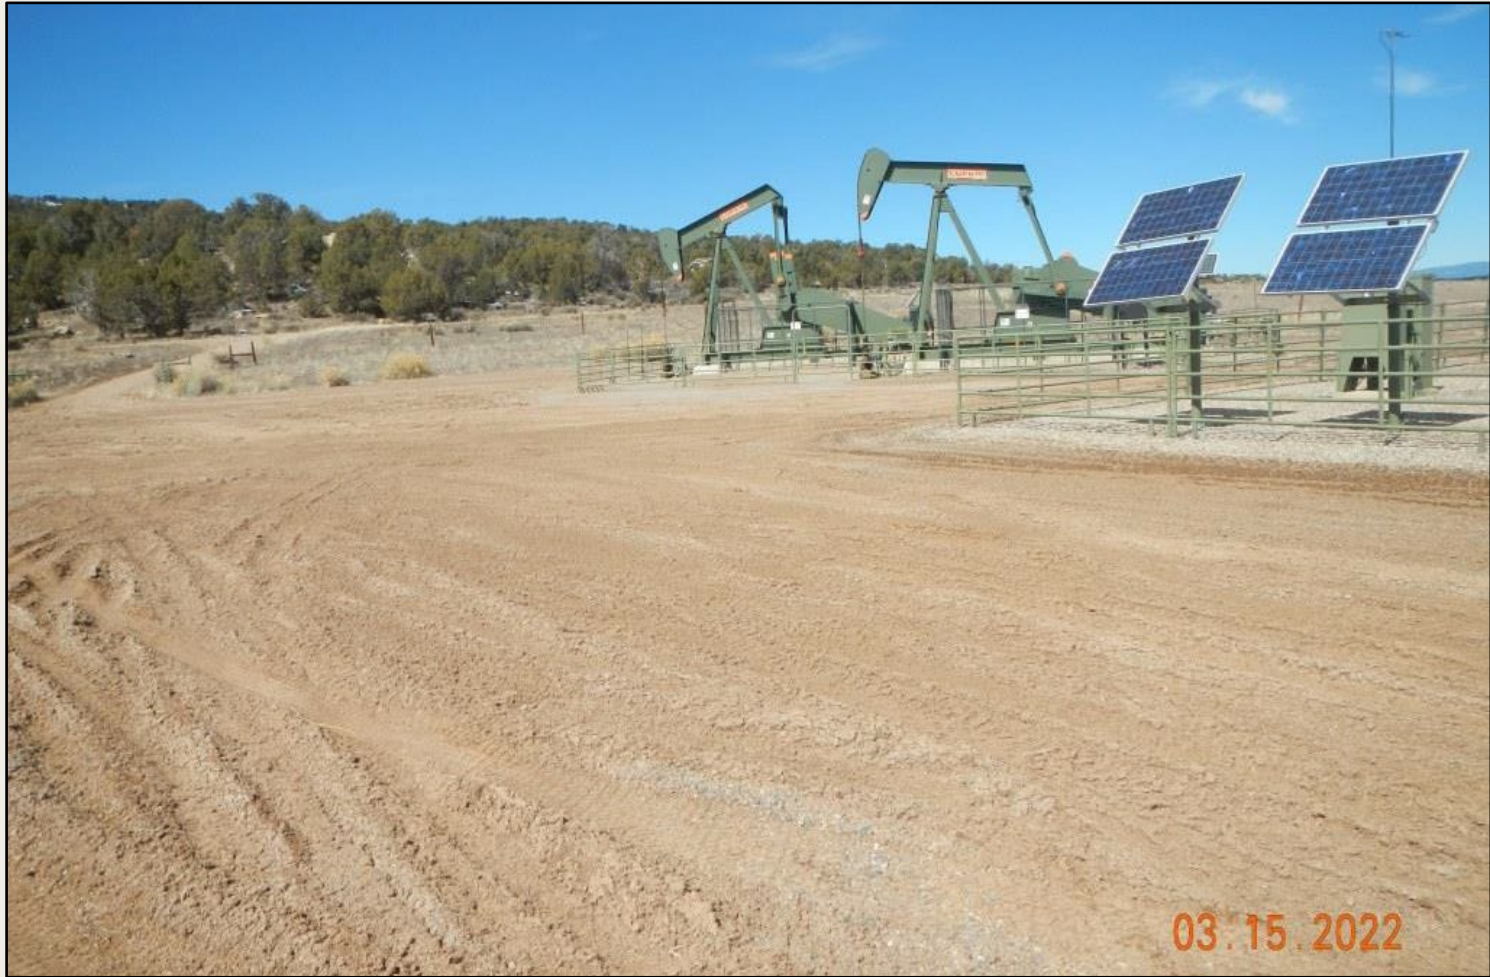
Photo 1. View of the project area from the southeastern corner facing center.

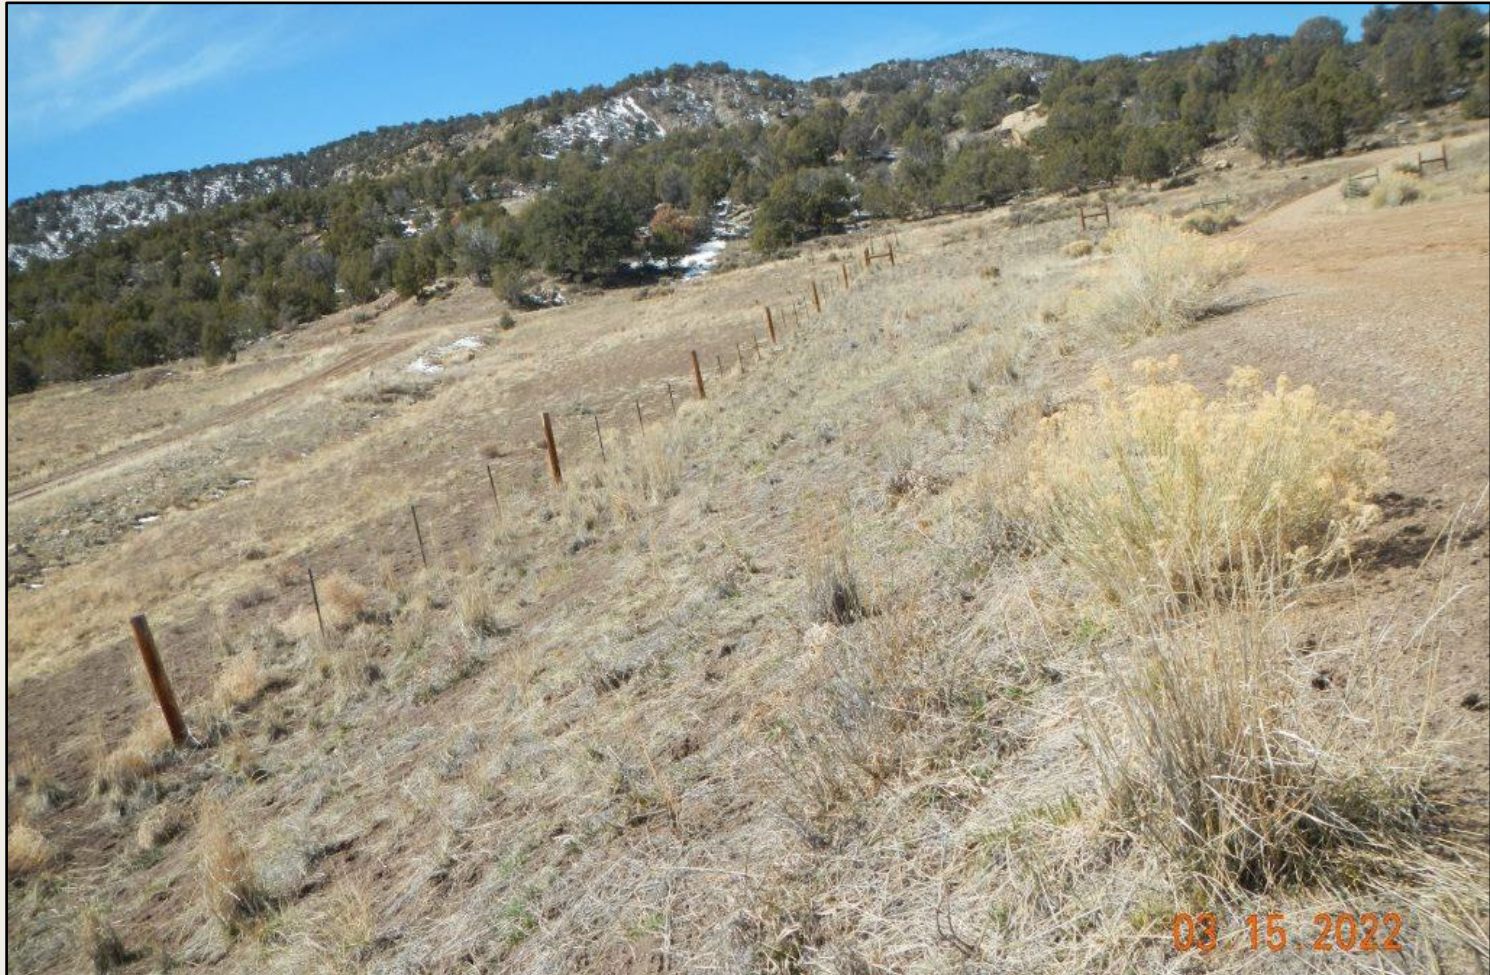
Photo 2. View of the southern fill slope from the southeastern corner facing westward. Revegetation is progressing with intermediate wheatgrass, crested whatgrass, and sand dropseed.

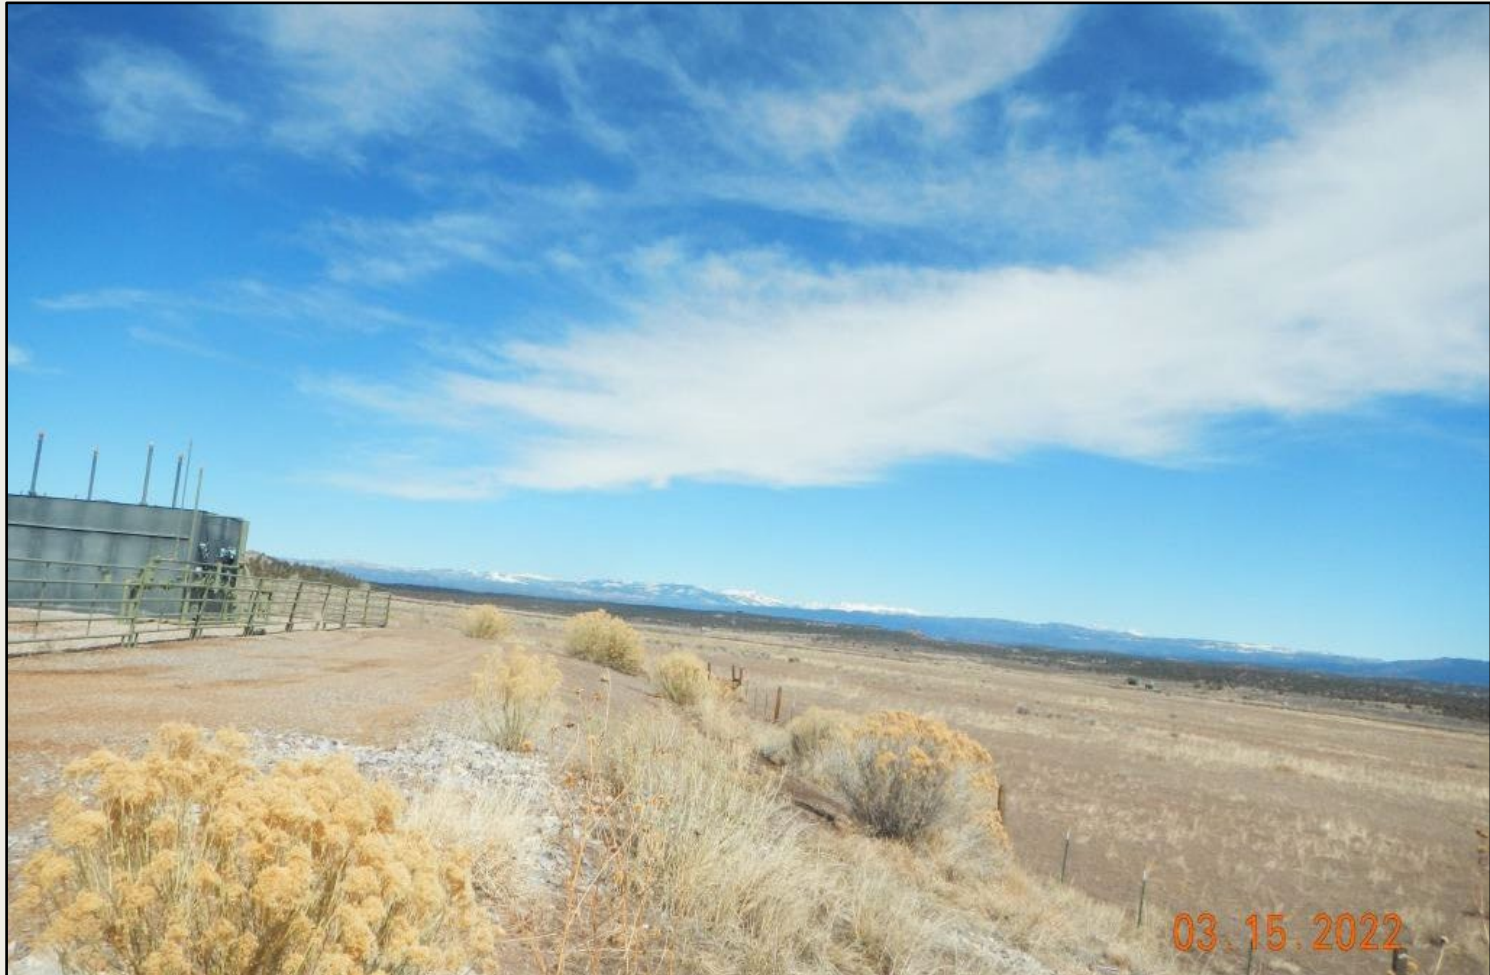
Photo 3. View of the eastern fill slope from the southeastern corner facing northward.

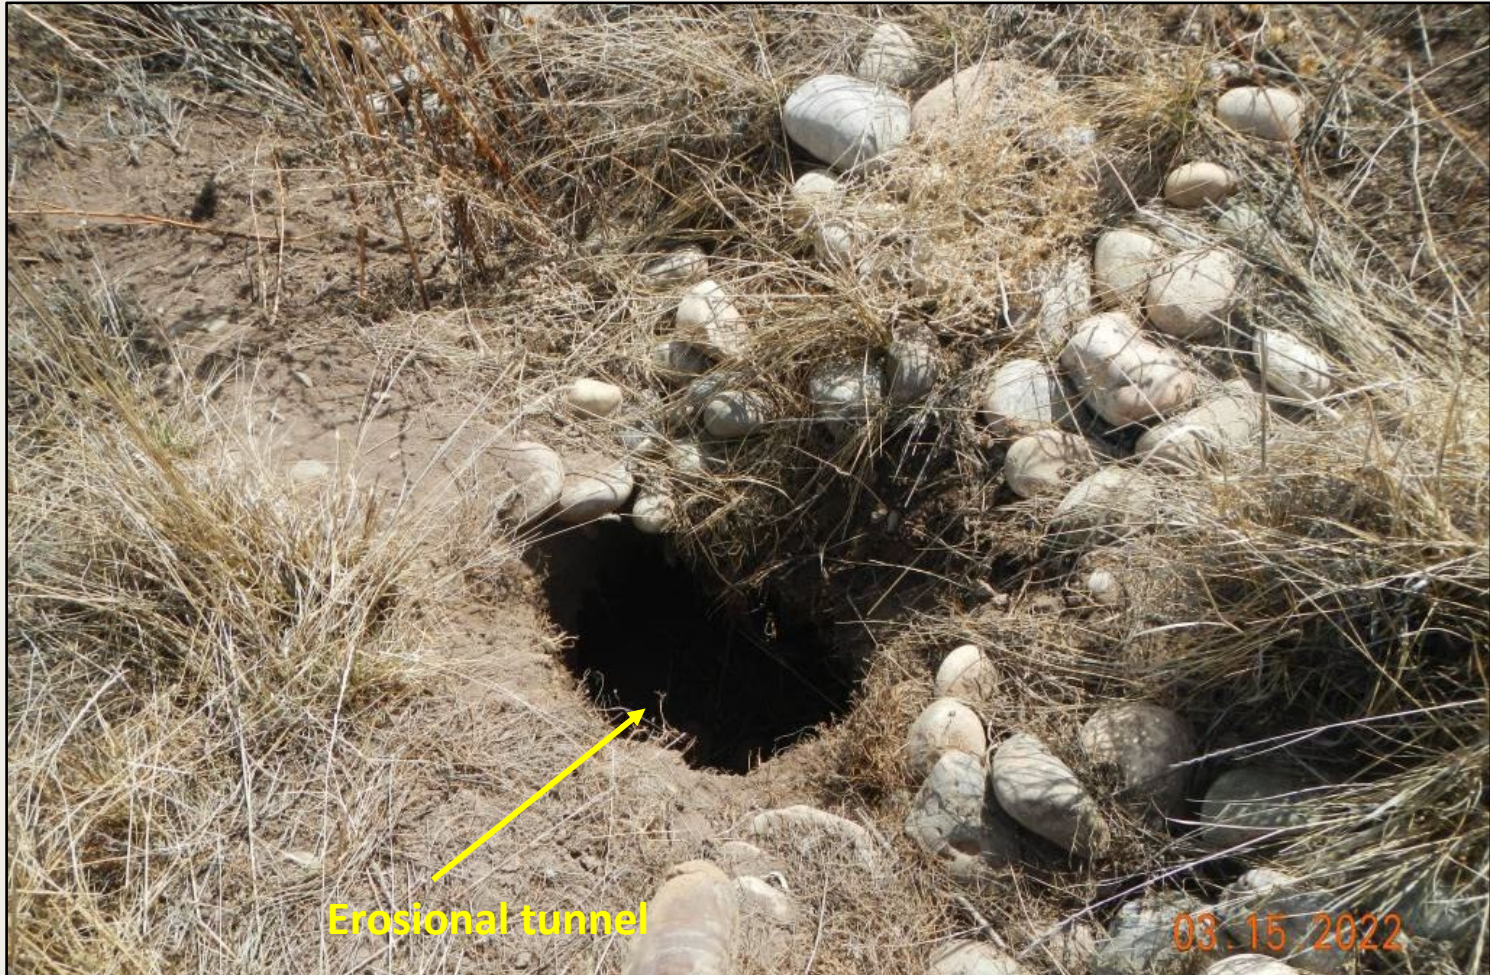
Photo 4. View of erosional tunneling in the southeastern corner of the well pad, approx. 2-3 ft deep. .

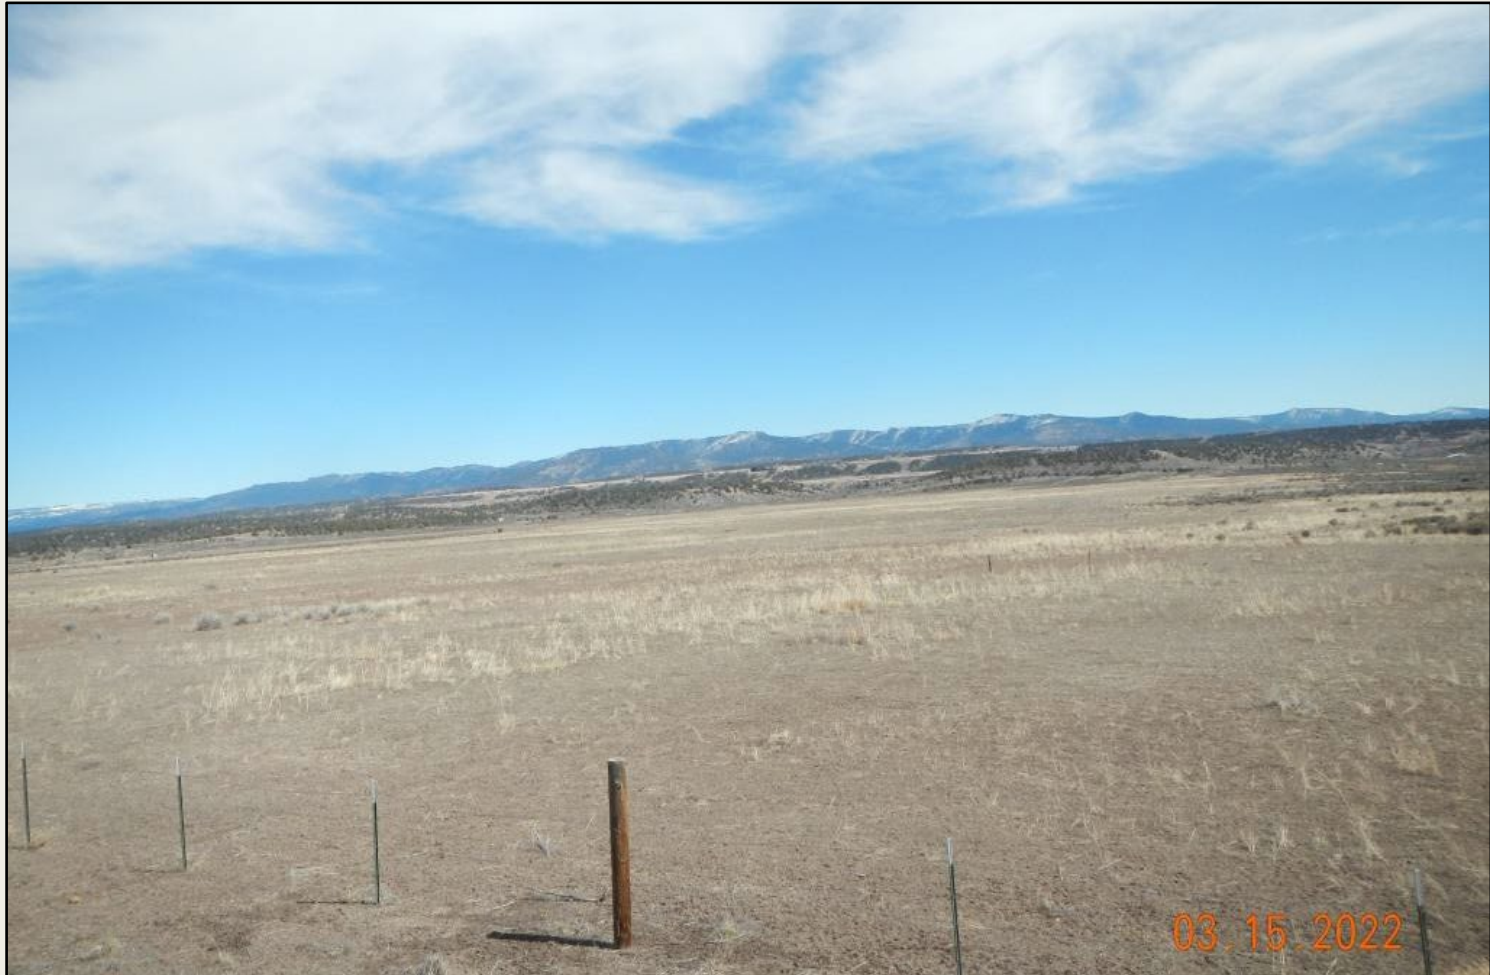
Photo 5. View of reference area comprised of open grass fields and sagebrush shrubland mosaic with western wheatgrass and sand dropseed observed.
