Inspection Photos
Operator: Simcoe
API: 067-05139
Date: 3/15/2022

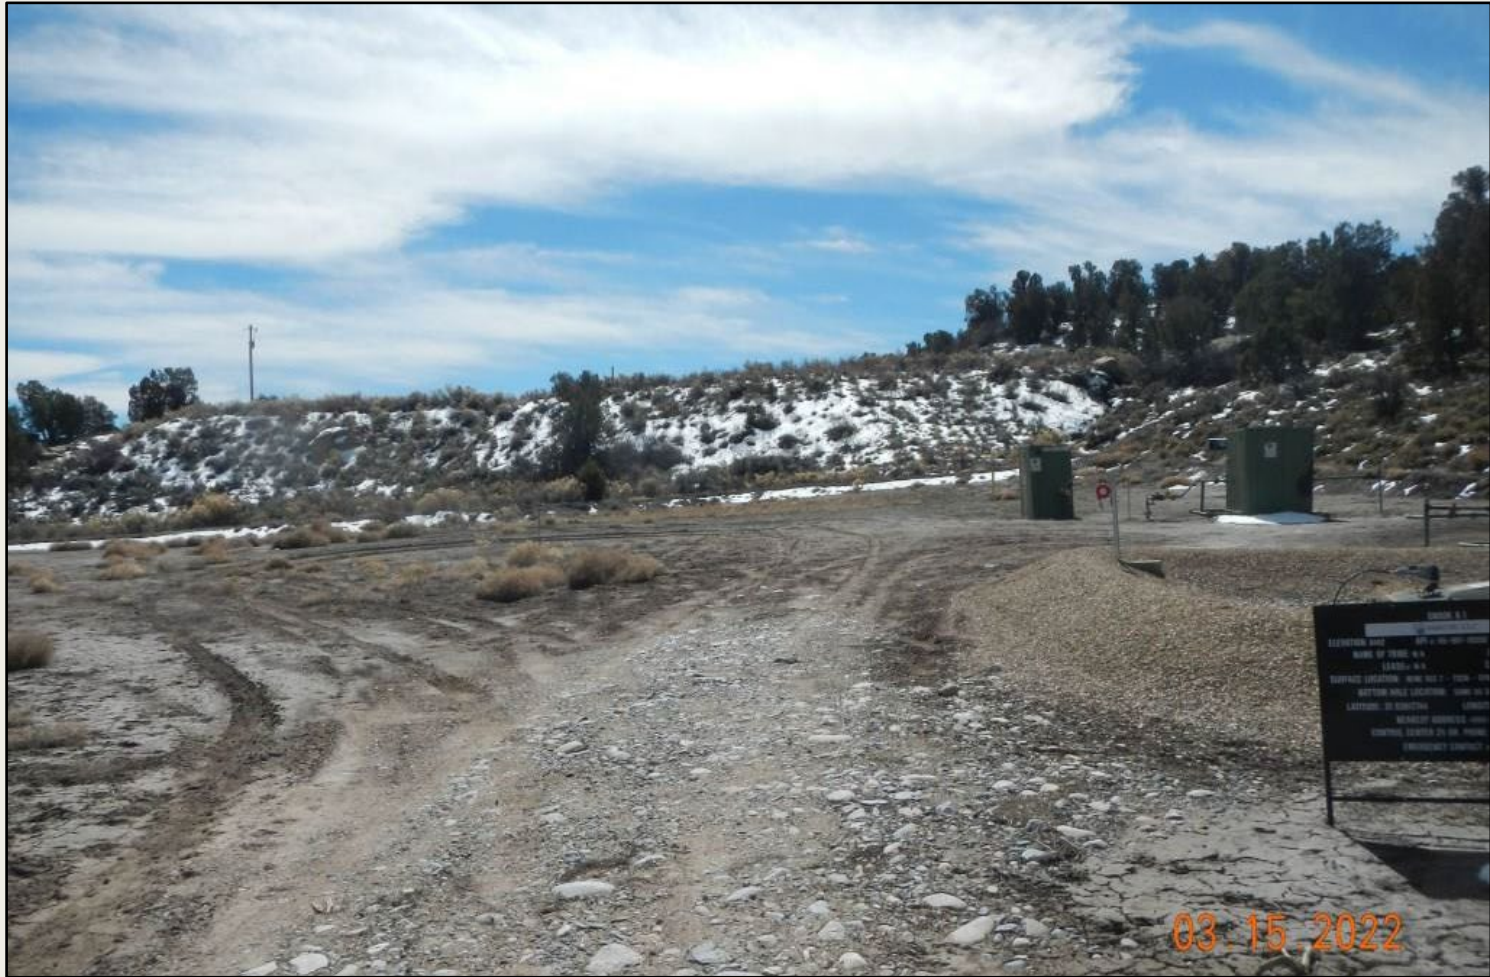
Photo 1. View of the project area from the well pad entrance facing center.

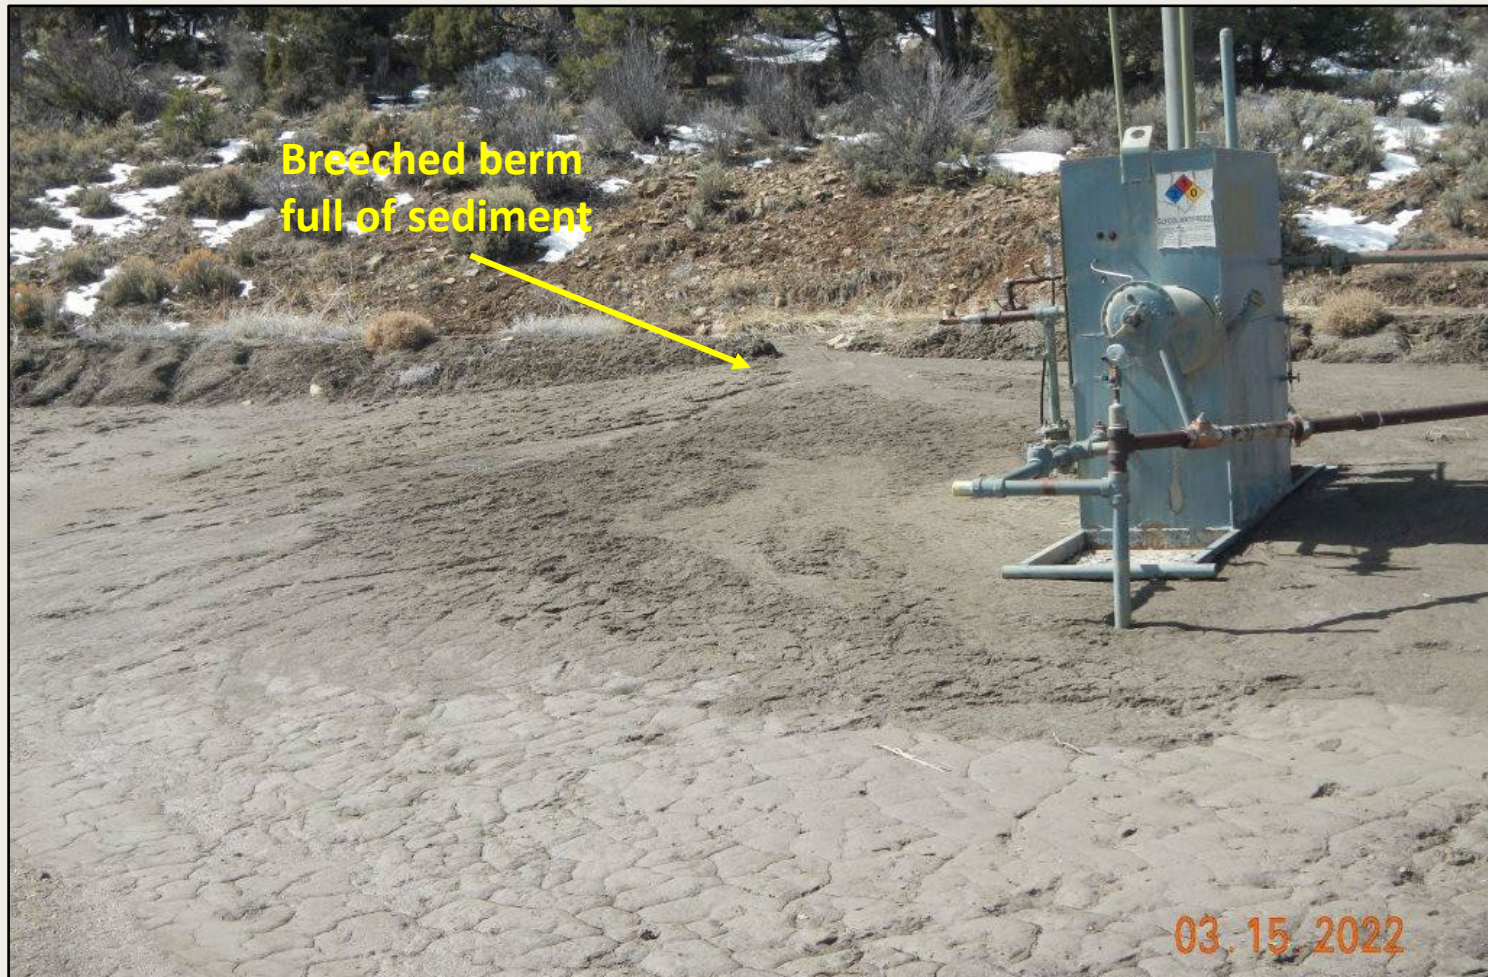
Photo 2. View of area where the western berm has breached and is depositing large volumes of sediment on the well pad. BMPs are not maintained or adequate.

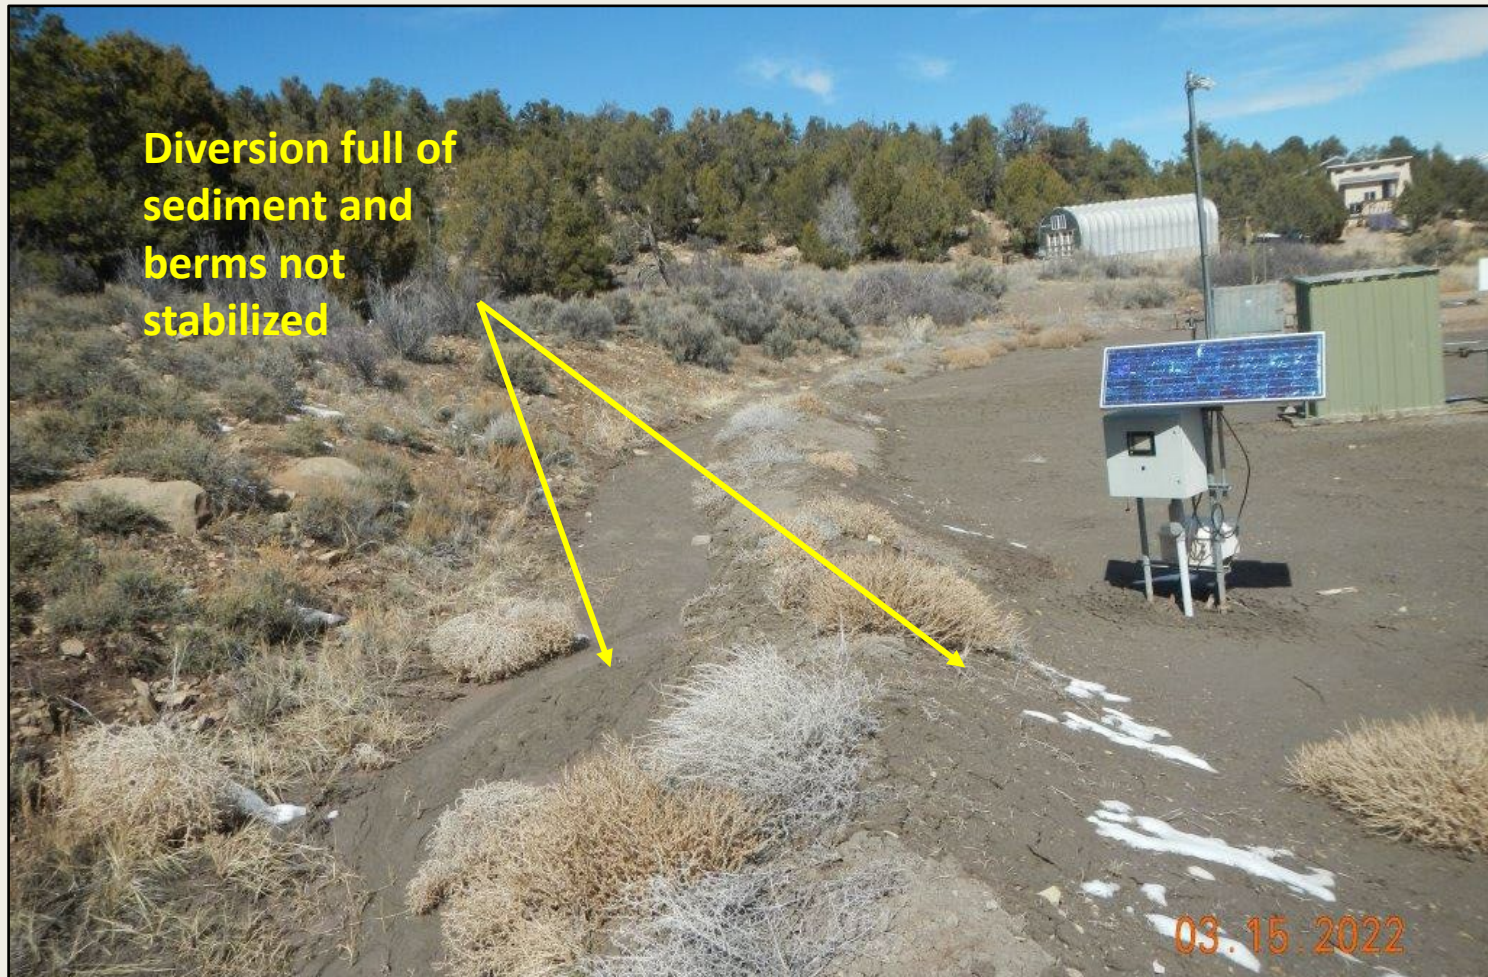
Photo 3. View of the western fill slope from the southwestern corner facing northward. Berms are not stabilized, diversion is full of sediment.

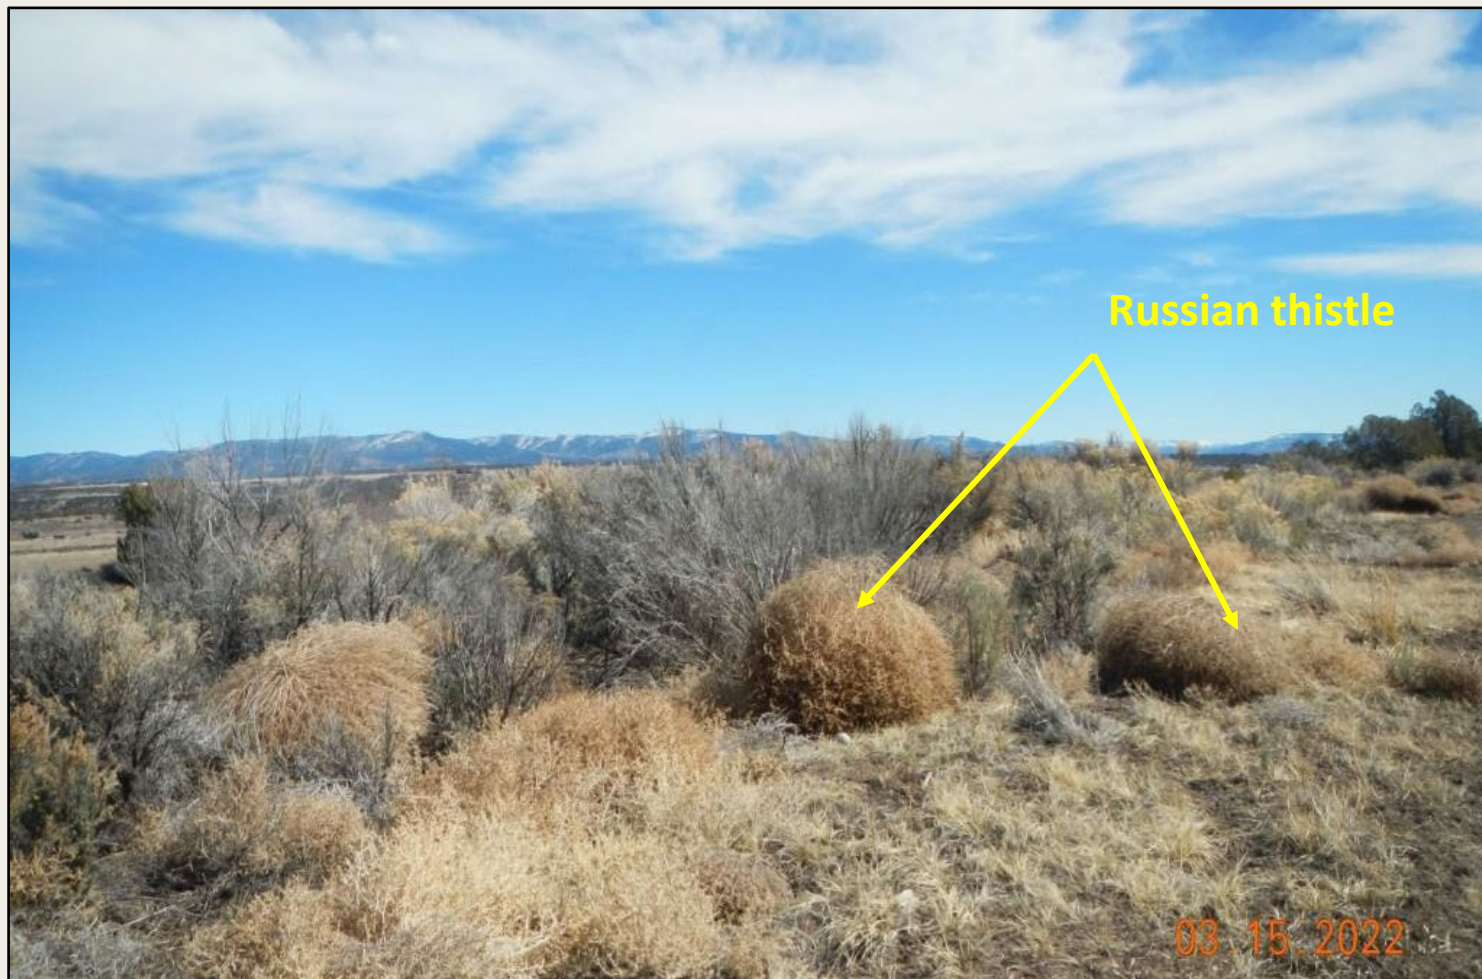
Photo 4. View of Russian thistle debris blowing off of the project area.

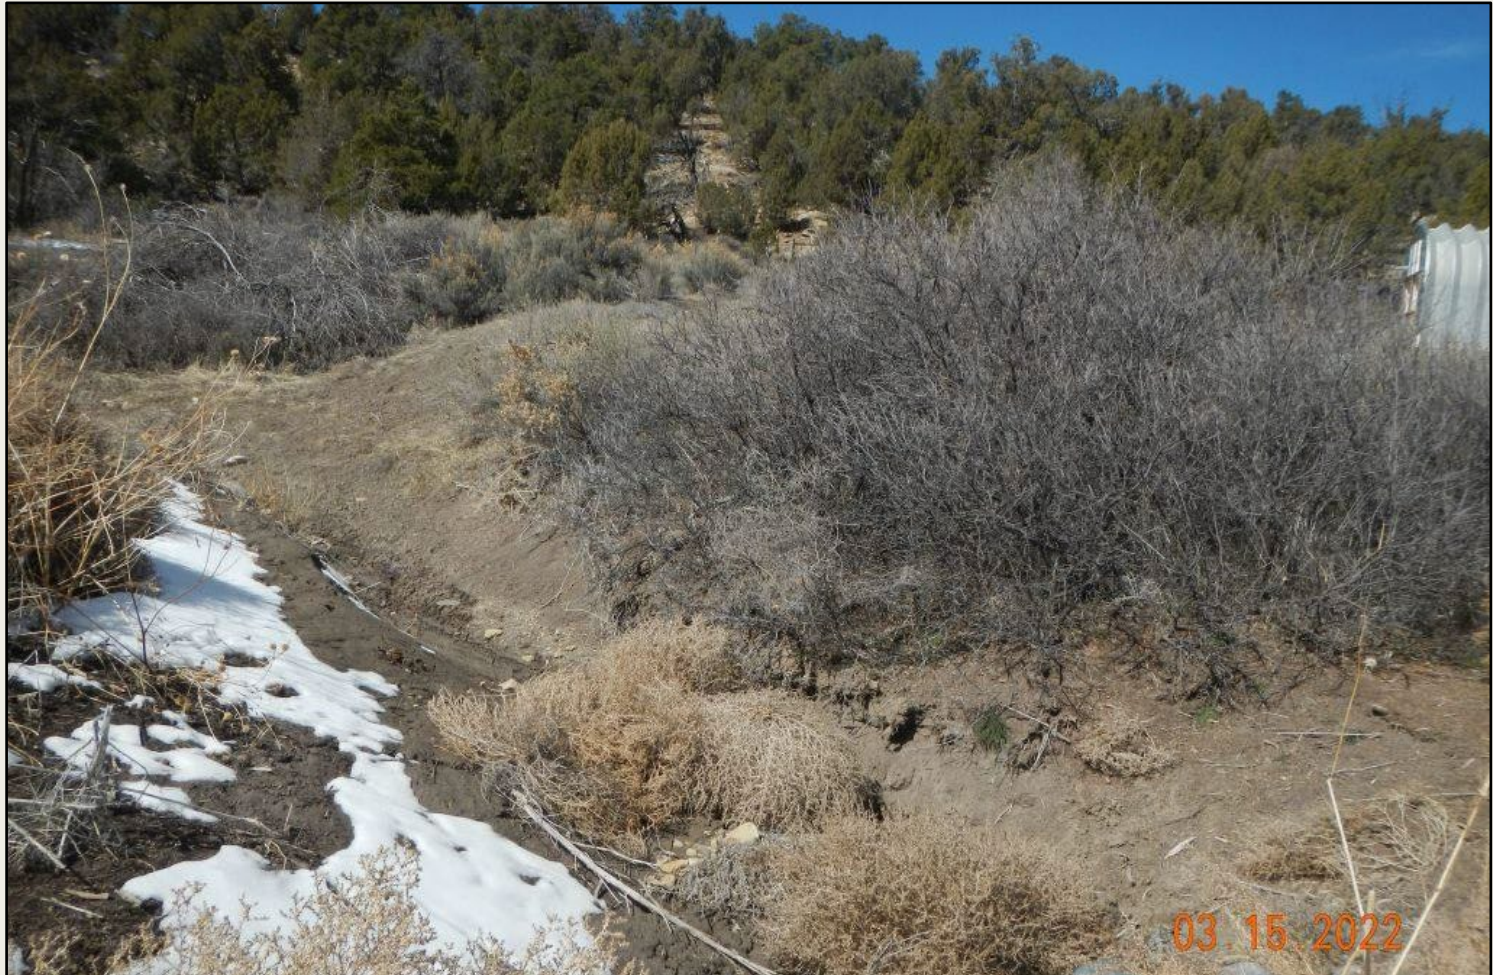
Photo 5. View of the northwestern diversion full of sediment and Russian thistle debris.

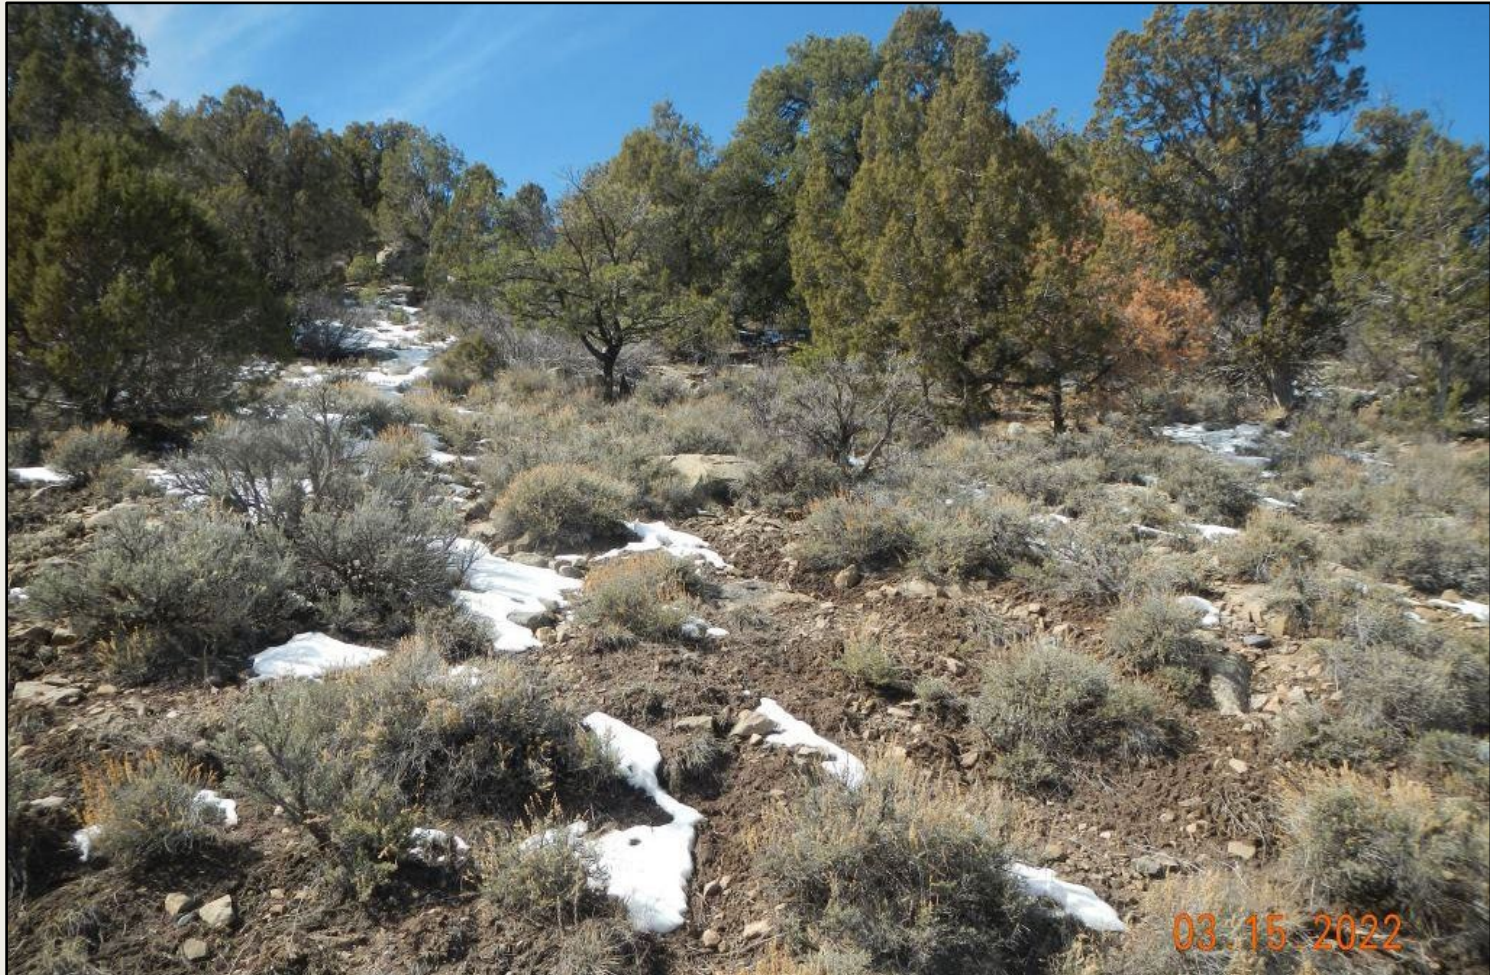
Photo 6. View of reference area comprised of pinyon and juniper woodland with understory of black sagebrush, yucca, James galleta.
