Inspection Photos
Location Name: Hadky O Gorman #3
Location ID: 332971

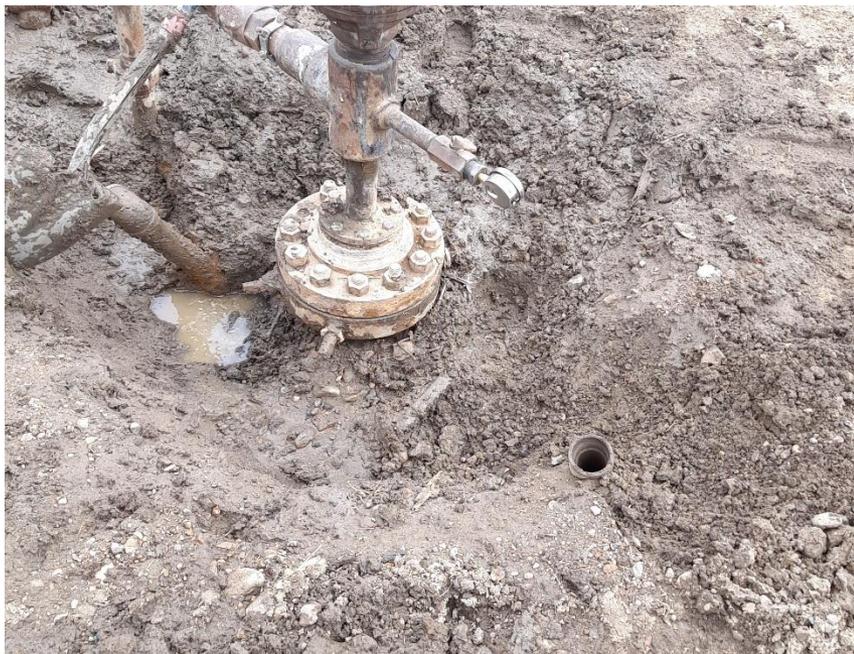
Photo 1 Crew digging up casing and braden head lines to perform test

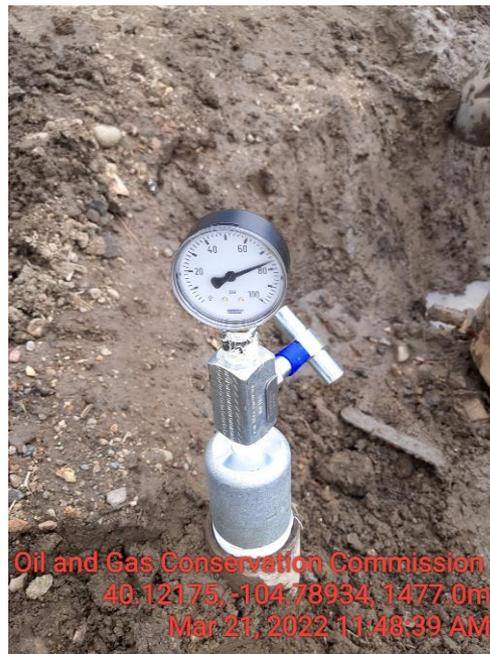
Photo 2 Casing pressure when opened

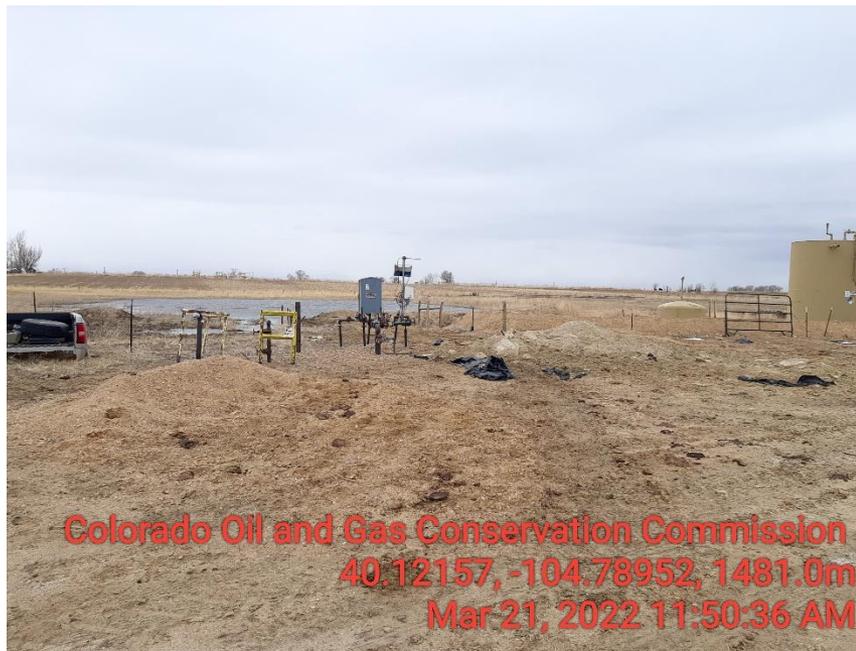
Photo 3 not BMP's or fencing around contaminated material

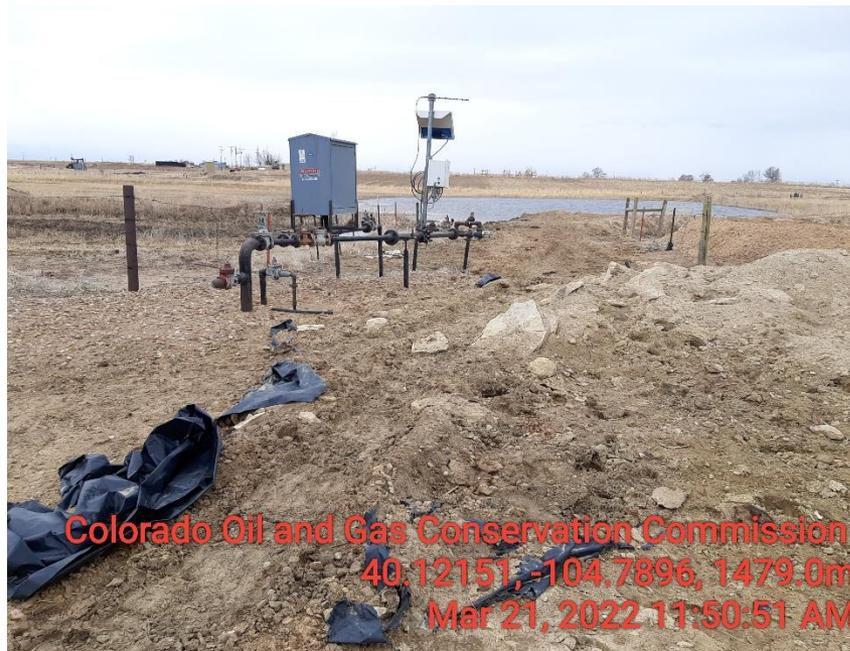
Photo 4 Contaminated material liner is ripped and into pices due to no fence or BMPs

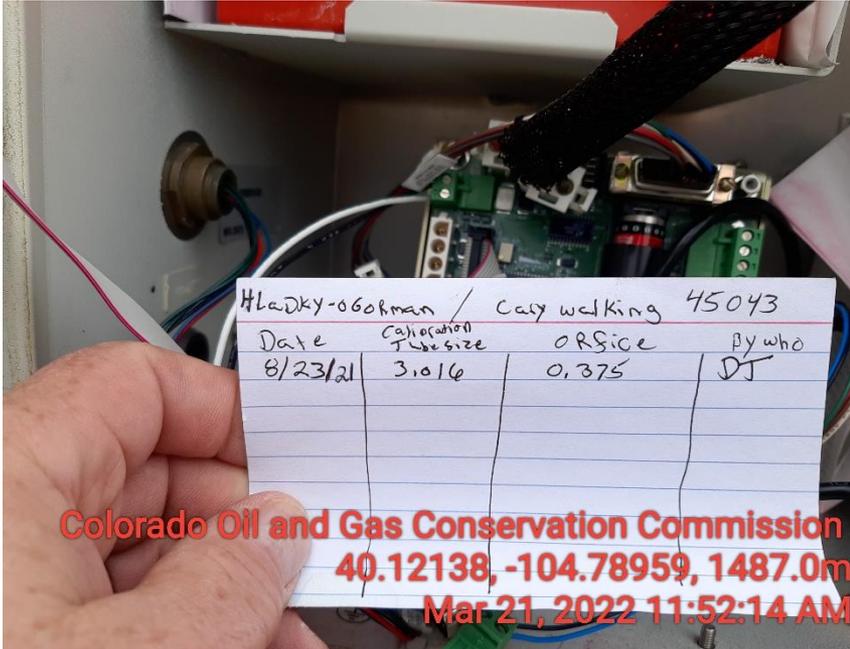
Photo 5 meter calibration card

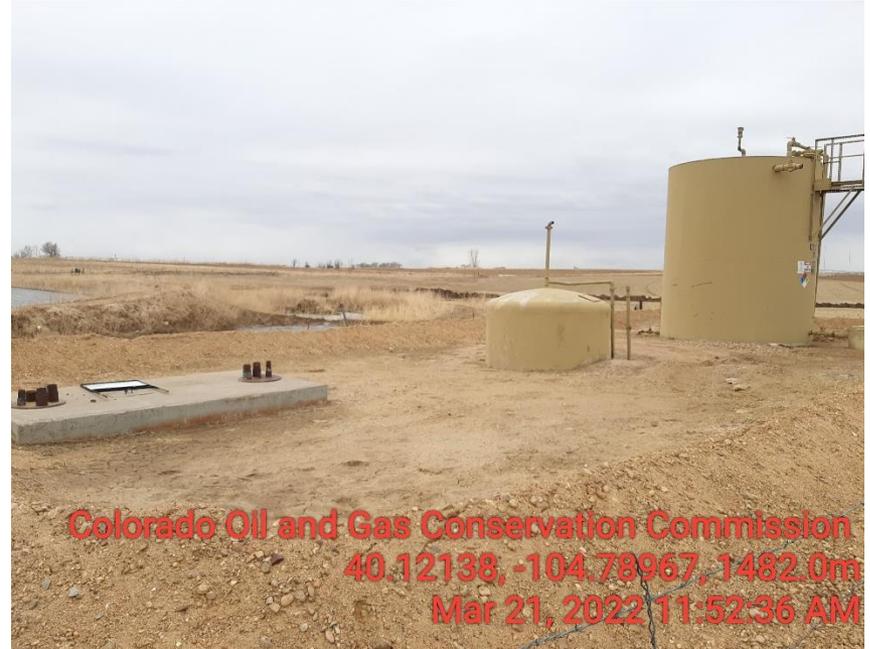
Photo 6 TNK BTRY

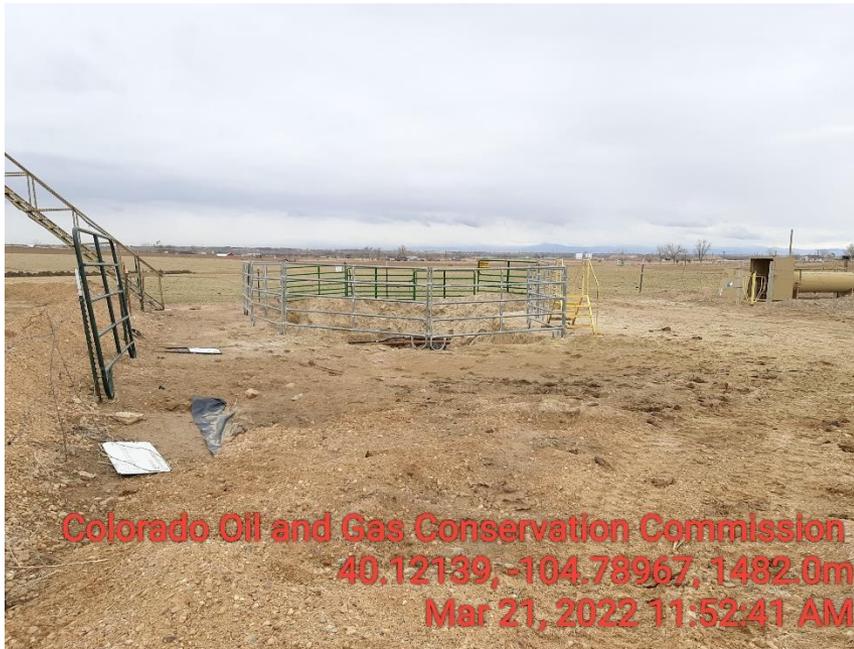
Photo 7 Open excavation

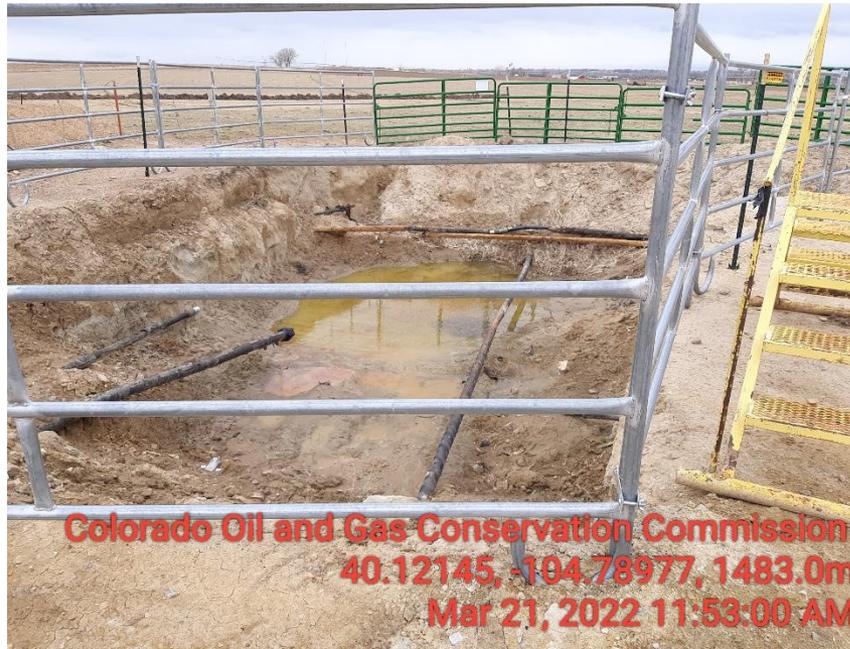
Photo 8 open excavation

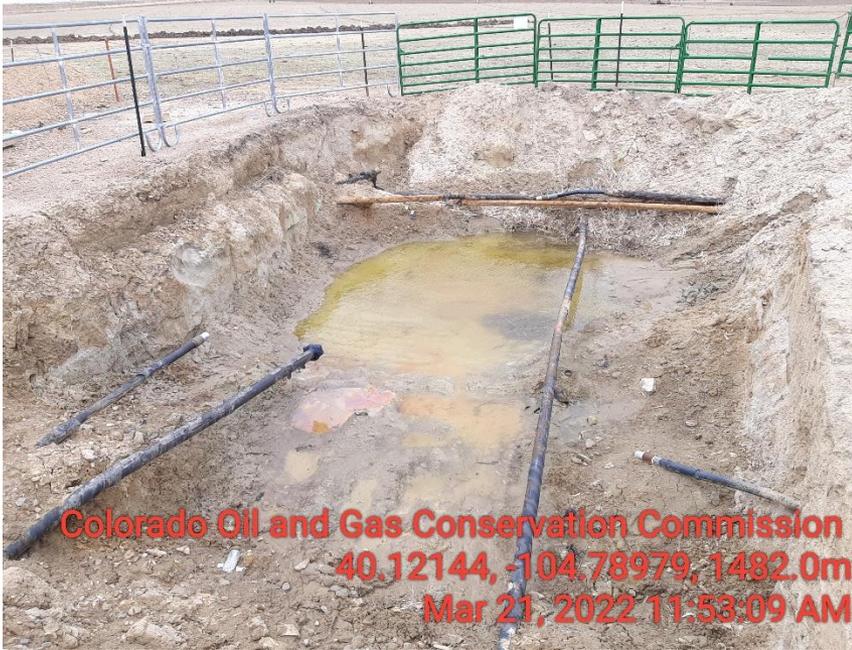
Photo 9 open excavation

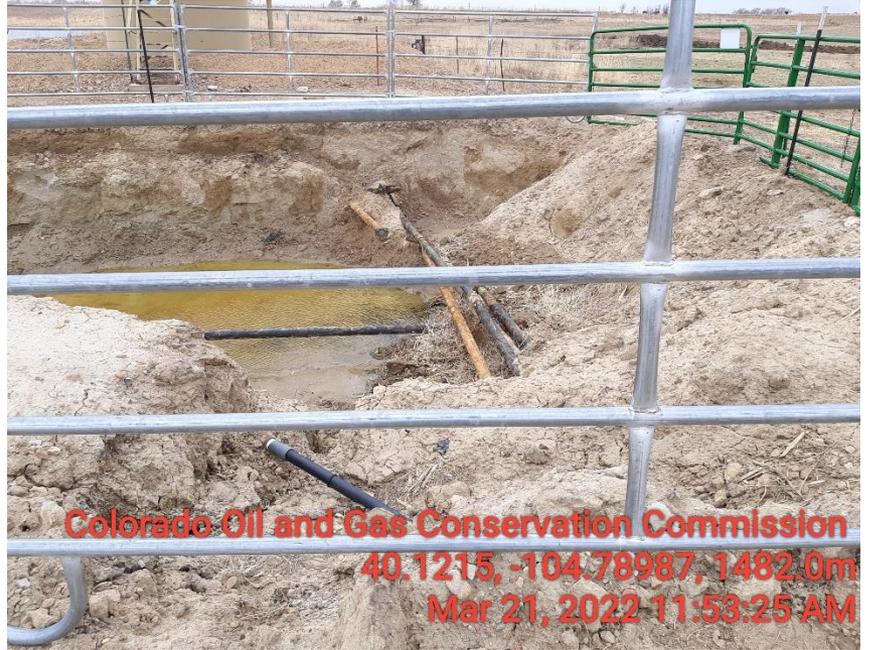
Photo 10 open excavation.

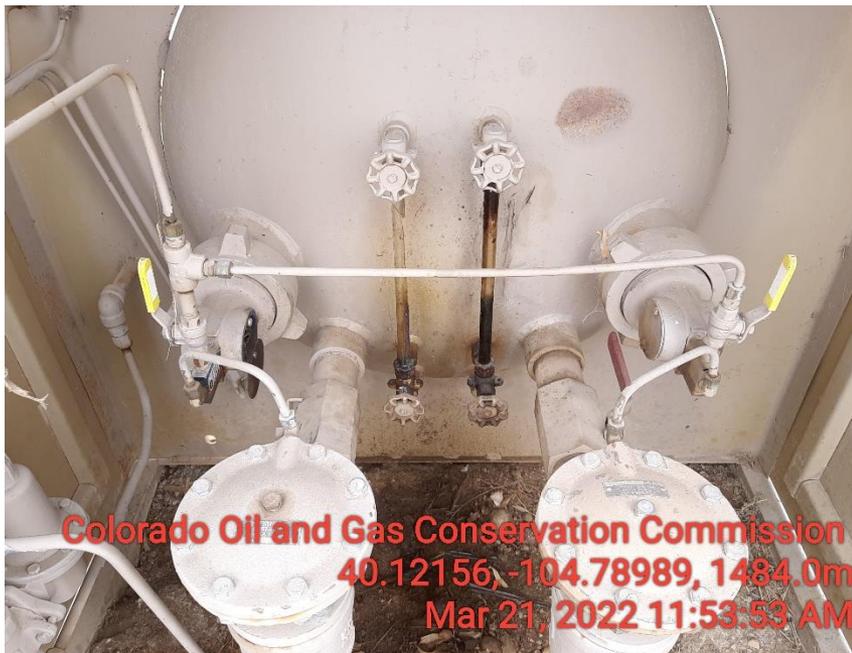
Photo 11 mechanical issue (sight Glass) and stained soil.

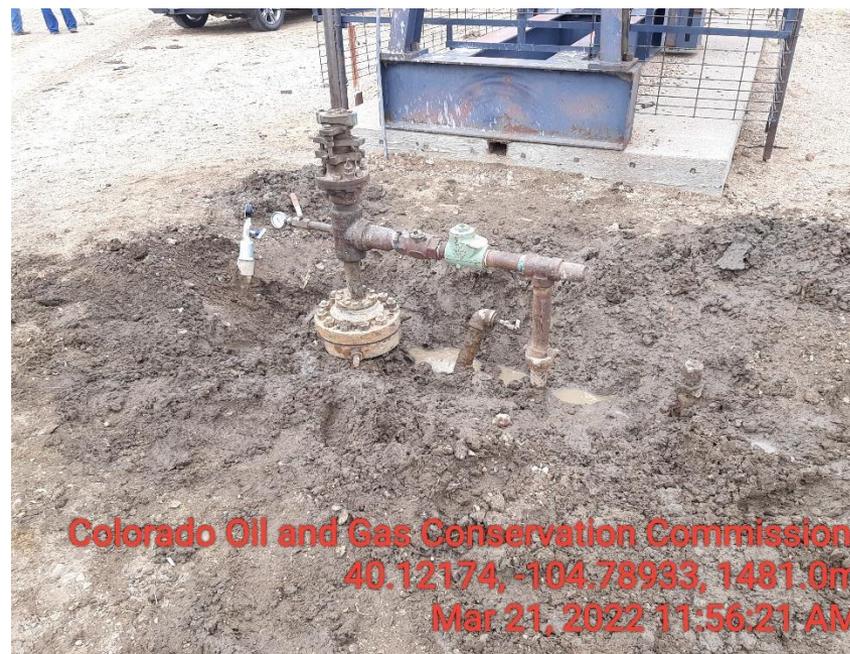
Photo 16 braden head test no gauge on braden head line.

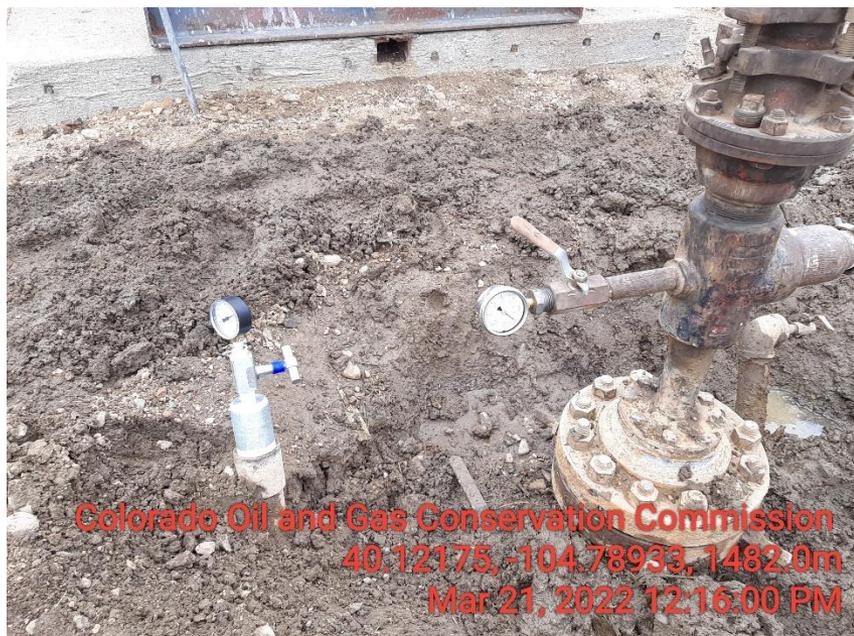
Photo 17 end of test

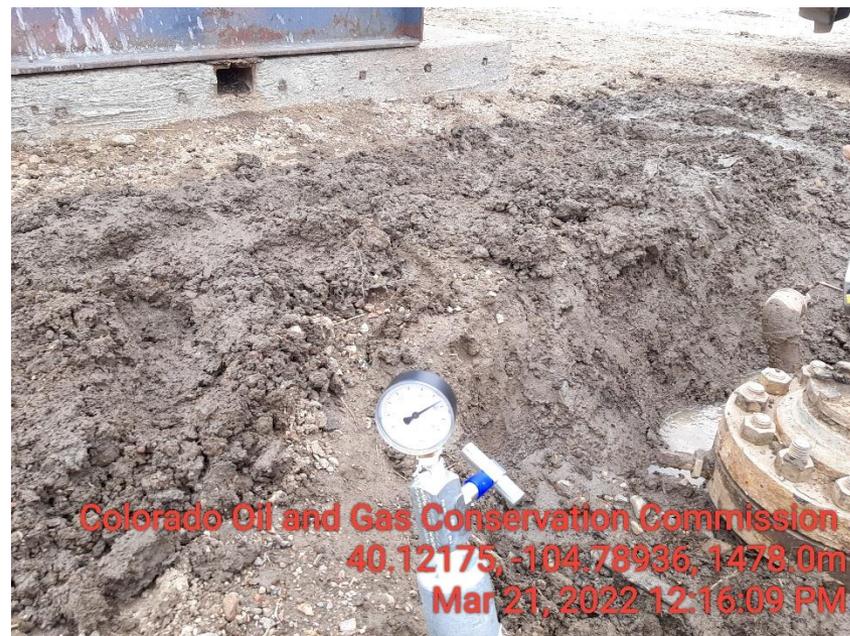
Photo 18 end of test.

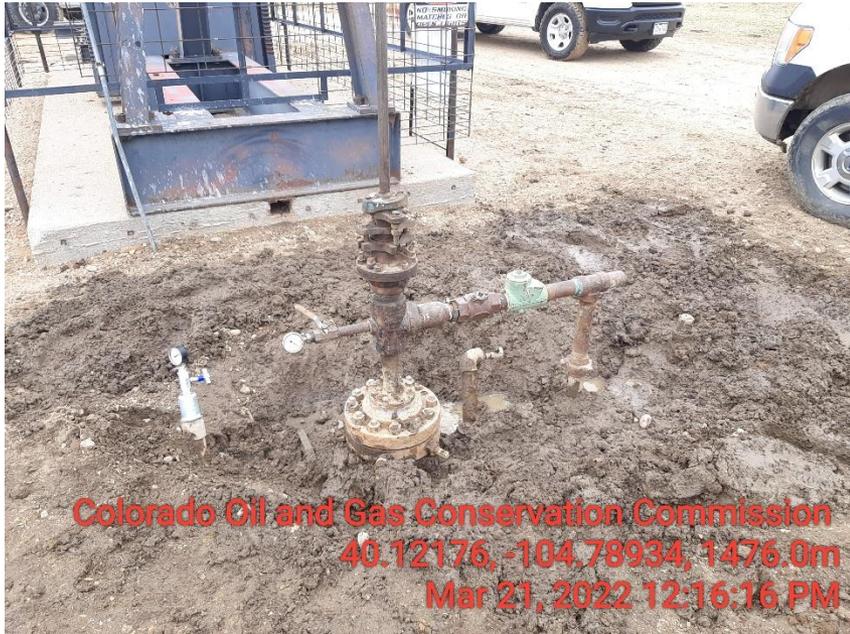
Photo 19 end of test.
