Inspection Photos

Location Name: CAERUS PICEANCE LLC FEDERAL-67S95W /30SESW

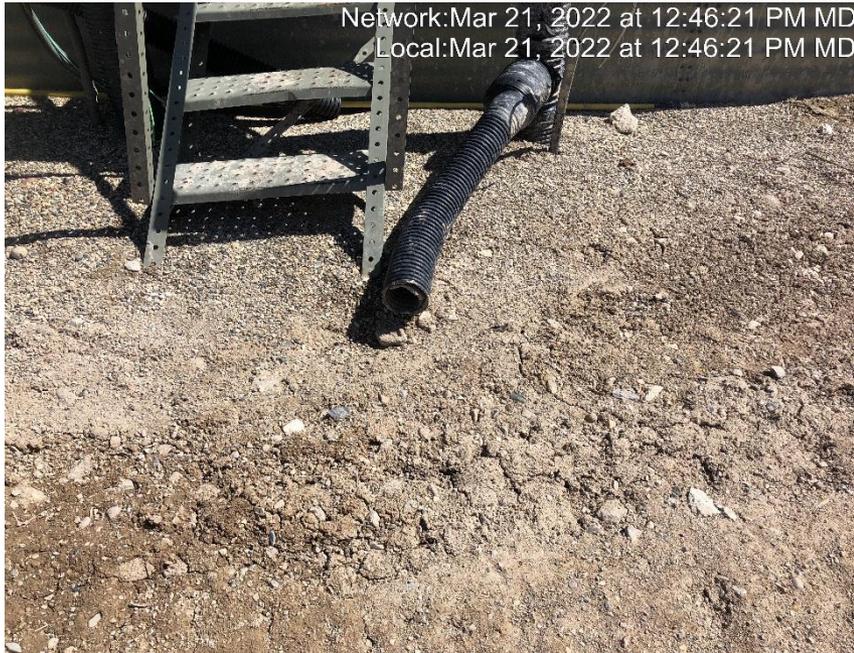
Photo #6257 flow line heating insulation open ended and not capped.

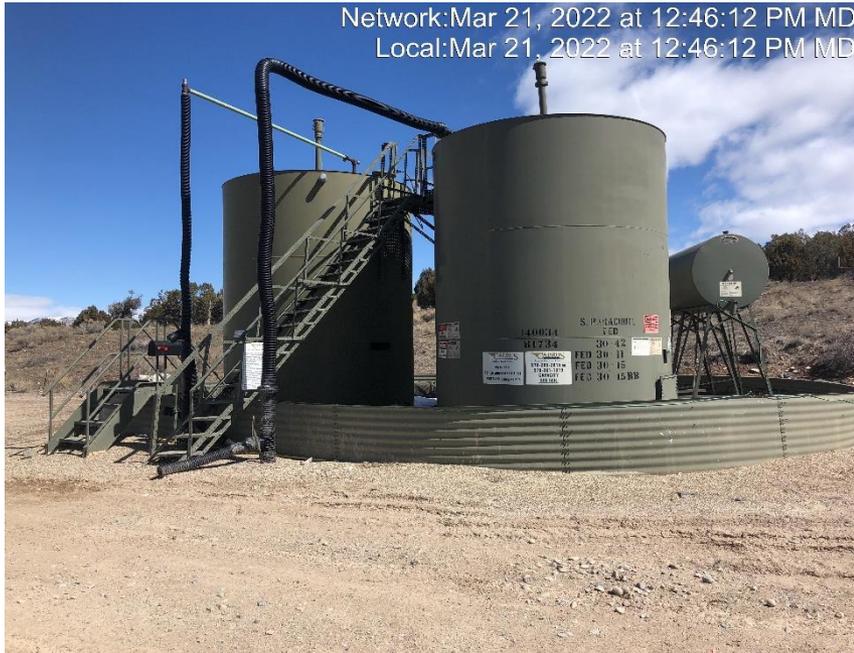
Photo #6256 No battery sign located at the tank battery.
