Inspection Photos

Location Name: Southern Ute 33-9 #20-2 Water Line

Spill/Release Point ID: 481824

COLORADO
Oil & Gas Conservation
Commission
Department of Natural Resources

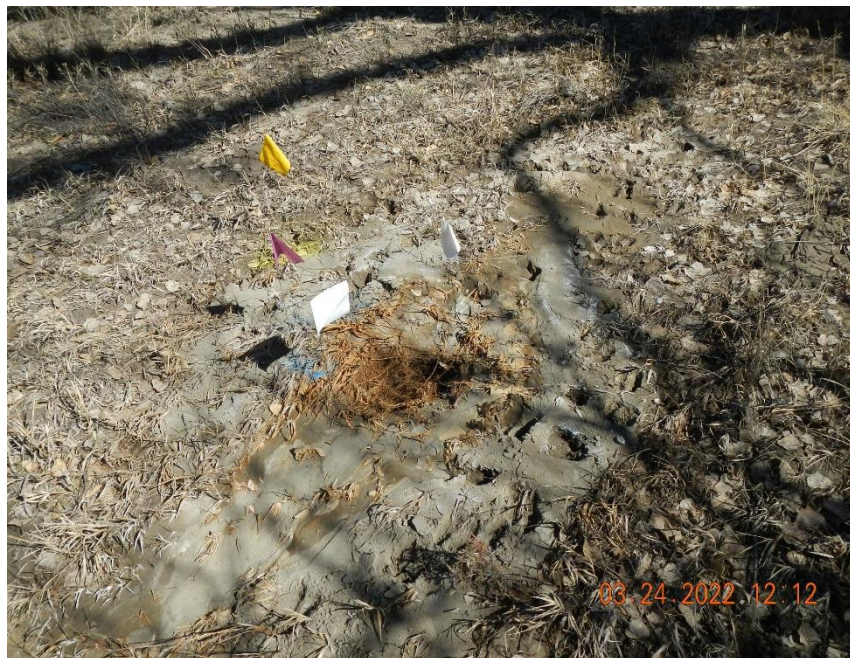
Area where Spill/Release Point ID #481824 day lighted. An approximately 1' diameter hole was observed.

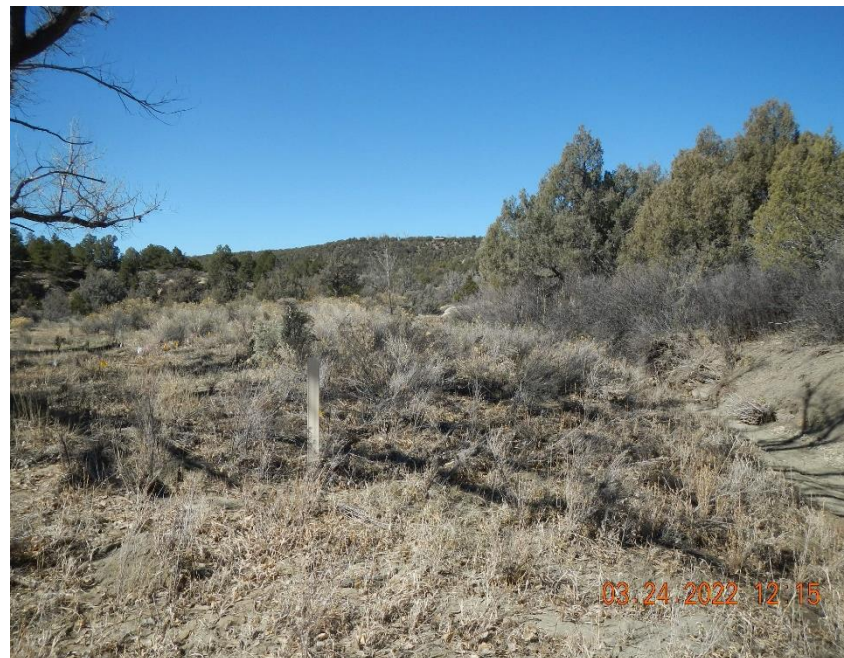
Proximity of release to Gaines Canyon. Pin flags on left side of photo mark release point.

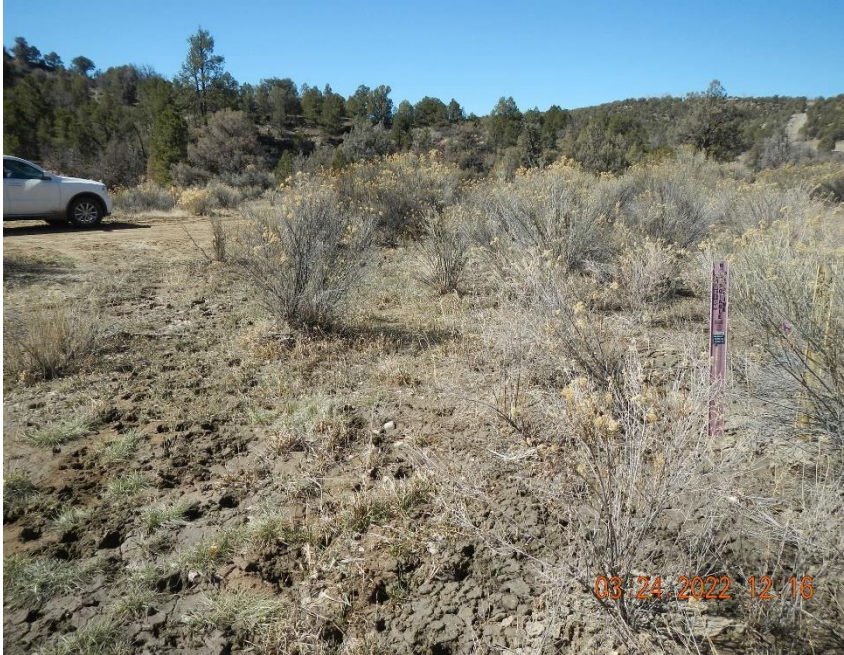
Damp area leading towards access road.

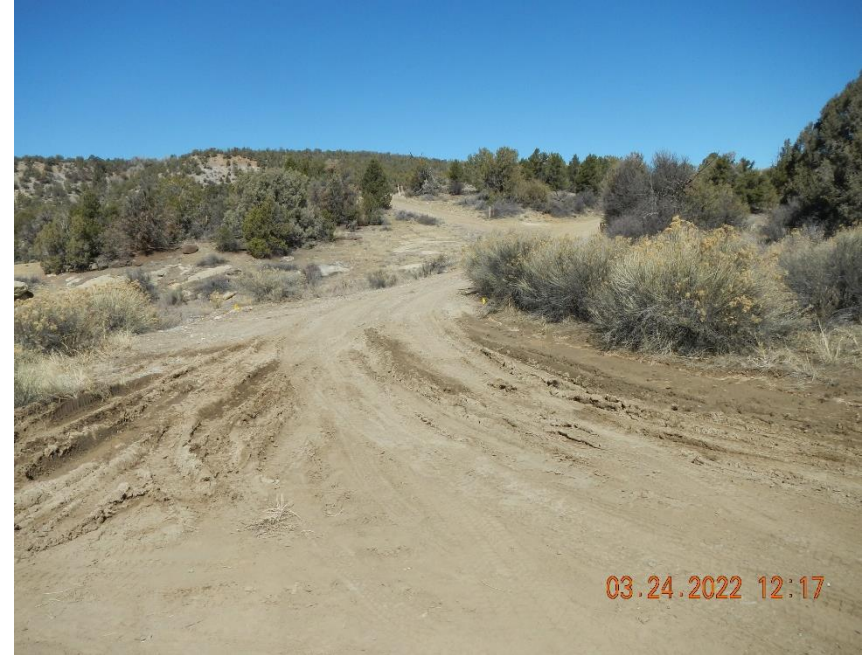
Damp and rutted area along access road.

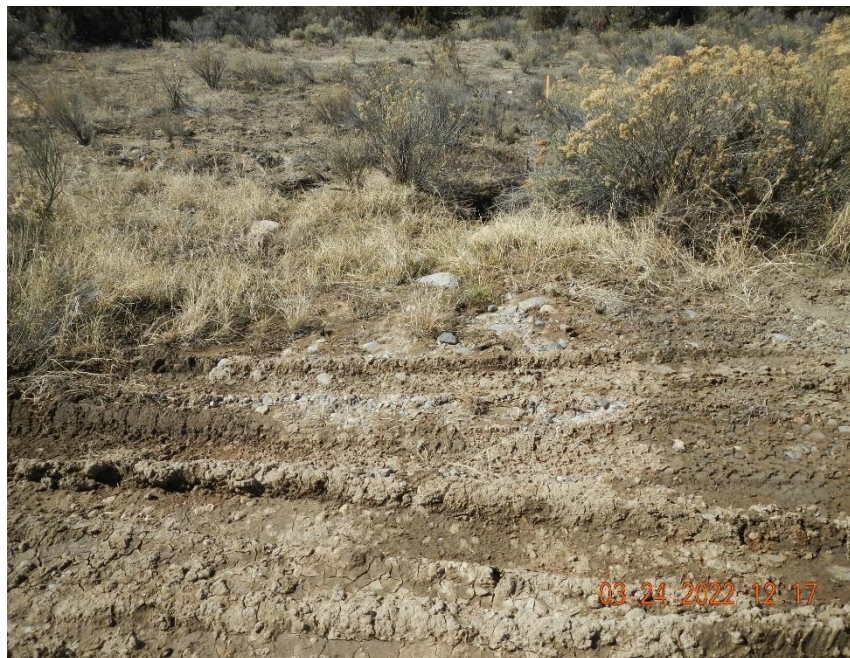
Damp and stained area on the opposite side of the access road.

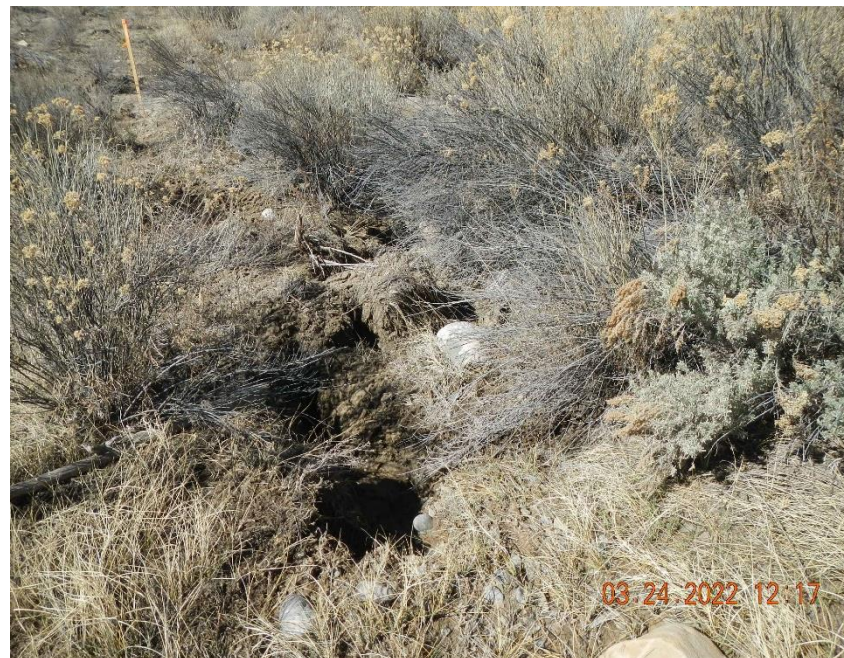
Close up of damp erosional channel visible in top center of previous photo.

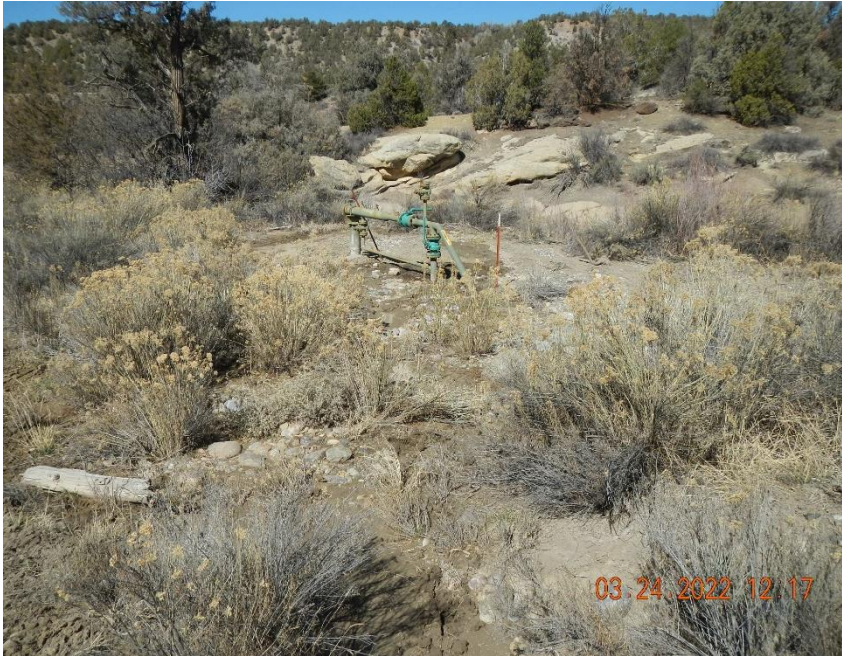
Damp area leads towards pipeline riser.

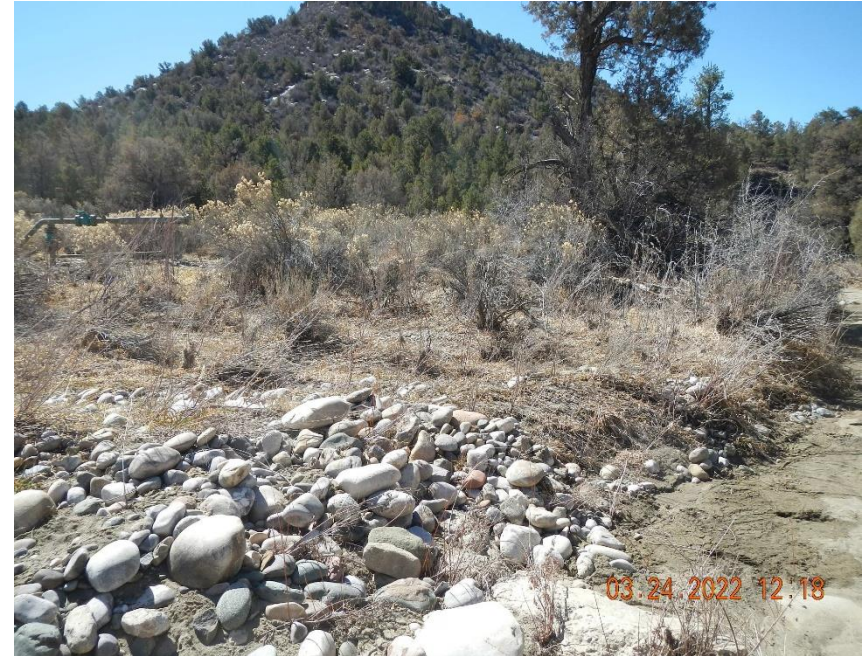
Creek bed and bank are damp with evidence of flow.

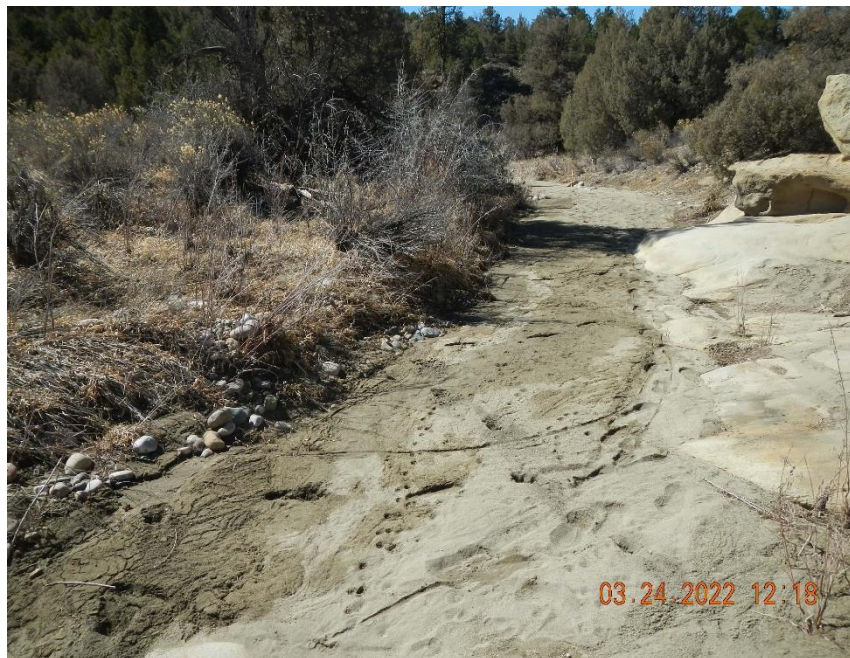
View looking downstream in Gaines Canyon creek bed.

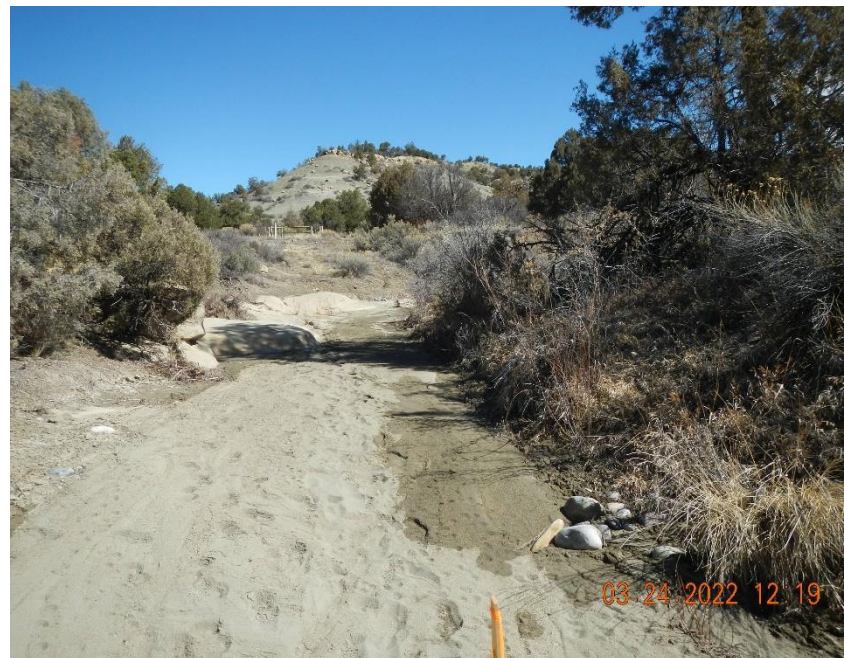
Photo taken looking upstream in Gaines Canyon creek bed near apparent terminus of release.
