Inspection Photos

Location ID: 311676

Location Name: DEVER-66S92W 18SWSE

Inspection Document #: 702800056

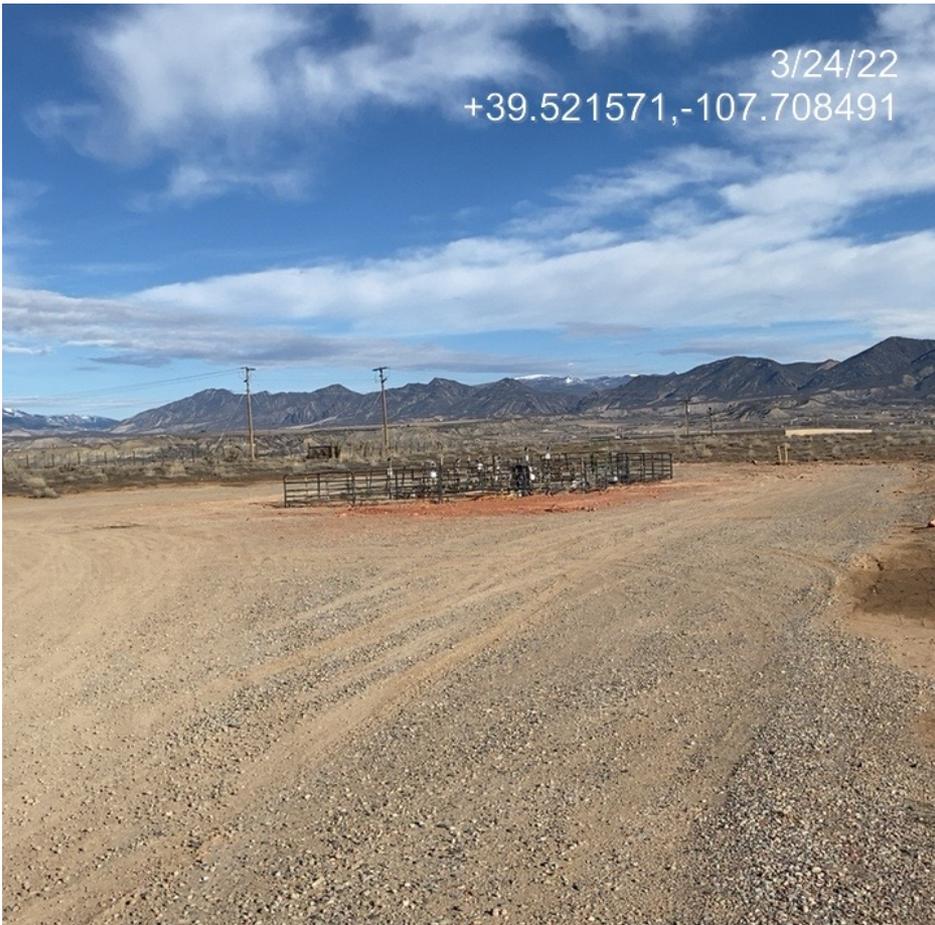
Photo 1. Photo taken from the Location entrance shows an overview of the northeastern production area.

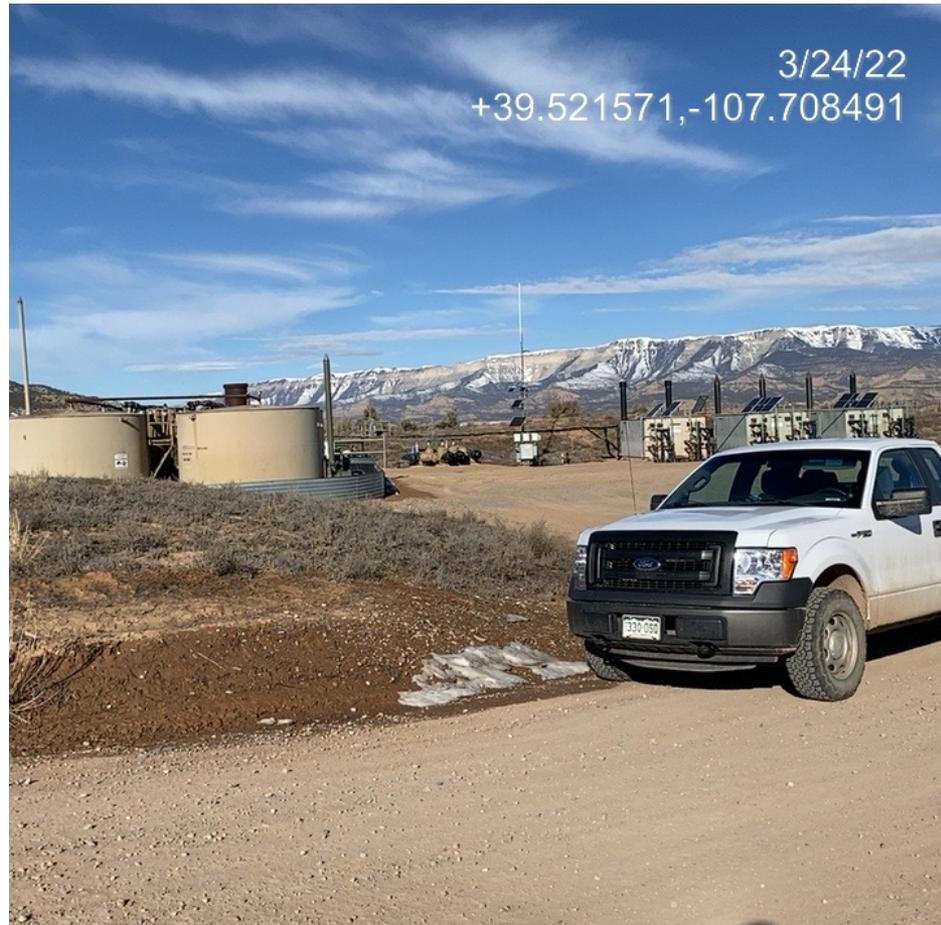
Photo 2. Photo taken from the Location entrance shows an overview of the southwestern production area.

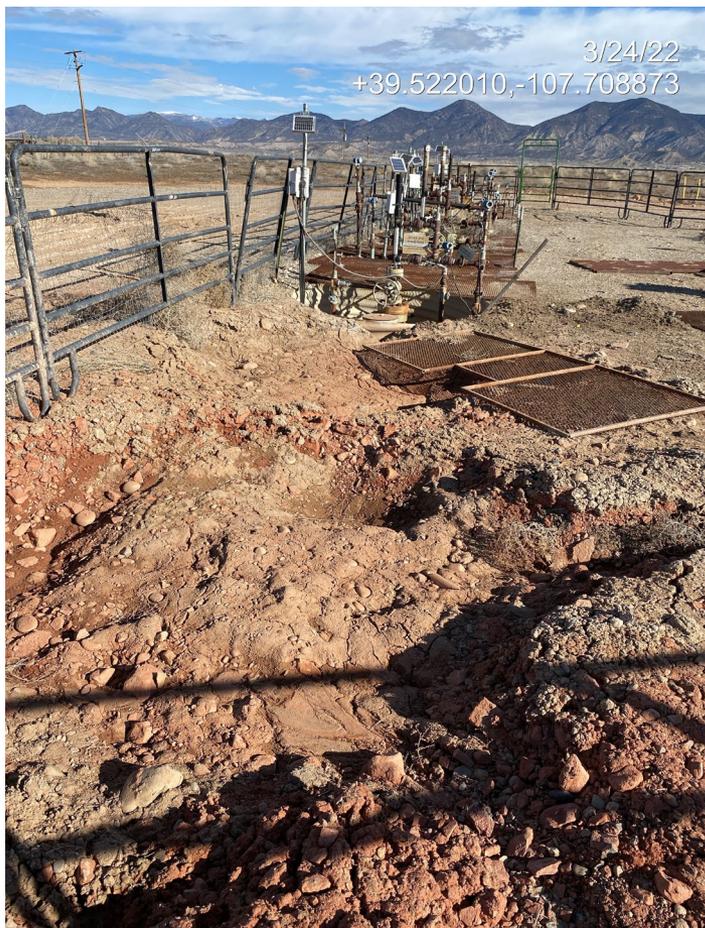
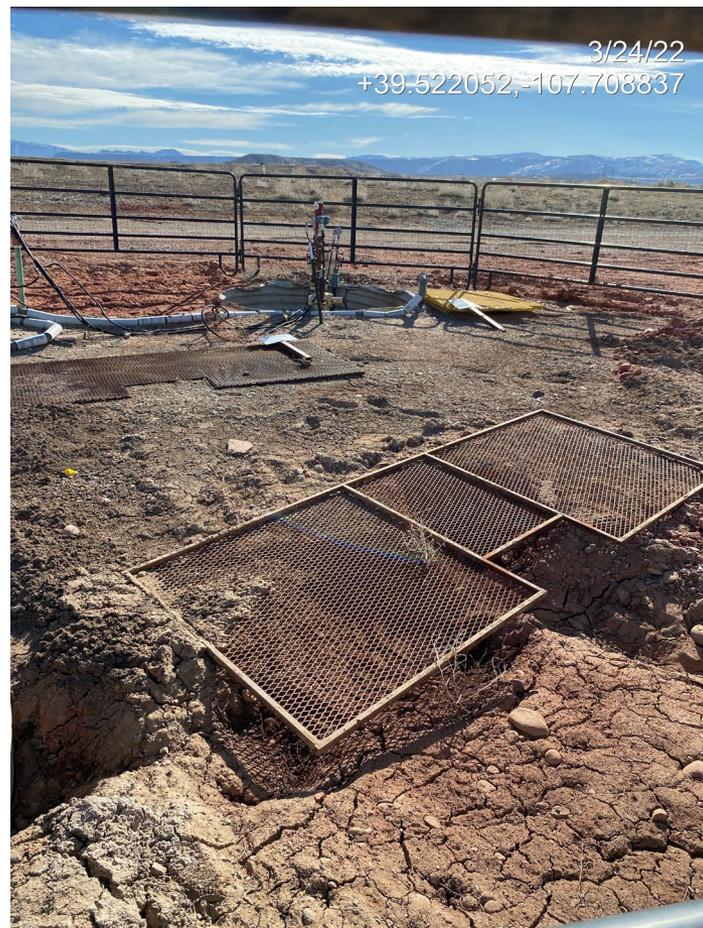
Photo 3. Photo taken from the well area shows unused or improperly installed well cellar grates throughout the well area.

Photo 4. Refer to Photo 3 comment.

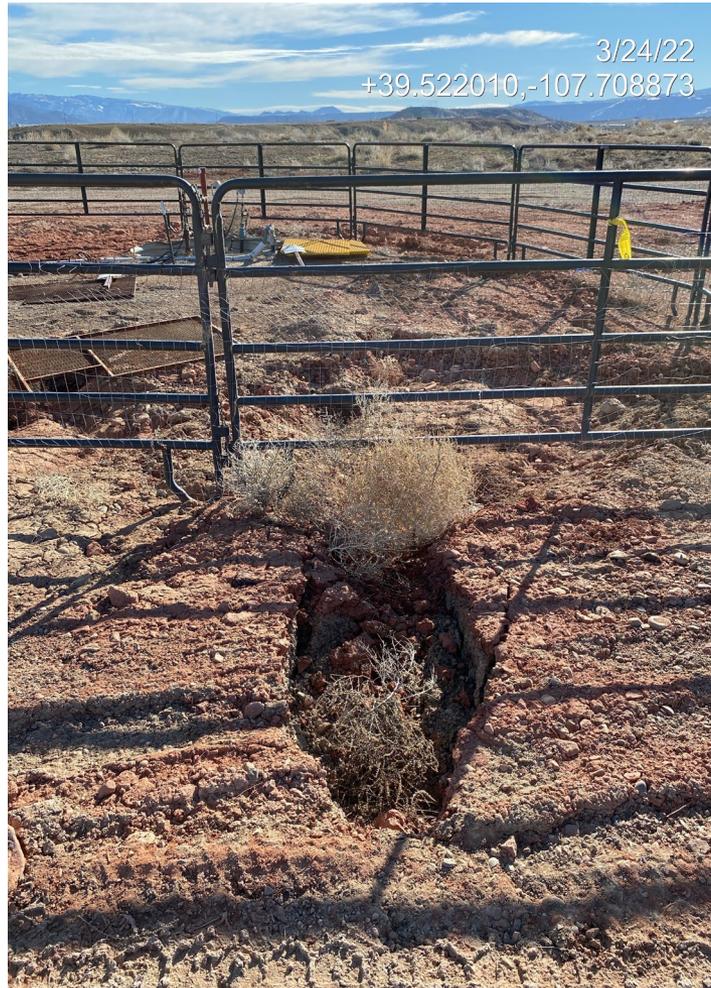
Photo 5. Photo taken from the wells facing east shows subsidence in a trench.

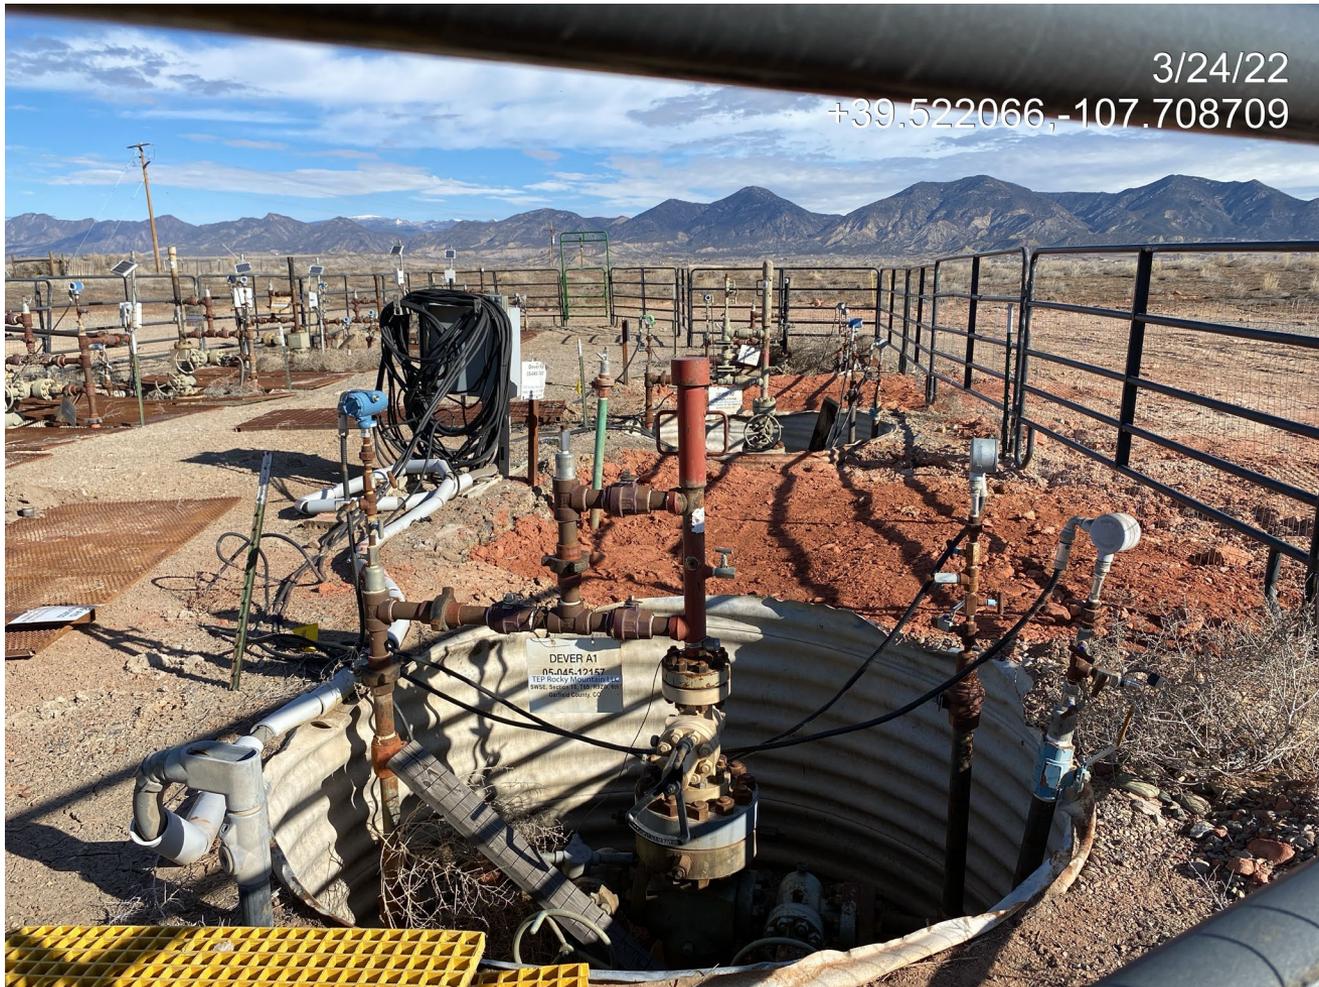
Photo 6. Photo taken from well area shows BMPs to prevent wildlife access to well cellars were missing or insufficient

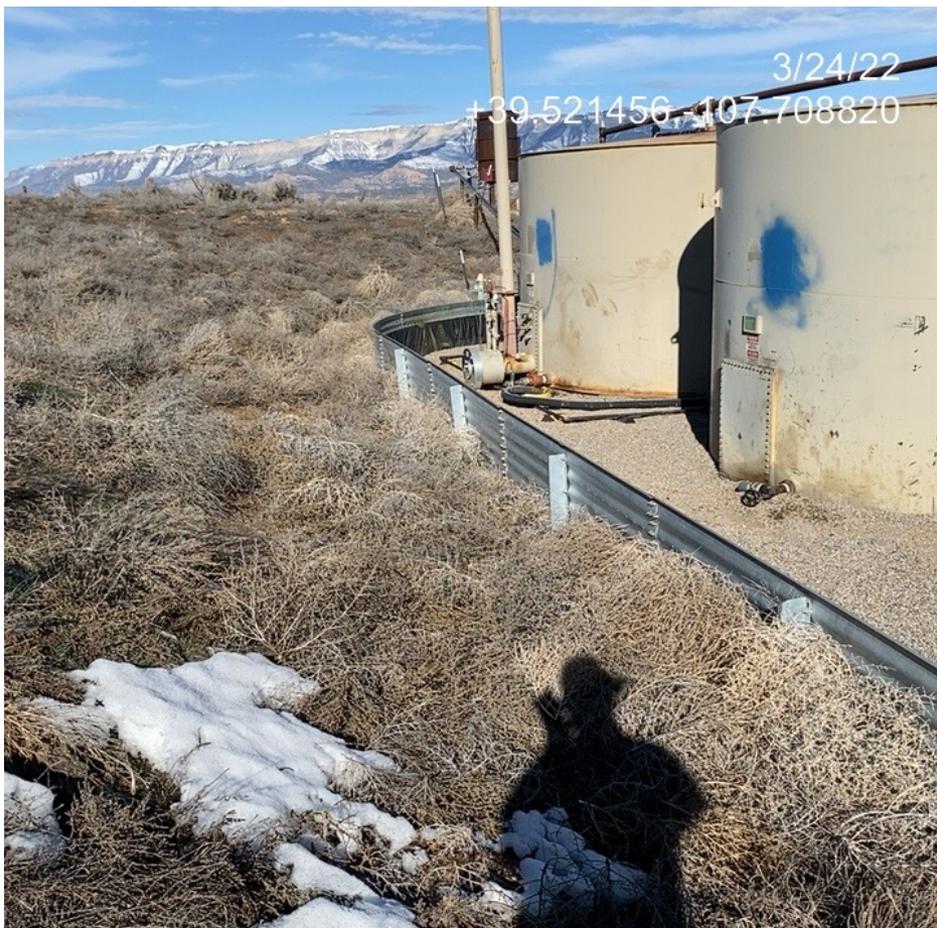
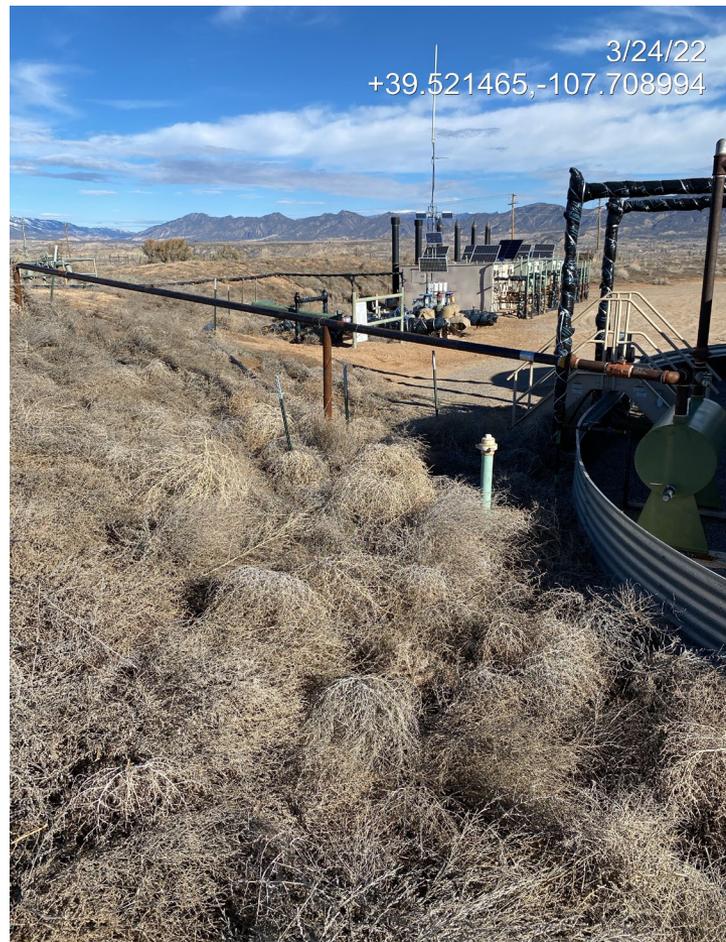
Photo 7. Photo taken from the southwest of the Location shows undesirable plant species/weed debris accumulating in interim areas and production areas adjacent to the tank battery.

Photo 8. Refer to Photo 7 comments.

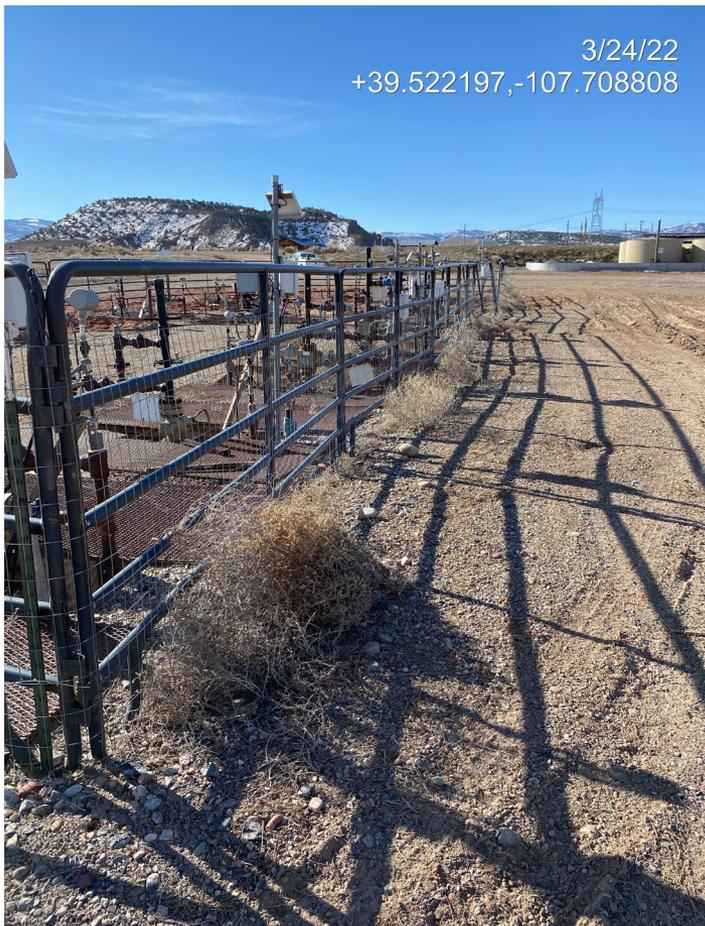
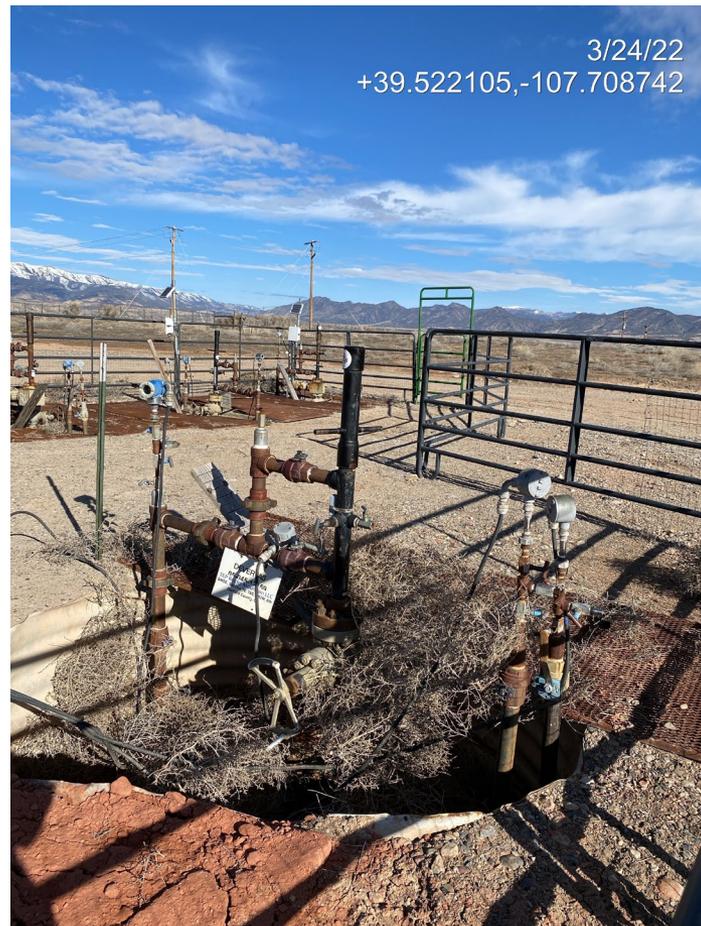
Photo 9. Photo taken from the well area shows undesirable plant species/weed debris accumulating in production areas.

Photo 10. Refer to Photo 9 comments.

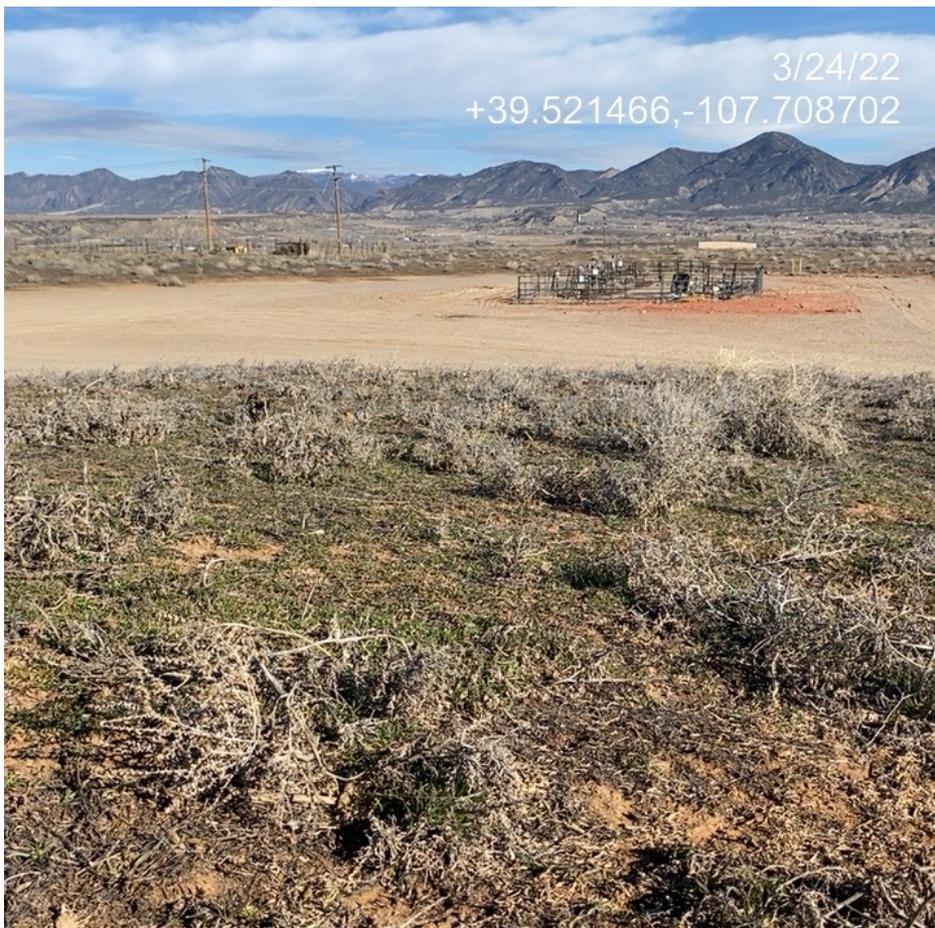
Photo 11. Photo taken from the south of the Location facing north shows interim areas dominated by annual grass and the undesirable plant species/weed, kochia.

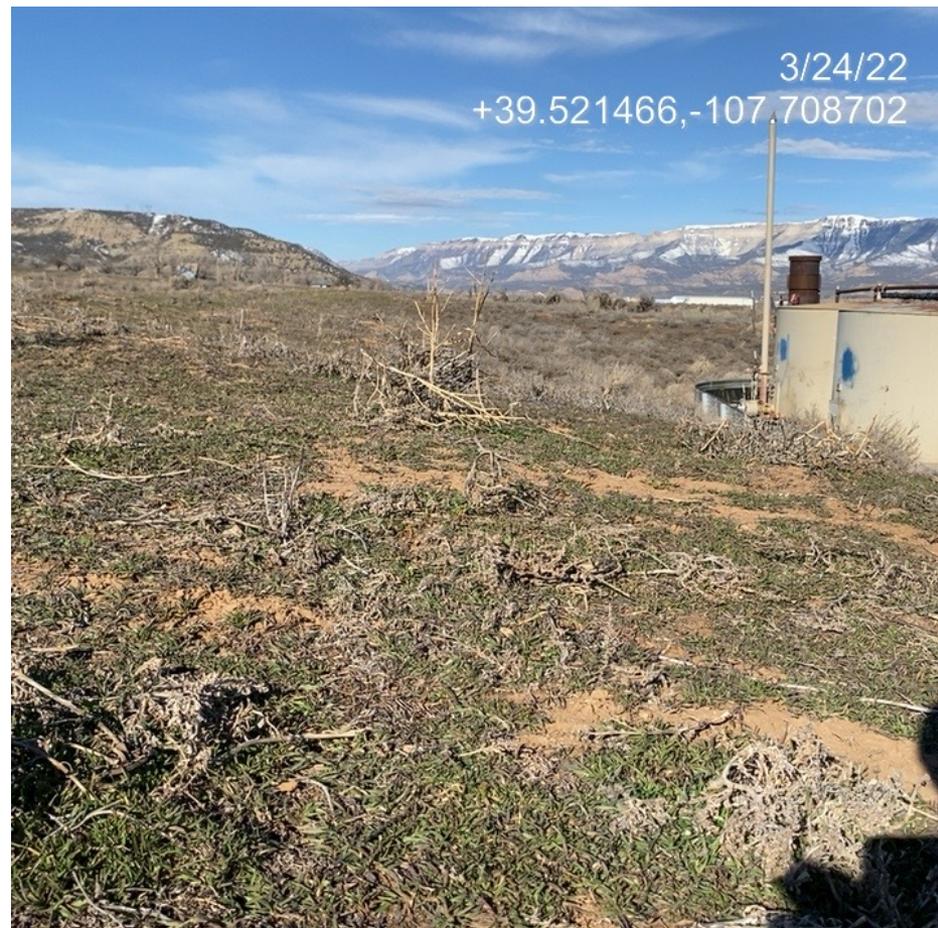
Photo 12. Photo taken from the south of the Location facing west. Refer to additional comments under Photo 11.

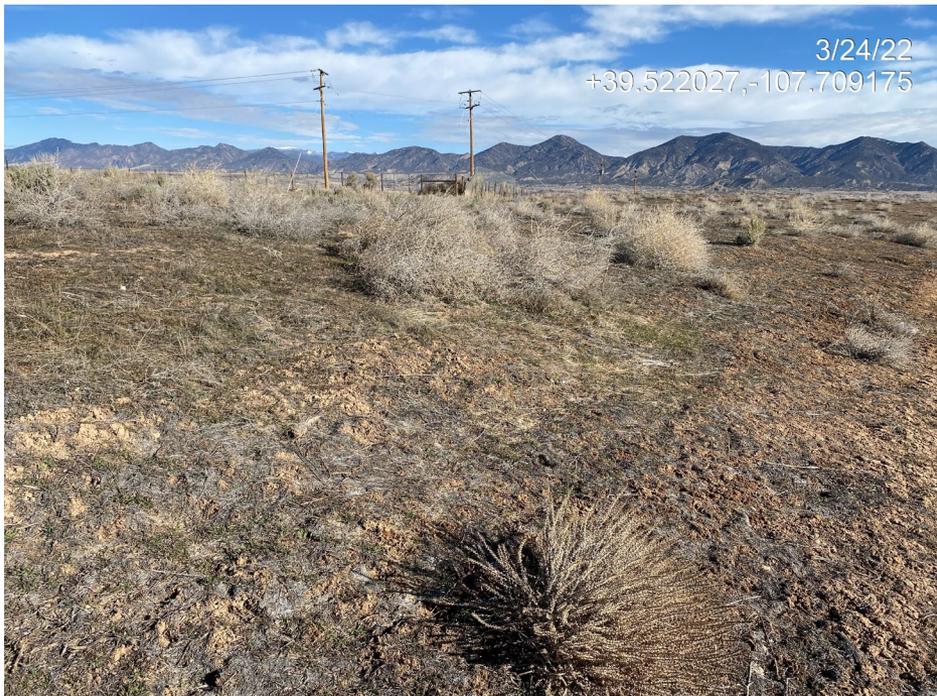
Photo 13. Photo taken from the west of the Location facing north shows interim areas dominated by annual grass and the undesirable plant species/weeds, kochia and Russian thistle.

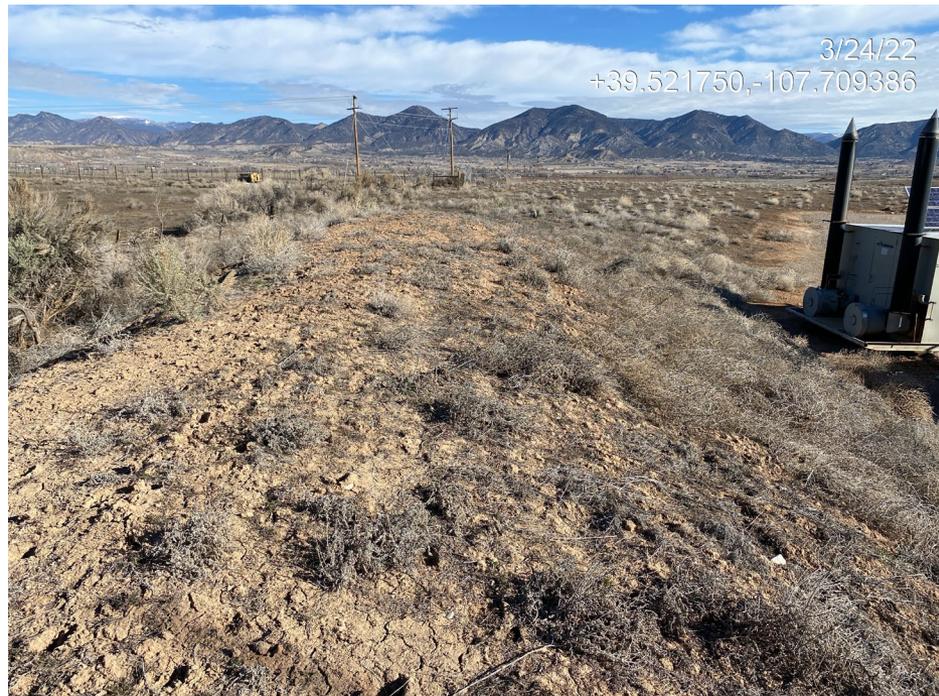
Photo 14. Photo taken from the west of the Location facing north shows interim areas dominated by annual grass and the undesirable plant species/weed, kochia.

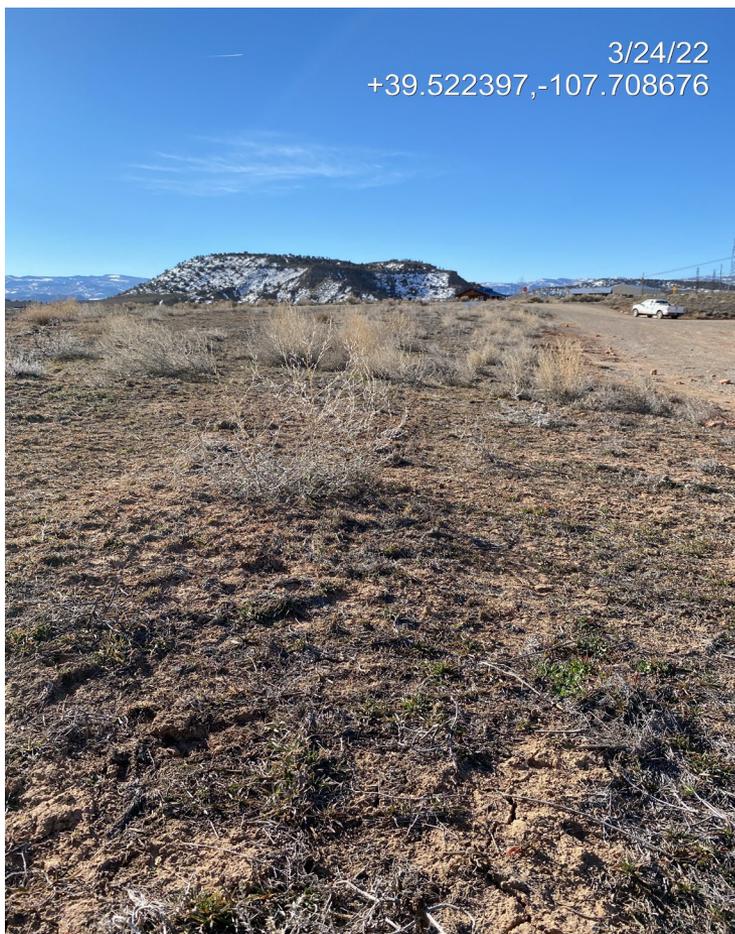
3/24/22
+39.522397,-107.708676

Photo 15. Photo taken from the north of the Location facing south shows interim areas dominated by annual grass and the undesirable plant species/weed, kochia.

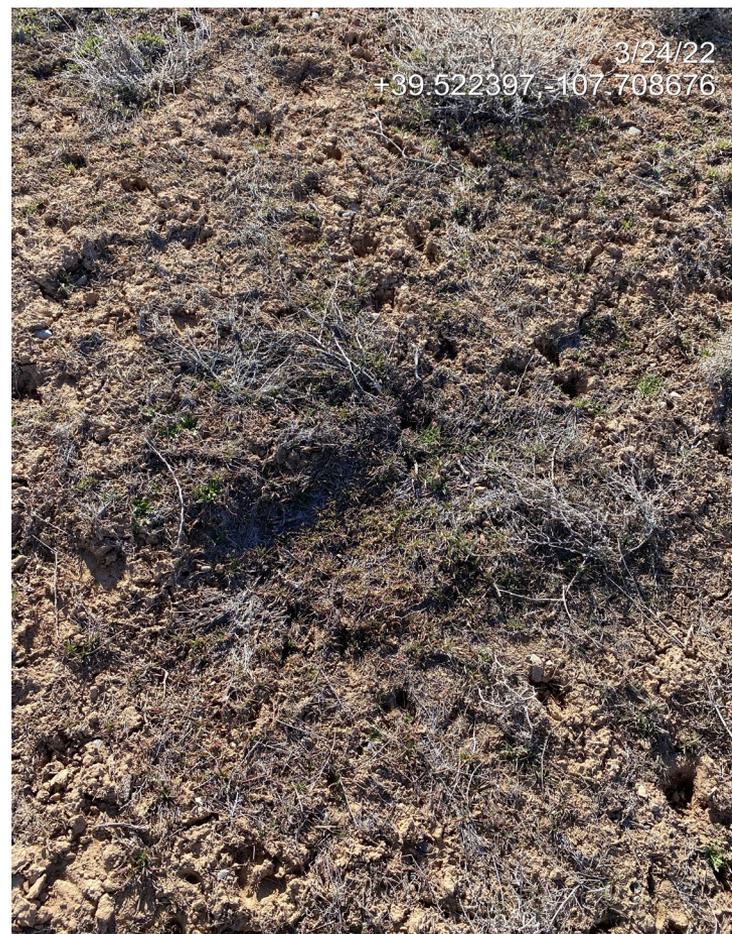
3/24/22
+39.522397,-107.708676

Photo 16. Photo taken from the north of the Location shows interim areas colonized by annual grass.

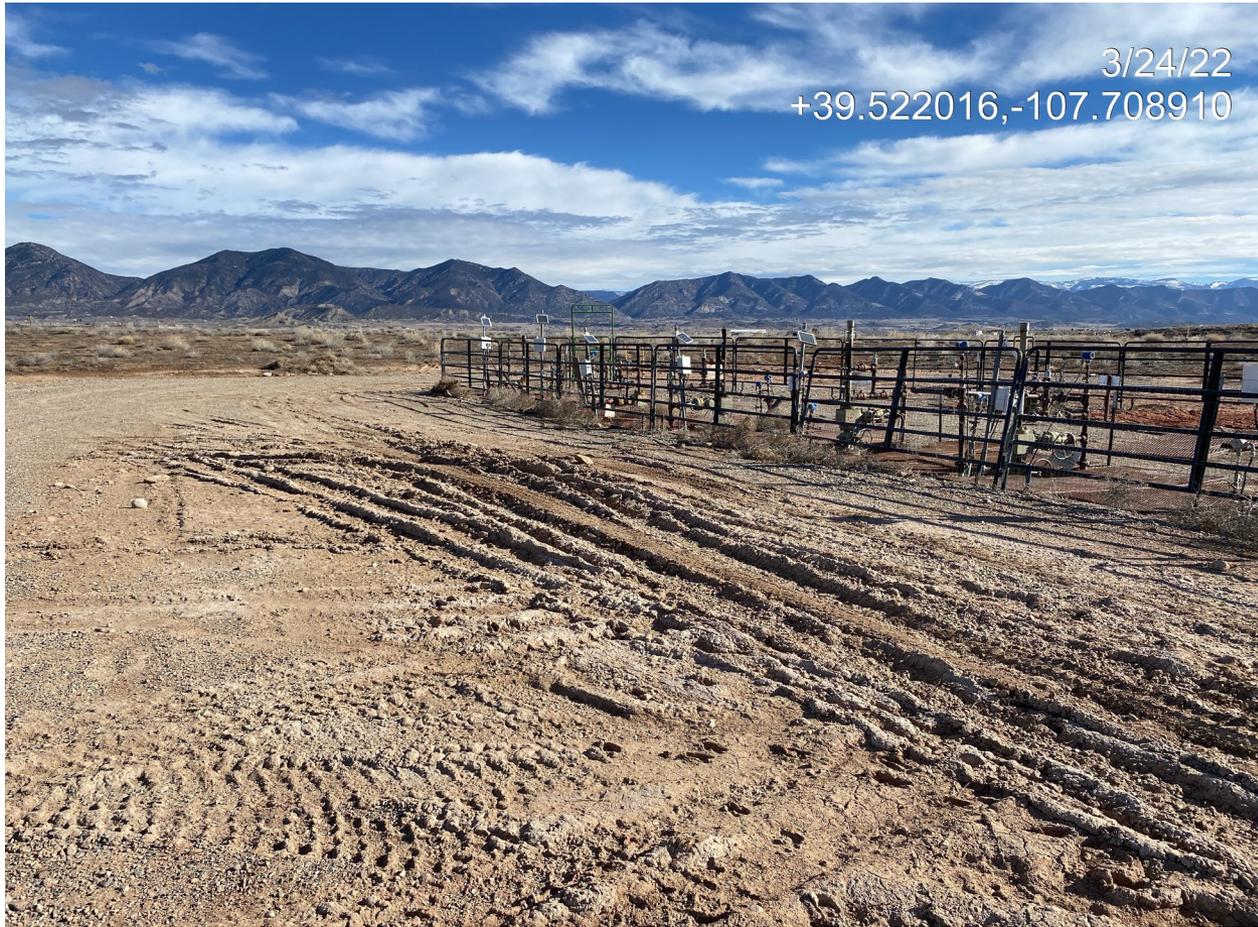
Photo 17. Photo taken from the west of the wells facing north shows rutting occurring on the pad.
