Inspection Photos

Location Name: CAERUS PICEANCE LLC HYRUP-68S96W /2NWSE

Location ID: 334158

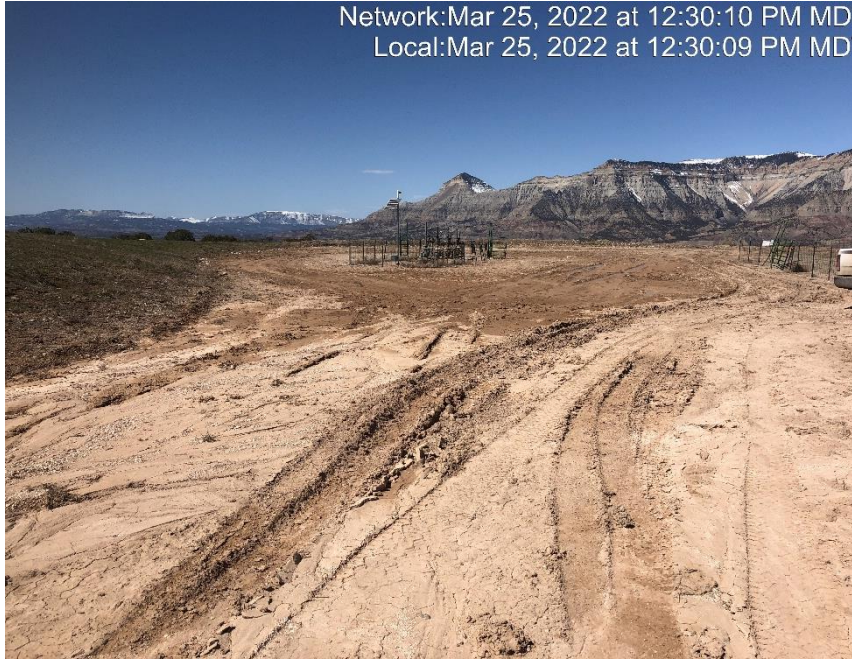
Photo #6288 from entrance to location.

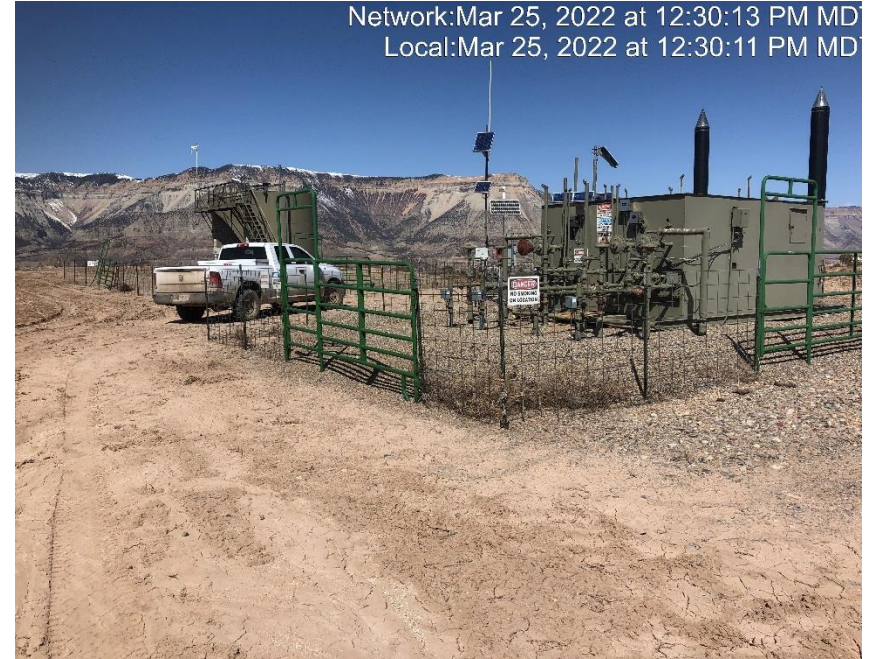
Photo #6289 from entrance to location.

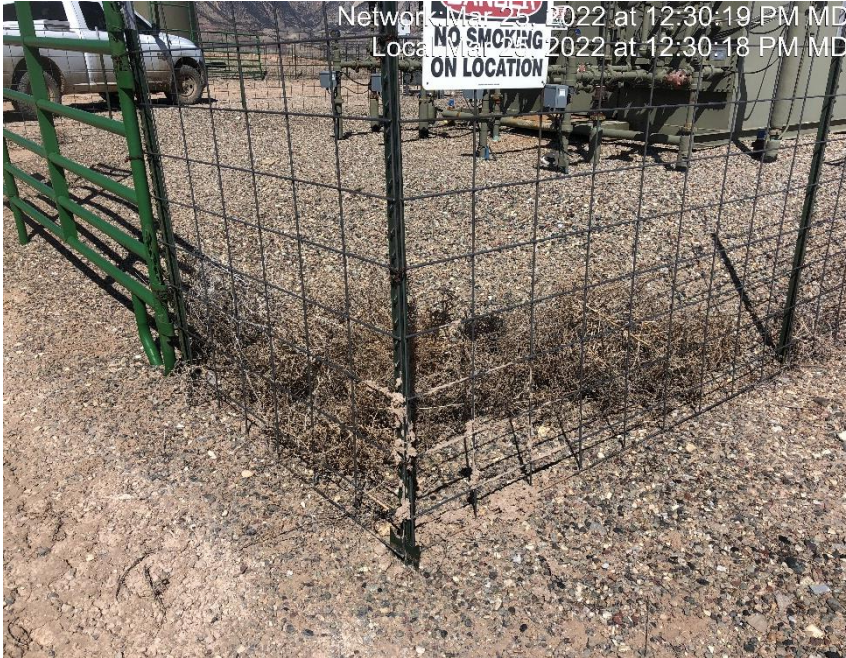
Photo #6290 Multiple places with Debris on location.

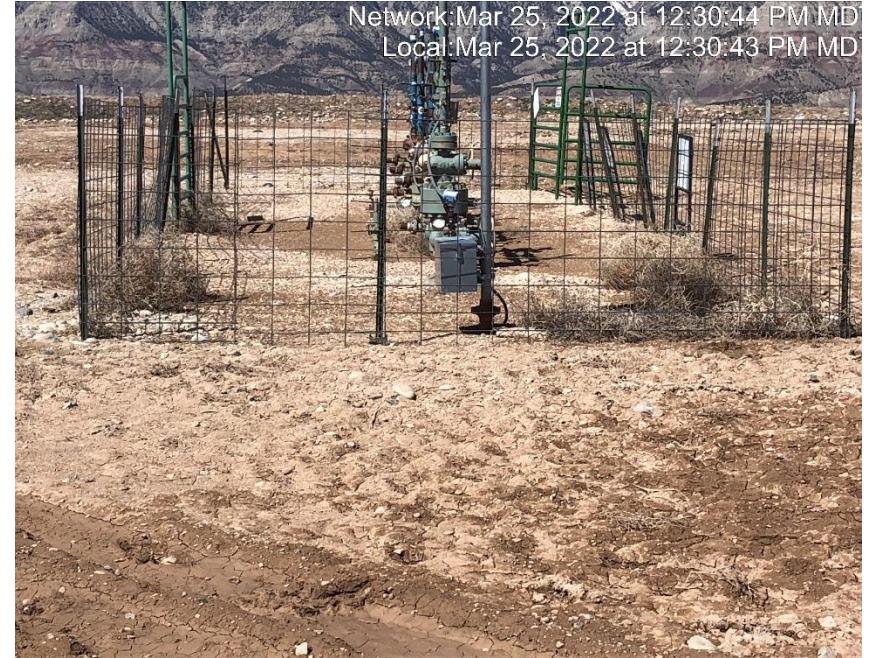
Photo #6291 Multiple places with debris on location.

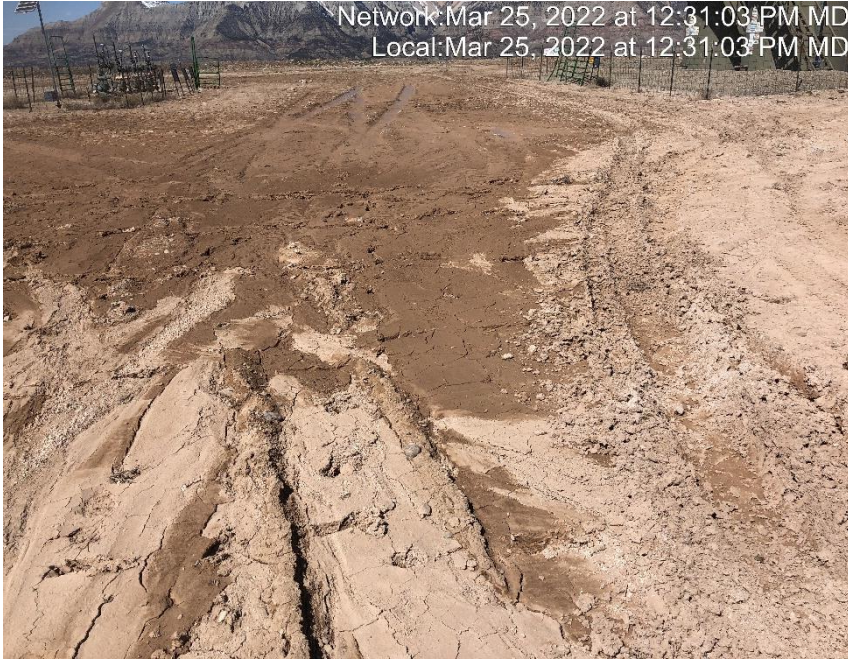
Photo #6292 Location lacks stabilization.

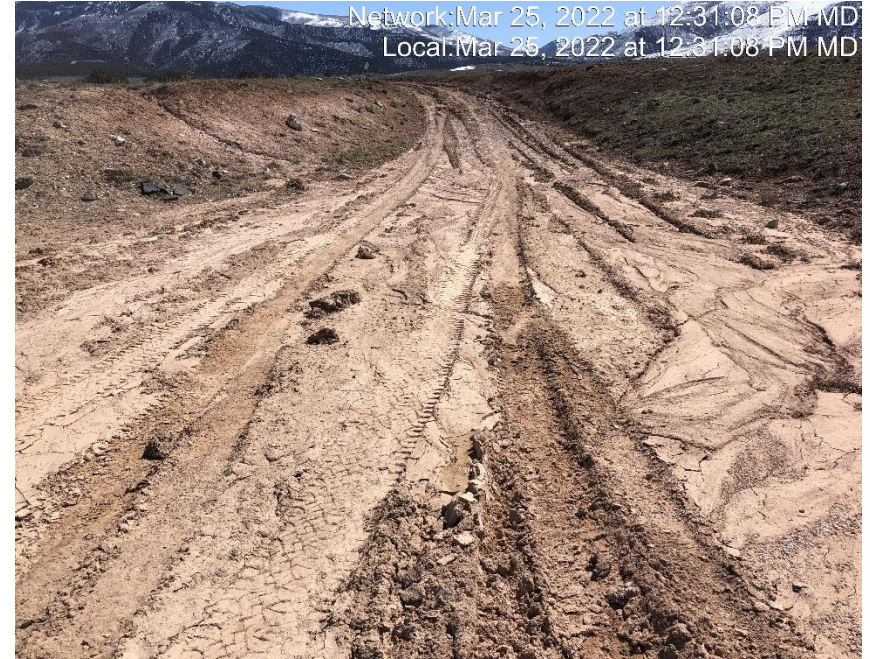
Photo #6292 Location lacks stabilization.

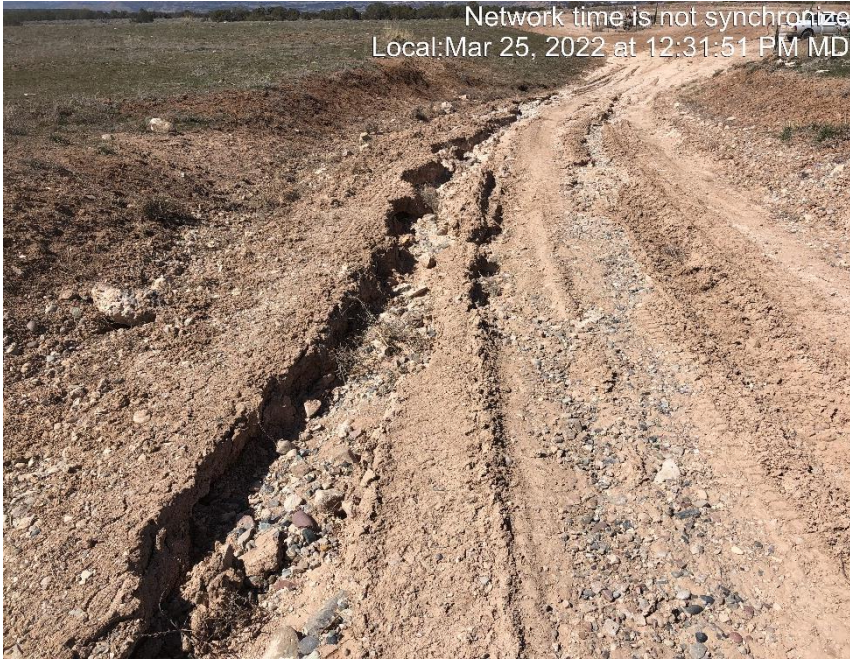
Photo #6294 Access road lacks stabilization.

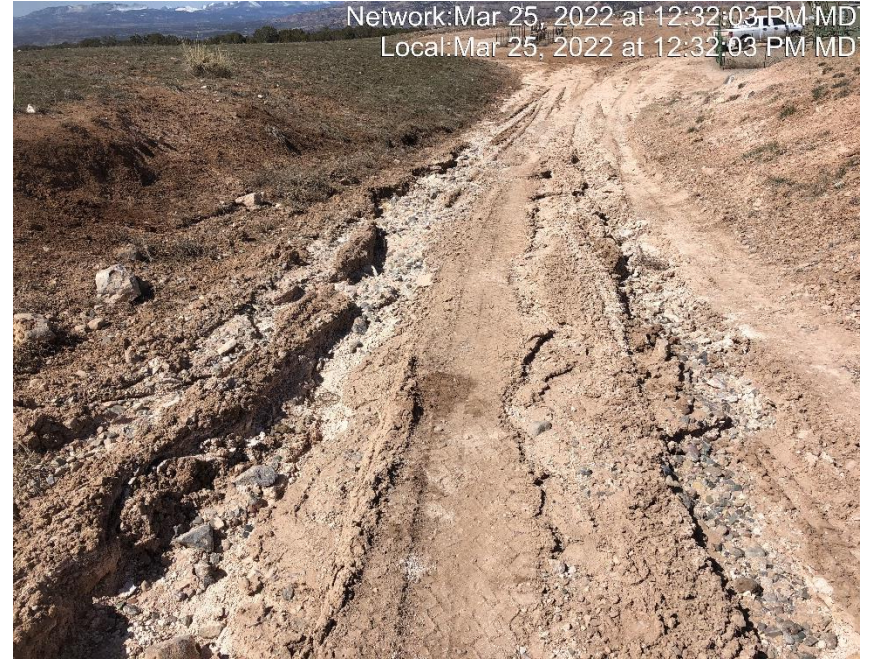
Photo #6295 Sediment has been transported from access road on to location.

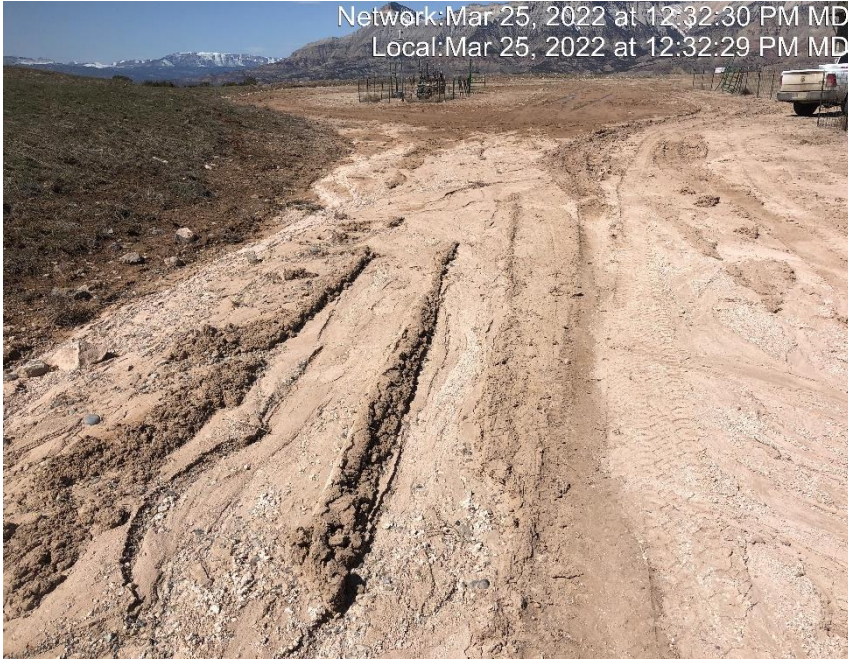
Photo #6297 Sediment has been transported on to location.

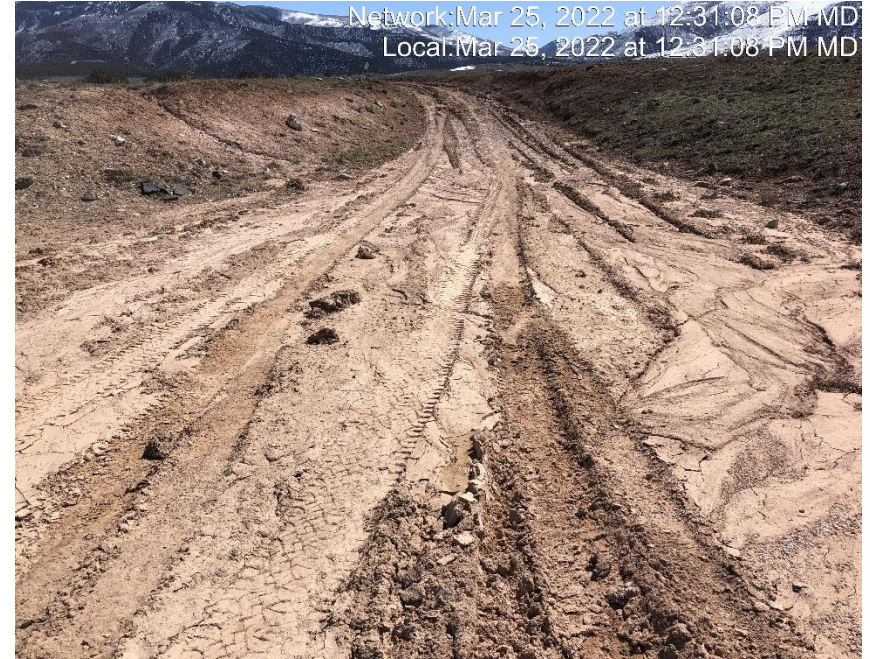
Photo #6293 Insufficient tracking controls at entrance to location.
