Inspection Photos

Location Name: CAERUS PICEANCE LLC HYRUP-68S96W /12SWNE

Location ID: 334061

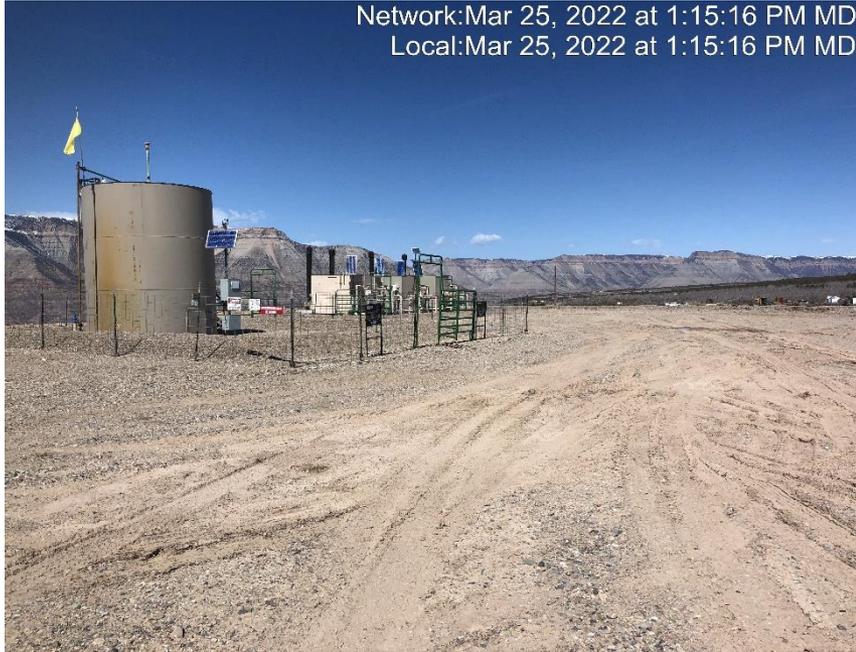
Photo #6298 from entrance to location.

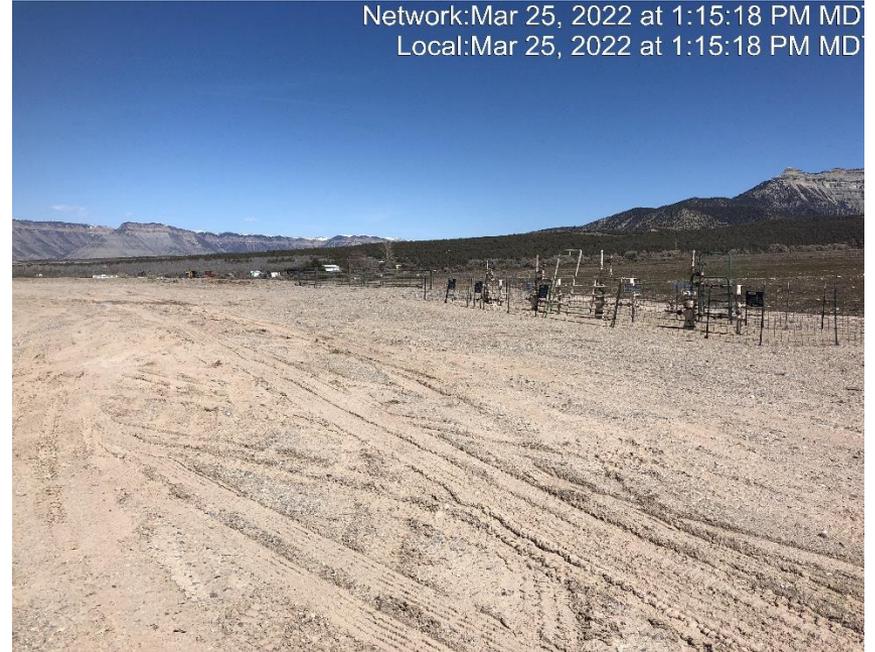
Photo #6299 from entrance to location.

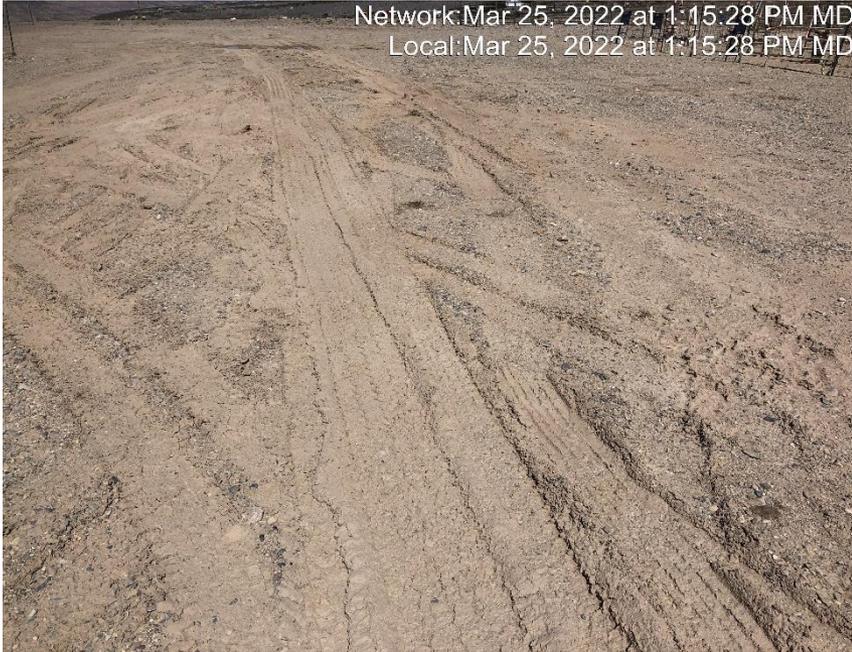
Photo #6300 Location lacks stabilization.

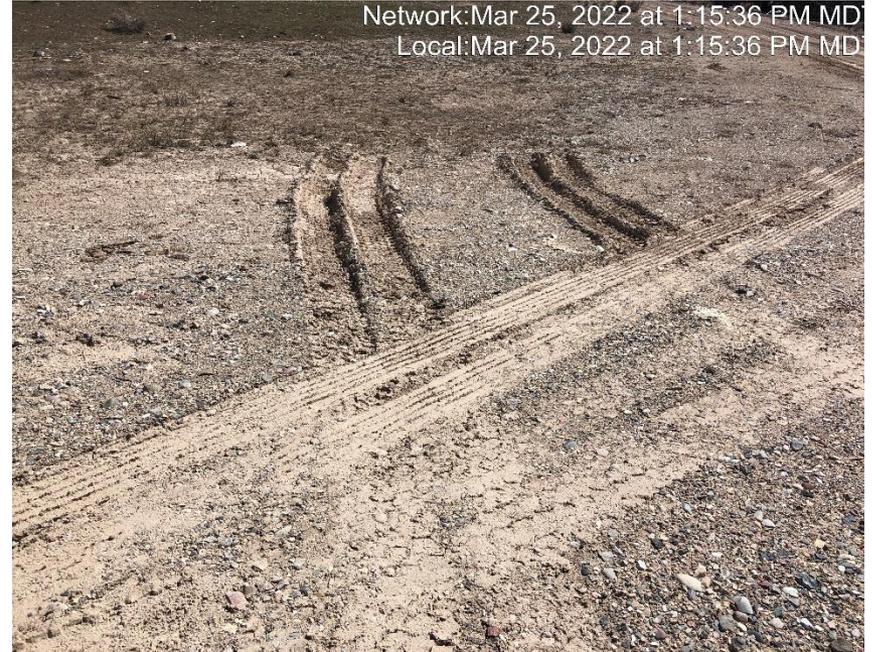
Photo #6301 Location lacks stabilization.

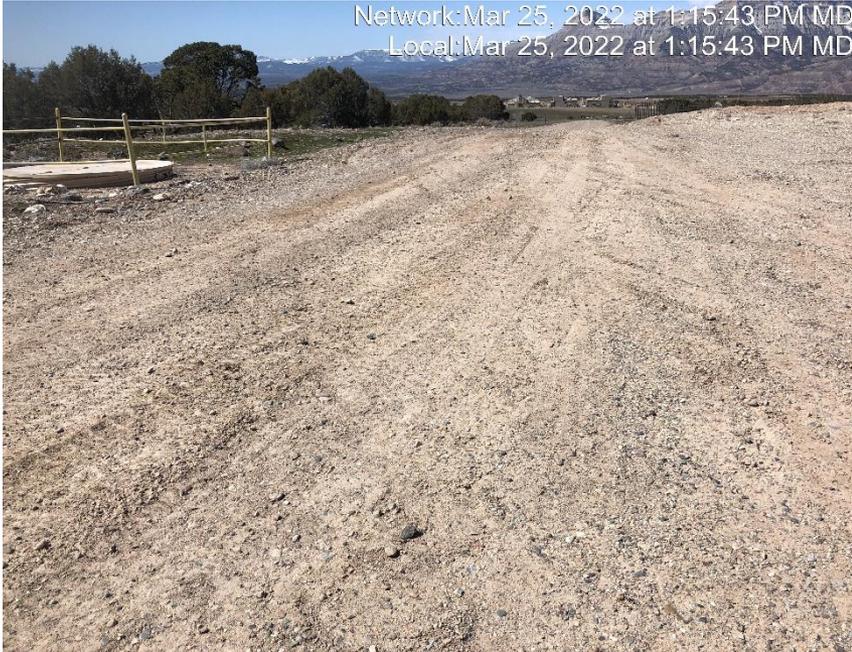
Photo #6302 Insufficient tracking control at entrance to location.
