Inspection Photos

Location Name: CAERUS PICEANCE LLC HYRUP-68S95W /18NWSW

Location ID: 312705

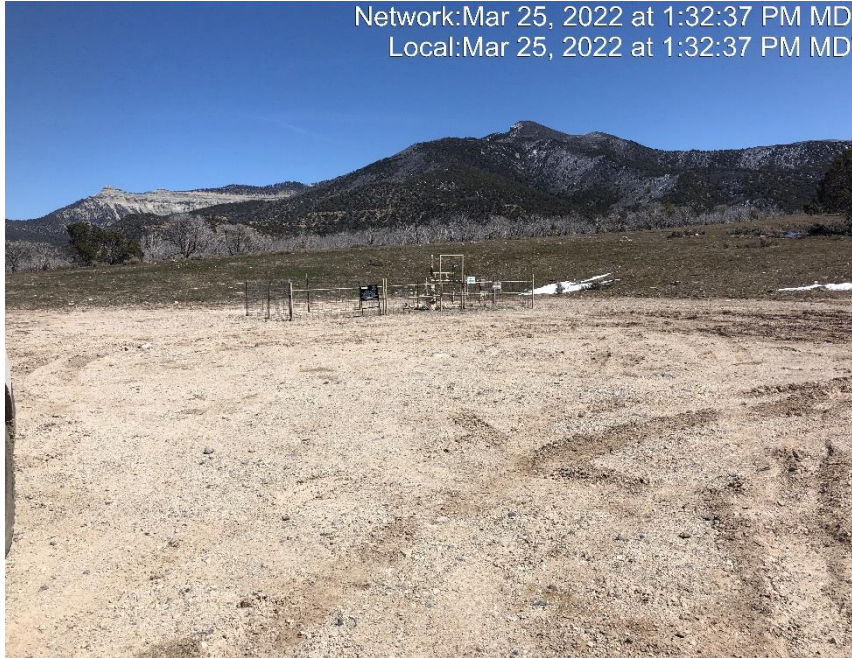
Photo #6303 from entrance to location.

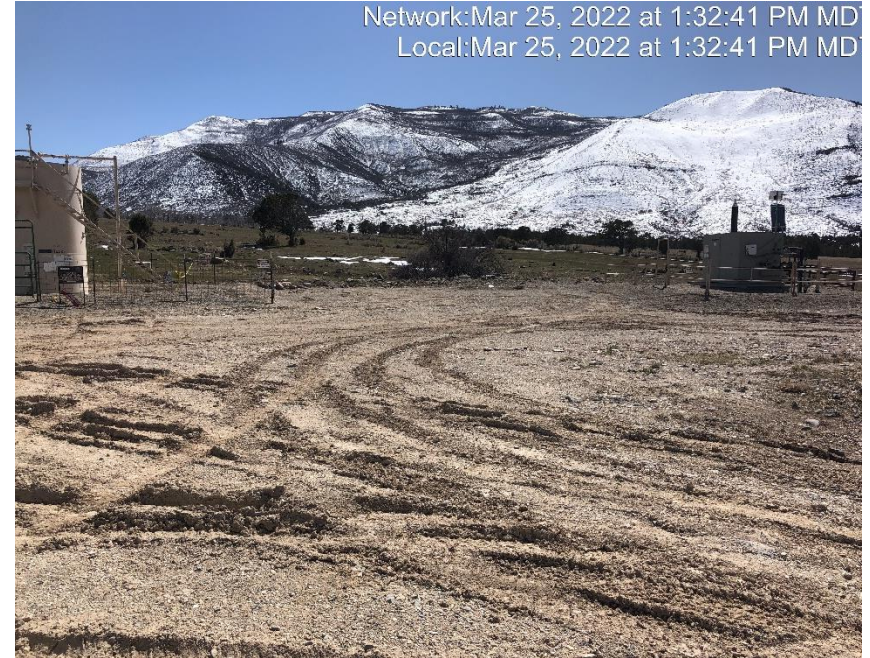
Photo #6304 from entrance to location.

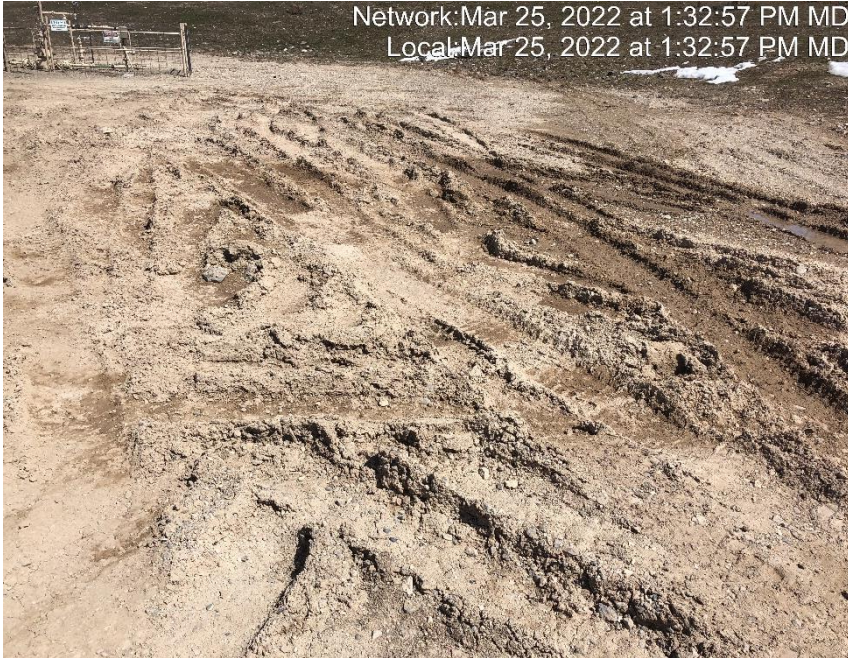
Photo #6305 Location lacks stabilization.

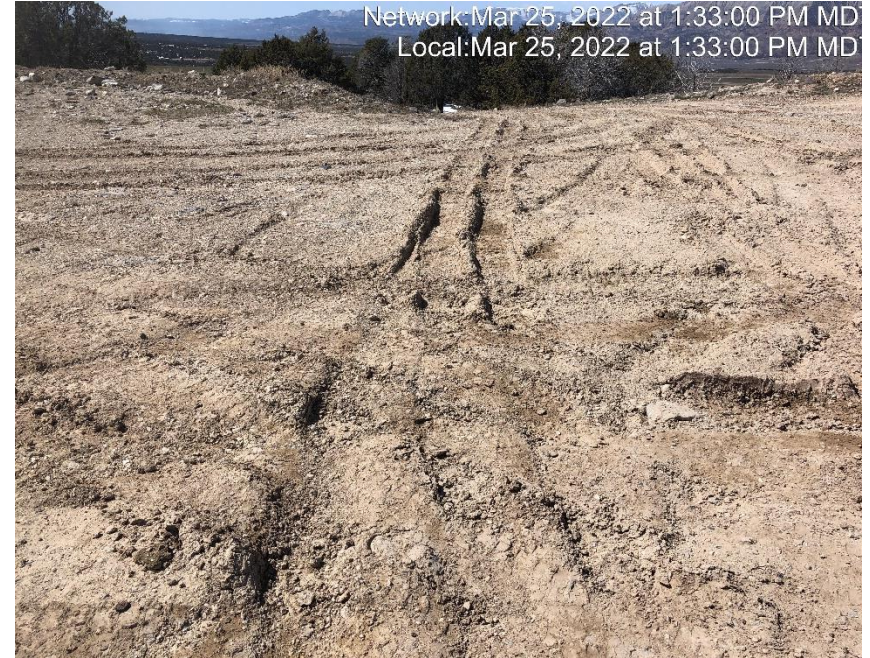
Photo #6306 Location lacks stabilization.

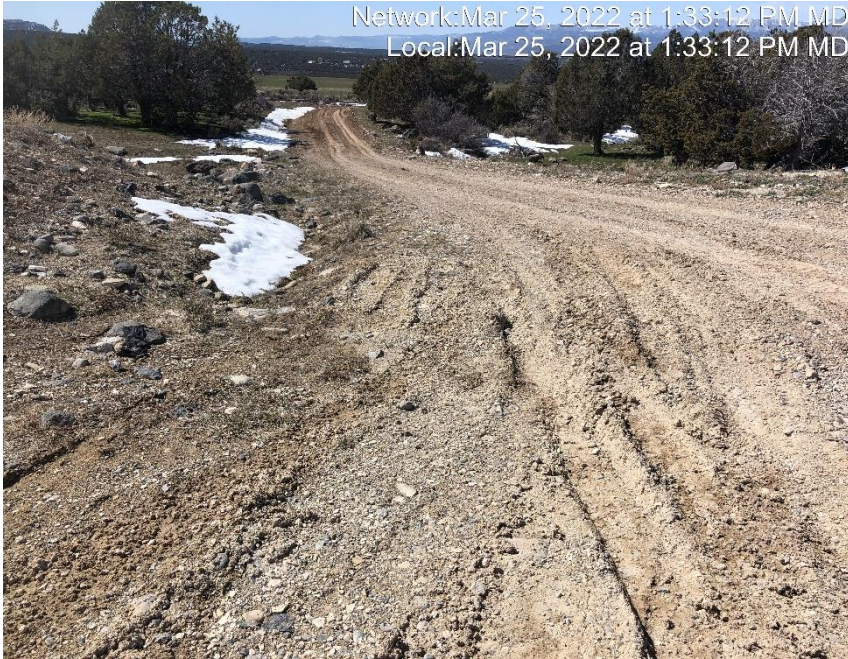
Photo #6307 Insufficient tracking control at entrance to location.
