Inspection Photos

Location Name: CAERUS PICEANCE LLC SGV /12H PAD

Location ID: 312697

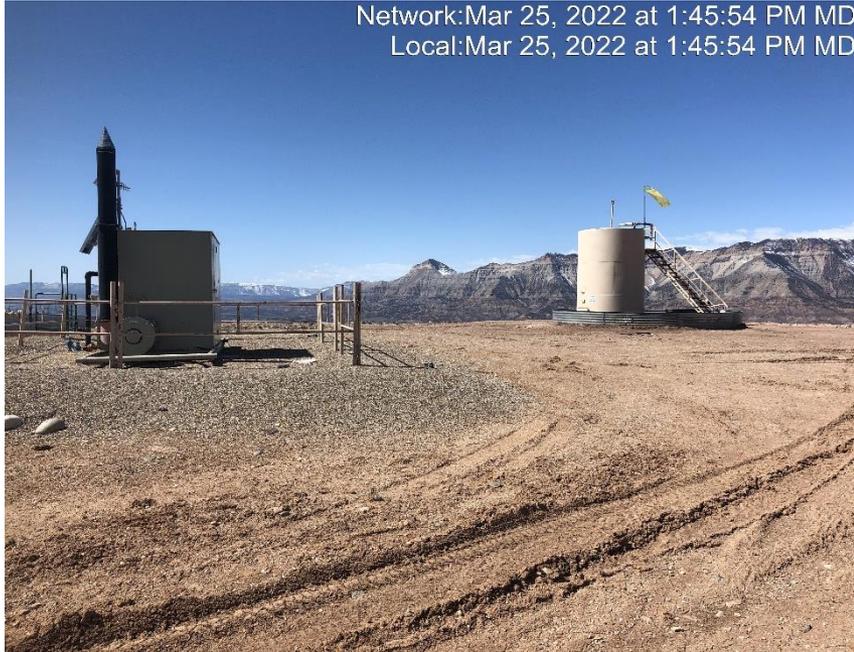
Photo #6308 from entrance to location.

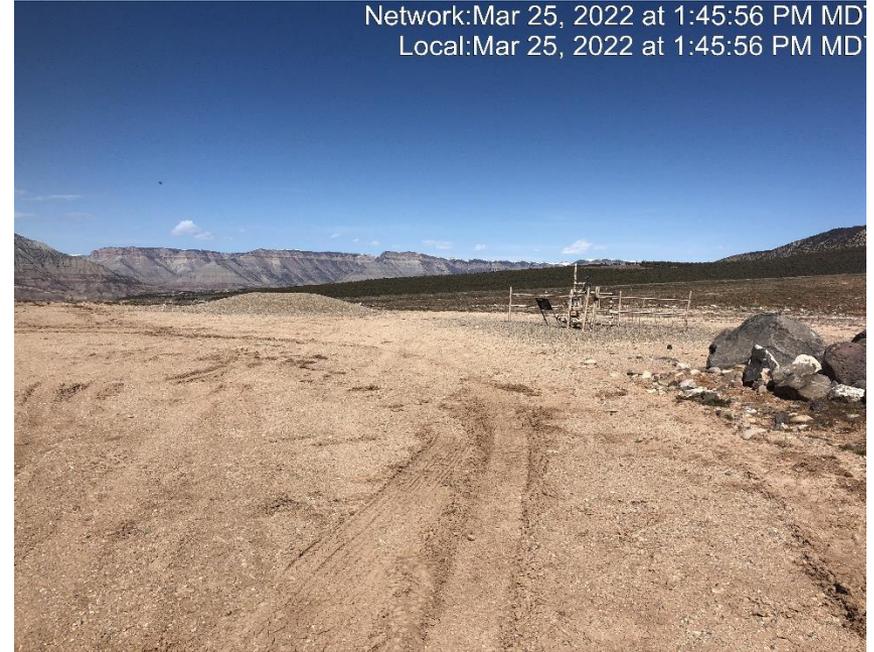
Photo #6309 from entrance to location.

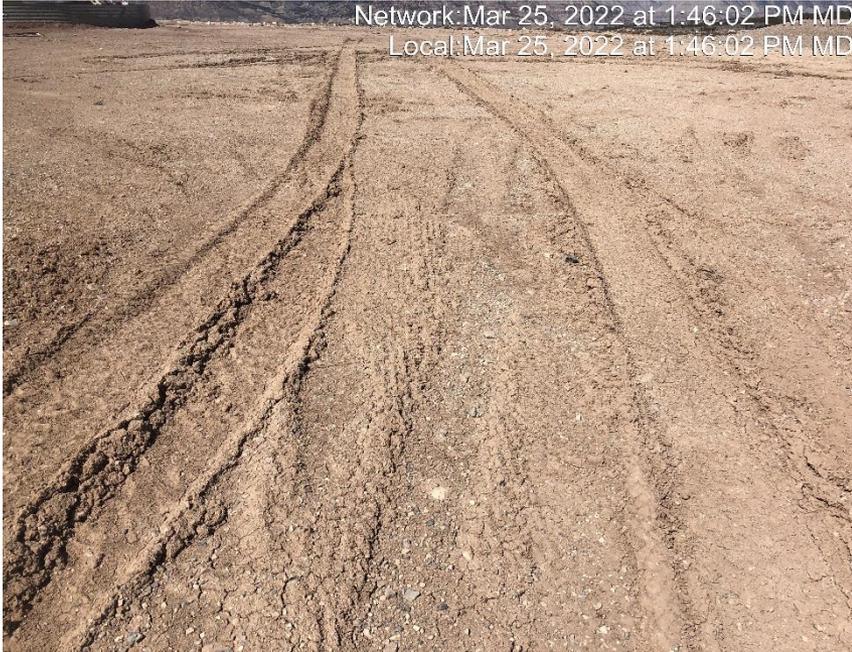
Photo #6310 Location lacks stabilization.

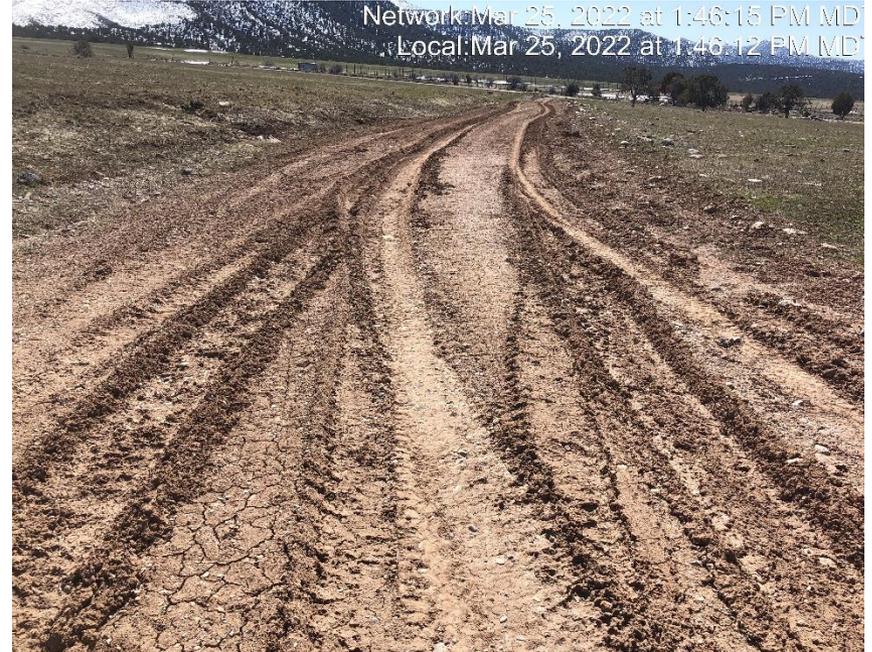
Photo #6311 Insufficient tracking control at entrance to location.
