TEP
RMV 126-4
Location # 324075

COLORADO
Oil & Gas Conservation
Commission
Department of Natural Resources

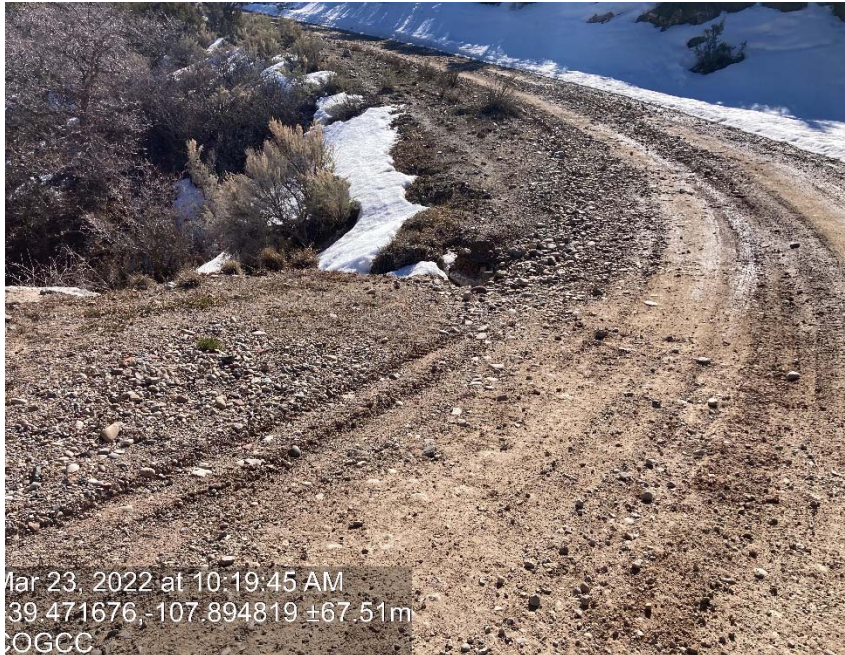
Erosion

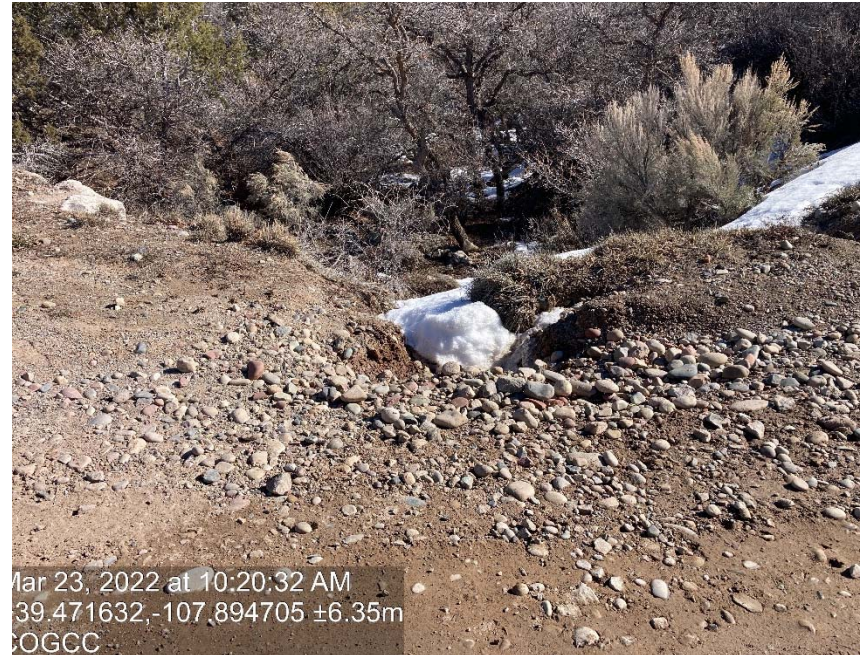
Erosion

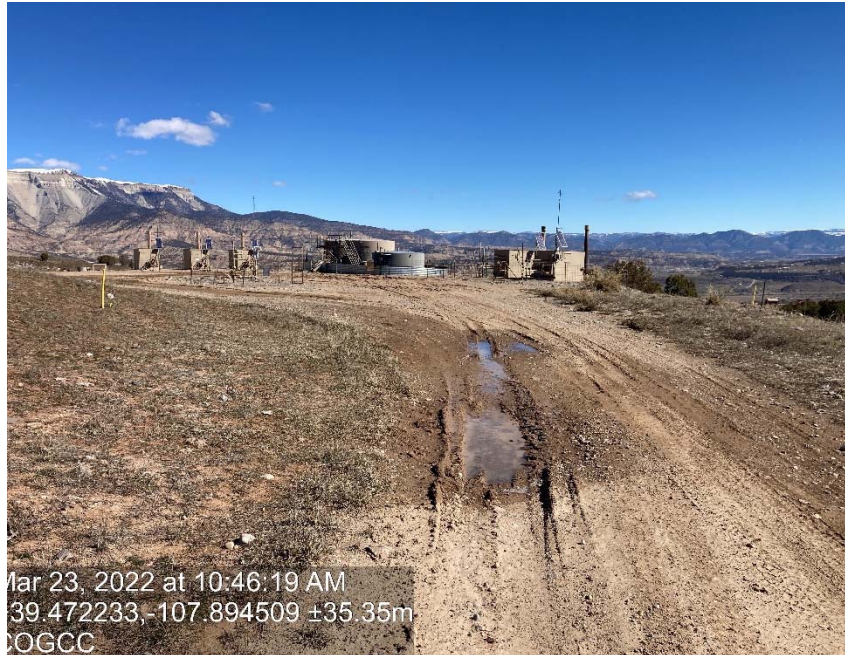
Location and Lack of stabilization/compaction

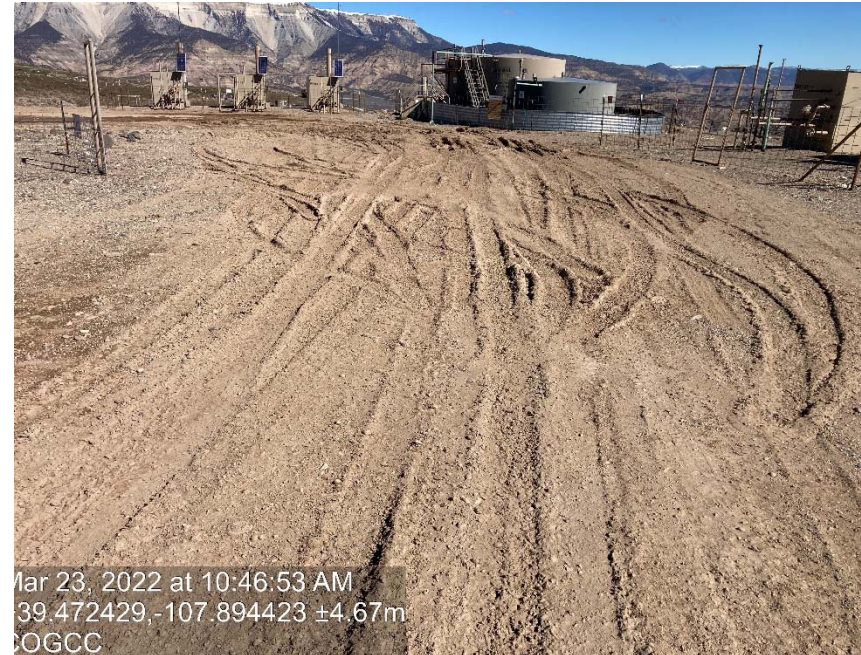
Lack of stabilization/compaction

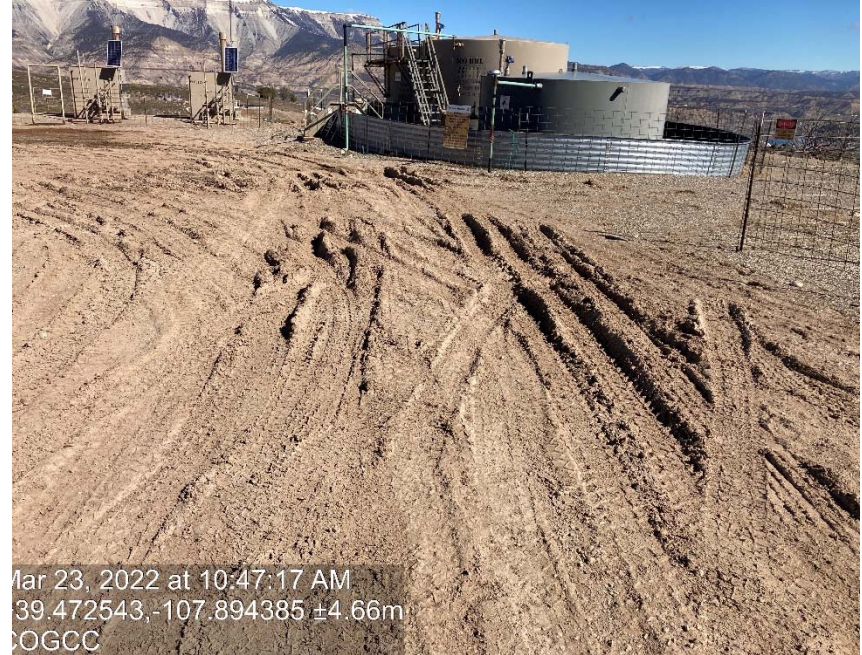
Lack of stabilization/compaction

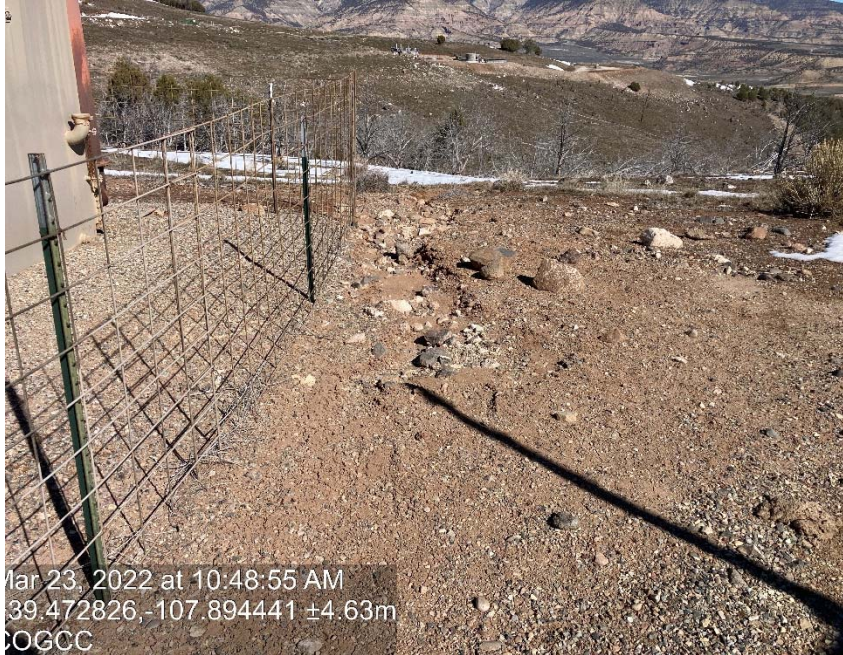
Lack of stabilization/compaction/erosion and sediment migration

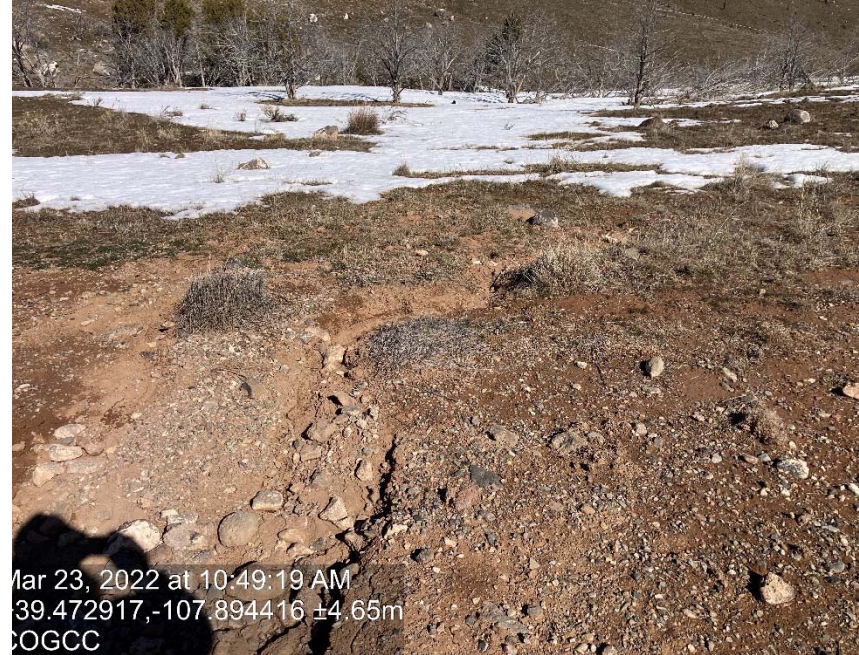
Lack of stabilization/compaction/erosion and sediment migration

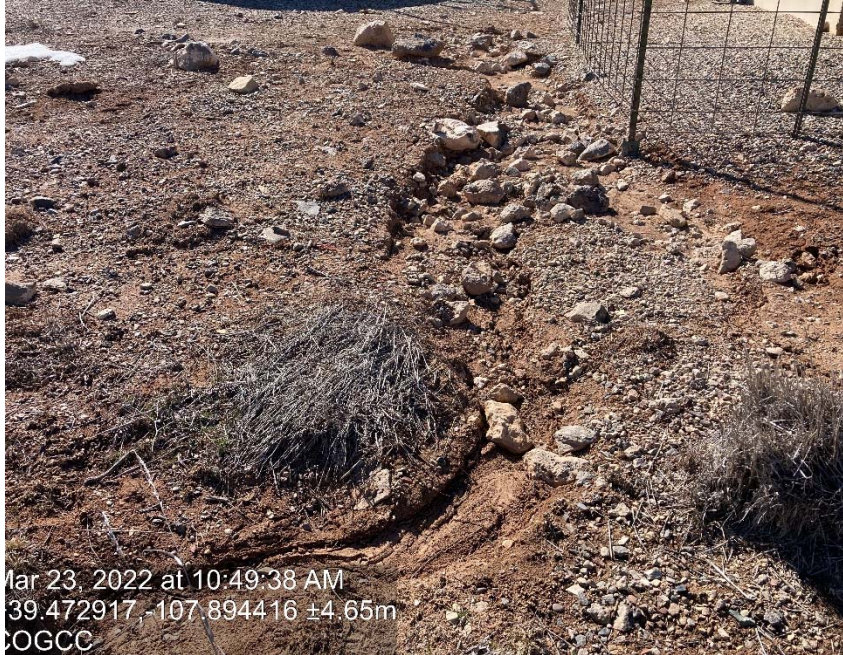
Lack of stabilization/compaction/erosion and sediment migration

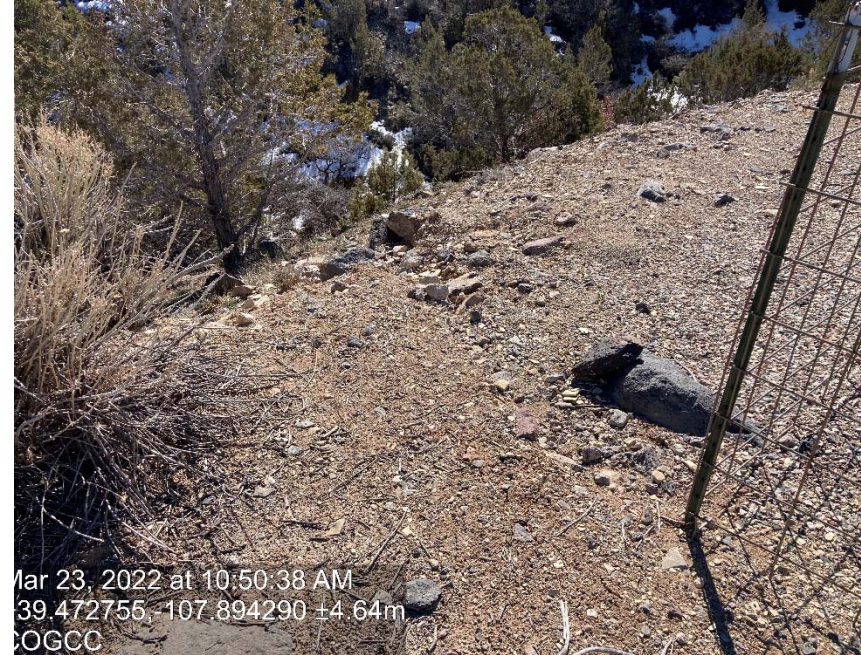
Lack of stabilization/compaction/erosion and sediment migration

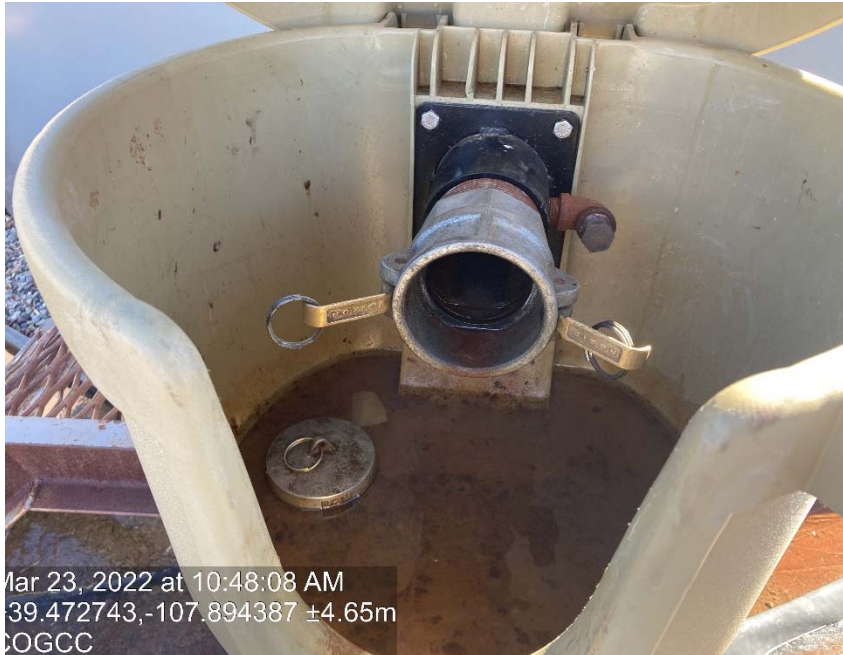
Valve missing cap/plug
