Inspection Photos
Hladky-OGorman&CaryWalking1
Facility ID: 480225
Spill ID: 480738/ Remediation Project No. 19246

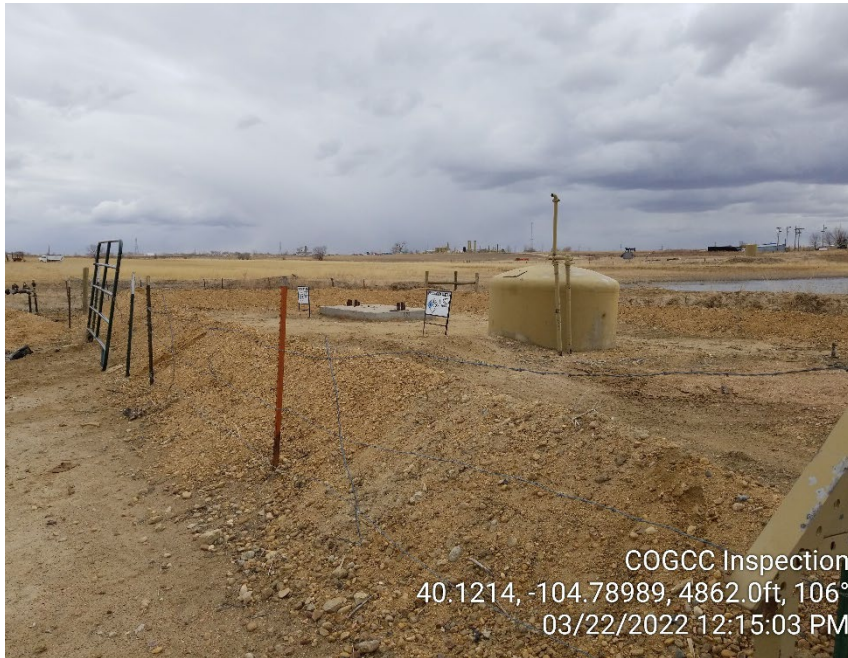
Photo 1 – Produced water vaults at battery. Cement vault to be removed in Rem 19246 remains in place.

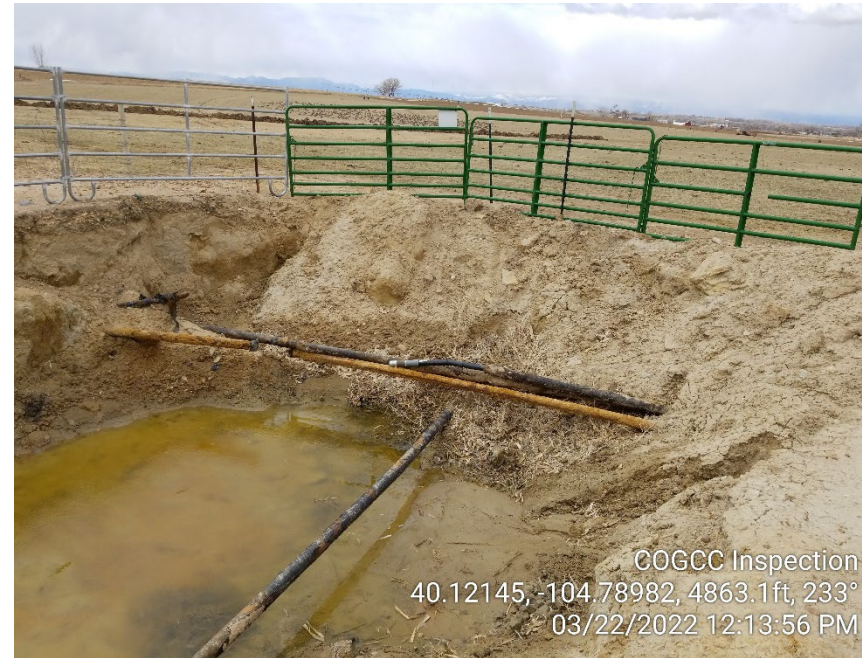
Photo 2 – Open excavation for Spill 480738. Groundwater with hydrocarbon sheen visible in excavation.

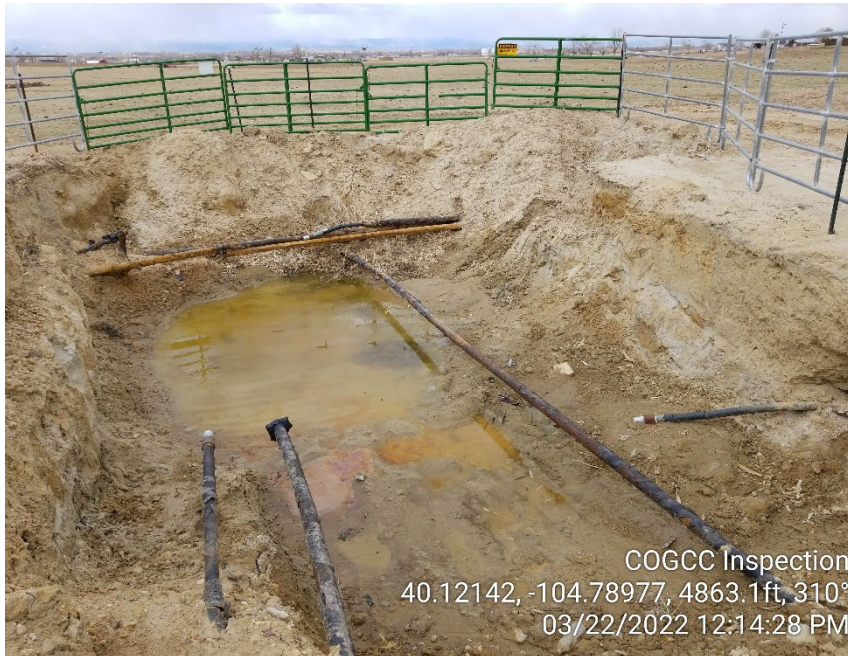
Photo 3 – Open excavation for Spill 480738.
Groundwater with hydrocarbon sheen visible in excavation.

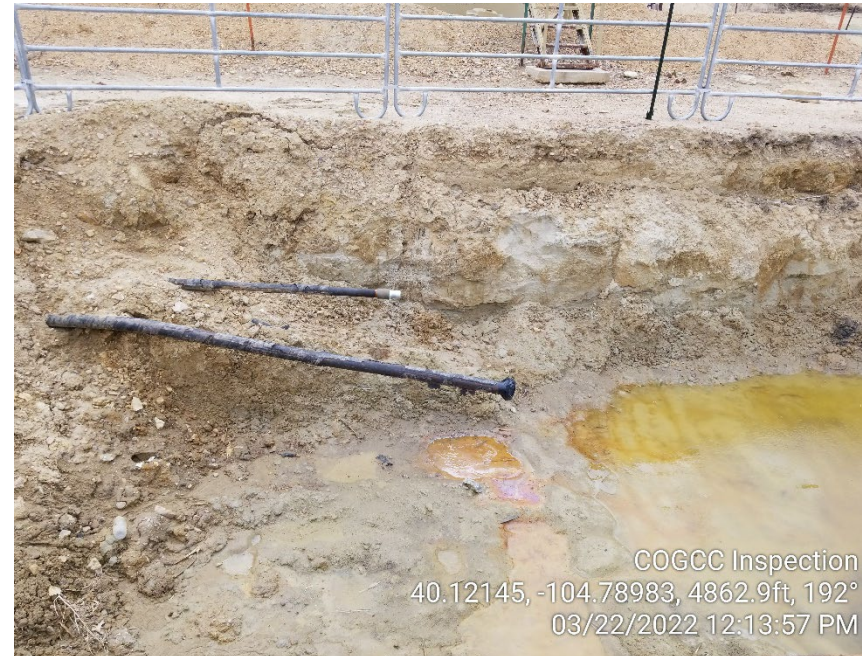
Photo 4 – Open excavation for Spill 480738.
Groundwater with hydrocarbon sheen visible in excavation.

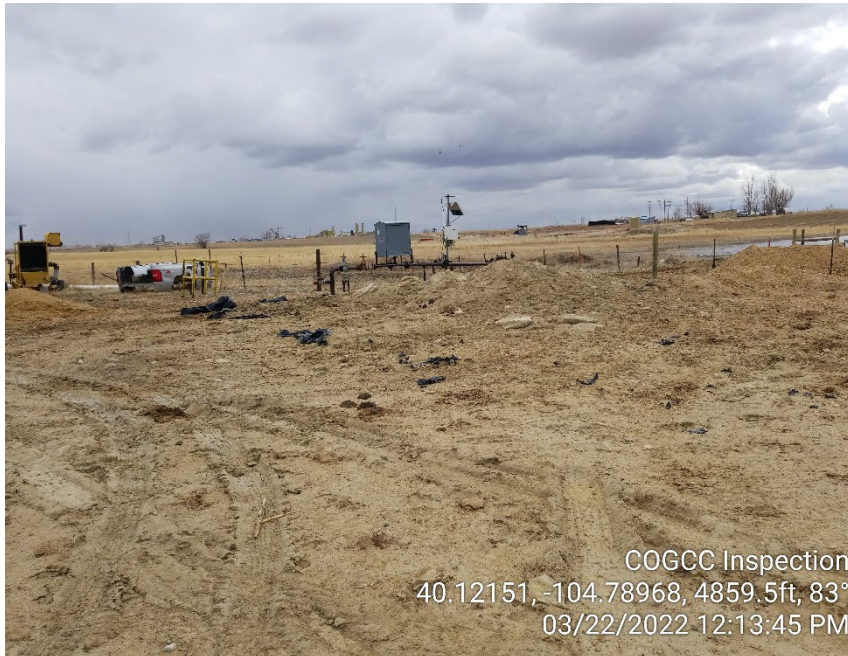
Photo 5 – Soils stored on location. Lining is torn and stormwater BMPs are inadequate.

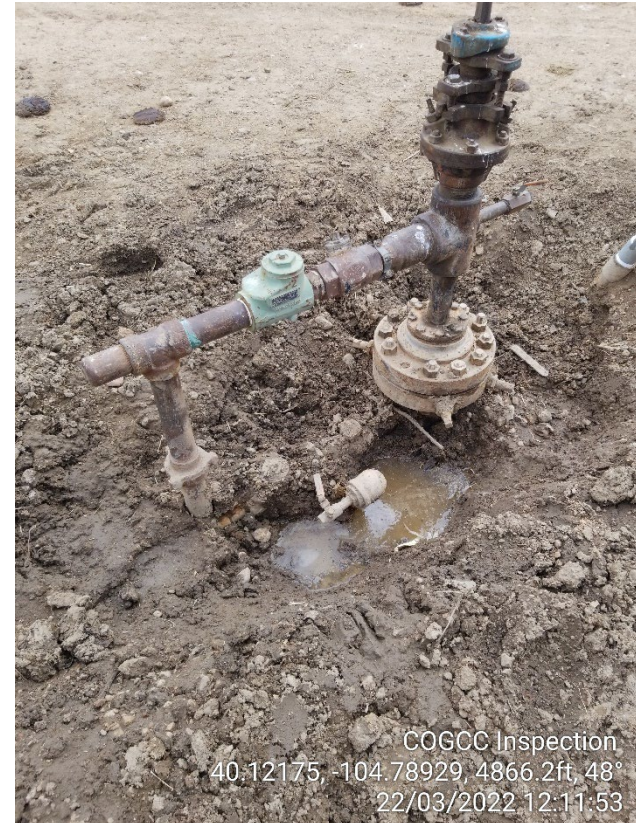
Photo 6 – Soils dug out around wellhead.
