Inspection Photos
Location Name: Florida River Estates 33-9 #17-3A
API: 05-067-09367

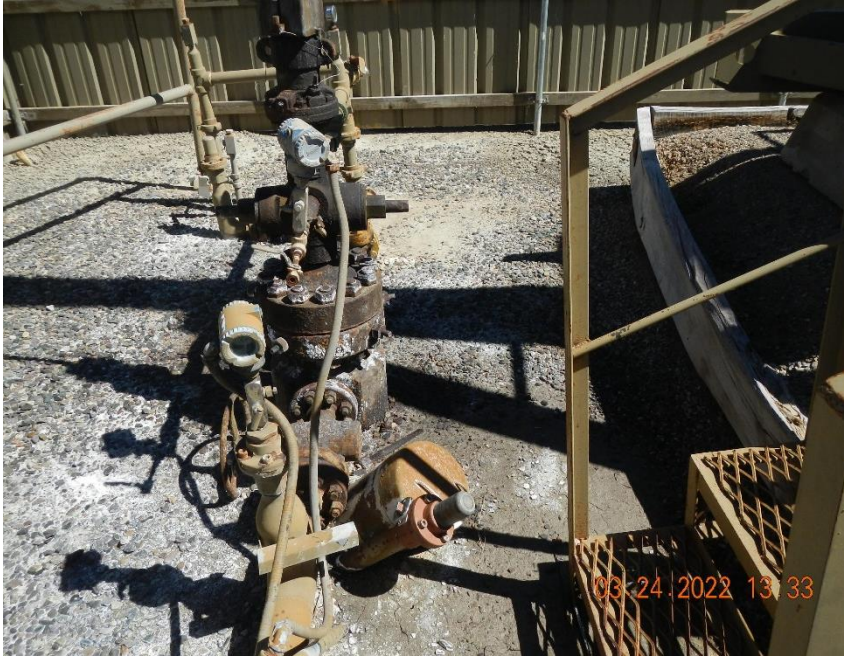
#17-3A well head and surrounding area are stained. Damp soil observed during this inspection.

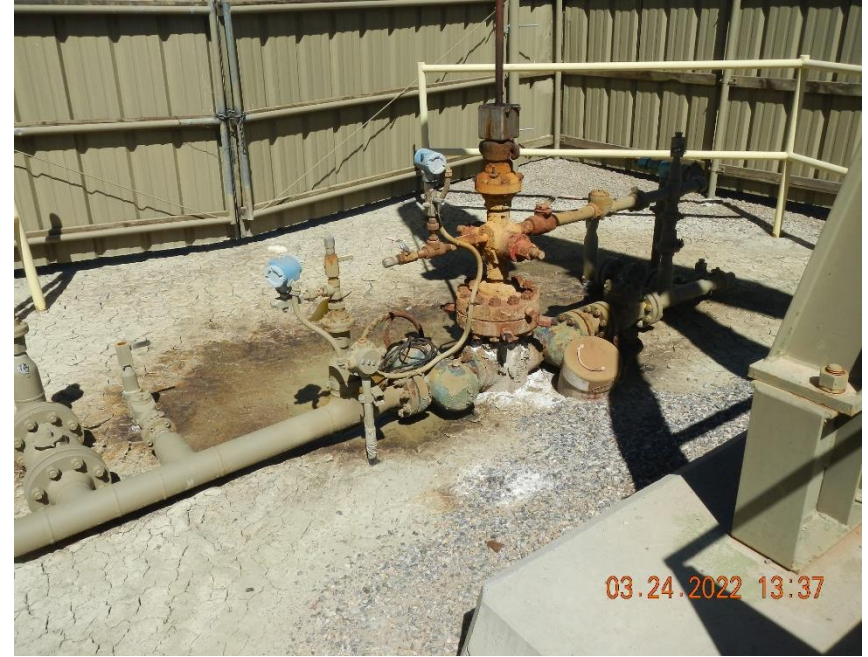
Stained and wet area around #17-3 well head.

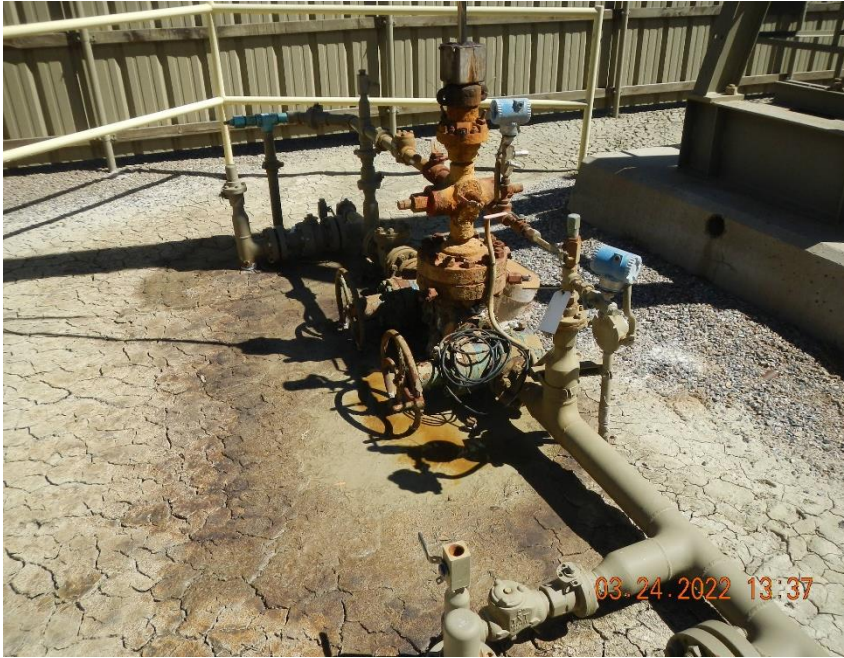
Standing water beneath #17-3 well head.

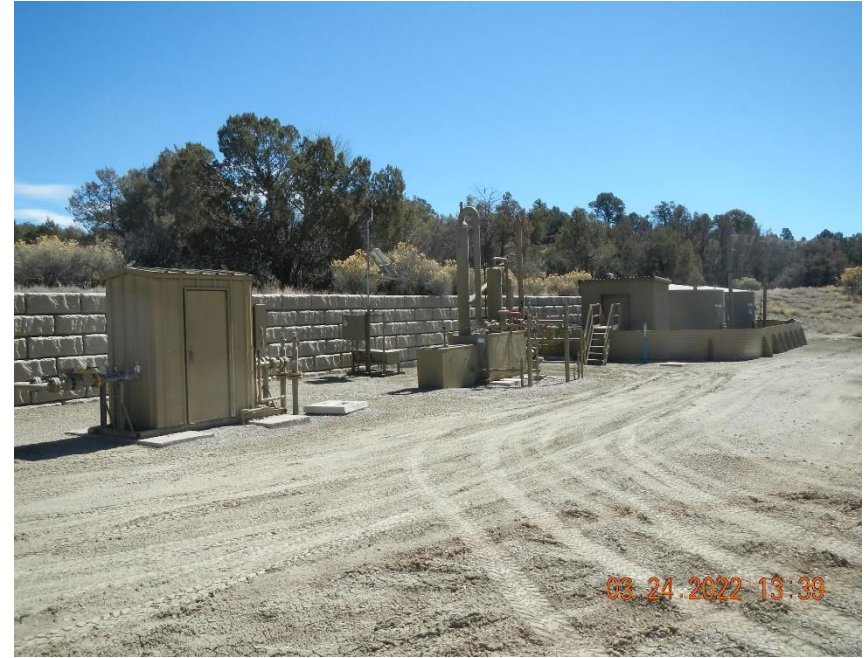
Production equipment on location.

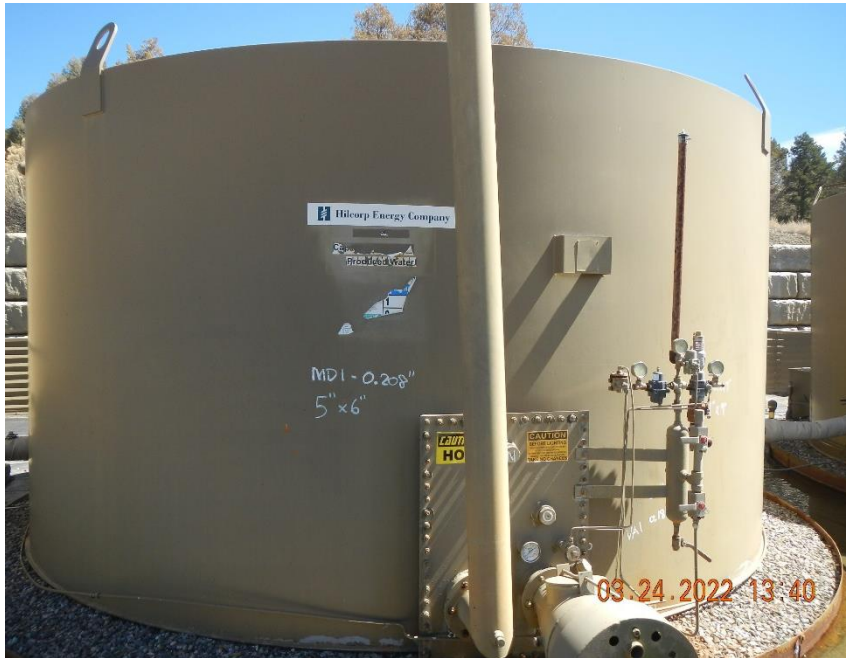
Illegible labels on northern AST.

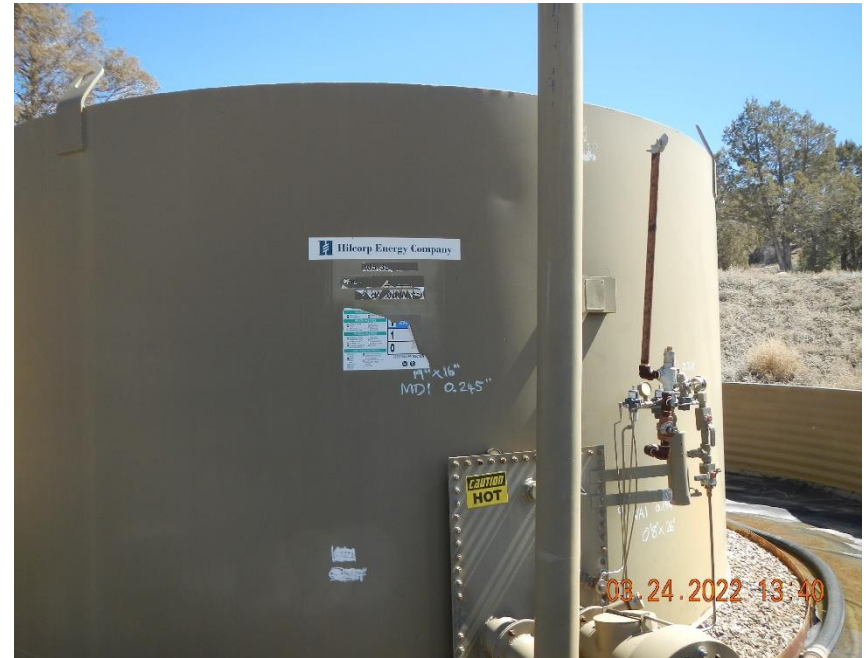
Illegible labels on southern AST.
