Inspection Photos

03/28/2022

Operator: NONSUCH NATURAL GAS INC #
10163

Location ID: 324169
Garfield County, CO

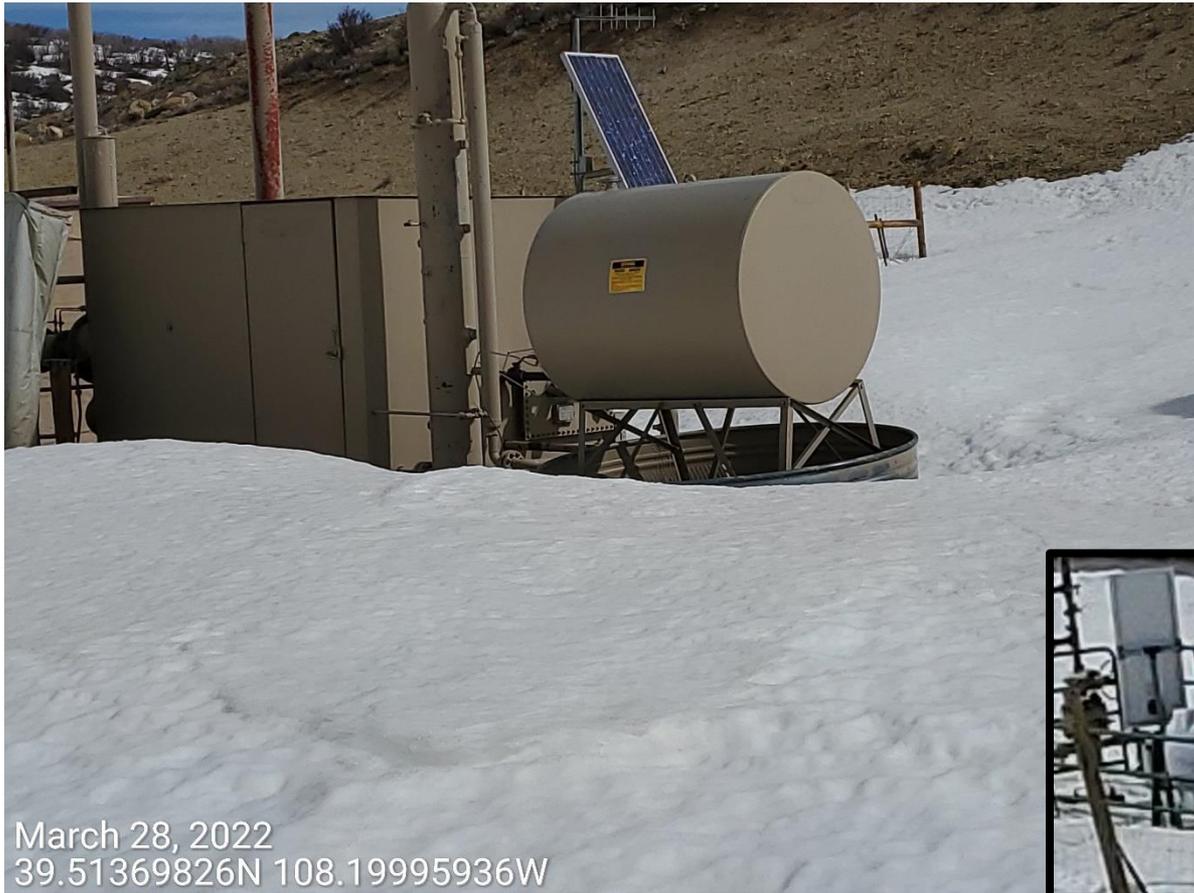
Photo 1: Photo shows wildlife protection devices to prevent wildlife access remain missing or insufficient from the secondary containment BMPs at the tanks.

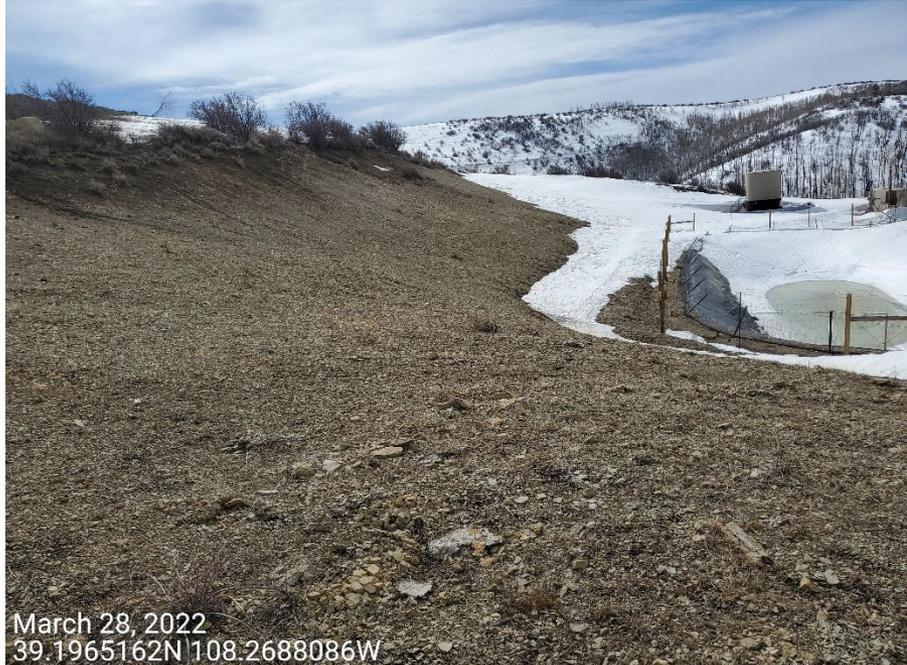
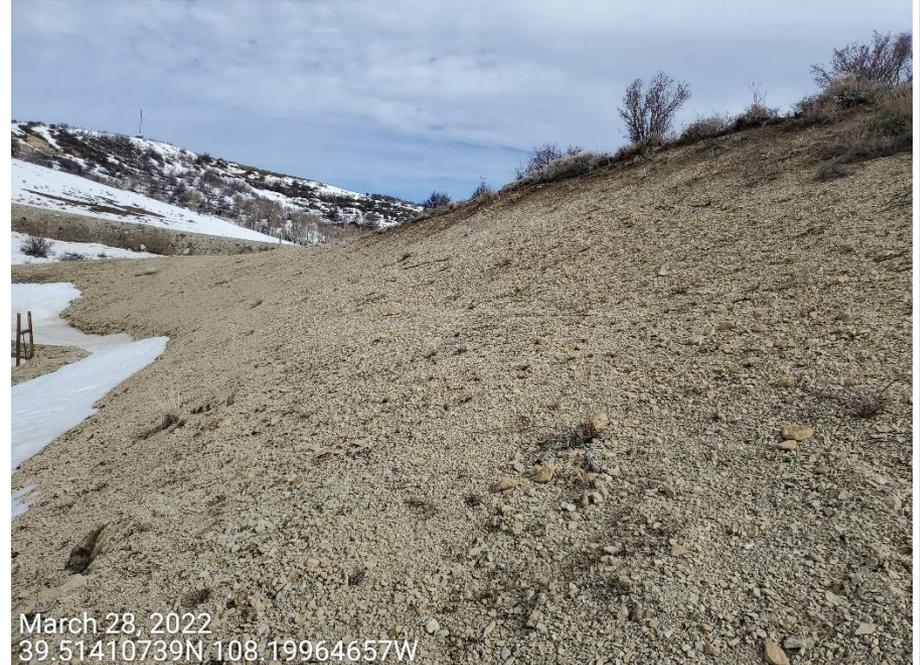
Photo 2: Photos taken from the interim areas on the North/East ends of the Location. Unable to find evidence that additional reclamation performed; reclamation not progressing towards 1003 standards. Photo also shows control measures to protect/stabilize the slopes of the Location remain missing or insufficient. Soils are loose, and composed of fine and rocky materials.

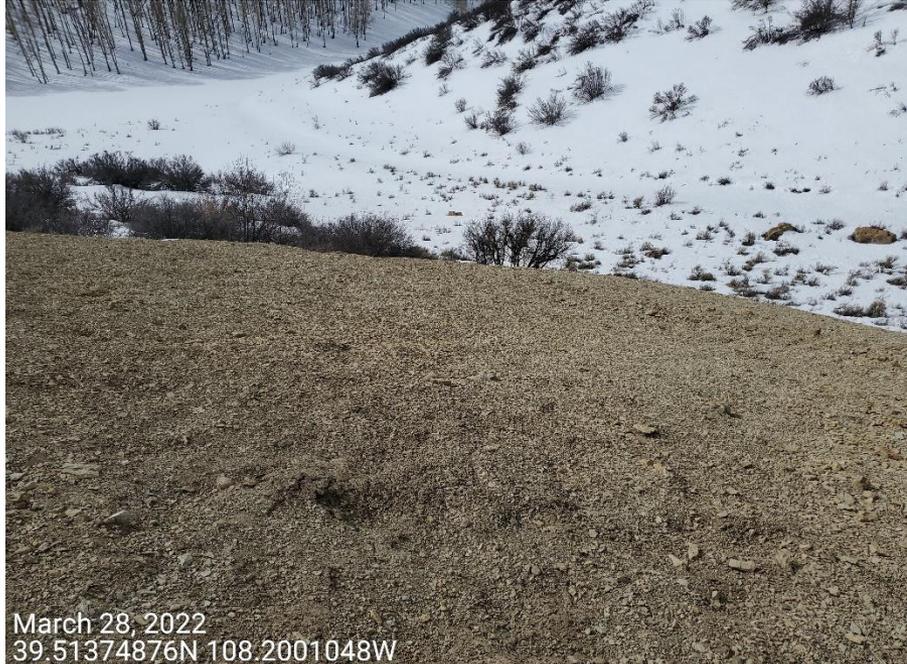
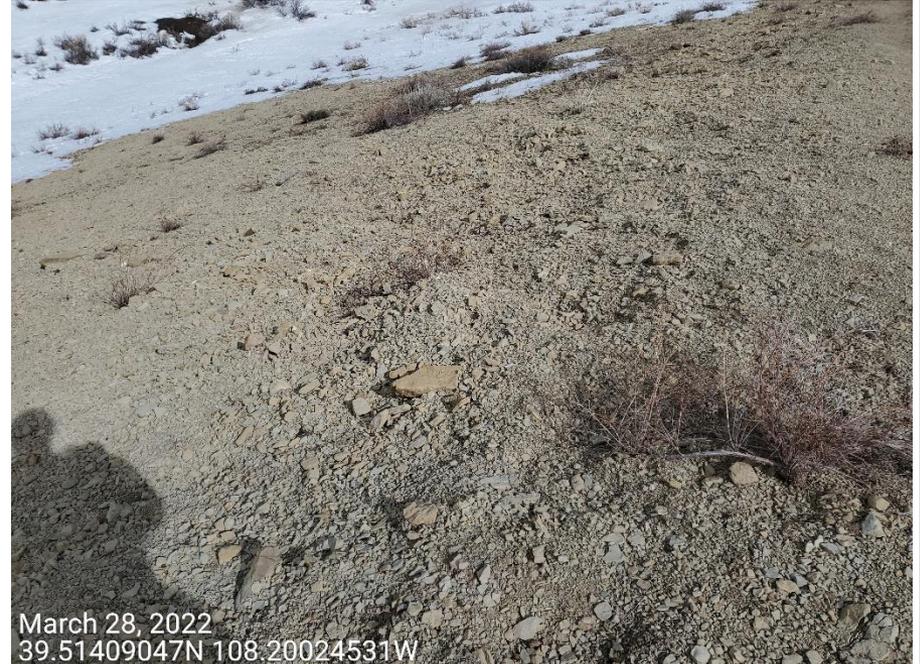
Photo 3: Photos taken from the interim areas on the west end of the Location. Unable to find evidence that additional reclamation performed; reclamation not progressing towards 1003 standards. Photo also shows control measures to protect/stabilize the slopes of the Location, and to prevent offsite sediment transport remains missing or insufficient. Soils are loose, and composed of fine and rocky materials.

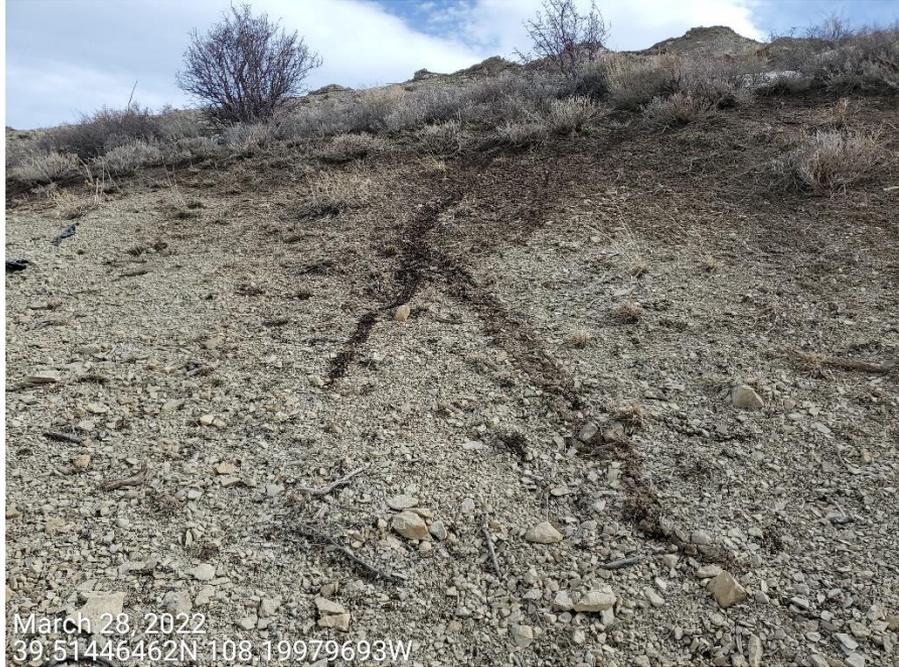
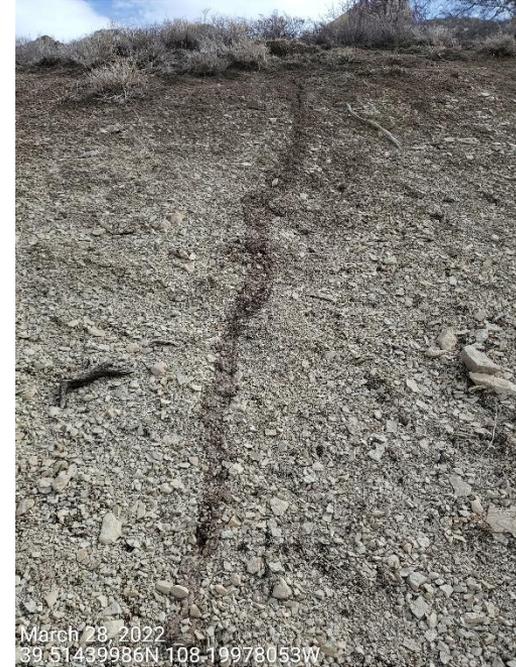
Photo 4: Photos taken from the slopes on the North/East end of the Location. Photo shows erosion and sediment transport.

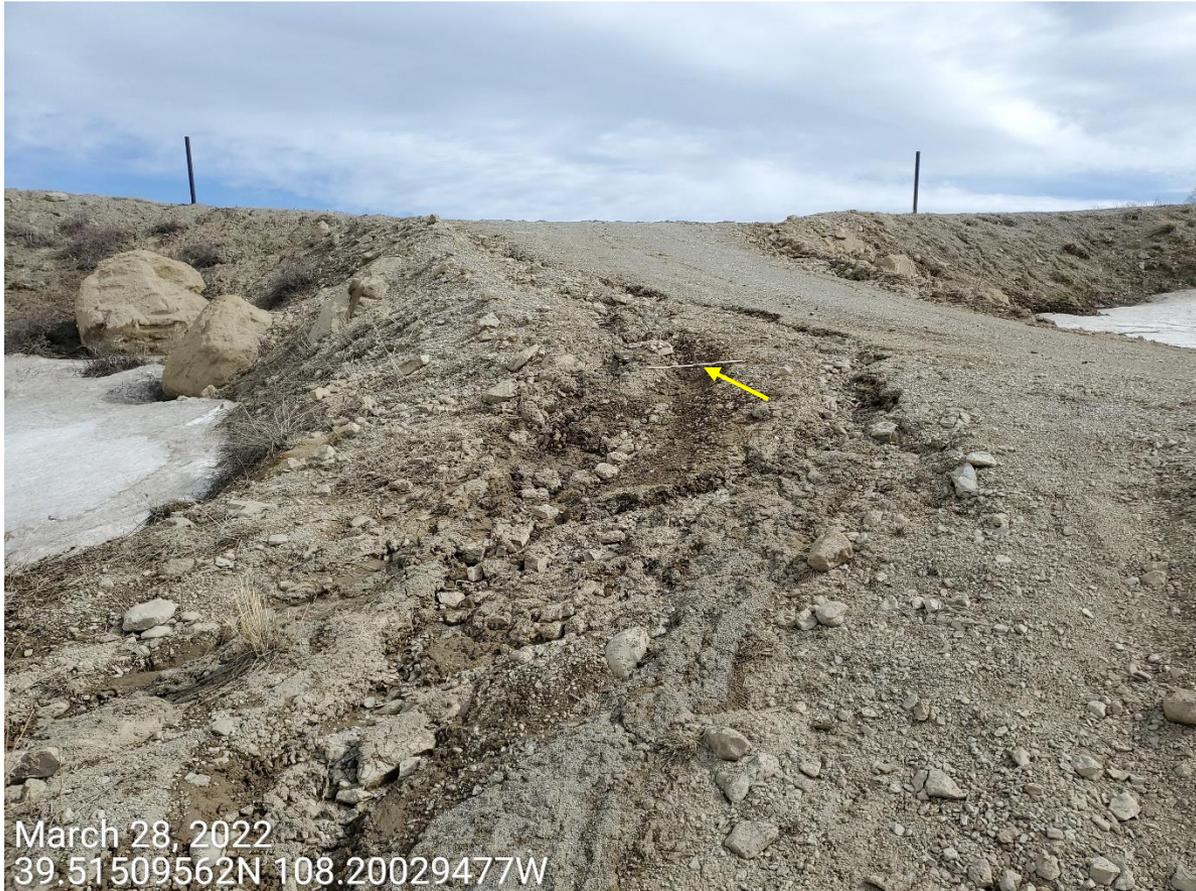
Photo 5: Photo taken from the access road on the north end of the Location. Photo shows erosion degradation has persisted along access road; control measures to stabilize, manage runoff and minimize erosion and sediment transport remains missing or insufficient at access road. 2 foot measuring stick for reference (arrow).

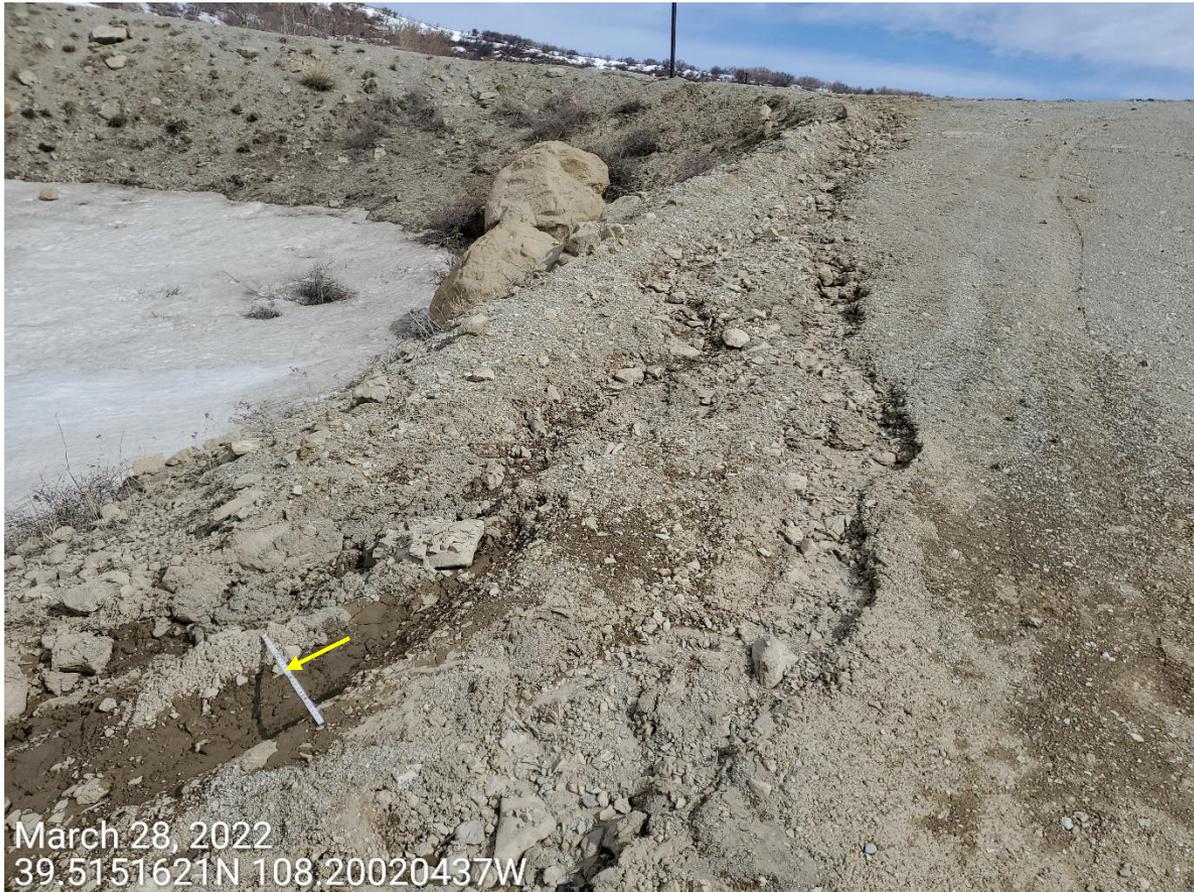
Photo 6: Photo taken from the access road on the north end of the Location. Photo shows erosion degradation has persisted along access road; control measures to stabilize, manage runoff and minimize erosion and sediment transport remains missing or insufficient at access road. 2 foot measuring stick for reference (arrow).

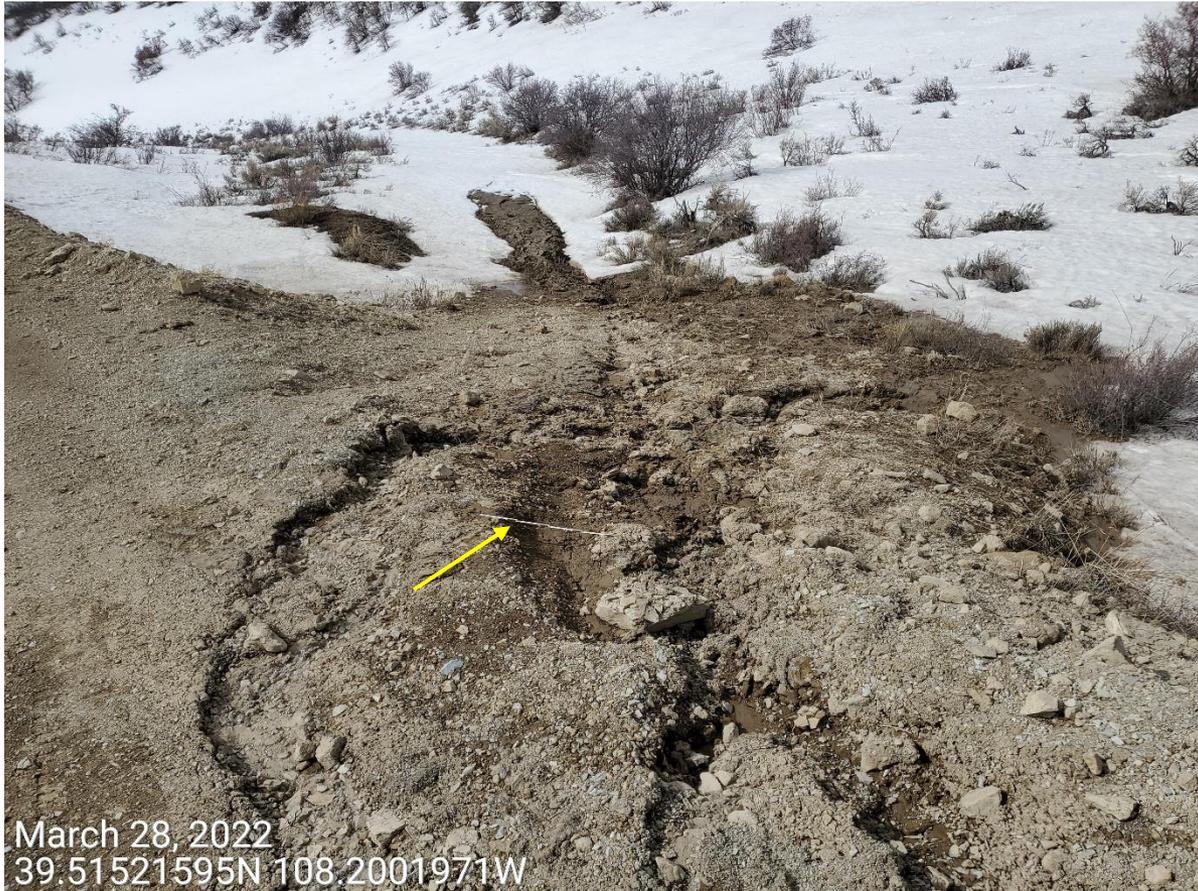
Photo 7: Photo taken from the access road on the north end of the Location. Photo shows erosion degradation has persisted along access road; control measures to stabilize, manage runoff and minimize erosion and sediment transport remains missing or insufficient at access road. 2 foot measuring stick for reference (arrow).

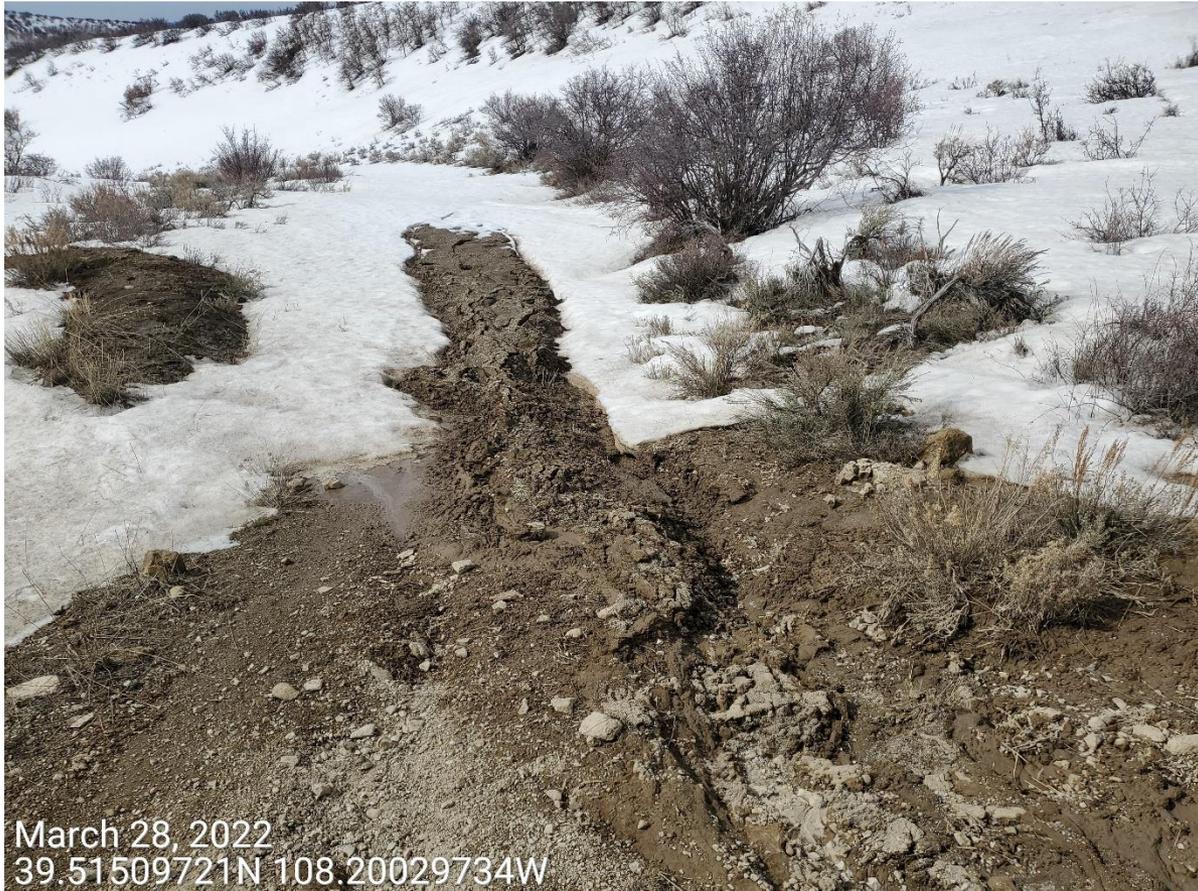
Photo 8: Photo shows sediment deposition due to erosion degradation and sediment transport from the access road.
