Inspection Photos

API: 071-06811

Operator: WAPITI OPERATING LLC

Inspection Date: 3/29/2022

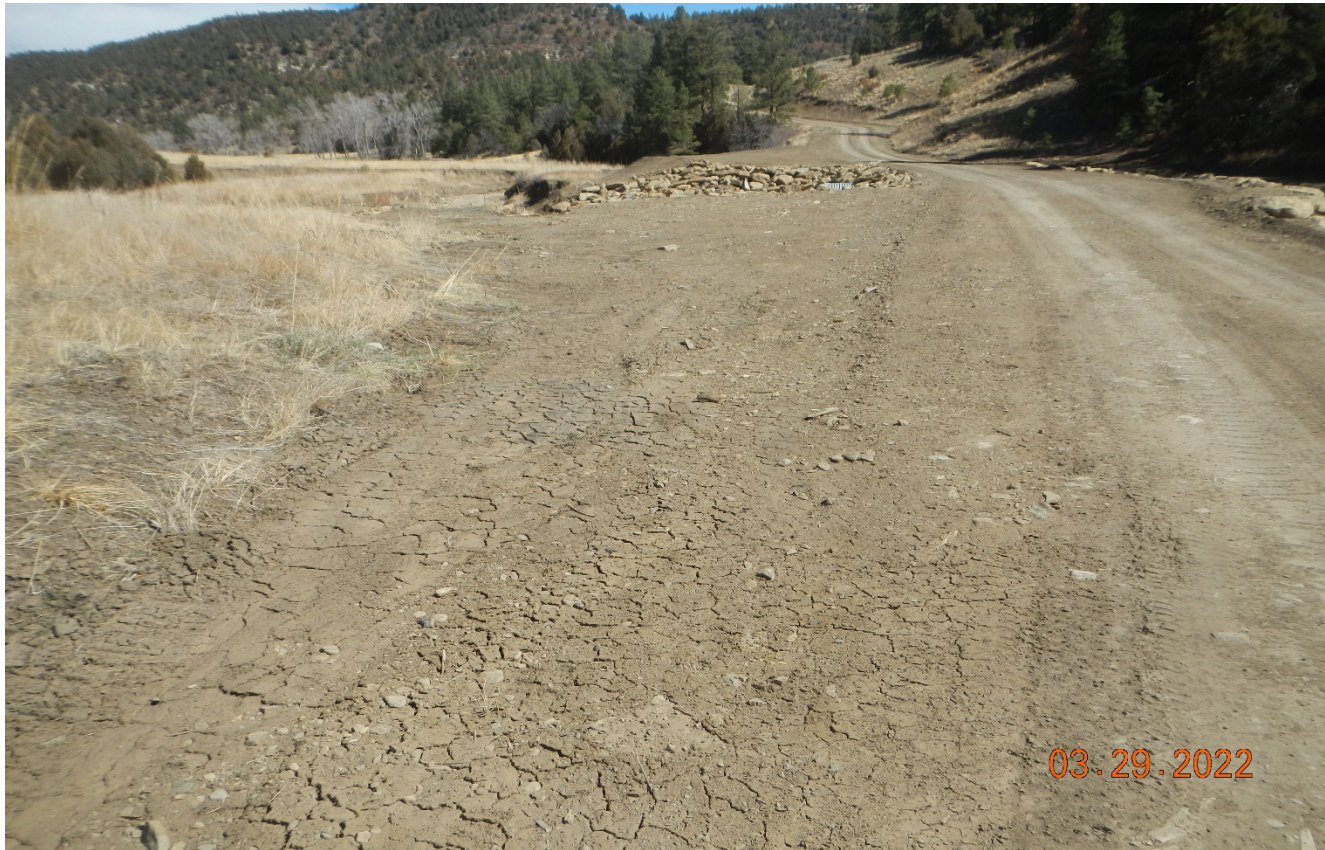
Photo 1. The disturbed bare soils along the roadside at the creek crossing have not been seeded and stabilized. Previous corrective action was not completed.

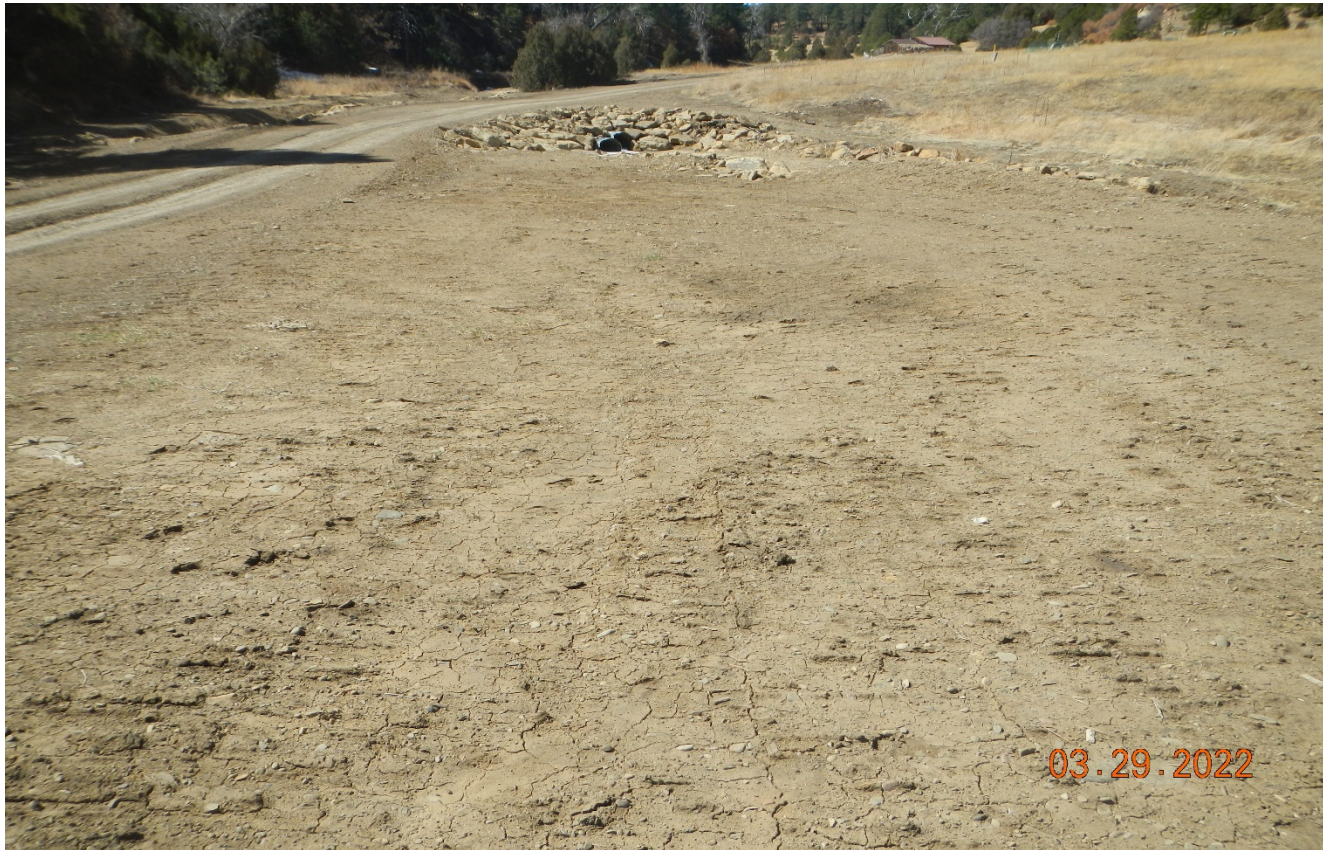
Photo 2. The disturbed bare soils along the roadside at the creek crossing have not been seeded and stabilized. Previous corrective action was not completed.

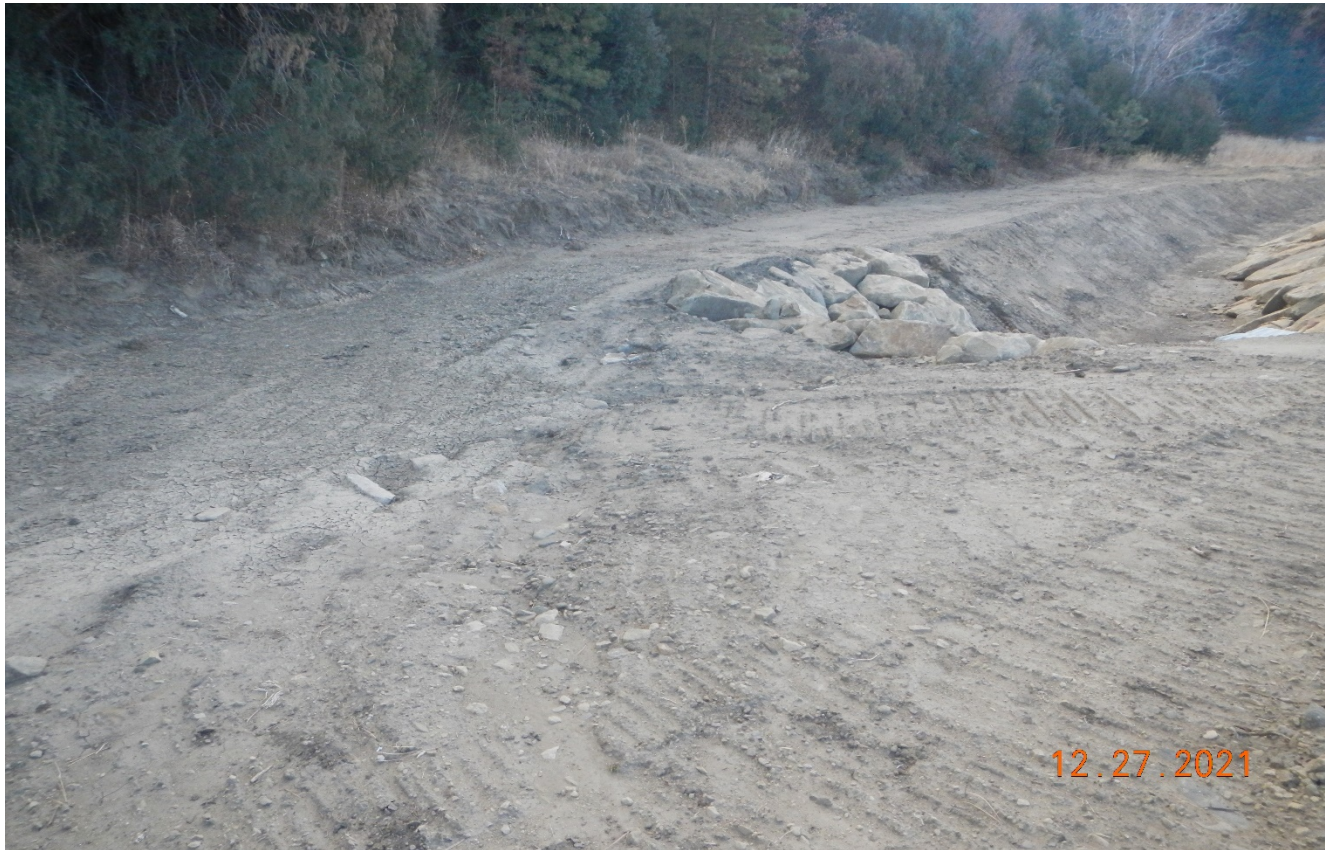
Photo 4. Facing at south side of the road at the additional culvert inlet. Disturbed bare soils have not been seeded and stabilized.

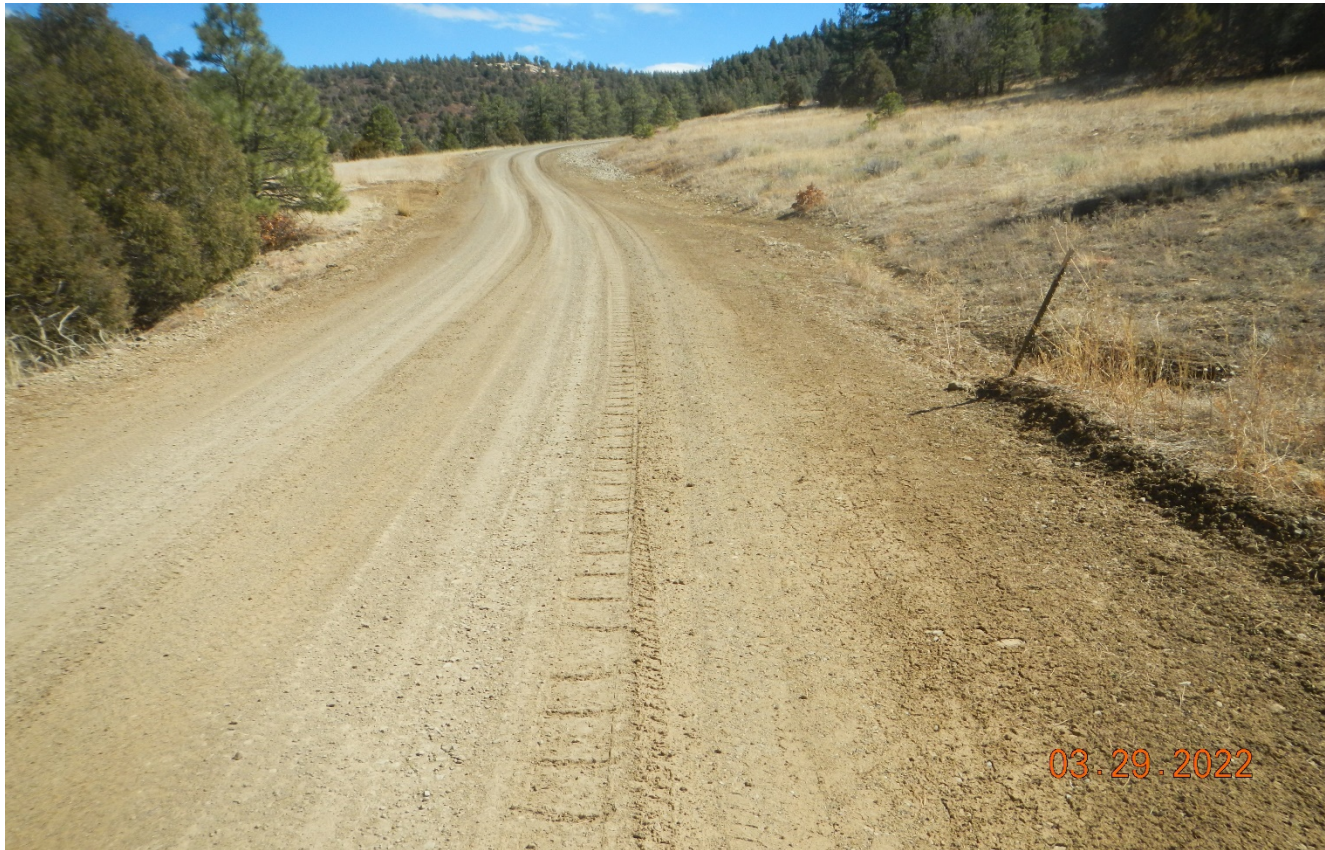
Photo 5. Facing northeast along the road. Areas of erosion along the road side have been filled in and repaired.

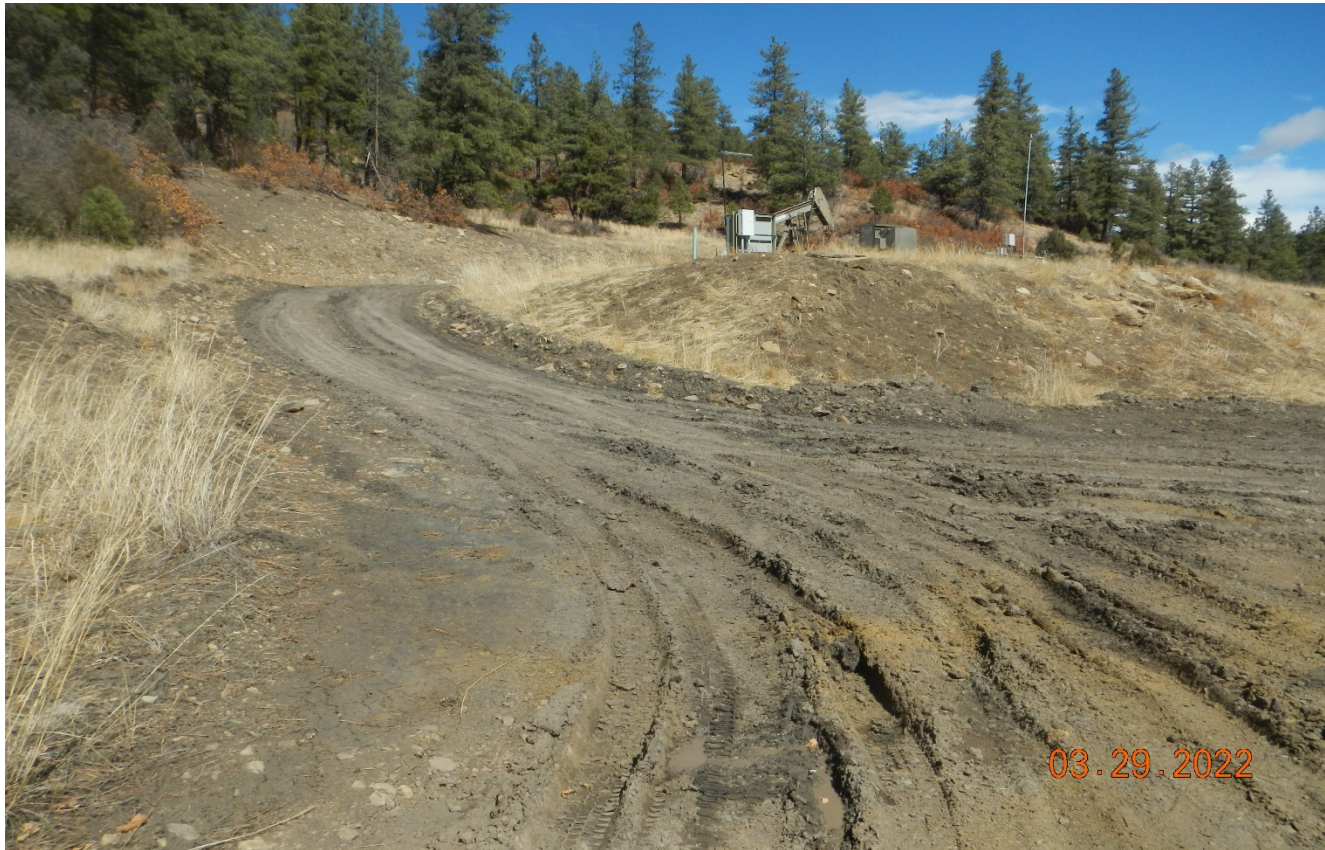
Photo 6. Facing northwest toward the well site.
